GLNG EIS Supplement

Gas Transmission Pipeline, Surface Water Assessment

NOVEMBER 2009

Prepared for
Santos
32 Turbot Street,
Brisbane, QLD 4000.
42626443

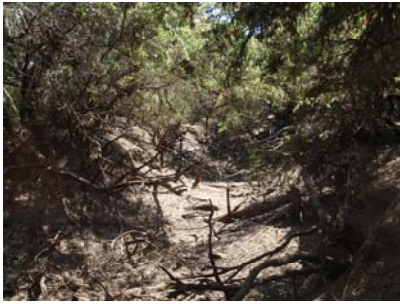
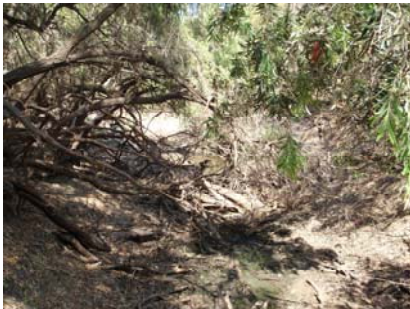
Photo: Looking Upstream

Photo: Looking Downstream

GLNG Supplementary EIS–Surface Water Assessment-Pipeline	
Location No.	1
Location Name	Larcom Creek
<u>Easting:</u>	297,715
<u>Northing:</u>	7,358,412
<u>Site Description:</u> <i>Larcom Creek is located within the Calliope River Catchment. The site is located at the Bruce Highway road crossing. An assessment was undertaken slightly upstream of the road crossing. This ephemeral creek is heavily vegetated with eroded banks and bed.</i>	
<u>Channel Depth:</u>	<i>LB 5m, RB 6m</i>
<u>Channel Width:</u>	<i>6m</i>
<u>Floodplain Width:</u>	<i>>100m</i>
<u>Bank Slope:</u>	<i>LB 2:1, RB 2:1</i>
<u>Channel Banks:</u> Both banks were extremely eroded with undercutting evident. Banks were grassed with small and larger trees.	
<u>Substrate Type:</u> The bed substrate is moderate compaction, which is framework dilated (32 - 60% fine sediment, low availability of interstitial spaces). The predominate particle size is gravel and silt/clay.

<u>Channel Bed:</u> A considerable amount of debris and overlying trees were found within the channel. The bed was severely eroded and dominated by gravel and silt/clay.	
<u>Water Quality:</u> No water present.	
<u>Floodplain:</u> Grazed bushland.

<u>Catchment Size:</u>	<i>184km²</i>		
<u>Channel Slope:</u>	<i>3.1 m/km</i>		
<u>Catchment Storage:</u> Poorly defined and meandering stream.			
<u>Catchment Relief:</u> Rolling with slopes of 1.5 – 4%			
	Q2	Q10	Q100
Intensity	10mm	15mm	23mm
Flow	117m ³ /s	15m ³ /s	661m ³ /s
Depth	0.2m	0.4m	0.7m

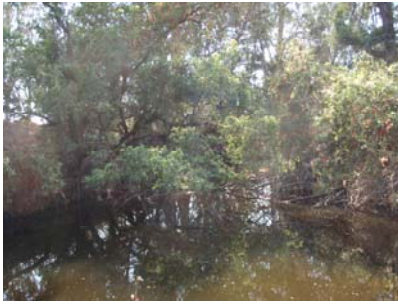
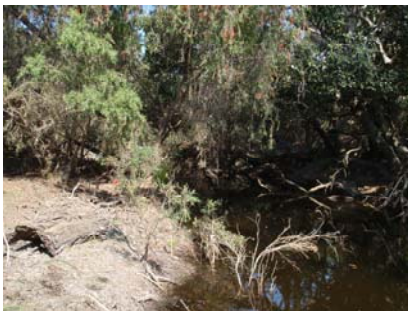
Photo: Looking Upstream

Photo: Looking Downstream

GLNG Supplementary EIS–Surface Water Assessment-Pipeline	
Location No.	2
Location Name	Larcom Creek
<u>Easting:</u>	235,610
<u>Northing:</u>	7,358,610
<u>Site Description:</u> <i>Larcom Creek is located within the Calliope River Catchment. The site is located east (upstream) of the Bruce Highway. Water was present within this heavily vegetated ephemeral creek.</i>	
<u>Channel Depth:</u>	<i>LB 10m, RB 6m</i>
<u>Channel Width:</u>	<i>10m</i>
<u>Floodplain Width:</u>	<i>>100m</i>
<u>Bank Slope:</u>	<i>LB 2:1, RB 3:1</i>
<u>Channel Banks:</u> Both left and right banks are fair to moderately unstable. The bank slope is convex in shape. Vegetation (ie small and large trees) are present along the banks, before entering a grassy floodplain.	
<u>Substrate Type:</u> Water was present therefore the bed compaction and sediment matrix of the bed was unable to be identified. The predominate particle size is silt/clay.

<u>Channel Bed:</u> The bed is predominantly silt/clay. The stability of the bed was unable to be determined due to the presents of water.	
<u>Water Quality:</u> Water was absent of sediment oils and odours. Water sheen present. The water was slightly turbid, and of brown colouring. No flow.	
<u>Floodplain:</u> Grazed bushland.

<u>Catchment Size:</u>	<i>193km²</i>		
<u>Channel Slope:</u>	<i>2.9 m/km</i>		
<u>Catchment Storage:</u>	<i>Poorly defined and meandering stream.</i>		
<u>Catchment Relief:</u>	<i>Rolling with slopes of 1.5 – 4%</i>		
	Q2	Q10	Q100
Intensity	10mm	15mm	23mm
Flow	123m ³ /s	288m ³ /s	693m ³ /s
Depth	1.0m	1.4m	1.9m

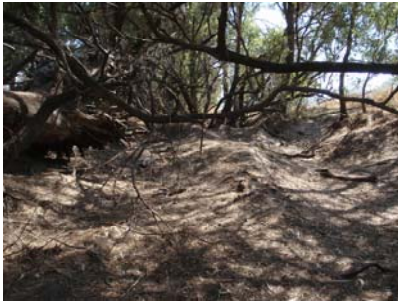
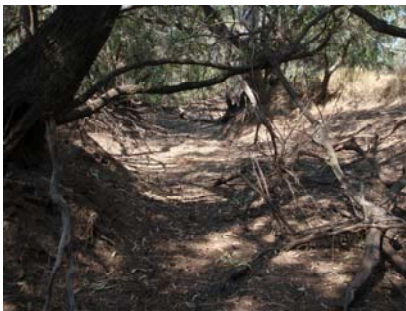
Photo: Looking Upstream

Photo: Looking Downstream

GLNG Supplementary EIS–Surface Water Assessment-Pipeline	
Location No.	3
Location Name	Larcom Creek
Easting:	299,526
Northing:	7,358,747
Site Description: <i>Larcom Creek is located within the Calliope River Catchment. The site is located east (upstream) of the Bruce Highway and consisted of moderately eroded banks and bed with overlying trees.</i>	
Channel Depth:	<i>LB 2.5m, RB 2m (LB 1m, RB 2m low flow channel)</i>
Channel Width:	<i>6m (4m low flow channel)</i>
Floodplain Width:	<i>>100m</i>
Bank Slope:	<i>LB 1:1, RB 2:1</i>
Channel Banks: Many eroded areas were evident on both banks. The banks are convex in shape with overlying trees.	
Substrate Type: The bed substrate is packed, unarmoured which is framework dilated (32 - 60% fine sediment, low availability of interstitial spaces). The predominate particle size is silt/clay and gravel.	
Channel Bed: Moderate erosion is apparent with the channel bed. The bed consists of gravel and silt/clay.

Water Quality: No water present.	
Floodplain: Grazed bushland.

Catchment Size:	<i>194km²</i>		
Channel Slope:	<i>2.9 m/km</i>		
Catchment Storage: Poorly defined and meandering stream.			
Catchment Relief: Rolling with slopes of 1.5 – 4%			
	Q2	Q10	Q100
Intensity	10mm	15mm	23mm
Flow	123m ³ /s	289m ³ /s	695m ³ /s
Depth	1.1m	1.6m	2.2m

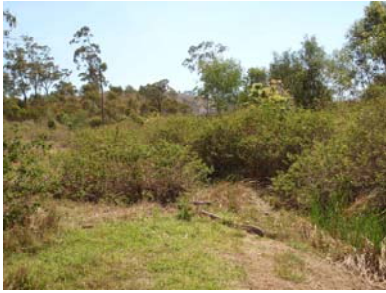
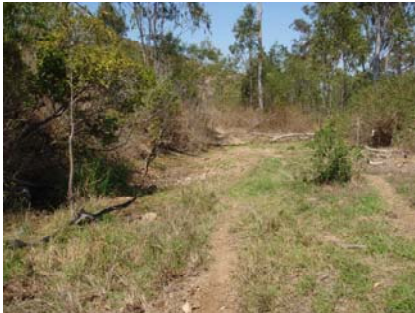
Photo: Looking Upstream

Photo: Looking Downstream

GLNG Supplementary EIS–Surface Water Assessment-Pipeline	
Location No.	4
Location Name	Sneaker Gully
<u>Easting:</u>	302,110
<u>Northing:</u>	7,369,845
<u>Site Description:</u> <i>Sneaker Gully is located upstream of Larcom Creek. The site was found to be heavily grassed with a clay silt bed surface..</i>	
<u>Channel Depth:</u>	<i>LB 2m, RB 1m</i>
<u>Channel Width:</u>	<i>3m (2m low flow channel)</i>
<u>Floodplain Width:</u>	<i>>100m</i>
<u>Bank Slope:</u>	<i>LB 1:1, RB 1:1</i>
<u>Channel Banks:</u> Both banks are poor to unstable. The left bank is convex in shape whereas the right bank is concave in shape.	
<u>Substrate Type:</u> The bed substrate is tightly packed, armoured, which is framework dilated (32 - 60% fine sediment, low availability of interstitial spaces). The predominate particle size is silt/clay.	
<u>Channel Bed:</u> The channel has a clay silt bed surface which is tightly packed, armoured. The bed is severely eroded.

<u>Water Quality:</u> Profuse sediment oils and globs of water oils were found. No water or sediment odours were detected. The water was turbid, brown in colour, with the presence of moulds.	
<u>Floodplain:</u> Grazed bushland.

<u>Catchment Size:</u>	<i>0.88km²</i>		
<u>Channel Slope:</u>	<i>2.9 m/km</i>		
<u>Catchment Storage:</u> Poorly defined and meandering stream.			
<u>Catchment Relief:</u> Rolling with slopes of 1.5 – 4%			
	Q2	Q10	Q100
Intensity	10mm	15mm	23mm
Flow	0.6m ³ /s	15m ³ /s	23m ³ /s
Depth	0.01m	0.02m	0.02m

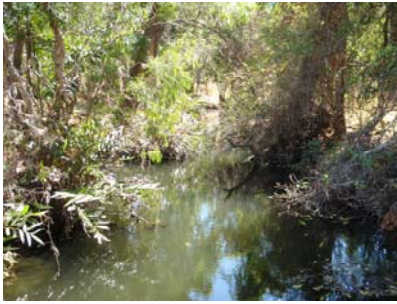
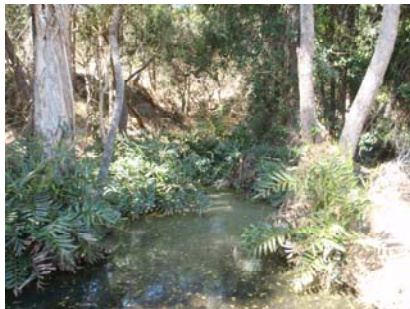
Photo: Looking Upstream

Photo: Looking Downstream

GLNG Supplementary EIS–Surface Water Assessment-Pipeline	
Location No.	5
Location Name	Humpy Creek
<u>Easting:</u>	306,504
<u>Northing:</u>	7,370,677
<u>Site Description:</u> <i>Humpy Creek is a tributary of Mosquito Creek located within the Calliope River Catchment. Water was found within this ephemeral stream. Large trees were present on the banks.</i>	
<u>Channel Depth:</u>	<i>LB 5m, RB 1m</i>
<u>Channel Width:</u>	<i>3m</i>
<u>Floodplain Width:</u>	<i>>100m</i>
<u>Bank Slope:</u>	<i>LB 1:1, RB 1:1</i>
<u>Channel Banks:</u> Both left and right banks appear fairly stable. The banks are concave. The left bank consists of grasses and small and large trees, whereas the right bank it predominantly grassed at the location assessed.	
<u>Substrate Type:</u> Water was present therefore substrate type was not identified.	
<u>Channel Bed:</u> Characteristics of the bed were unable to be determined due to the presents of water. The width of bed was 3m.

<u>Water Quality:</u> No water present.	
<u>Floodplain:</u> Grazed bushland.

<u>Catchment Size:</u>	<i>5.04km²</i>		
<u>Channel Slope:</u>	<i>12 m/km</i>		
<u>Catchment Storage:</u>	Poorly defined and meandering stream.		
<u>Catchment Relief:</u>	Rolling with slopes of 1.5 – 4%		
	Q2	Q10	Q100
Intensity	29mm	42mm	65mm
Flow	11m ³ /s	26m ³ /s	61m ³ /s
Depth	0.5m	0.7m	1.0m

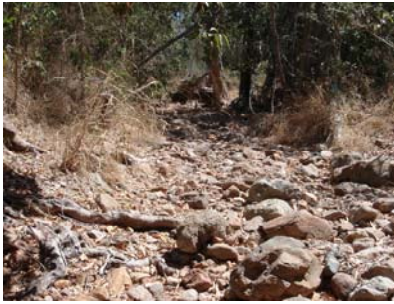
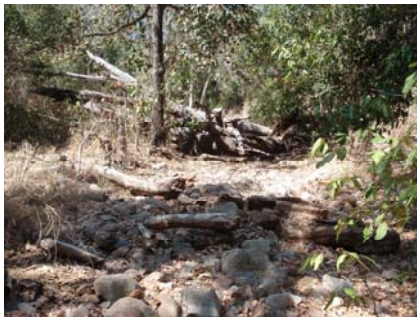
Photo: Looking Upstream

Photo: Looking Downstream

GLNG Supplementary EIS–Surface Water Assessment-Pipeline	
Location No.	7
Location Name	Targinie Creek
Easting:	307,440
Northing:	7,368,074
Site Description: The small stream is located upstream of the coastal plain north of Gladstone. The location the proposed pipeline will cross on Targinie Creek was inaccessible. Therefore a site upstream of this location was assessed instead. The bed of Targinie Creek at this site was dominated by boulders and cobbles.	
Channel Depth:	LB 0.5m, RB 2m
Channel Width:	4m
Floodplain Width:	>100m
Bank Slope:	LB 1:3, RB 1:3
Channel Banks: Both left and right banks appear fair to moderately stable, with areas of erosion detected. The left bank slope is concave in shape, whilst the right slope is convex in shape. The banks are grassed with small and large trees.	
Substrate Type: The bed substrate is tightly packed, armoured, which is matrix filled contact framework (5 - 32% fine sediment, moderate availability of interstitial spaces). The predominate particle size is boulder/cobble.

Channel Bed: Large log jams were found across the entire width of channel bed. The bed was also dominated by boulders/cobbles and was tightly packed. The bed was found to be stable.	
Water Quality: No water present.	
Floodplain: Grazed bushland.

Catchment Size:	15km ²		
Channel Slope:	14 m/km		
Catchment Storage:	Poorly defined and meandering stream.		
Catchment Relief:	Rolling with slopes of 1.5 – 4%		
	Q2	Q10	Q100
Intensity	22mm	31mm	48mm
Flow	21m ³ /s	48m ³ /s	114m ³ /s
Depth	0.2m	0.3m	0.5m

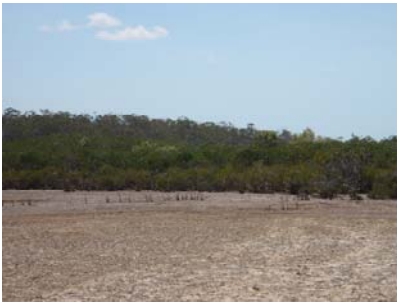
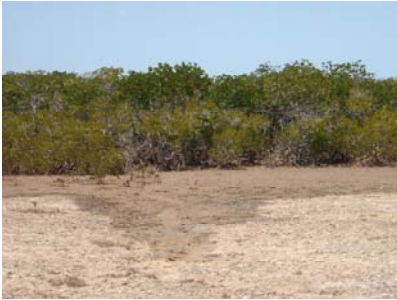
Photo: Mosquito Creek

GLNG Supplementary EIS–Surface Water Assessment-Pipeline	
Location No.	8,9,10
Location Name	Mosquito Creek and Targinie Creek
<u>Easting:</u>	306,504
<u>Northing:</u>	7,370,677
<u>Site Description:</u> <i>Mosquito Creek and downstream Targinie Creek are within the coastal plain and are estuarine. An assessment was undertaken within the floodplain due to difficulties accessing watercourses.</i>	
<u>Channel Banks:</u> The waterways are fringed by narrow riparian strips of vegetation which are relics of the extensive woodlands that were once present throughout the region.	
<u>Substrate Type:</u> Silty-clay

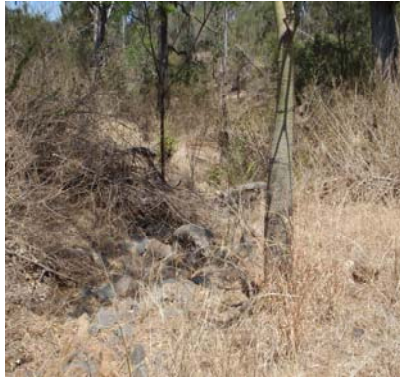
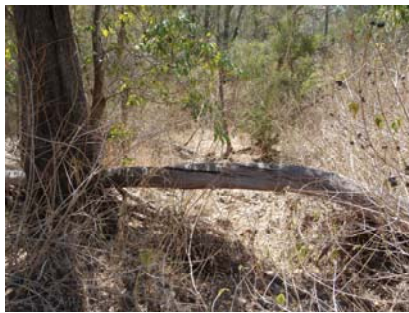
Location No.	11
Location Name	Collard Creek
<u>Easting:</u>	255,734
<u>Northing:</u>	7,320,137
<u>Site Description:</u> <i>Collard Creek, a tributary of Bell Creek, is located to the south west of Gladstone. The ephemeral stream is heavily vegetated with mature larger trees, dense scrubs on the banks and juvenile trees on the coarse gravel bed.</i>	
<u>Channel Depth:</u>	<0.5m
<u>Channel Width:</u>	1.5m
<u>Floodplain Width:</u>	>100m
<u>Bank Slope:</u>	LB 1:10, RB 1:10
<u>Channel Banks:</u> Both left and right banks appear fairly stable, with no evidence of erosion or bank failure at the site location. The low grade left bank slope is concave in shape, whilst the right steeper slope is convex in shape. The banks are grassed with a scatter of small trees.	
<u>Substrate Type:</u> The bed substrate is of low compaction which is matrix dominated (>60% fine sediment, interstitial spaces virtually absent). The predominate particle size is a coarse gravel.

<u>Channel Bed:</u> This small stream is approximately 1.5m wide and has a depth of less than 0.5m. The channel has a flat gravel bed surface.	
<u>Water Quality:</u> No water present.	
<u>Floodplain:</u> Grazed bushland.

Photo: Looking Downstream

Photo: Looking Upstream

<u>Catchment Size:</u>	71km ²		
<u>Channel Slope:</u>	9.7 m/km		
<u>Catchment Storage:</u> Well defined system of small watercourses.			
<u>Catchment Relief:</u> Hilly, with average slopes of 4 – 8%			
	Q2	Q10	Q100
Intensity	15mm	21mm	33mm
Flow	90m ³ /s	211m ³ /s	503m ³ /s
Depth	1.2m	1.6m	2.0m

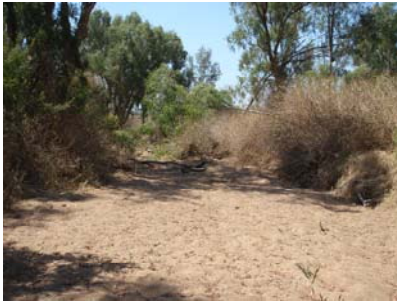
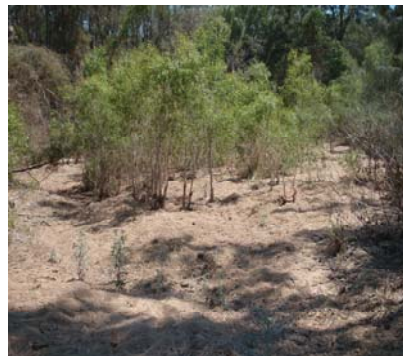
Photo: Looking Upstream

Photo: Looking Downstream

GLNG Supplementary EIS–Surface Water Assessment-Pipeline	
Location No.	17
Location Name	Bell Creek
<u>Easting:</u>	257,438
<u>Northing:</u>	7,322,521
<u>Site Description:</u> <i>Bell Creek is located to the south west of Gladstone. The ephemeral stream is heavily vegetated with mature larger trees, dense scrubs on the banks and juvenile trees on the coarse gravel bed.</i>	
<u>Channel Depth:</u>	0.5m
<u>Channel Width:</u>	8m
<u>Floodplain Width:</u>	20m
<u>Bank Slope:</u>	LB 1:40, RB 1:40
<u>Channel Banks:</u> The left bank is fair to moderately unstable whilst the right bank is unstable with evidence of erosion. Both banks are concave. The banks are grassed with a scatter of small and larger trees.	
<u>Substrate Type:</u> The bed substrate is of low compaction which is matrix dominated (>60% fine sediment, interstitial spaces virtually absent). The predominate particle size is gravel and sand, with pebbles and some boulders.

<u>Channel Bed:</u> The bed is fairly sandy and has moderate deposition. The bed is approximately 8m wide.	
<u>Water Quality:</u> No water present.	
<u>Floodplain:</u> Grazed bushland.

<u>Catchment Size:</u>	108km ²		
<u>Channel Slope:</u>	6 m/km		
<u>Catchment Storage:</u>	Poorly defined and meandering stream.		
<u>Catchment Relief:</u>	Rolling with slopes 1.5 - 4%		
	Q2	Q10	Q100
Intensity	13mm	19mm	29mm
Flow	94m ³ /s	19m ³ /s	526.5m ³ /s
Depth	0.6m	1.1m	1.9m

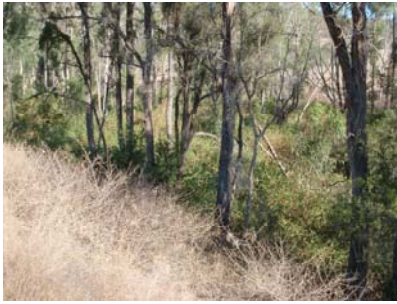
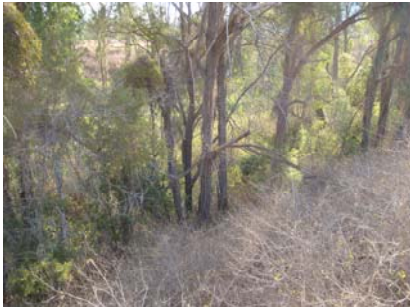
Photo: Looking Upstream

Photo: Looking Downstream

GLNG Supplementary EIS–Surface Water Assessment-Pipeline	
Location No.	18
Location Name	Bell Creek
Easting:	260,885
Northing:	7,322,770
Site Description: <i>Bell Creek is located to the south west of Gladstone. The ephemeral stream is heavily vegetated with mature larger trees, dense scrubs on the banks and juvenile trees on the coarse gravel bed. This overgrown reach of the creek was unable to be accessed therefore the assessment was taken from the upper banks.</i>	
Channel Depth:	
Channel Width:	
Floodplain Width:	>100m
Bank Slope:	
Channel Banks: The channel banks were considerably high (approximately 25m). Banks were fairly stable and concave in shape. Banks were overgrown in grasses, small and large trees.	
Substrate Type: Water was present therefore the bed compaction and sediment matrix of the bed was unable to be identified. The predominate particle size is silt/clay.	
Channel Bed: Unable to access creek bed as too overgrown.

Water Quality: Unable to identify if water was present in creek channel.	
Floodplain: Grazed bushland.

Catchment Size:	105km ²		
Channel Slope:	6 m/km		
Catchment Storage: Poorly defined and meandering stream.			
Catchment Relief: Rolling with slopes of 1.5 – 4%			
	Q2	Q10	Q100
Intensity	13mm	19mm	29mm
Flow	84m ³ /s	m ³ /s	514m ³ /s
Depth	0.7m	1.2m	2.1m

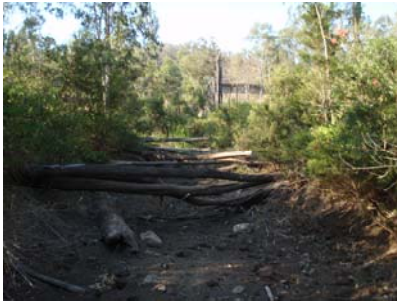
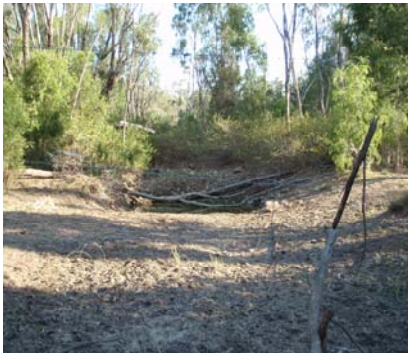
Photo: Looking Upstream

Photo: Looking Downstream

GLNG Supplementary EIS–Surface Water Assessment-Pipeline	
Location No.	21
Location Name	Bell Creek
<u>Easting:</u>	259,502
<u>Northing:</u>	7,323,830
<u>Site Description:</u> <i>Bell Creek is located to the south west of Gladstone. The ephemeral stream is heavily vegetated with mature larger trees, dense scrubs on the banks and juvenile trees on the coarse gravel bed.</i>	
<u>Channel Depth:</u>	<i>LB 1m, RB 2m</i>
<u>Channel Width:</u>	<i>4m</i>
<u>Floodplain Width:</u>	<i>>100m</i>
<u>Bank Slope:</u>	<i>LB 1:3, RB 1:3</i>
<u>Channel Banks:</u> Bank stability was poor and convex in shape. The banks are grassed with a scatter of small trees.	
<u>Substrate Type:</u> The bed substrate is packed, unarmoured which is matrix dominated (>60% fine sediment, interstitial spaces virtually absent). The bed was fairly muddy. The predominate particle size is silt/clay.	
<u>Channel Bed:</u> Little vegetation was found within the channel bed. The bed was severely eroded with the presence of debris (log jams across the channel).

<u>Water Quality:</u> No water present.	
<u>Floodplain:</u> Grazed bushland.

<u>Catchment Size:</u>	<i>92km²</i>		
<u>Channel Slope:</u>	<i>6 m/km</i>		
<u>Catchment Storage:</u> Poorly defined and meandering stream.			
<u>Catchment Relief:</u> Rolling, with slopes of 1.5 – 4%			
	Q2	Q10	Q100
Intensity	14mm	20mm	31mm
Flow	88m ³ /s	206m ³ /s	491m ³ /s
Depth	1.4m	2.1m	3.0m

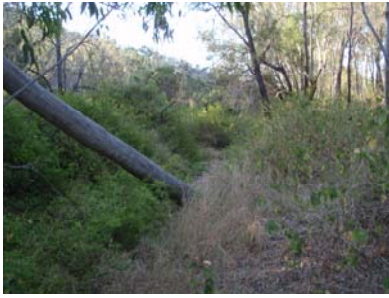
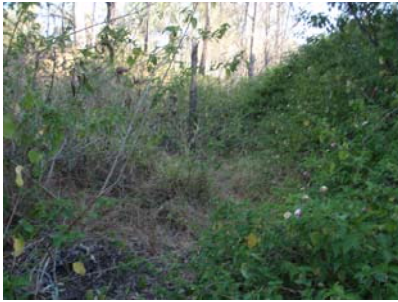
Photo: Looking Upstream

Photo: Looking Downstream

GLNG Supplementary EIS–Surface Water Assessment-Pipeline	
Location No.	23
Location Name	Bell Creek
<u>Easting:</u>	260,134
<u>Northing:</u>	7,324,137
<u>Site Description:</u> <i>Bell Creek is located to the south west of Gladstone. The ephemeral stream is heavily vegetated with mature larger trees and dense scrubs on the banks.</i>	
<u>Channel Depth:</u>	<0.5m
<u>Channel Width:</u>	2m
<u>Floodplain Width:</u>	>100m
<u>Bank Slope:</u>	LB 1:2, RB 1:2
<u>Channel Banks:</u> The moderately stable banks are concave in shape and contain a large amount of lantana and scarred riparian vegetation.	
<u>Substrate Type:</u> The bed substrate is packed, unarmoured, which is matrix dominated (>60% fine sediment, interstitial spaces virtually absent). The predominate particle size is sand.	
<u>Channel Bed:</u> The stable bed is 2m wide, with a sand dominated particle size.	
<u>Water Quality:</u> No water present.	
<u>Floodplain:</u> Grazed bushland.

<u>Catchment Size:</u>	91km ²		
<u>Channel Slope:</u>	6.5 m/km		
<u>Catchment Storage:</u>	Poorly defined and meandering stream.		
<u>Catchment Relief:</u>	Flat, with slopes of 0 – 1.5%		
	Q2	Q10	Q100
Intensity	14mm	20mm	31mm
Flow	87m ³ /s	203m ³ /s	484m ³ /s
Depth	2.5m	3.1m	3.9m

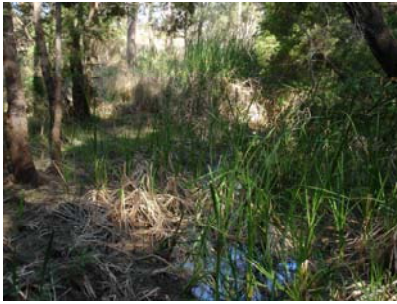
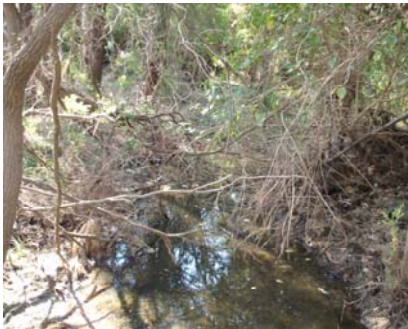
Photo: Looking Upstream

Photo: Looking Downstream

GLNG Supplementary EIS–Surface Water Assessment-Pipeline	
Location No.	26
Location Name	Bell Creek
<u>Easting:</u>	260,885
<u>Northing:</u>	7,325,276
<u>Site Description:</u> <i>Bell Creek is located to the south west of Gladstone. The ephemeral stream is heavily vegetated with mature larger trees and grasses on the banks.</i>	
<u>Channel Depth:</u>	<i>Stage 1- Shallow, Stage 2 – 1m, Stage 3- 8 to 10m</i>
<u>Channel Width:</u>	<i>Stage 1- 1m, Stage 2 – 25m, Stage 3- 45m</i>
<u>Floodplain Width:</u>	<i>>100m</i>
<u>Bank Slope:</u>	<i>Approximately 1:10</i>
<u>Channel Banks:</u> The multi staged channel has concave shaped banks. These banks are fairly stable and are grassed with a scattering of mature trees.	
<u>Substrate Type:</u> Water was present therefore the bed compaction and sediment matrix of the bed was unable to be identified. The predominate particle size is silt/clay.	
<u>Channel Bed:</u> The multi stage channel has a silt/clay substrate and is fairly stable. Grasses were found within the bed.

<u>Water Quality:</u> Water had moderate sediment oils and a water sheen. No water or sediment odours were detected. The water was slightly turbid, however fairly clear, with the presence of vegetation and algae.	
<u>Floodplain:</u> Grazed bushland.

<u>Catchment Size:</u>	89km ²		
<u>Channel Slope:</u>	7.5 m/km		
<u>Catchment Storage:</u>	Poorly defined and meandering stream.		
<u>Catchment Relief:</u>	Rolling with slopes of 1.5 – 4%		
	Q2	Q10	Q100
Intensity	14mm	20mm	31mm
Flow	84m ³ /s	197m ³ /s	468m ³ /s
Depth	0.5m	0.8m	1.4m

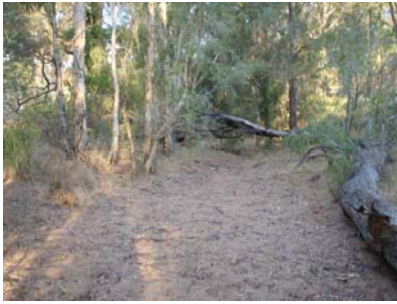
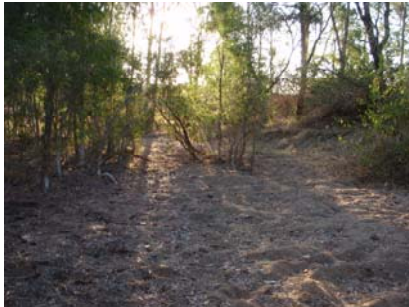
Photo: Looking Upstream

Photo: Looking Downstream

GLNG Supplementary EIS–Surface Water Assessment-Pipeline	
Location No.	28
Location Name	Bell Creek
<u>Easting:</u>	267,862
<u>Northing:</u>	7,326,744
<u>Site Description:</u> <i>Bell Creek is located to the south west of Gladstone. The ephemeral stream is heavily vegetated with mature larger trees and grasses on the banks.</i>	
<u>Channel Depth:</u>	<i>LB 3m, RB 1.5m</i>
<u>Channel Width:</u>	<i>6m</i>
<u>Floodplain Width:</u>	<i>>100m</i>
<u>Bank Slope:</u>	<i>LB 1:1, RB 1:1</i>
<u>Channel Banks:</u> Both left and right banks appear fairly stable, with only small evidence of erosion. Both banks are convex in shape. The banks are grassed with small and large trees.	
<u>Substrate Type:</u> The bed substrate is low compaction, which is matrix dominated (>60% fine sediment, interstitial spaces virtually absent). The predominate particle size is gravel and sand.	
<u>Channel Bed:</u> Moderate deposition was evident within the sand and gravel dominated bed.

<u>Water Quality:</u> No water present.	
<u>Floodplain:</u> Grazed bushland.

<u>Catchment Size:</u>	<i>89km²</i>		
<u>Channel Slope:</u>	<i>7.5 m/km</i>		
<u>Catchment Storage:</u> Poorly defined and meandering stream.			
<u>Catchment Relief:</u> Rolling with slopes of 1.5 – 4%			
	Q2	Q10	Q100
Intensity	15mm	22mm	35mm
Flow	56m ³ /s	131m ³ /s	35m ³ /s
Depth	0.6m	1.0m	1.6m
