Survey of the Laird Point Dredge Material Placement Facility Intertidal Area

Prepared for
Santos
32 Turbot St
Brisbane QLD 4000
42626446

Date: **November 2009**
Reference: 42626446/02/C
Status: FINAL

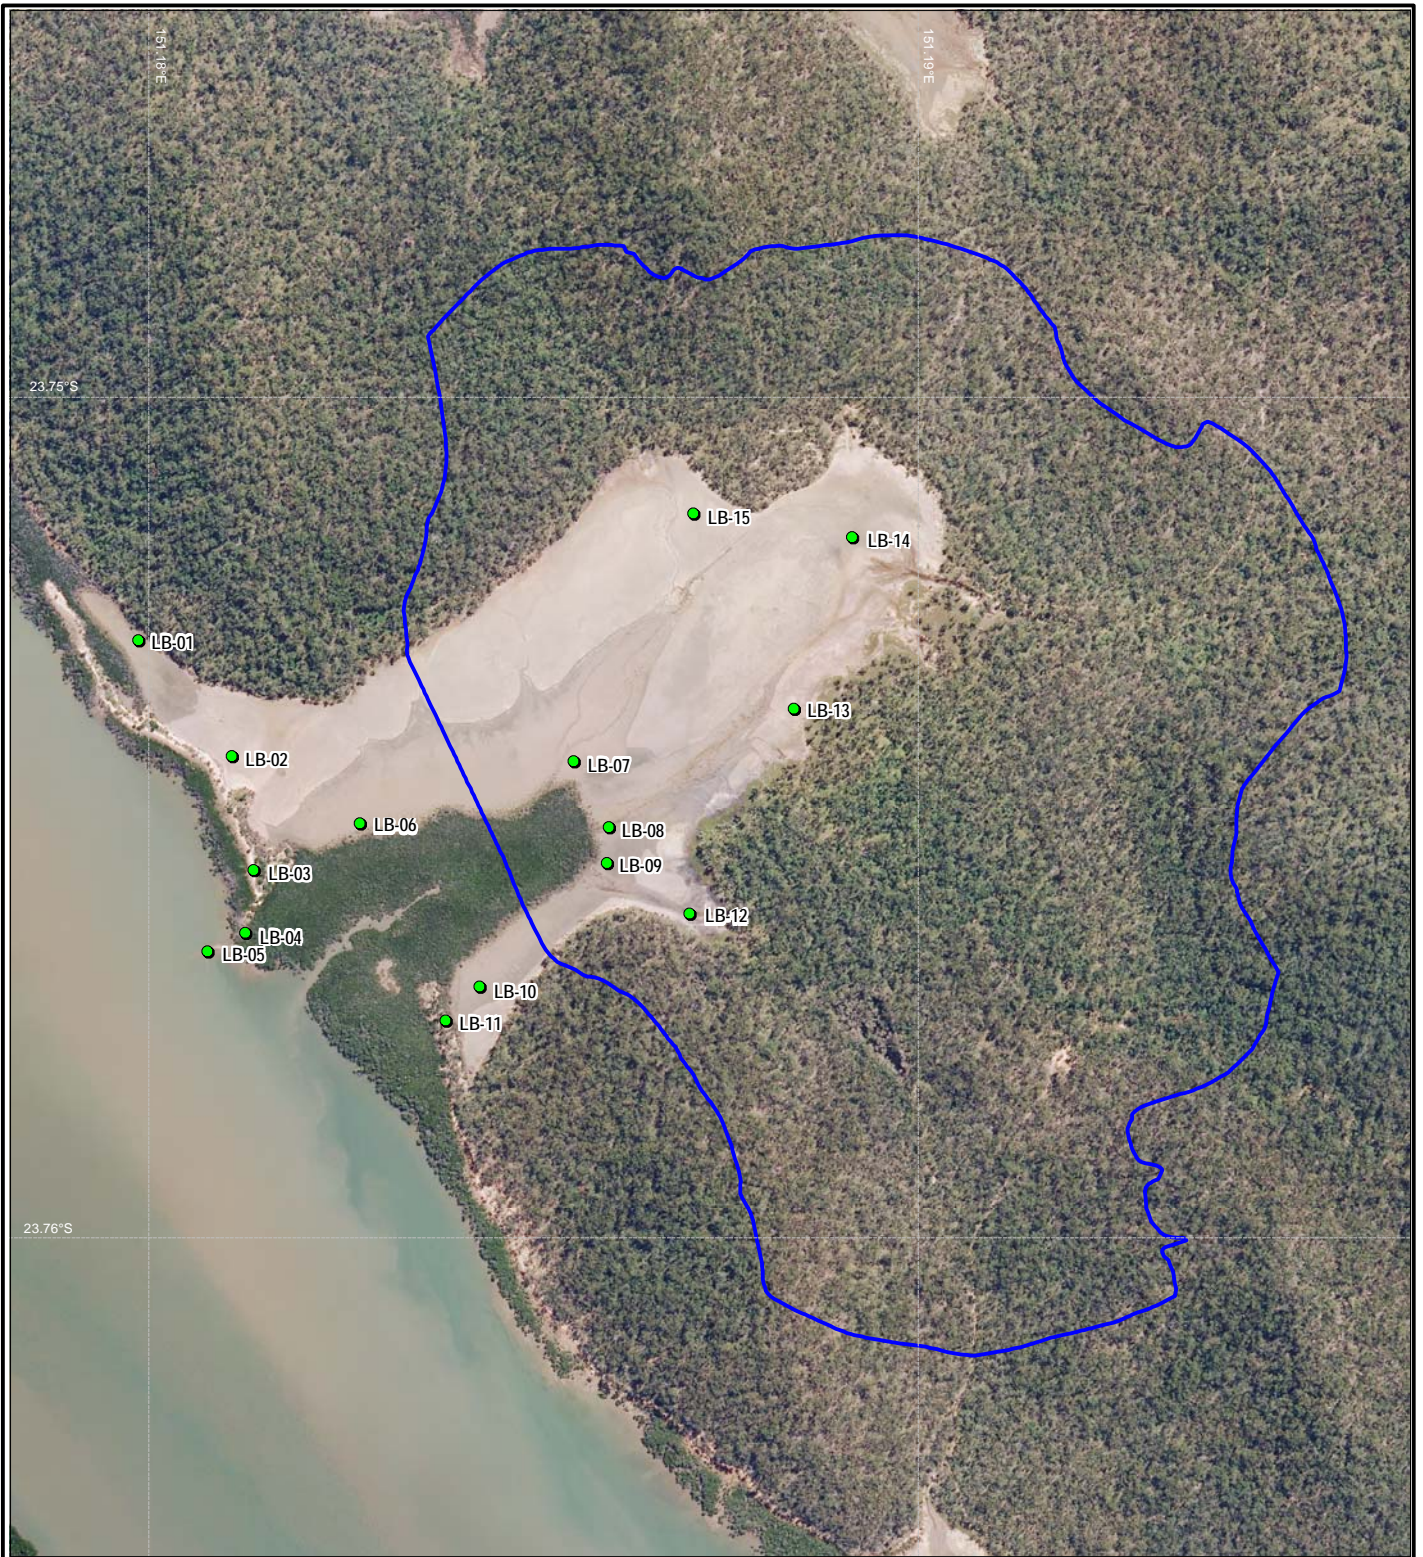
Project GLADSTONE LNG PROJECT ENVIRONMENTAL IMPACT STATEMENT SUPPLEMENT MARINE ECOLOGY		Title LAIRD BAY INTERTIDAL SITES	
	Drawn: RG Job No: 4262 6440/6220	Approved: JB File No: 42626440-g-2027.wor	Date: 06-11-2009	Figure: 2-1

Dredge Material Placement Facility Footprint

Laird Bay Survey Sites

The survey was conducted during the low tide on 30 August 2009 between approximately 9:30 am and 1:30 pm. Field scientists took photographs and notes at a number of sites (Table 2-1 and Figure 2-1). Photographic evidence and field observations were recorded during this study.

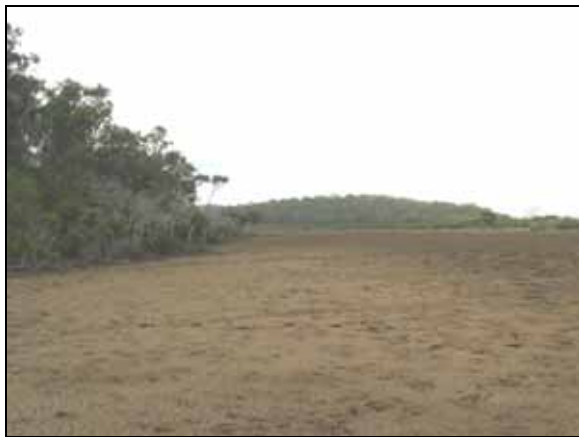
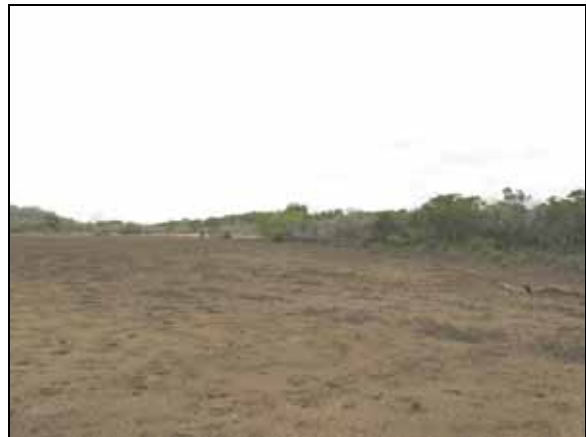
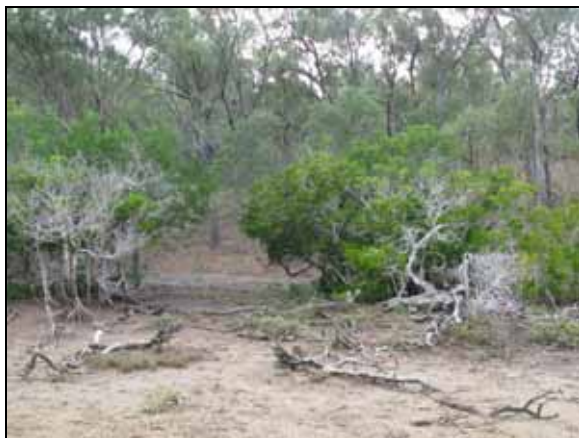
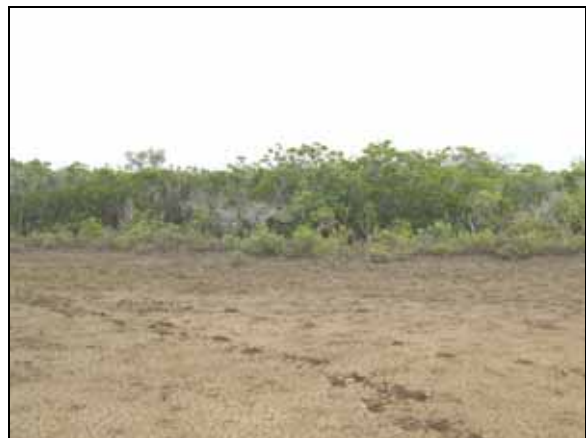
Plate 3-1 Site LB-01

Site LB-1 is located in a narrow tongue of salt flat to the west of the DMPF. The salt flat was covered with a cyanobacterial algal mat (a and b) with very little vegetation or evidence of fauna. The landward side (c) had a thin strip of mangroves, approximately two to three trees wide, with several species; *Excoecaria agallocha* (milky mangrove), *Aegiceras corniculatum* (river mangrove), *Lumnitzera racemosa* (white-flowered black mangrove), *Bruguiera gymnorhiza* (large-leafed orange mangrove), *Osbornia octodonta* (myrtle mangrove), *Ceriops australis* (smooth-fruited yellow mangrove) and *Avicennia marina* (grey mangrove). Beyond this mangrove strip there was Eucalypt woodland. The seaward side (d) consisted of a narrow zone (approximately 10 – 30 m wide) of shrubland communities dominated by *Ceriops australis* and *Avicennia marina*. Minor species included *Aegialitis annulata* (club mangrove) and *Lumnitzera racemosa*.

(a) Looking north-west

(b) Looking south-east

(c) Looking north-east

(d) Looking south-west

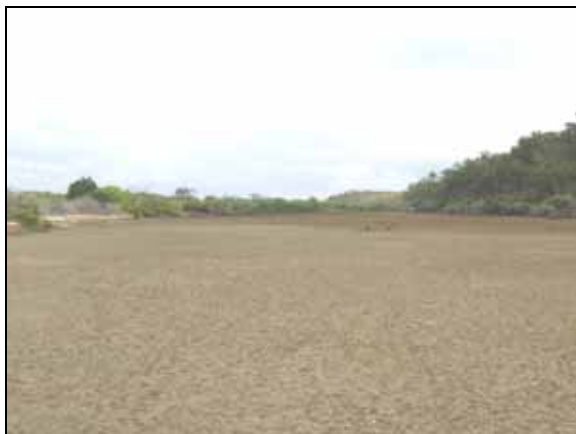
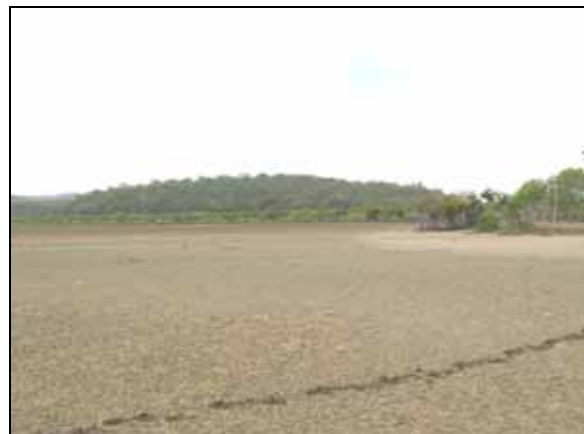
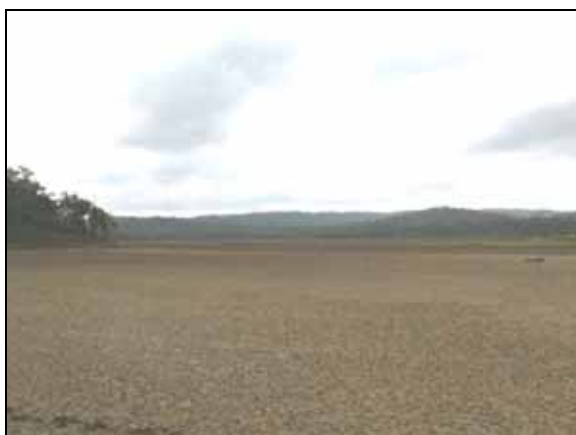
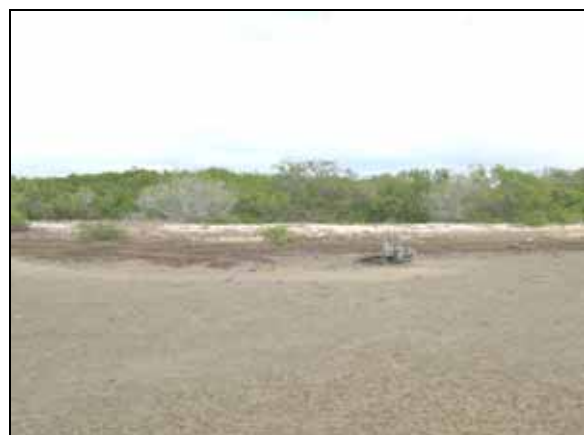
Plate 3-2 Site LB-02

Site LB-2 is located approximately 200 m to the south-east of LB-1. The salt flat (Plate 3-2 a, b and c) is the same as described for site LB-1. Plate 3-2 (d) shows the presence of cheniers or beach ridges (shoe-string shaped sand/shell deposits formed during storm events) with a species-rich and very localised habitat. The cheniers, which are supratidal in elevation (approximately 1.5 m above the salt flat), provide localised freshwater seepage at their margins with the surrounding mudflats and, together with a different substrate type (calcareous sands and shell gravel), these conditions have developed narrow mangrove habitats of either a mixed species woodland on the chenier crests (*Excoecaria agallocha*, *Lumnitzera racemosa*, *Bruguiera gymnorhiza*, *Xylocarpus moluccensis* and *Xylocarpus granatum*) or a mixed species shrubland on chenier slopes (*Avicennia marina*, *Rhizophora stylosa*, *Ceriops tagal*, *Aegialitis annulata*, *Aegiceras corniculatum*, *Lumnitzera racemosa* and *Osbornia octodonta*). Coastal dune species and halophytic grasses (*Sporobolus virginicus*) and shrubs (*Sueada* sp.) also occur on the cheniers together with some non-mangrove tree species. Plate 3-3 shows the view from the top of the chenier ridge (a), along with some of the plants found there.

(a) Looking north-west

(b) Looking south-east

(c) Looking north-east

(d) Looking south-west

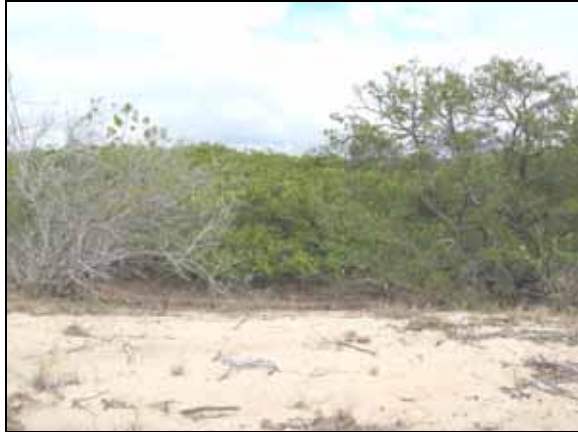
Plate 3-3 Detail of chenier ridge at Site LB-02

(a) Looking south-west from top of chenier ridge

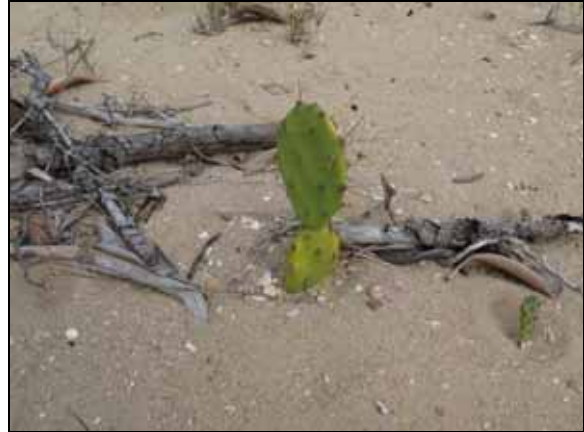
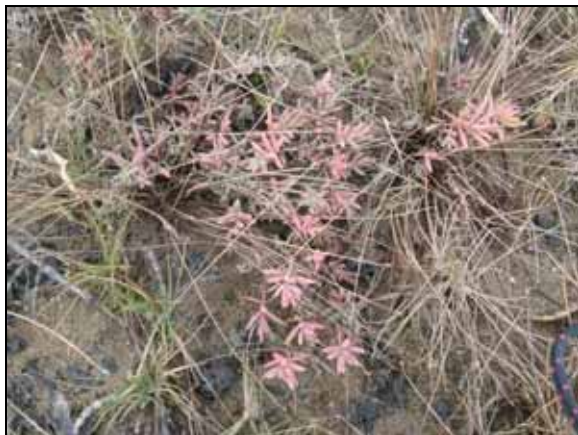
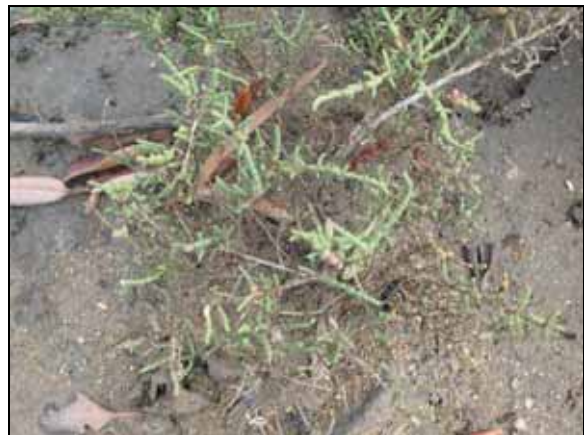
(b) Prickly pear on swale

(c) Ruby saltbush (*Enchylaena tomentosa*) and salt couch (*Sporobolus virginicus*)

(d) Bearded samphire (*Sarcocornia quinqueflora*)

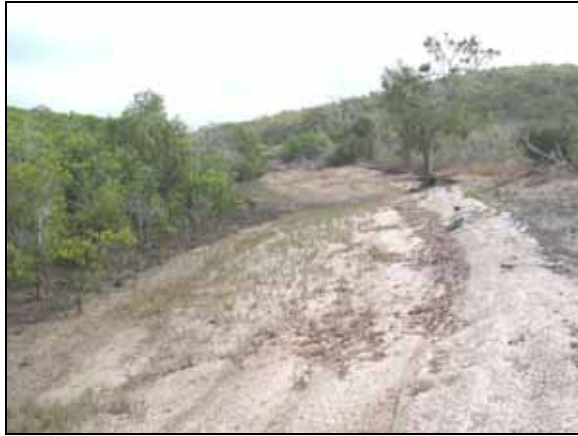
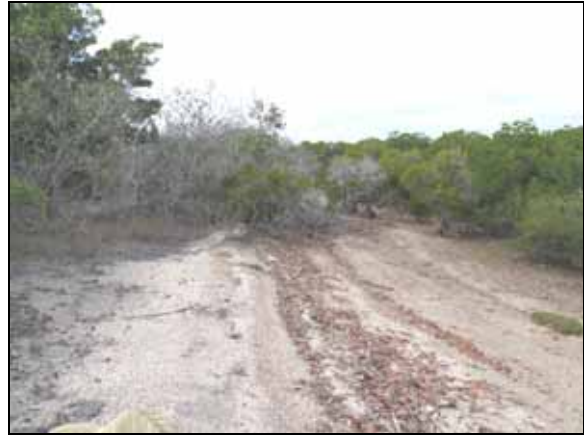
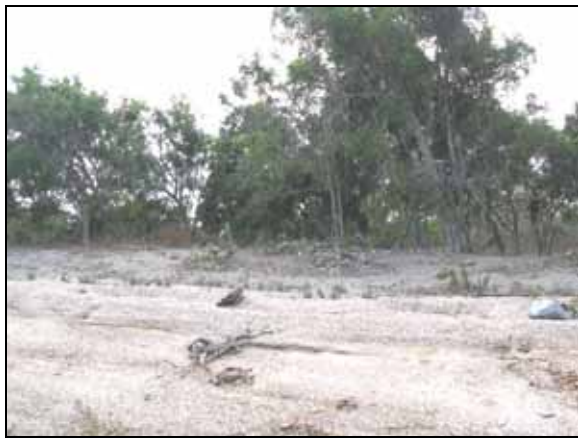
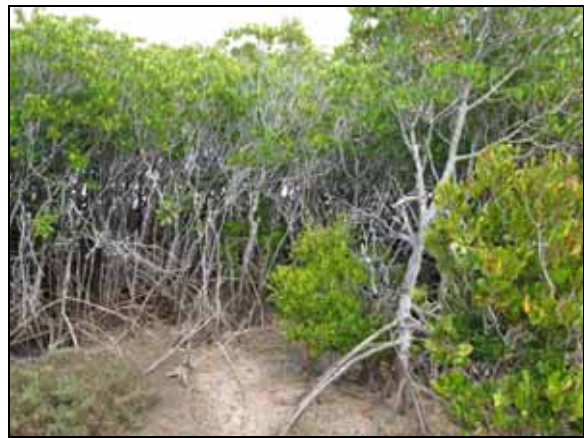
Plate 3-4 Site LB-03

Site LB-3 is located approximately 200 m to the south-south-east of LB-2 along the chenier ridge. Eucalypt woodland can be observed on the higher reaches of the chenier ridge, with low mangroves at its base (Plate 3-4 a, b and c). Plate 3-4 (d) shows the view to the south-west where dense mangrove habitat occurs (primarily stilt mangroves, *Rhizophora stylosa*).

(a) Looking north-west

(b) Looking south-east

(c) Looking north-east

(d) Looking south-west

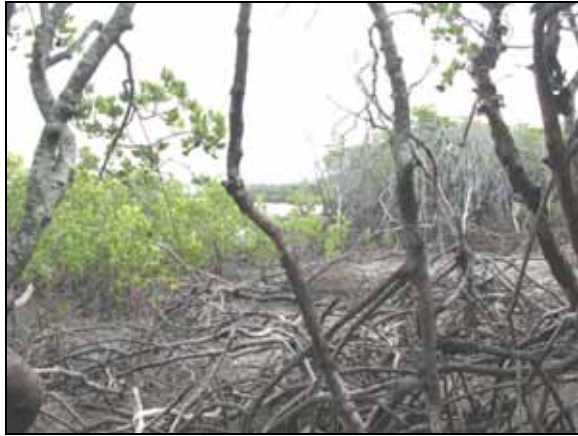
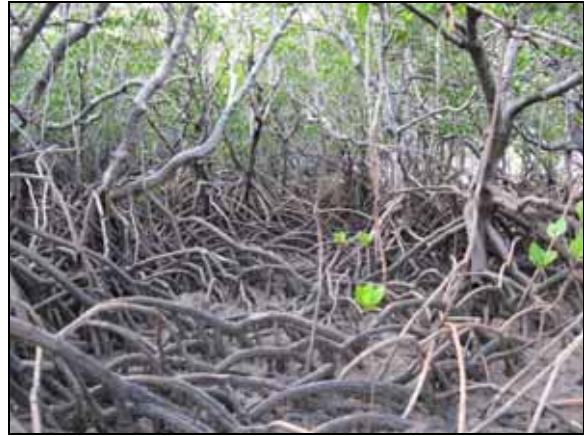
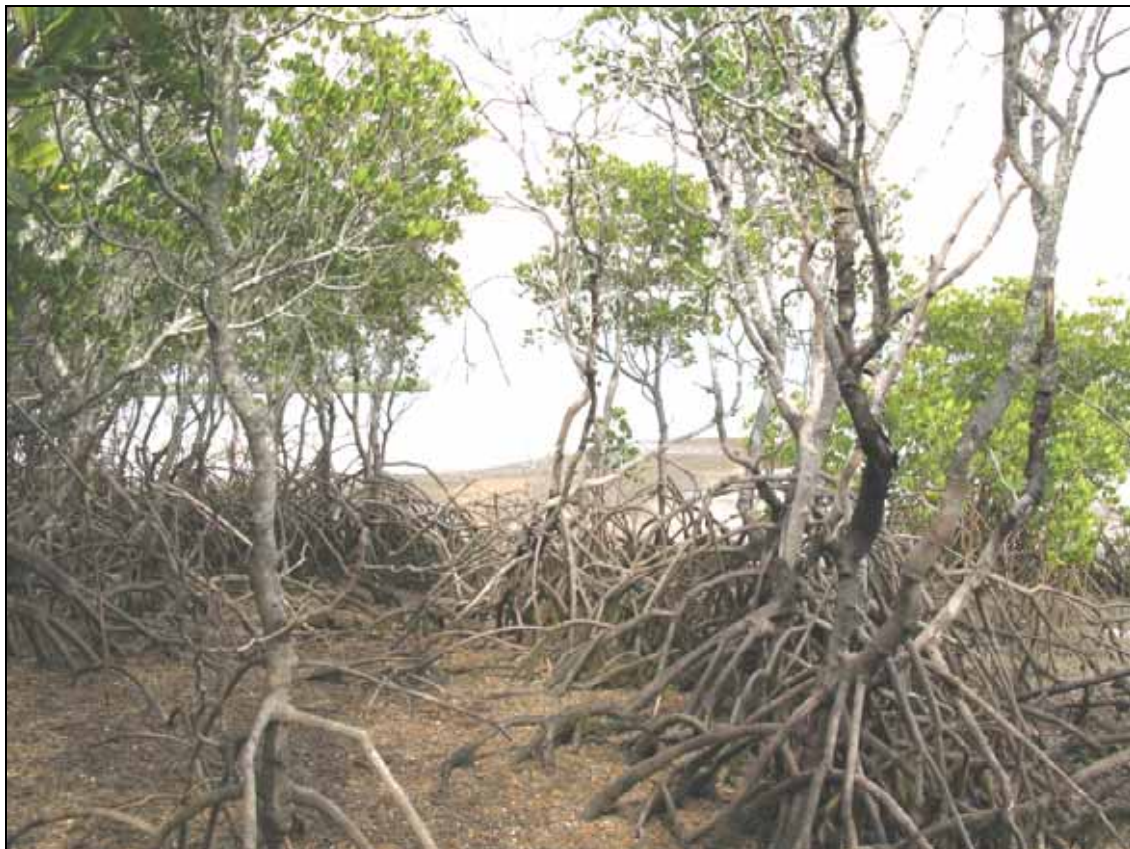
Plate 3-5 Site LB-04

Site LB-4 is located approximately 100 m to the south-south-west of LB-3, amongst the mangrove habitat fringing the seaward edge (Plate 3-5). *Rhizophora stylosa* is the dominant species. North Passage Island is visible in the background of Plate 3-5 (c). Numerous crab holes were observed at this site.

(a) Looking north-west

(b) Looking south-east

(c) Looking south-west

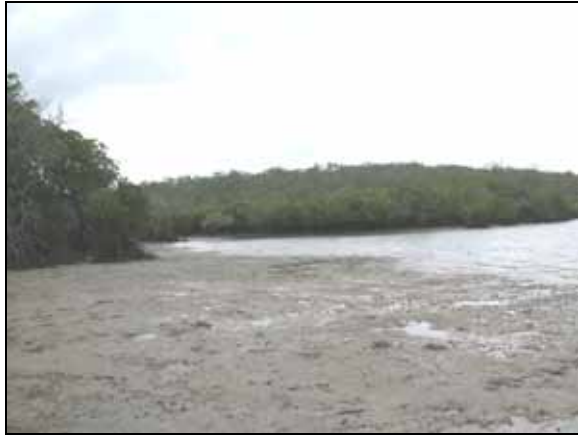
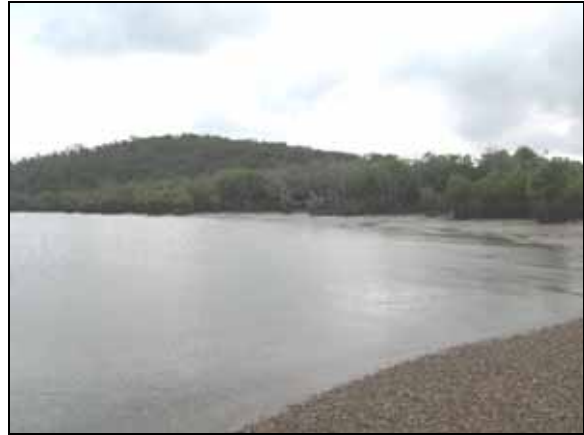
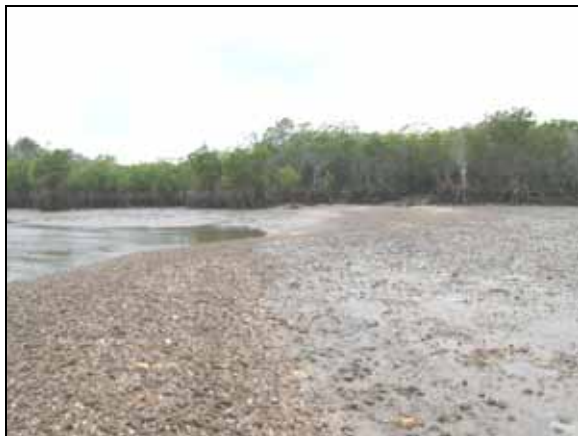
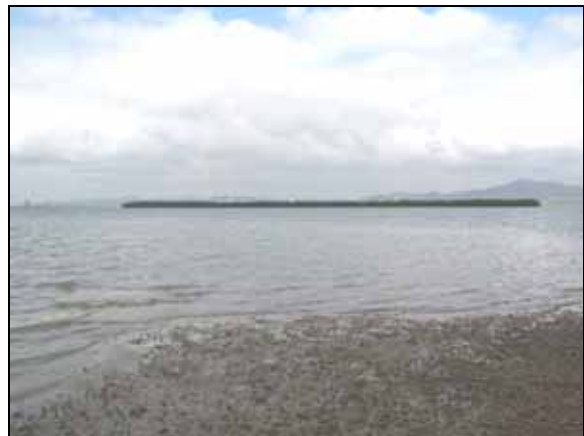
Plate 3-6 Site LB-05

Site LB-5 is located approximately 75 m to the south-west of LB-4. This site is on a mudflat spit (with rubble) on the seaward edge of the mangroves (6). The mouth of the creek leading into the DMPF area is visible in Plate 3-6(a).

(a) Looking east towards mouth of creek

(b) Looking north

(c) Looking north-east

(d) Looking south towards North Passage Island

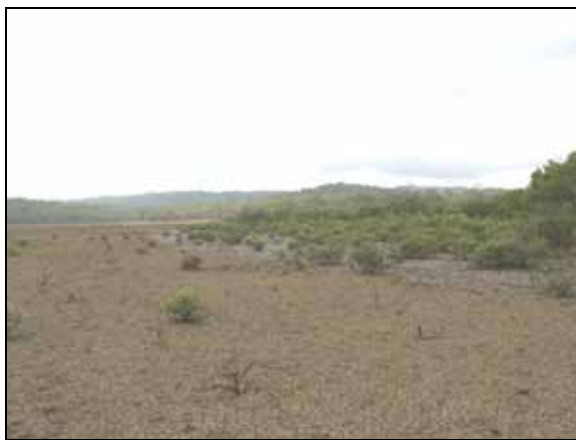
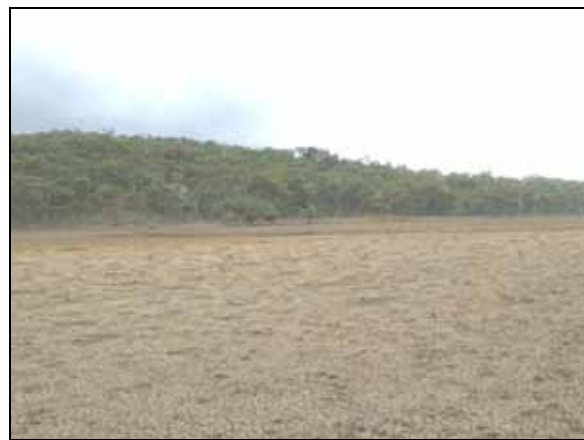
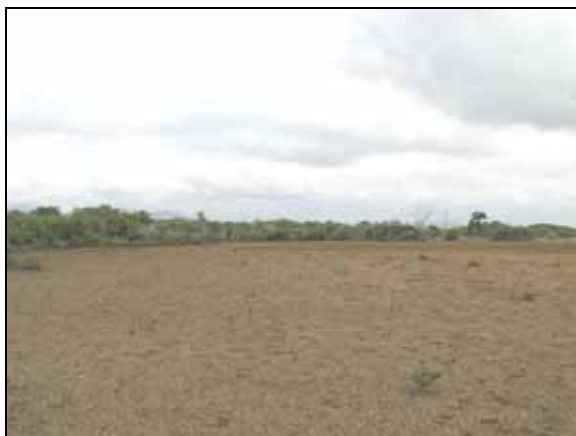
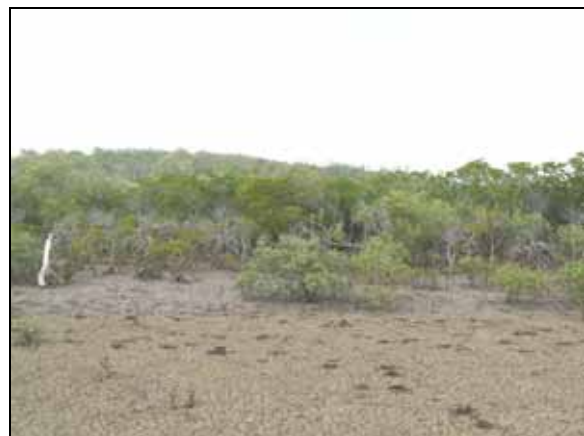
Plate 3-7 Site LB-06

Site LB-6 is located approximately 200 m to the east-north-east of LB-3. It is located on the northern edge of the mangrove habitat fringing the creek leading into Laird Bay. Plate 3-7 (a) and (d) show the interface between the mangroves and the salt flat. Small saltbush and samphire plants are visible near the edges of the mangroves. *Ceriops australis* and *Avicennia marina* are the dominant mangrove species.

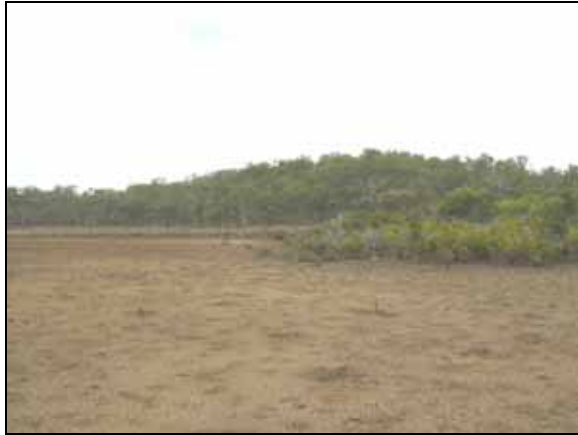
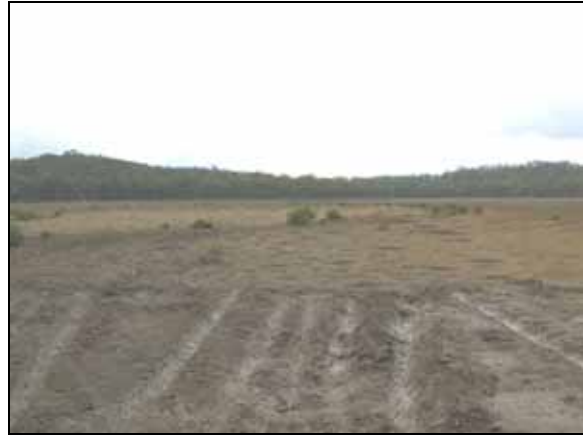
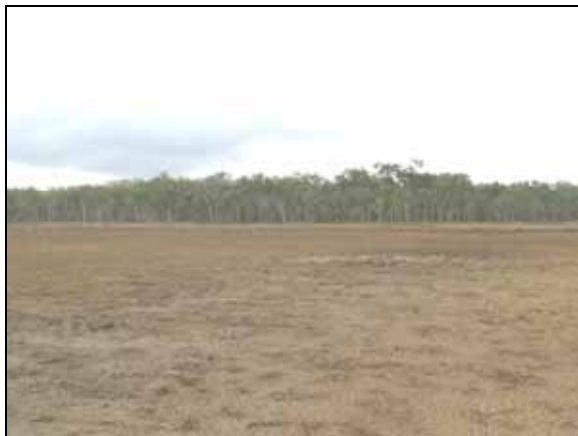
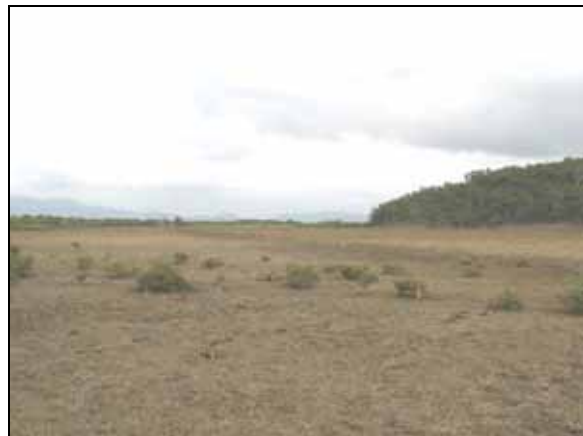
Plate 3-8 Site LB-07

Site LB-7 is located approximately 300 m to the east-north-east of LB-6 at the north-eastern edge of the mangroves adjacent to the creek. Plate 3-8(a) shows the low mangroves. To the west (d) and north (b) can be seen the drainage channel, with low shrubs.

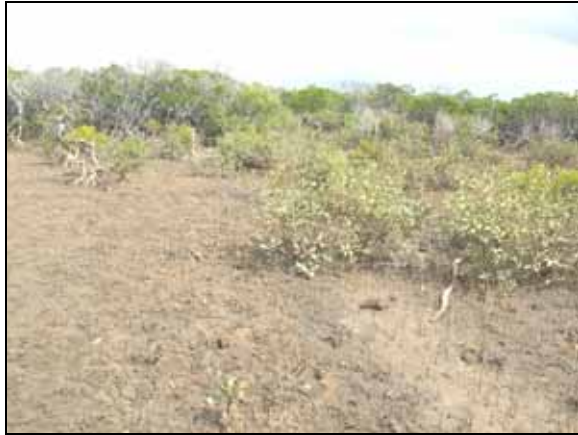
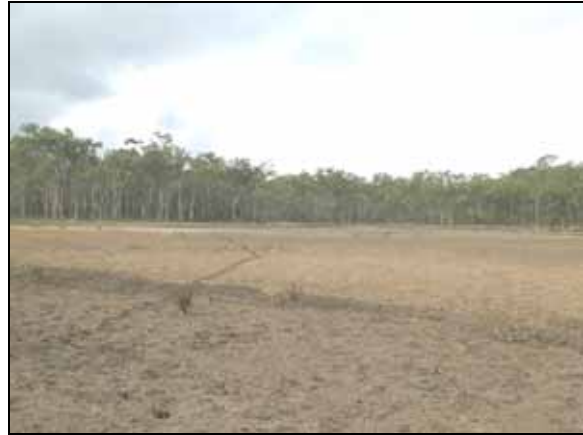
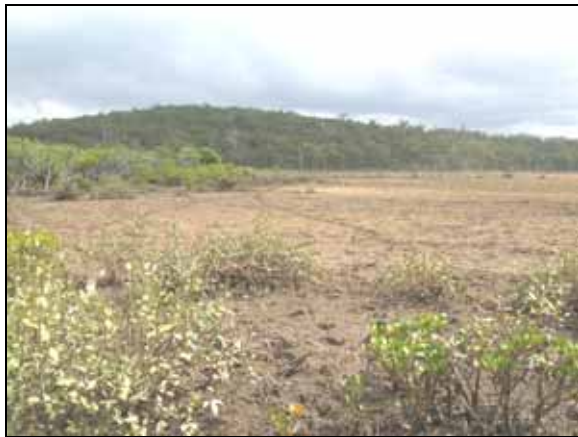
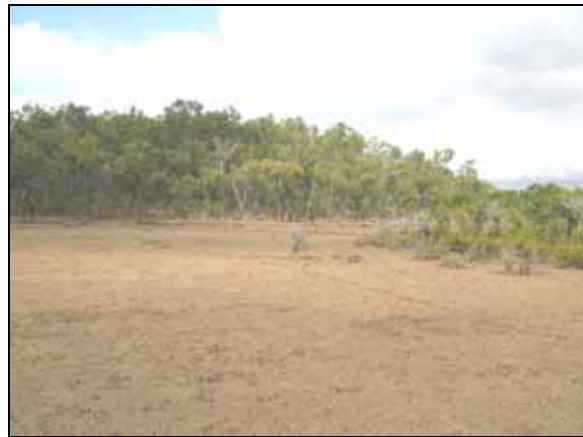
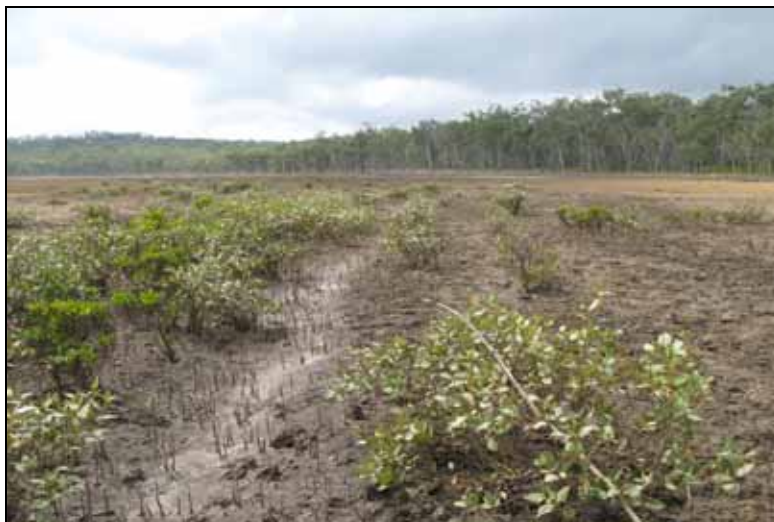
Site LB-8 is located approximately 100 m to the east-south-east of LB-7 where the main drainage channel emerges from the creek. Plate 3-9 (e) is a photograph taken looking along the drainage channel and shows stunted mangroves and a slight depression. Plate 3-10 shows some of the fauna found in this drainage channel.

(e) Looking north-east. End of creek where mangroves meets salt flat

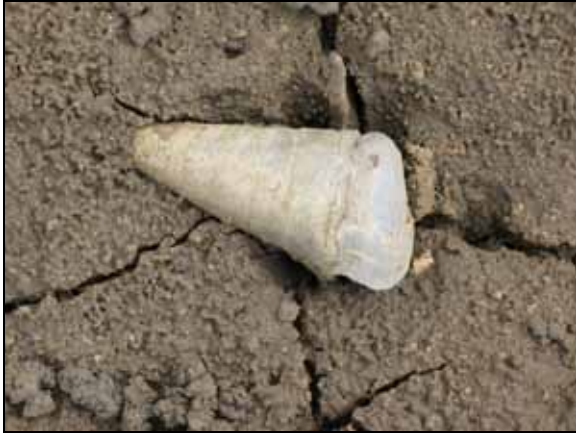
Plate 3-10 Fauna at Site LB-08

(a) Mud whelk (*Telescopium telescopium*).

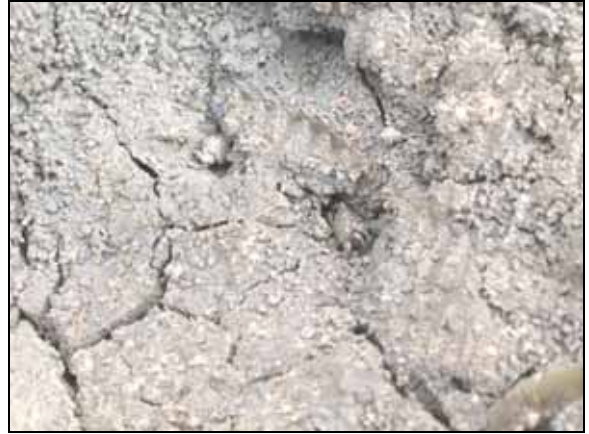
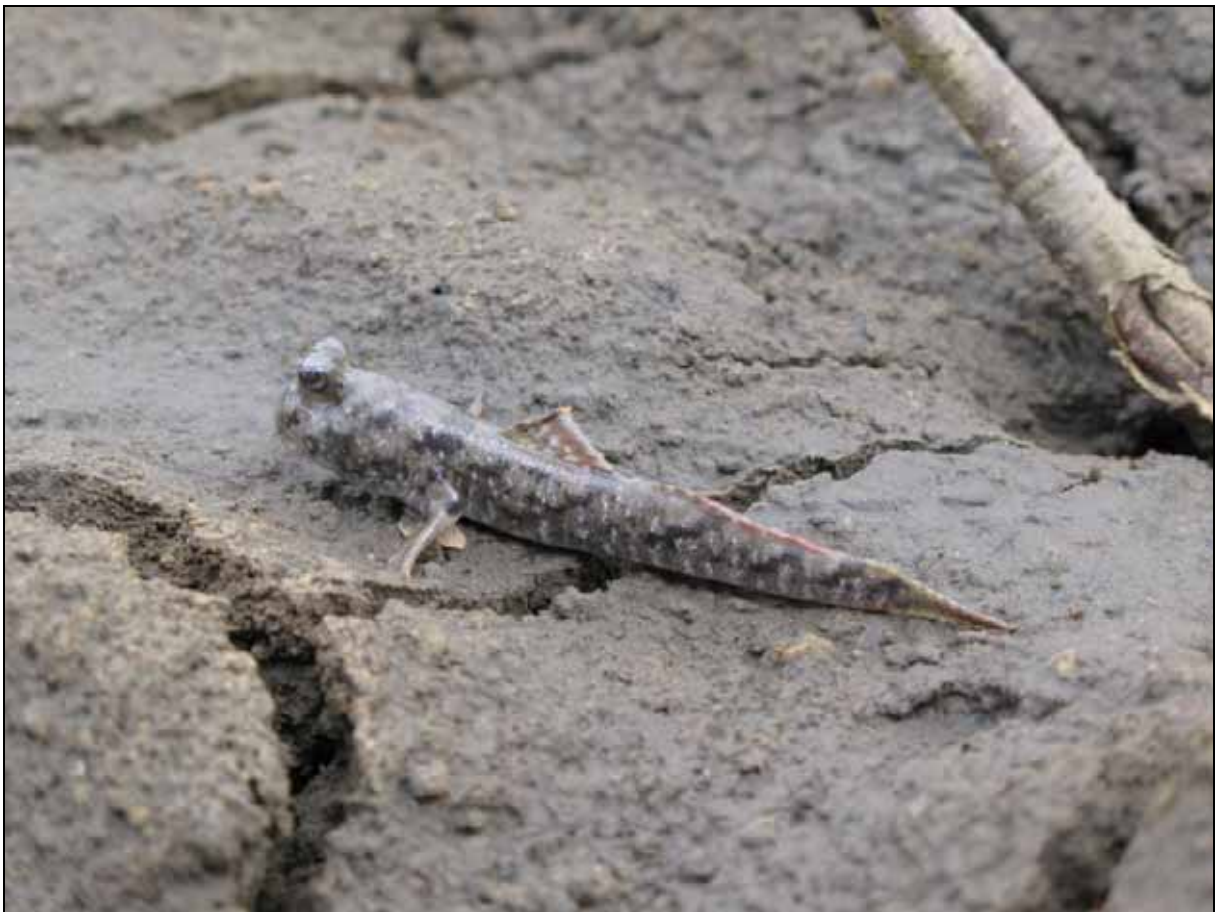
(b) Unidentified crab

(c) Mudskipper (*Periophthalmus* sp.)

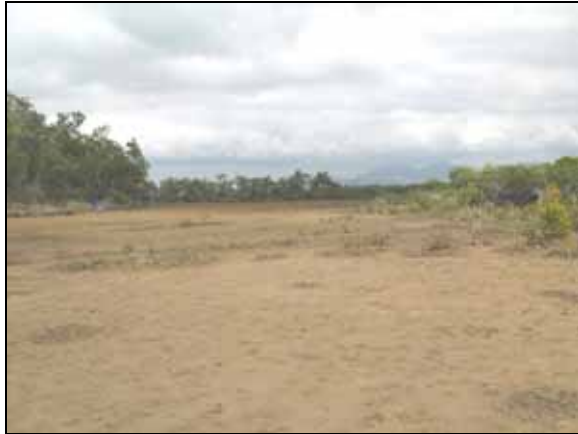
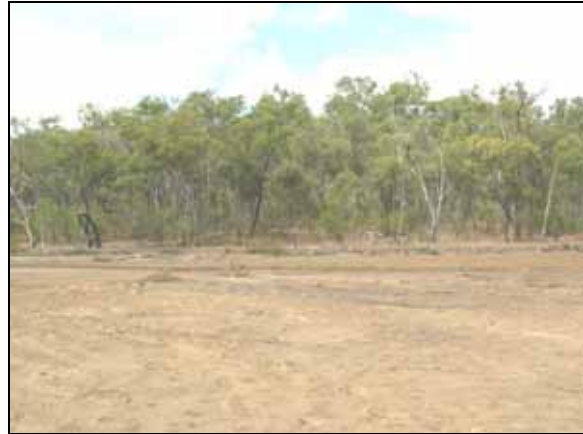
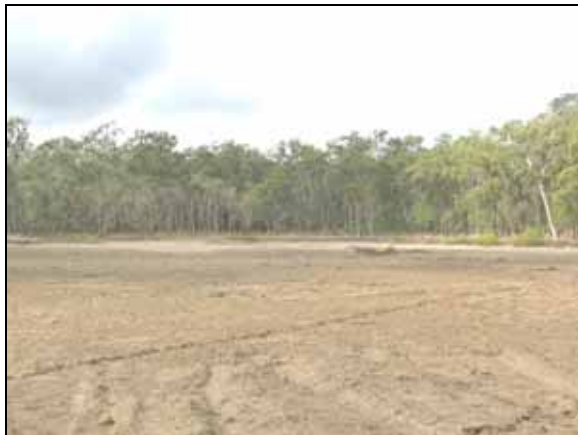
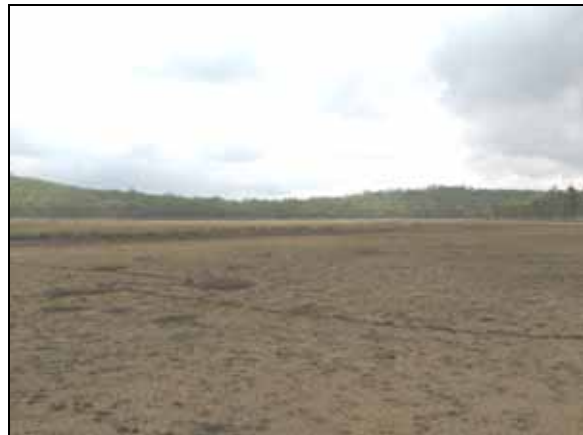
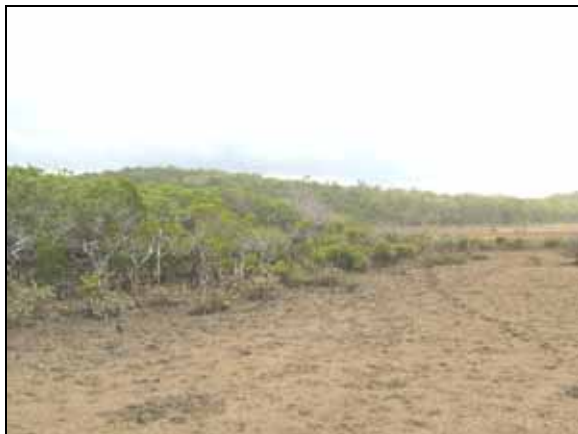
Plate 3-11 Site LB-09

Site LB-09 is located approximately 75 m south of LB-08 at the south-eastern edge of the mangroves adjacent to the creek. The salt flat is as described for site LB-01.

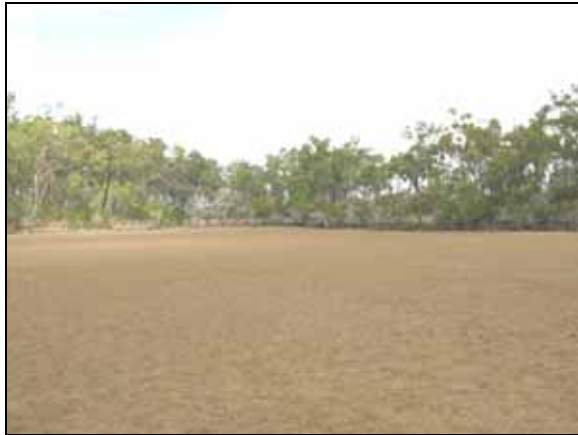
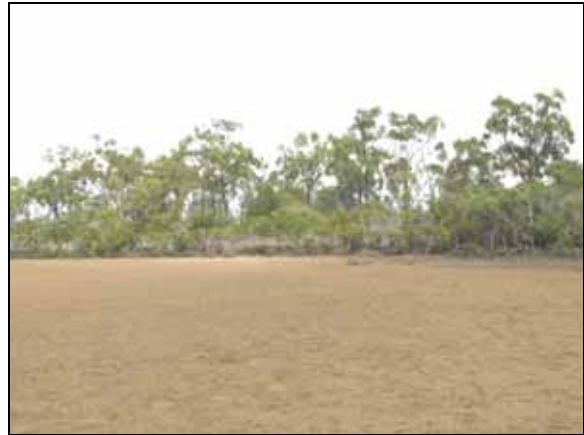
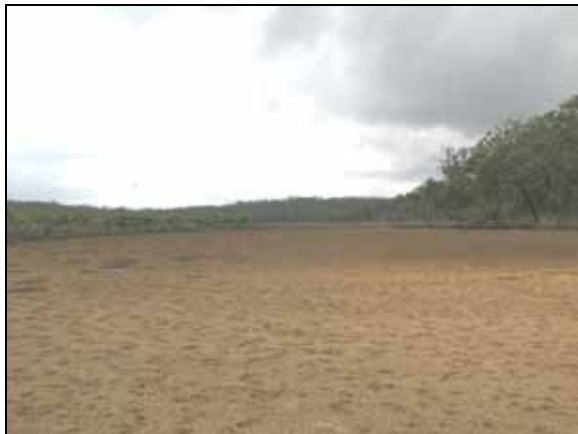
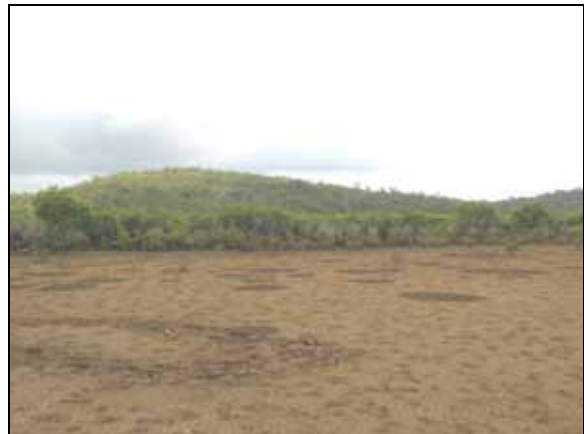
Plate 3-12 Site LB-10

Site LB-10 is very similar to site LB-01. To the south-west is a chenier ridge with a fringe of mangroves and Eucalypt woodland behind (Plate 3-12 b).

(b) Looking south-west

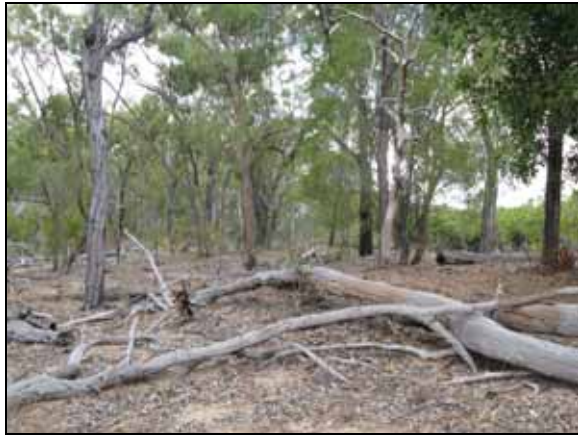
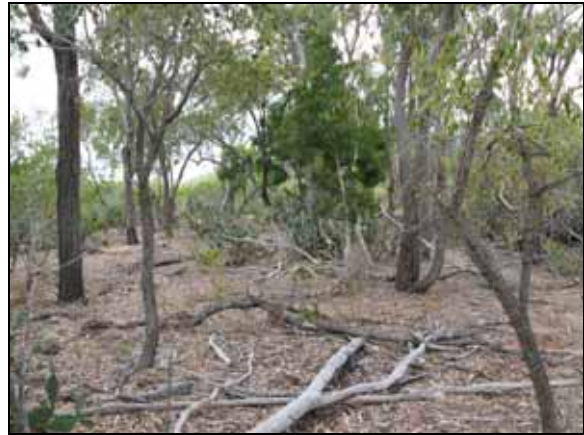
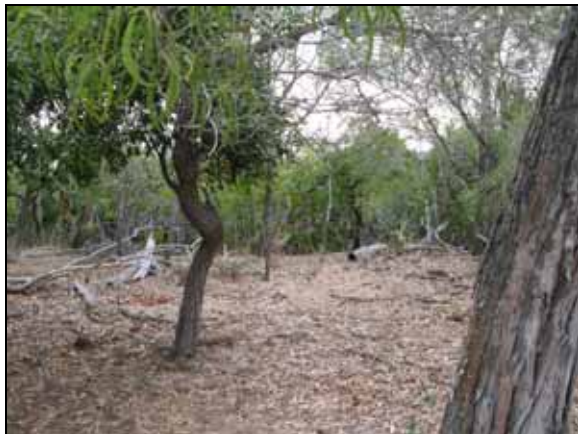
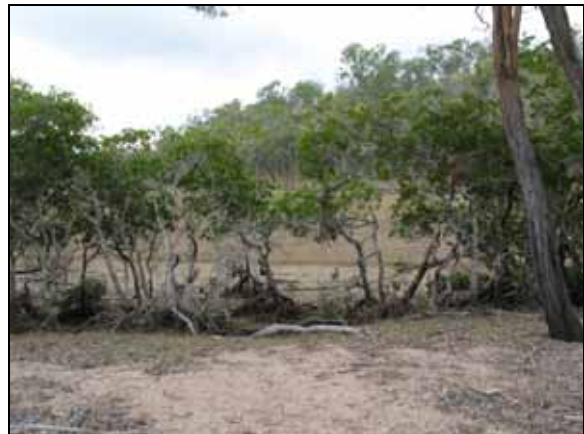
Plate 3-13 Site LB-11

Site LB-11 is approximately 100 m to the south-west of LB-10 within the chenier ridge. This ridge is approximately 1.5 m above the salt flat and contains a Eucalypt woodland community (Plate 3-13).

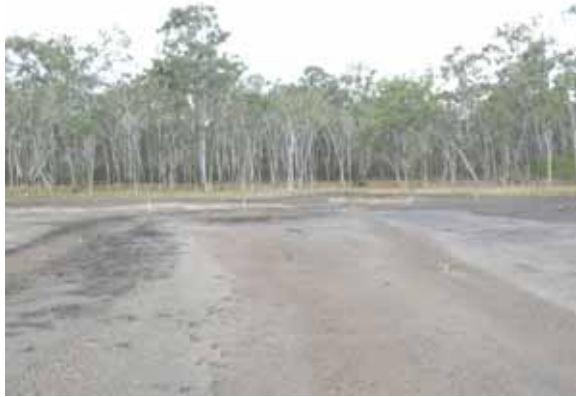
Plate 3-14 Site LB-12

Site LB-12 is located within a small embankment on the south-eastern edge of the salt flat. The salt flat was softer at this location, possibly from the influx of water from the adjacent gully. Grasses occurred on the landward fringes, prior to grading into open Eucalypt woodland (Plate 3-14 d).

(a) Looking east

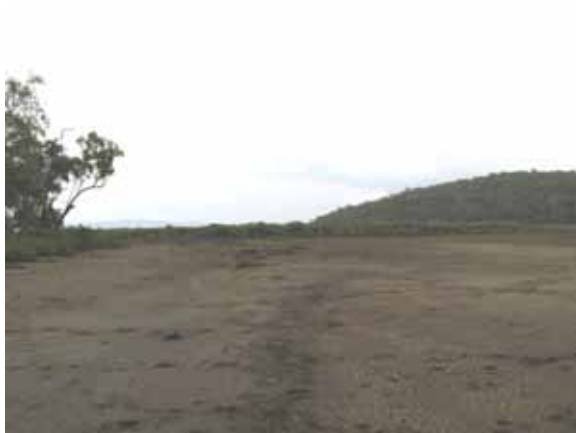
(c) Looking west

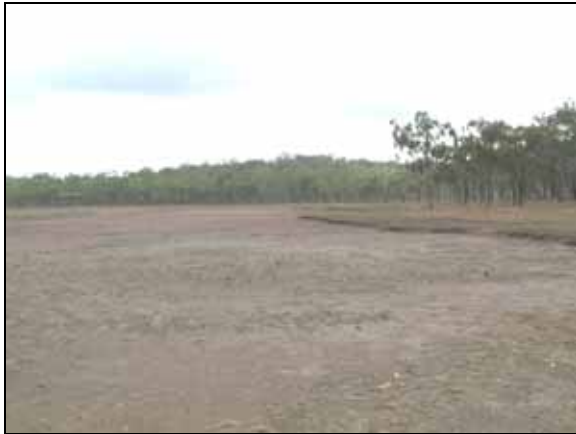
Plate 3-15 Site LB-13

Site LB-13 is approximately 300 m to the north-east of LB-12 and displays many similarities. A small eroded edge is visible in Plate 3-15 (a) and (c) where the salt flat meets the grassed area, with open woodland in the background.

(a) Looking north-east

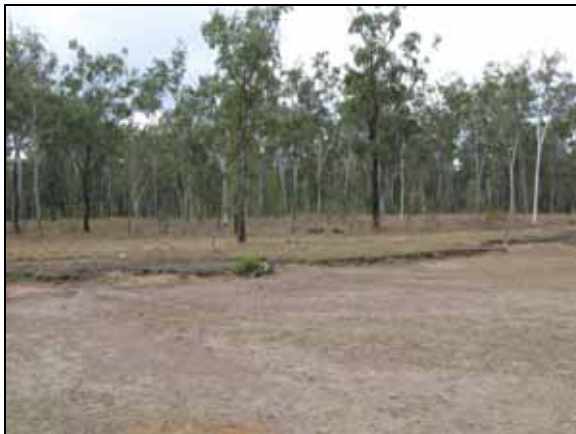
(c) Looking south-east

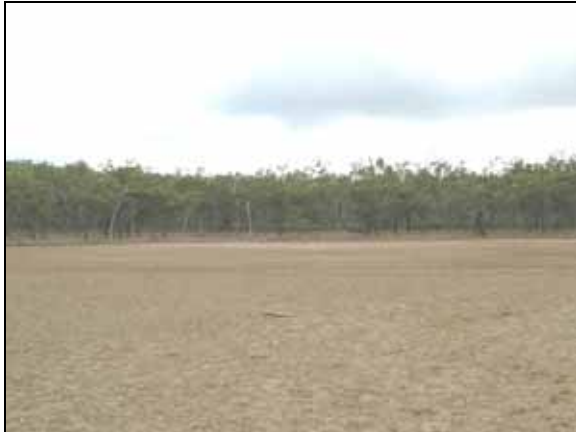
Plate 3-16 Site LB-14

Site LB-14 is located at the extreme north-east end of the salt flat (Plate 3-16). The salt flat is as described previously.

(a) Looking north-east

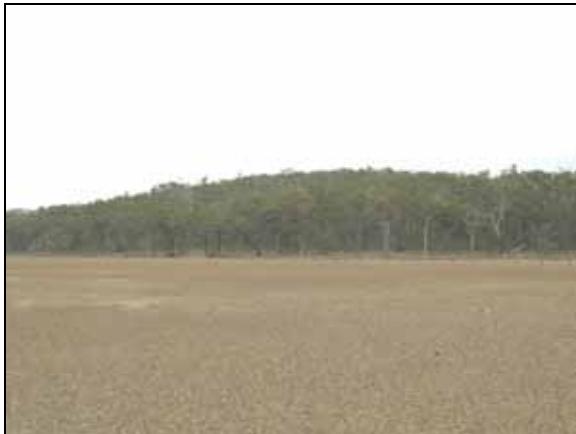
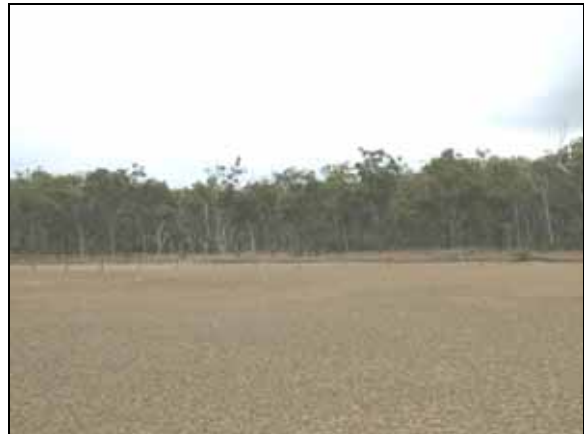
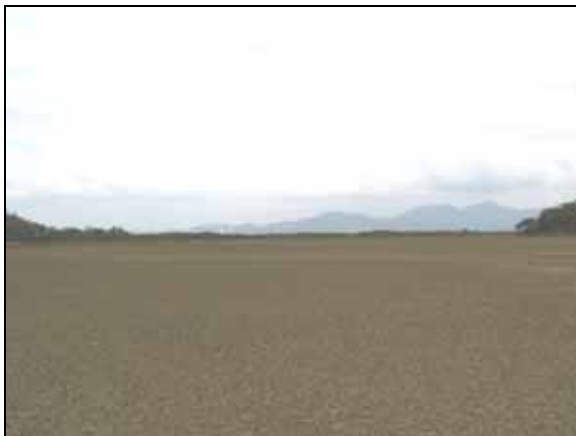
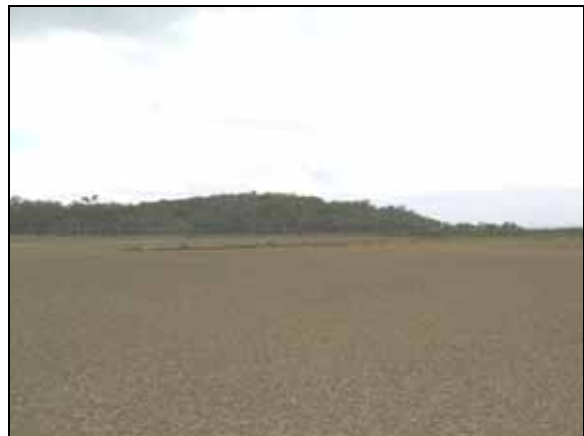
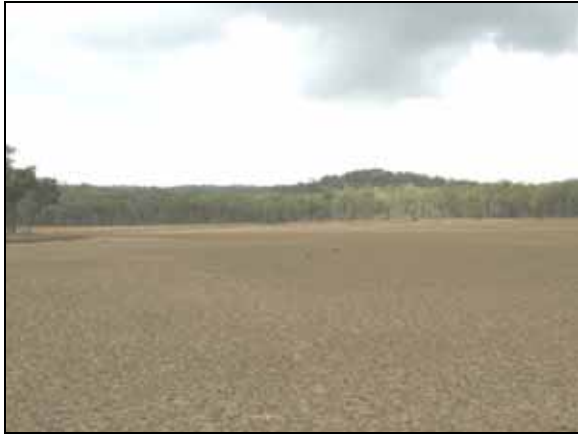
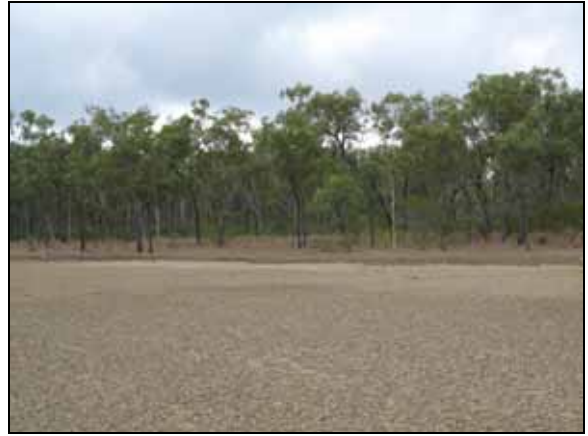
Plate 3-17 Site LB-15

Site LB-15 is located approximately 200 m to the west of LB-14. The salt flat is as described previously (Plate 3-17). Several horses were observed feeding on the grassy edges approximately 200 m to the west (Plate-18).
