June 2007  
aquatic biology technical report  
hinze dam stage 3 environmental impact statement  
Hinze Dam Alliance

## aquatic ecology technical report hinze dam stage 3 environmental impact statement Hinze Dam Alliance

Reference E11\_HDS3EIS\_AquaticEcologyTechnicalReport\_Rev01\_010607

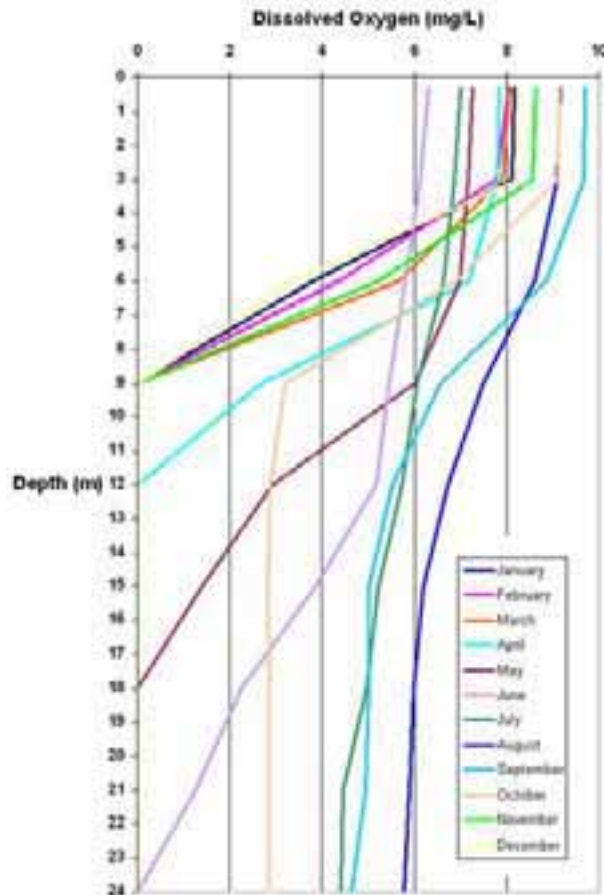
Figure 4.1 Mean monthly vertical DO profiles for Hinze Dam, 1999 - 2007

Figure 4.1 shows the transition from oxic to anoxic conditions for Hinze Dam during summer. It also shows that Autumnal stratification typically occurs at a depth between 6 and 9m from the lake surface, although the epilimnetic DO concentrations begin to decline somewhere between 3 and 6m.

To estimate the area of available habitat, a threshold for DO must be selected. The adoption of a DO concentration of less than 1m (i.e. the depth at which the metalimnion yields to the hypolimnion) is considered inappropriate, as most aquatic species would be placed under considerable stress by such low DO levels and would migrate higher in the water column where DO was more prevalent. Conversely, using the upper margin of the metalimnion for this purpose would likely underestimate the available habitat, since many aquatic species will utilise habitat that is within the upper margins of the metalimnion. The problem is further exacerbated by the coarse sampling intervals, since the inflexion point for DO might occur at any point within the 3m range.

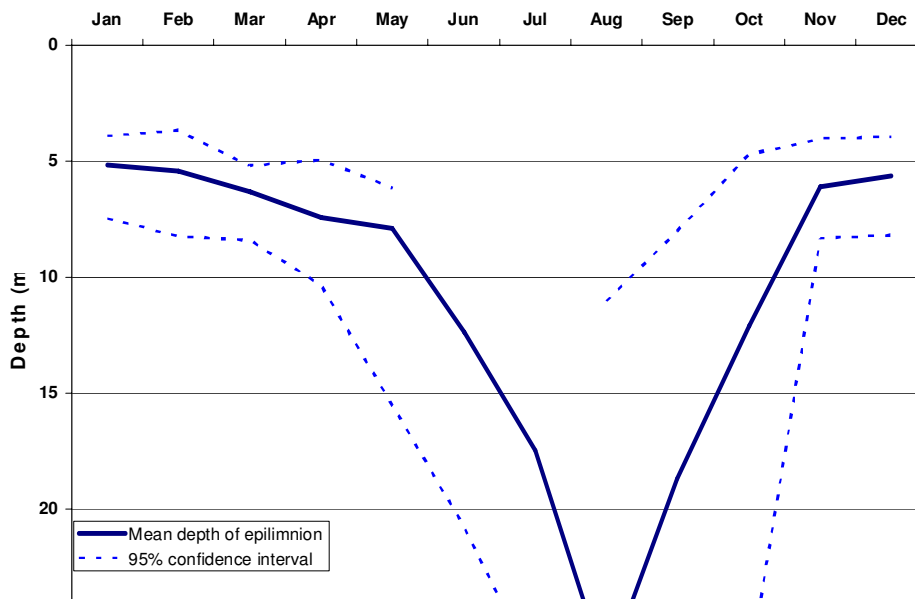
Figure 4.2 Mean depth of epilimnion (1999-2007) based on 5mg/L DO threshold. Broken lines indicate the 95% confidence interval.

For the purposes of this assessment, a nominal 5mg/L trigger level for DO has been adopted. Hence the epilimnetic depth has been estimated as the distance from the water surface to the point at which DO falls below 5mg/L. While this figure has been arbitrarily selected, it is likely that most aquatic species could tolerate DO concentrations in this range. To estimate the depth at which the 5mg/L trigger would be obtained in an average year at Hinze Dam, the slope of the profile between the monitoring points immediately above and below the 5mg/L DO concentrations was calculated for each month and the depth at which 5mg/L oxygen trigger would be expected was calculated from the resulting equation. Figure 4.2 shows epilimnetic depth for Hinze Dam in an average year, along with 95% upper and lower confidence intervals.

It should be noted that on average, August is the only month in which DO concentrations within the storage exceed 5mg/L at depths below 24m. A break in the upper 95% confidence interval occurs for the months of June and July, as highly variable DO concentrations have been recorded in the upper layers of the lake over the past 6-7 years, presumably as a result of destabilisation of thermal stratification, senescence of algal and/or macrophyte populations and a range of other limnological processes. During this period, surface DO concentrations have often been below the arbitrary 5mg/L trigger level, hence the standard deviation of the data is very high.

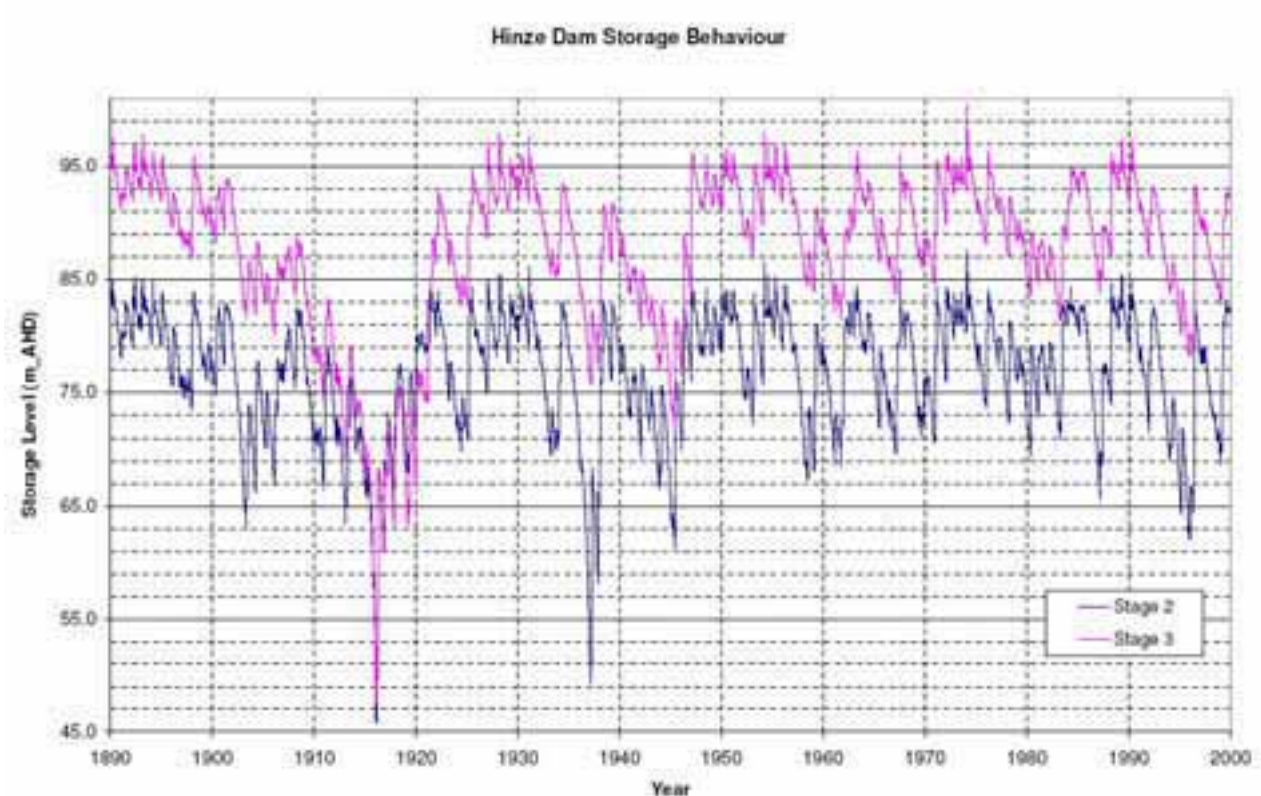
Figure 4.6 Storage behaviour curve for Hinze Dam Stage 2 and 3.  
(source Hinze Dam Alliance 2007)

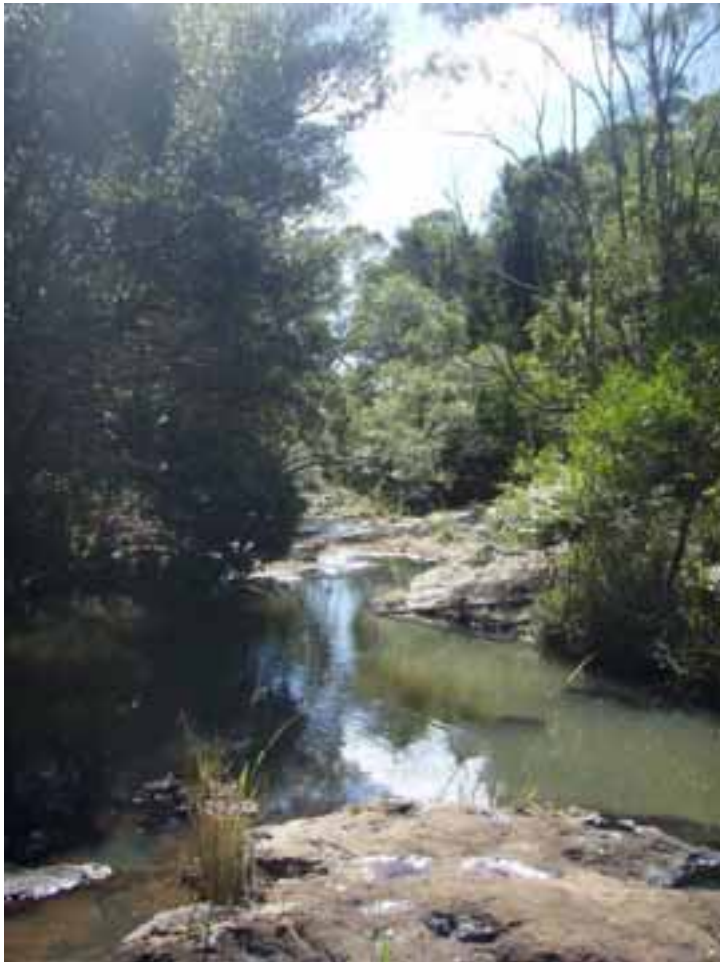
Figure 6.1 Example of aquatic macrophyte habitat within the freshwater reaches upstream of the Hinze Dam.

The freshwater reaches above Hinze Dam were generally shallow (<0.5m) comprised of bedrock substrate with sand in silt in the deeper holes. Terrestrial vegetation was frequently observed overhanging the channel and providing shaded conditions (Figure 6.1 Example of aquatic macrophyte habitat within the freshwater reaches upstream of the Hinze Dam). Small sections of this reach had reeds or rushes along the bank margins. Apart from this, aquatic vegetation was relatively sparse and dominated by *Azolla* and *Cladophora*, *Isolepis* c.f. *fluitans* and *Vallisneria* c.f. *nana* (Table 6.1). A complete species list of reeds and rushes could not be prepared due to time constraints.

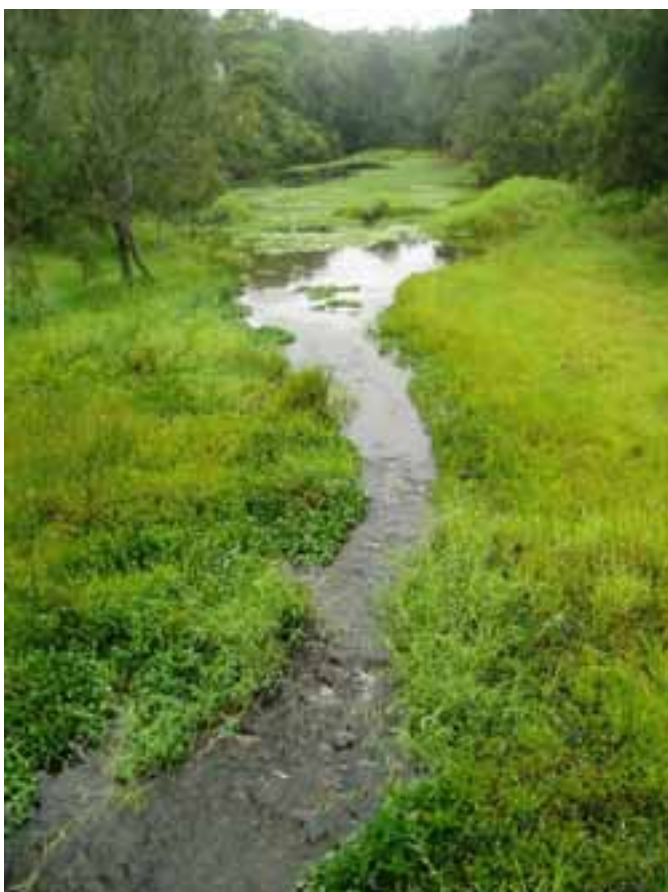
Figure 6.2 Example of aquatic macrophyte habitat within the freshwater reaches of the Nerang River downstream of the Hinze Dam. Note dense weed infestations and reduced channel width.

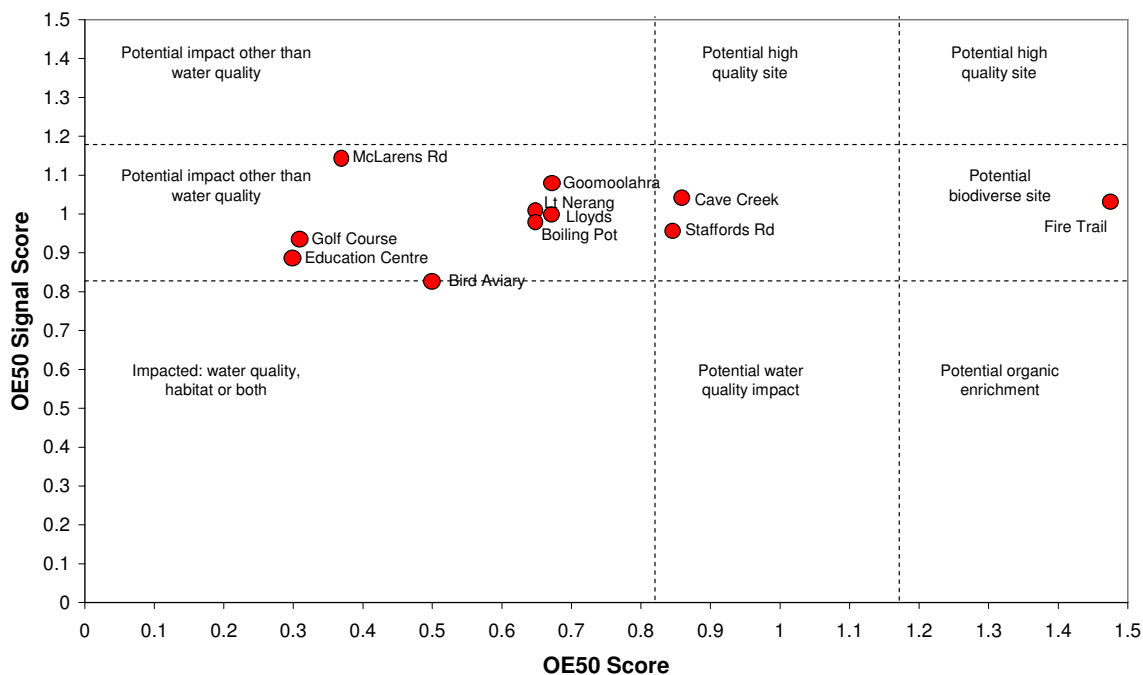
Figure 7.2 OE taxa vs OE signal scores for Hinze Catchment AusRivAS sites, 2005-06.

Figure 7.2 depicts OE vs OE signal scores for each site and habitat type, along with interpretive information.
