# Non-Indigenous Cultural Heritage Survey Report

INLAND RAIL—BORDER TO GOWRIE ENVIRONMENTAL IMPACT STATEMENT

Appendix W – Non-Indigenous  
Cultural Heritage Survey Report

Document Number:  
2-0001-310-EAP-10-RP-0219

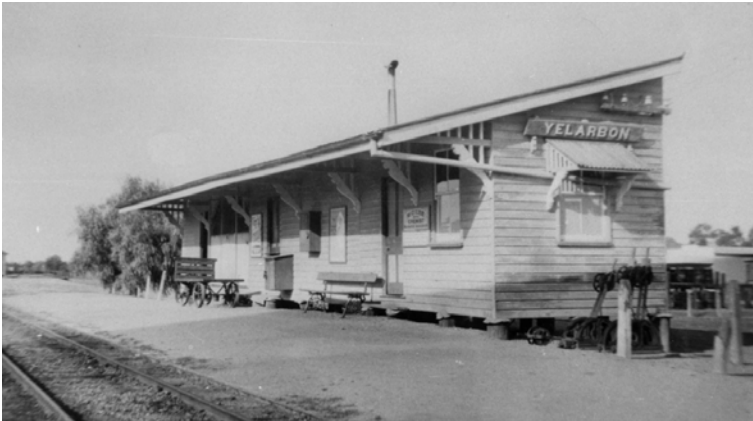
Photograph 4.1 Yelarbon Station c1935 (SLQ 149429)

Yelarbon was established in 1908 as a station on the South Western Line, named for what is believed to be an Aboriginal word for a large lagoon (*Queenslander* 25 April 1914:8). A station master was employed in 1914, and by 1916 the station featured a station building, siding, horse and carriage loading bank, animal yards, crane and scale. Over the next two decades these facilities expanded to include a telegraph connection, goods and cream sheds, side and end loading banks, and a platform shelter (Kerr 1966: Vol 2) (refer Photograph 4.1). From the 1960s, however, changes in transport technology and in the local economy meant that fewer passengers were using the station, and that facilities for stock and for cream were no longer required. The yards, cream shed and platform shelter were accordingly removed and replaced with the current bulk grain handling facilities.

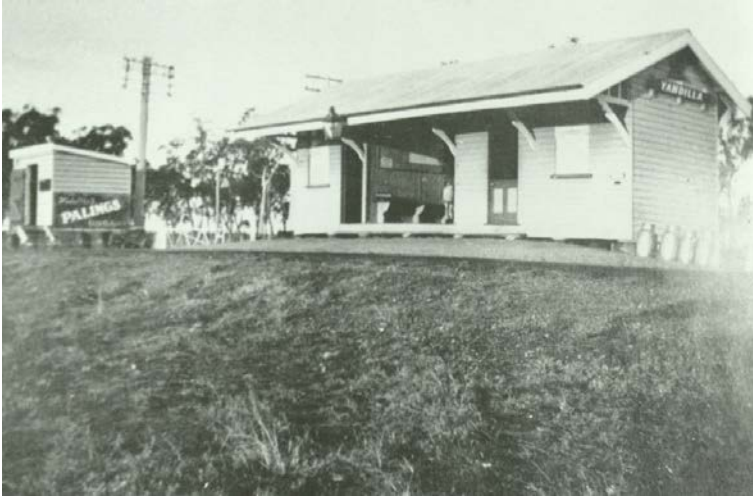
**Photograph 4.2 Yandilla Station c1960**

Yandilla Station was opened in 1911 as a part of the Millmerran Branch Line. The name was taken from the original pastoral run on which the station was located, which in turn was believed to be an Aboriginal word for 'running water' (*Queenslander* 25 April 1914:8). In 1916 the station featured a siding, horse and carriage loading bank, scales and animal yards (refer Photograph 4.2) (Kerr 1966: Vol 4). Over the next two decades these facilities expanded to include side and end loading banks, platform shelter, goods shed and cream shed and a 1 ton weighbridge which was subsequently replaced with a 6 ton version, and then 20 ton (metrication began in Australia in 1966). By the late 1950s, however, patronage of the station was waning, and in 1951 the decision was made to withdraw the station master, and convert the station to an isolated siding. The goods shed and the passenger station building was removed in the 1960s, and the first of the current concrete silos built. Further silos were added in the following years, and the last of the station buildings are believed to have been removed by the 1990s (Kerr 1966; Uebergang 2011).

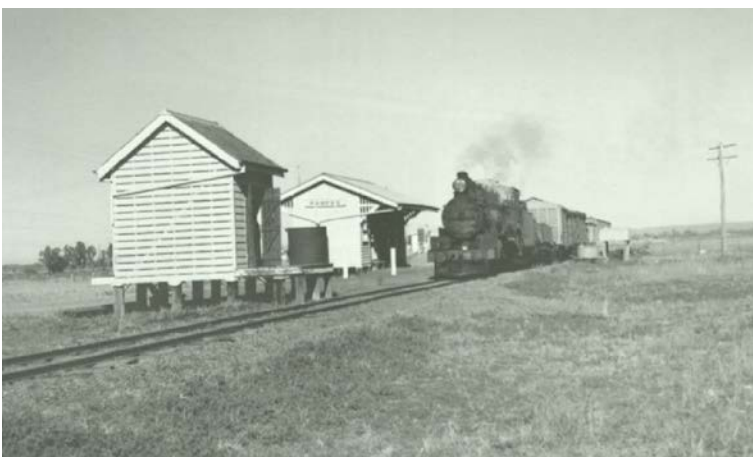
**Photograph 4.3 Pampas Station in 1968**

Pampas Station was opened in 1911 as a part of the Millmerran Branch Line, reportedly named for the wide plains (or pampas) that surrounded the site (*Queenslander* 11 April 1914:8). In 1916 the station featured a siding, horse and carriage loading bank, scales and animal yards (refer Photograph 4.3) (Kerr 1966: Vol 4). Over the next three decades these facilities expanded to include a side and end loading banks, platform shelter, goods shed and cream shed and a 1 ton a weighbridge which was subsequently replaced with a 6 ton version, and then 20 ton. The goods shed was removed in the 1950s, and the station building in the 1970s (Kerr 1966; Uebergang 2011).

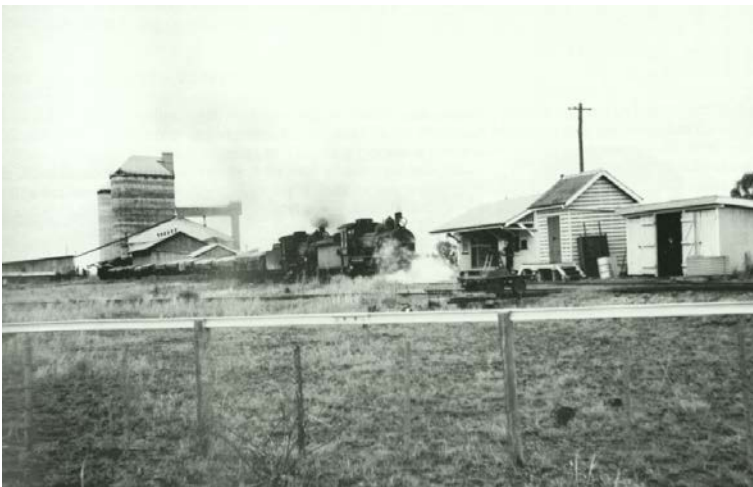
**Photograph 4.4 Brookstead Station 1967**

Brookstead Station was opened in 1911 as a part of the Millmerran Branch Line, named for the original pastoral run on which it was located (Brannock & Associates 2010). In 1916 the station featured a siding, horse and carriage loading bank, weighbridge and animal yards (Kerr 1966: Vol 4). Over the next three decades these facilities expanded to include side and end loading banks, platform shelter, goods shed, cream shed, and grain shed. In the 1950s, the business of the station became increasingly concentrated on grain transport. A station master was added to manage the burgeoning grain traffic, and the first bulk grain handling facilities were constructed (refer Photograph 4.4). Gradually, the other services, such as the goods and cream shed, were removed and the station closed in the 1980s. The station building was subsequently relocated to an adjacent park (Kerr 1966; Uebergang 2011).

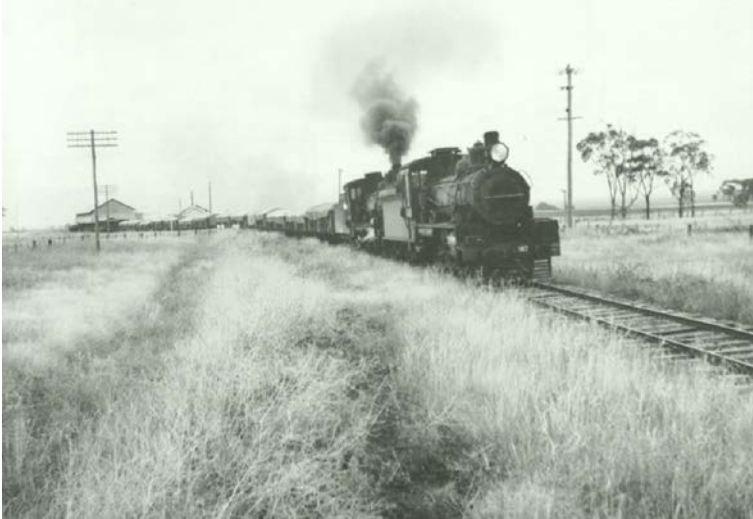
**Photograph 4.5 Murlaggan Station 1968**

Murlaggan Station was opened in 1911 as a part of the Millmerran Branch Line (Uebergang 2011). In 1916 the station consisted solely of a siding, to which a shelter was added in the 1930s (refer Photograph 4.5). Murlaggan lacked a station master for much of its operation, but was the base for a gang of fettlers, one of whom lived permanently on site (Uebergang 2011). The gang and their accommodation were relocated to Pittsworth in the 1970s and the station closed in 1981, by which time all remaining buildings had been removed (1984 QAP43540241).

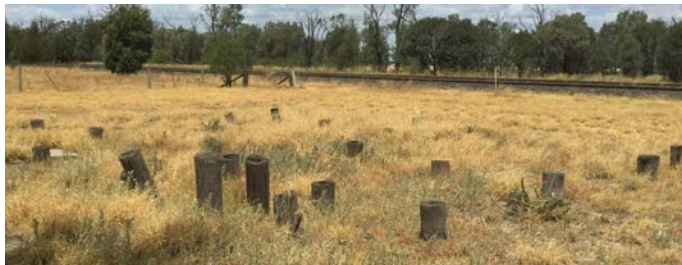
Photograph 6.1    Building stumps (B2G-19-H01)

Key elements			
Building stumps		Easting (GDA94 Z56)	Northing (GDA94 Z56)
Historical aerials from 1949 (QAP0009/107) – 1981 (QAP3996/100) show five main structures ranged along the northern side of the Kurumbul Station, on Georges Lane. The size and shape of these buildings are suggestive of houses, and the stumps noted at B2G 19-H01 are in the location of the easternmost structure.		261183 mE	6832205 mN

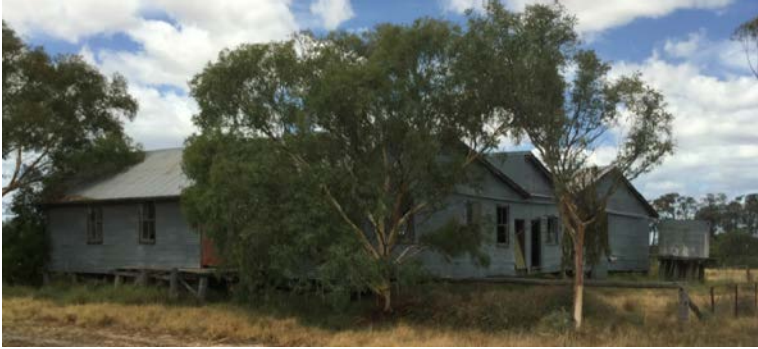
Key elements		
Shearing Shed	Easting (GDA94 Z56)	Northing (GDA94 Z56)
<p>Historical aerial images suggest that shearing shed has been in place since at least 1949 (QAP0009/113). The shed consists of two gabled buildings which have been joined by two narrow, skillion roofed structures, creating a 'sawtooth' roofline in the middle of the building. The northern elevation of this sawtooth insert features a row of windows to improve light and air circulation.</p> <p>The exterior of the building is clad entirely with corrugated iron, and widows are two-paned sash. Parts of shearing apparatus and stalls are visible through the windows.</p> <p>The two-paned sash windows used in the shed generally date to before the 1920s (Rechner 1998), suggesting it was built in the early 20<sup>th</sup> century. However, the unusual construction of the shed indicates it may have been built from repurposed structures or scavenged materials and so may date to a later period.</p>	271620 mE	6834397 mN

Photograph 6.3 Gibinbell shearing shed (B2G-19-H02)		
Shearers Quarters	Easting (GDA94 Z56)	Northing (GDA94 Z56)
<p>Like the shearing shed, the shearers' quarters have been in place since at least 1949. The structure consists of a long gabled building with a skillion verandah roof on the northern side, and is clad entirely with corrugated iron. Windows are two-paned sash, and doors are a mixture of three and four panel timber, both of which generally date to before 1920 (Rechner 1998). As suggested above, however, it is possible that the complex was built with scavenged materials, and so may date to a later period.</p>	271560 mE	6834362 mN

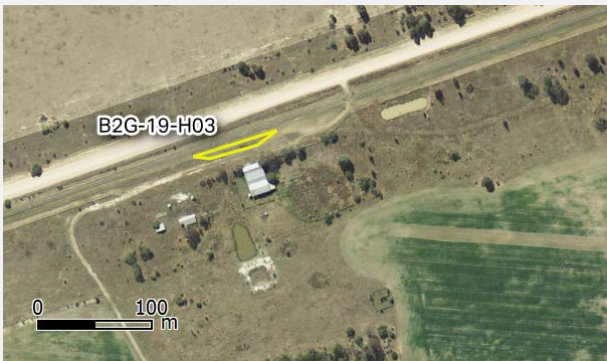
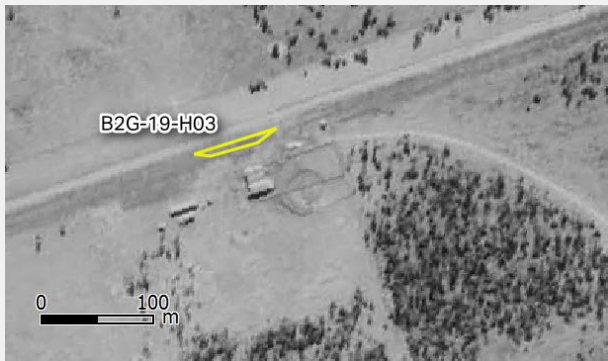
**Table 6.4 Inspection results – Gibinbell Siding (B2G-19-H03)**

Description
Railway siding established in 1908 as a part the South Western Line (Lot 413 SP119197). All station buildings have been removed, and much of the area graded to remove debris. The only extant element is an earthen loading bank.
Listings
None

Key elements			
Loading bank		Easting (GDA94 Z56)	Northing (GDA94 Z56)
The loading bank is a short earthen bund faced with a pre-cast concrete wall. A loading bank has been on site since 1916 (refer Section 4.2.2), but this would appear to be a much more modern structure.		271601 mE	6834423 mN

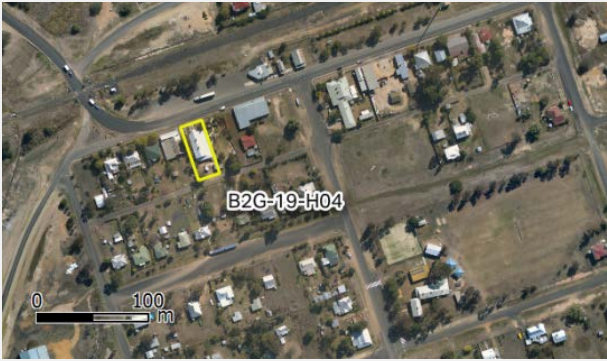
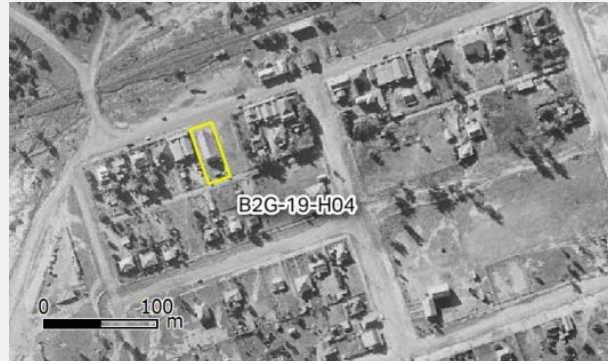
**Table 6.5 Inspection results – Yelarbon & District Soldiers Memorial Hall (B2G-19-H04)**

Description	
Memorial hall located on Taloom Street, Yelarbon (Lot 106 Y5691).	
Listings	
GRC LHR	
Current imagery	Historical imagery (1962 QAP1260/095)

Key elements		
Hall	Easting (GDA94 Z56)	Northing (GDA94 Z56)
<p>The Yelarbon &amp; District Soldiers Memorial Hall was constructed in 1920 to commemorate locals who had served in World War One (WWI). The endeavour was funded by public subscription at a cost of just over £1,000 (<i>Warwick Daily News</i> 12 August 1920:4).</p> <p>The design of the chamferboard clad building is consistent with the decorative carpenter styles of the Federation period (Apperly, Irving, &amp; Reynolds 1994). The corrugated iron roof is gabled on the main building, extending to a hip over what appears to be an original annex on the eastern façade. The entrance porch features a flying gable, and both it and the main gable have projecting screens and finials.</p> <p>The original multi-pane windows have been replaced with louvres and doors, but the building otherwise appears to be in largely original condition.</p>	280106 mE	6837259 mN

Site ID	Description	Potential impact	Likely magnitude of change
B2G-19-H04	Yelarbon & District Soldiers Memorial Hall	Dust and vibration from construction and operation may accelerate dilapidation	Medium
B2G-19-H05	Anzac Memorial Garden	Dust and vibration from construction and operation may impact gardens	Medium
B2G-19-H07	Church (former)	Dust and vibration from construction and operation may accelerate dilapidation. Structure is already in a poor condition and is vulnerable to damage.	Medium
B2G-19-H08	Yelarbon Mill 1	Dust and vibration from construction and operation may accelerate dilapidation of buildings. However, buildings are already subject to such impacts as it is an operating industrial site.	Negligible
B2G-19-H10	Petrol station	Dust and vibration from construction and operation may accelerate dilapidation of buildings	Low
B2G-19-H12	Tree trunk	May be subject to increased dust and vibration, but these are unlikely to have a noticeable impact	No change

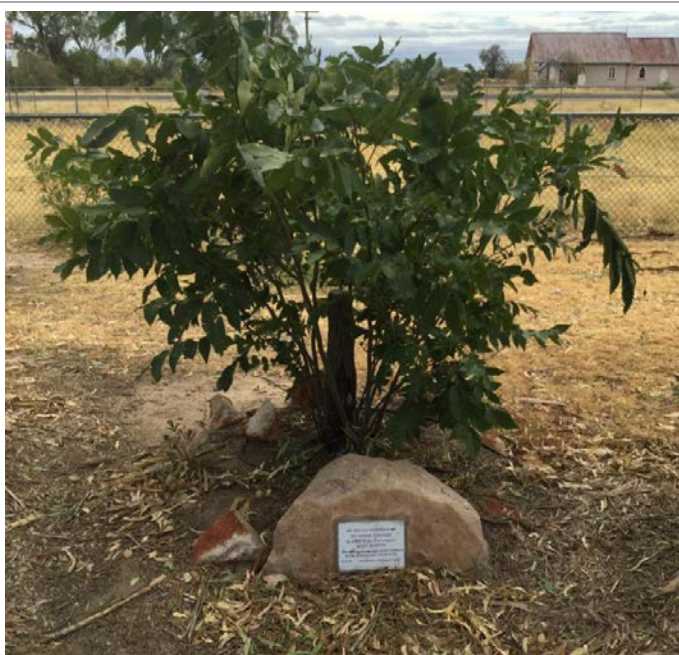
Photograph 6.10 Planting and Plaque (B2G-19-H06)

Planting and Plaque	Easting (GDA94 Z56)	Northing (GDA94 Z56)
Commemorative tree with small plaque mounted on an undressed sandstone block.	280121 mE	6837325 mN

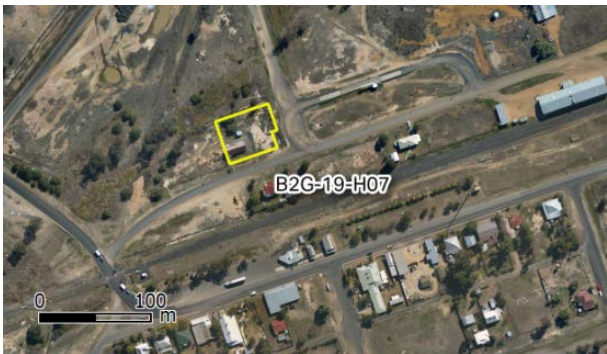
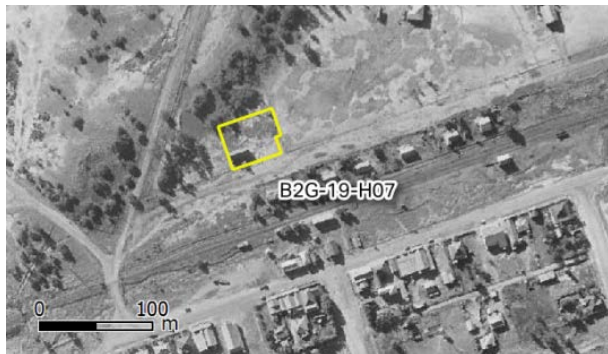
Description
Early 20 <sup>th</sup> century timber church located on Railway Parade, Yelarbon (Lot 2 RP120829). The site could not be accessed, but was visually inspected from a nearby public area.
Listings
None

Key elements			
Church		Easting (GDA94 Z56)	Northing (GDA94 Z56)
<p>The church was constructed by the Australian Presbyterian Church and dedicated to St Andrew in 1932 (<i>Brisbane Courier</i> 19 November 1932:5). The chamferboard clad building is a simple gable design, with entrance via a gabled southern porch. The windows and doors are all gothic arches, and plain finials are mounted on some of the gables. The western half of the building is slightly smaller than the eastern half, with differently sized windows, suggesting it may be a later extension.</p>		280118 mE	6837421 mN

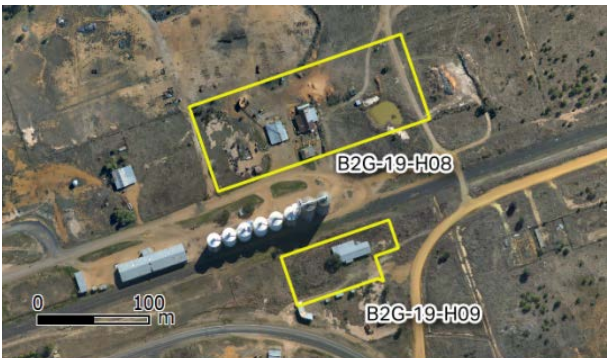
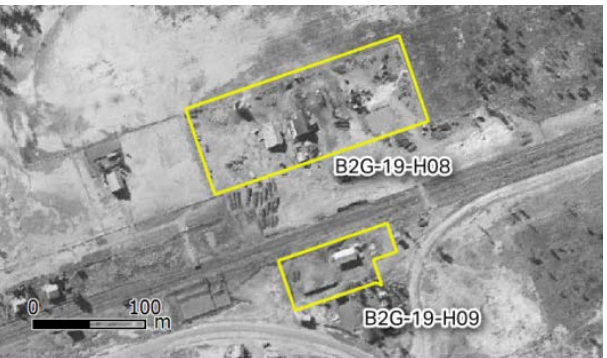
Table 6.9 Inspection results – Yelarbon Timber Mill 1 (B2G-19-H08)

Description	
<p>Part of a timber mill complex (refer also B2G-19-H09) established in 1917 by the Girle family, and located on the northern side of the Yelarbon Station (1 RP62008) (refer Table 6.12). A number of structures are located in the complex, with the main buildings consisting of two large timber sheds. The site could not be accessed, but was visually inspected from a nearby public area.</p>	
Listings	
None	
Current imagery

Key elements		
Timber Shed (West)	Easting (GDA94 Z56)	Northing (GDA94 Z56)
The westernmost of the main buildings is a large, timber framed structure with a gabled roof and skillion expansion, clad in horizontal weatherboards (refer Photograph 6.12). Historical aerial imagery suggests that this shed has been in place since at least the late 1940s, although it is unclear if it one of the original structures (1949 QAP0009/086).	280558 mE	6837592 mN

Photograph 6.12 Timber shed (west) (B2G-19-H08)		
Timber Shed (East)	Easting (GDA94 Z56)	Northing (GDA94 Z56)
The second large building is located on the east of the complex, and is of similar design, with a timber frame, main gable roof and skillion expansion, but clad with vertical boards (refer Photograph 6.13). This structure appears to date to the 1950s (1962 QAP1260/095).	280533 mE	6837585 mN

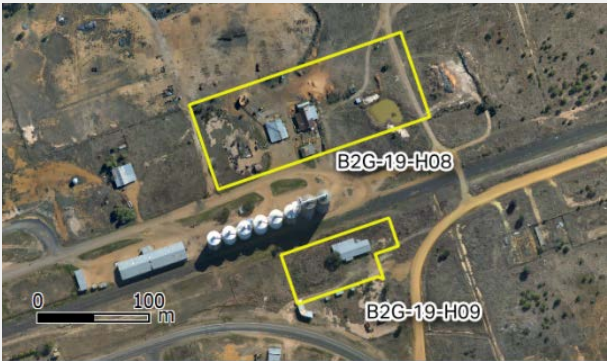
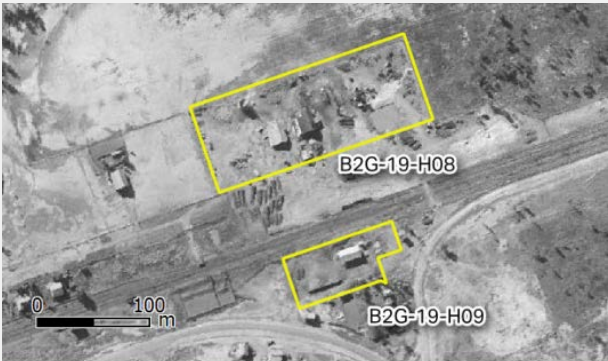
Description
Part of a timber mill complex established in 1917 by the Girle family (refer also B2G-19-H08), located on the southern side of the Yelarbon Railway Station (99 SP222802). Comprises a large metal shed.
Listings
None

Metal shed	Easting (GDA94 Z56)	Northing (GDA94 Z56)
A large shed with an iron clad gable roof, and open sides. Frame consists of metal lattice beams, trusses and posts. Interior contains lumber and remnants of sawmilling equipment, including rails. Historical aerial imagery suggests that this shed has been in place since at least the early 1960s (1962 QAP1260/095).	280601 mE	6837478 mN

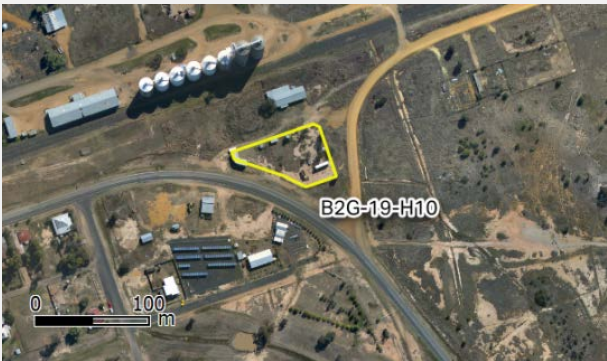
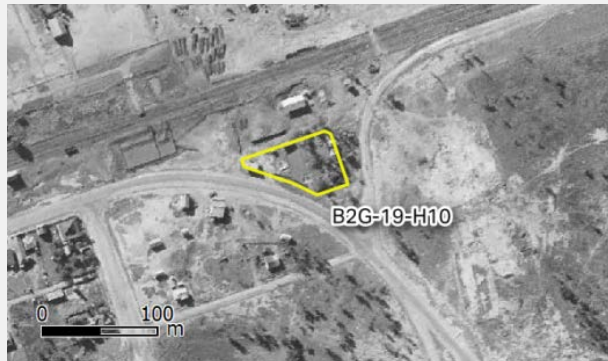
Table 6.11 Inspection results – Petrol Station (B2G-19-H10)

Description	
Mid-20 <sup>th</sup> century petrol station spread across three lots on the corner of Taloom Street and East Sawmill Road, Yelarbon (Lots 8 Y56911, 9 Y56911, 10 Y56911). Complex includes a toilet block, petrol bowsters and a main commercial building comprising a workshop and shopfront.	
Listings	
None	
Current imagery	Historical imagery (1962 QAP1260/095)

Key elements		
Commercial Building	Easting (GDA94 Z56)	Northing (GDA94 Z56)
The commercial building features a convex façade which is shaped to the corner block on which the structure is located. The building is clad predominately with horizontal chamferboards, with some weatherboards and vertical tongue and groove, and features a skillion roof with a plain palisade wall. The building appears to have been constructed in at least two phases, with two wings added to the small shopfront that now makes up the centre of the building. This is borne out by aerial imagery which shows a small square structure at the location until the early 1970s (1972 QAP2416/017).	280555 mE	6837427 mN

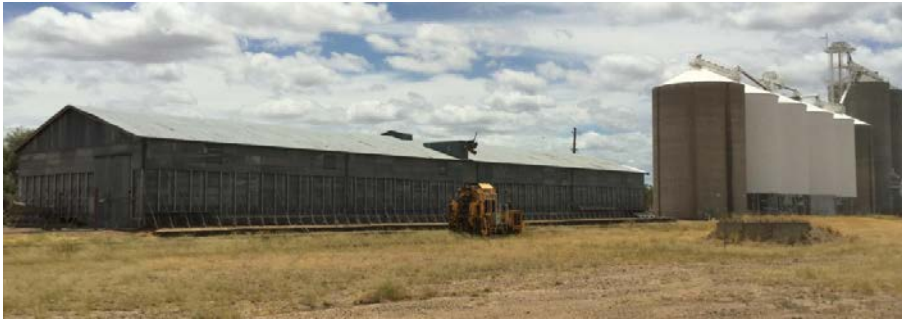
Photograph 6.16 Grain shed and silos (B2G-19-H11)

Key elements			
Grain shed and silos		Easting (GDA94 Z56)	Northing (GDA94 Z56)
Large corrugated iron grain shed and a series of concrete grain silos. Historical aerial imagery suggests that the shed and the four white silos were constructed in the late 1960s (1972 QAP2416/017), with the remaining silos added in the 1970s (1981 QAP3966/120).		280465 mE	6837482 mN

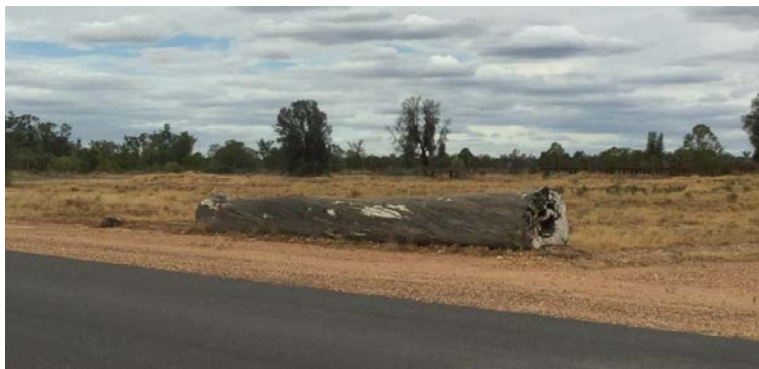
Photograph 6.17 Tree Trunk (B2G-19-H12)

Key elements			
Large Tree Trunk		Easting (GDA94 Z56)	Northing (GDA94 Z56)
Trunk of a large felled tree. Appears to have previously painted white, suggesting it may have been used as a sign or bollard.		280669 mE	6837415 mN

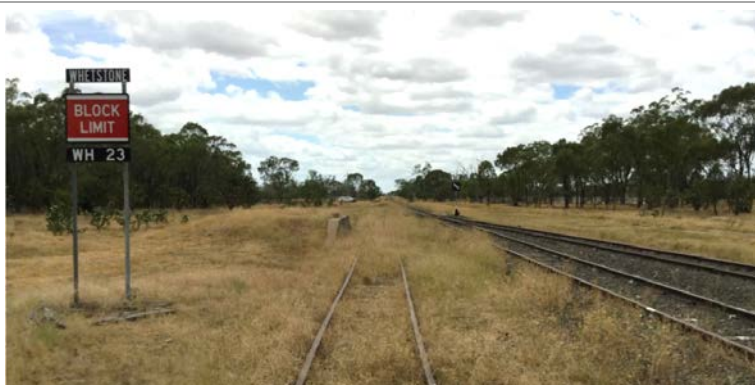
Photograph 6.18 Whetstone Siding (B2G-19-H13)

Loading bank	Easting (GDA94 Z56)	Northing (GDA94 Z56)
The loading bank is a short earthen bund faced with a pre-cast concrete wall.	297484 mE	6845990 mN

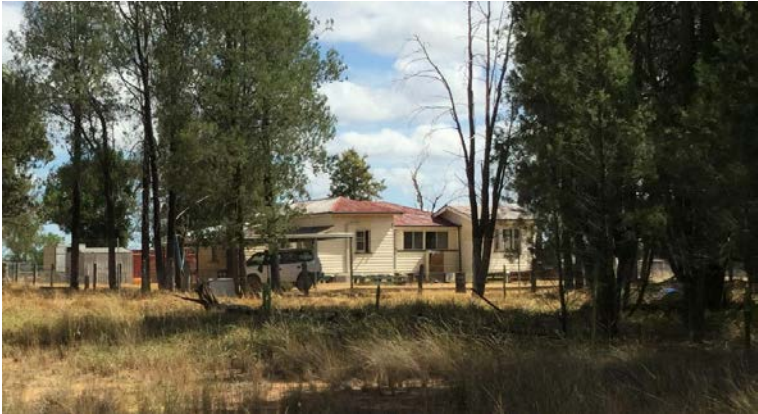
Photograph 6.19 Homestead Complex (B2G-19-H14)

Key elements		
Homestead	Easting (GDA94 Z56)	Northing (GDA94 Z56)
The dwelling visible from the road appears to be a mid-20 <sup>th</sup> century, weatherboard clad building with a hipped roof. A smaller, gabled structure has been added to the western side. Analysis of aerial images, however, suggests the presence of bungalow at the rear of the block that may date to the early 20 <sup>th</sup> century (1949 QAP0031/049).	301947 mE	6853233 mN

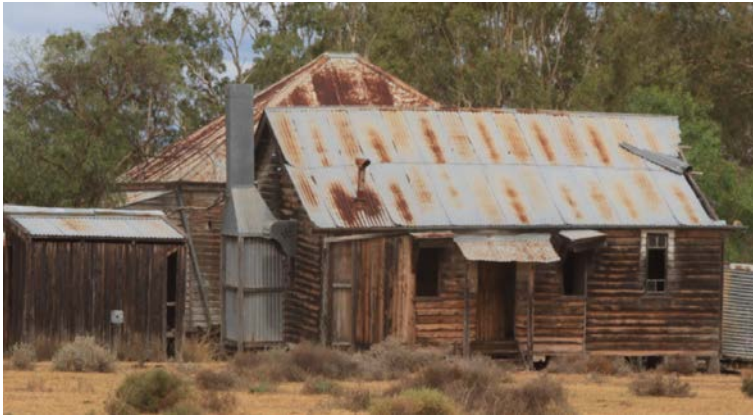
Photograph 6.20 Homestead (B2G-19-H15)

Key elements		
Homestead	Easting (GDA94 Z56)	Northing (GDA94 Z56)
<p>The homestead consists of two joined structures. The rear appears to be a weatherboard clad dwelling with a hipped roof and a stepped verandah on three sides, likely dating to the late colonial period. The front building potentially dates to the mid-colonial period (prior to 1880) and is a weatherboard clad gable roofed dwelling, with a corrugated iron chimney breast on the northern façade (National Trust of Queensland 1976; Rechner 1998).</p> <p>It is likely that the gabled building was the original dwelling, converted into a separate kitchen wing when the larger house was constructed to the east, oriented to the river.</p>	322109 mE	6885035 mN

Site ID	Description	Potential impact	Likely magnitude of change
B2G-19-H15	Homestead	Dust and vibration from construction and operation may accelerate dilapidation. Structure is already in a poor condition and is vulnerable to damage.	Medium
B2G-19-H18	Lookout	View may be altered. However, since the current view is of an industrial site, little substantive change is anticipated.	Low
B2G-19-H19	Outbuildings	Dust and vibration from construction and operation may accelerate dilapidation of any remaining structures	Medium
B2G-19-H22	Protest public art	Dust and vibration from construction and operation may accelerate dilapidation of structure	Medium
B2G-19-H25	Pampas Memorial Hall	Dust and vibration from construction and operation may accelerate dilapidation of structure if left in place	Medium
B2G-19-H28	Brookstead Station	None. No heritage structures remain.	No change
B2G-19-H29	Brookstead Station building (relocated)	Dust from construction and operation may accelerate dilapidation	Low

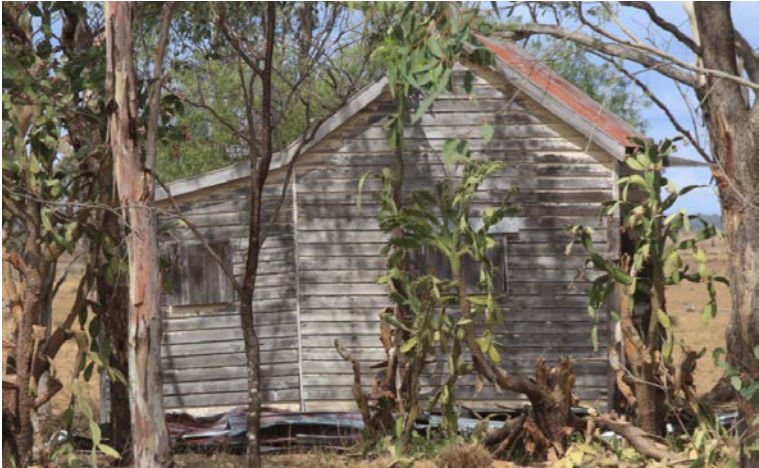
Photograph 6.21 Structure (B2G-19-H16)

Key elements			
Structure		Easting (GDA94 Z56)	Northing (GDA94 Z56)
A small, weatherboard clad gabled building with an enclosed skillion-roofed verandah. Windows have been replaced by wooden shutters. May have been an outbuilding or worker accommodation for the adjacent cattle property.		322109 mE	6886672 mN

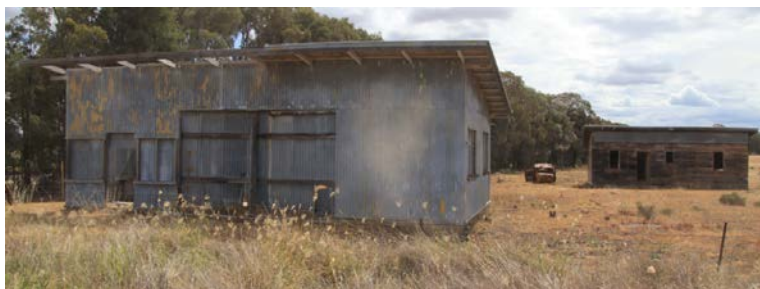
Photograph 6.22 Sheds (B2G-19-H17)

Key elements			
Sheds		Easting (GDA94 Z56)	Northing (GDA94 Z56)
Two skillion roofed sheds, one clad with corrugated iron, and one with weatherboards. Windows and doors have been removed or boarded over. Historical aerals suggest that the corrugated iron building has been in place since the 1950s (1959 QAP0969/067), with the weatherboard building added in the 1960s (1971 QAP2174/011). The function of these buildings is unknown.		322615 mE	6889642 mN

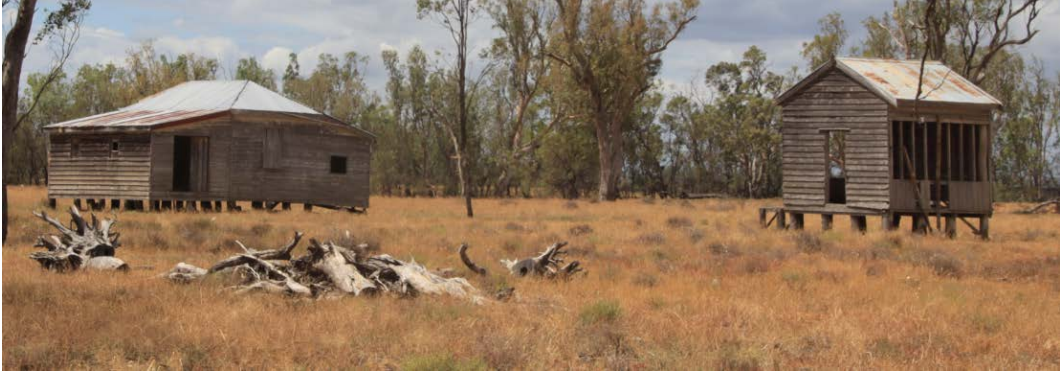
Photograph 6.24 Outbuildings (B2G-19-H19)

Key elements		
Outbuildings	Easting (GDA94 Z56)	Northing (GDA94 Z56)
<p>The larger of the two outbuildings is a weatherboard clad structure on short stumps with a hipped roof and enclosed skillion verandahs to the front and rear. A large doorway has been installed on the southern façade, and all windows have been removed, boarded over or covered with shutters.</p> <p>The smaller of the two outbuildings is a weatherboard clad structure on short stumps with a gabled roof. All doors and windows have been removed.</p> <p>Aerial imagery suggests that these two buildings are part of a large homestead complex which was located to the east and south but which was mostly removed in the early 1970s (1959 QAP0966/141; 1978 QAP3499/2968).</p>	337979 mE	6918642 mN

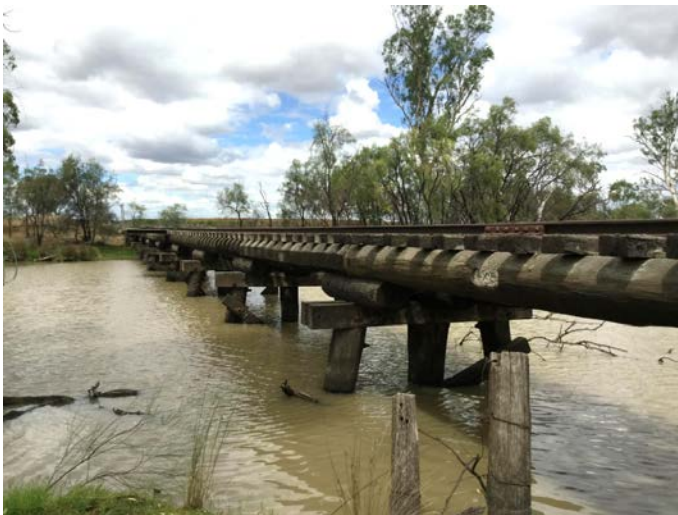
**Photograph 6.25 Rail bridge (B2G-19-H20)**

Key elements		
Rail Bridge	Easting (GDA94 Z56)	Northing (GDA94 Z56)
Low timber girder rail bridge.	338099 mE	6918596 mN

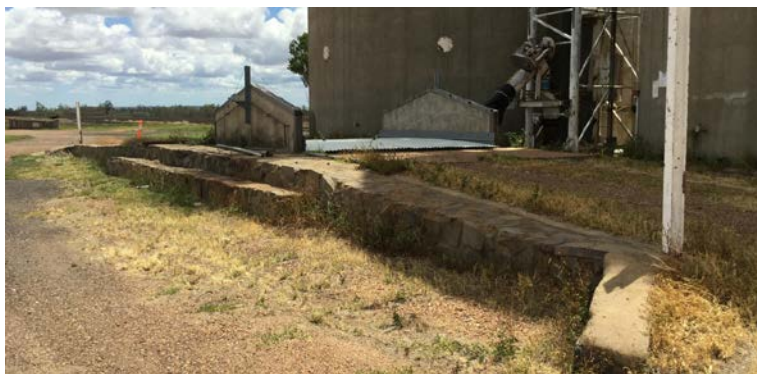
**Photograph 6.26 Weirbridge (B2G-19-H21)**

Key elements		
Weighbridge and silos	Easting (GDA94 Z56)	Northing (GDA94 Z56)
<p>Large corrugated iron grain shed and a series of concrete grain silos. Historical aerial imagery suggests that the row of four silos were added in 1960s (1971 QAP2160/009), with the remaining silos and the grain shed added in the 1970s (1984 QAP4351/131).</p> <p>The weighbridge is a metal structure surrounded by low, rubble course stone walls. The first weighbridge at the station was installed c1916, but has since been replaced twice. It seems likely that the current structure is the 20 ton weighbridge installed by the Wheat Board in 1945 (refer Section 4.2.5) (Kerr 1966:Vol 4).</p>	339166 mE	6919433 mN

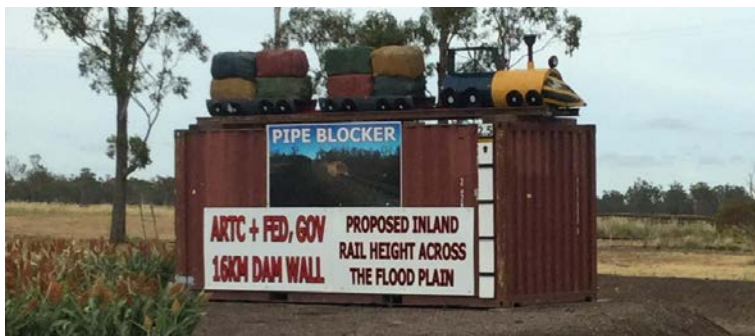
Photograph 6.27 Public Protest Artwork (B2G-19-H22)

Key elements			
Public Artwork		Easting (GDA94 Z56)	Northing (GDA94 Z56)
<p>Art installation by the local Millmerran Rail Group, who are protesting Inland Rail on the grounds that the alignment across the Condamine River floodplain will dam floodwaters, posing an unacceptable risk to life and property (The Millmerran Rail Group 2019). Although there are various examples of protest art along the Condamine River floodplain, this example is the best known and most elaborate.</p> <p>The installation comprises a model train placed on a shipping container, indicating an assumed height at which the track will be raised above the surrounding Condamine River floodplain, and describes the Project as a ‘16 km dam wall’. The train is constructed from elements readily found on agricultural properties and reflects the strong tradition in the country of manufacturing items from locally sourced materials. It is unclear from the available information whether this was predominately the work of an individual artist or a collective output. An image of the artwork is used as the Facebook profile picture of the Millmerran Rail Group.</p> <p>There is a growing awareness that such artwork serves to document community attitudes and actions that have the potential to bring about large-scale change, and that public institutions have a responsibility to curate such pieces (Williams 2017). Recent exhibitions of protest art and other ephemera at various Australian institutions speak to the importance of such pieces in representing the exercise of democratic rights (Powerhouse Museum 2016; State Library of Queensland 2017; York 2019).</p>		339311 mE	6919527 mN

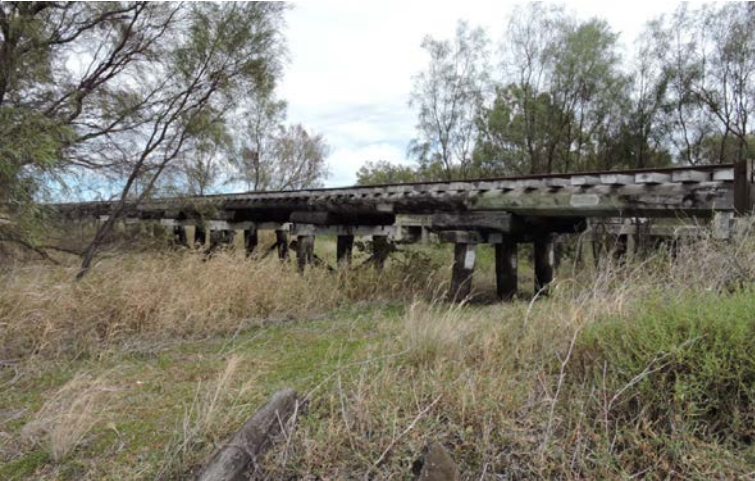
Photograph 6.28 Bridge (B2G-19-H23)

Key elements			
Bridge		Easting (GDA94 Z56)	Northing (GDA94 Z56)
Timber girder rail bridge with pre-cast concrete abutments over the Condamine River (North Branch).		340554 mE	6922077 mN

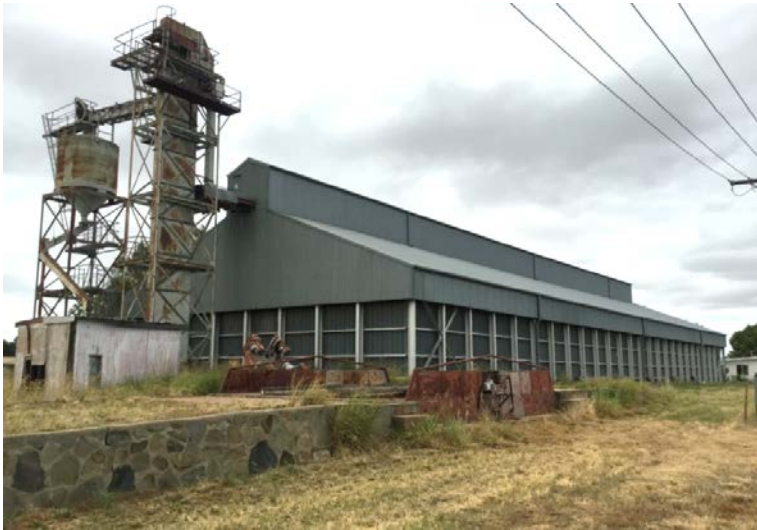
Photograph 6.29 Shed and Infrastructure (B2G-19-H24)

Key elements			
Shed and Infrastructure		Easting (GDA94 Z56)	Northing (GDA94 Z56)
<p>Large corrugated iron grain shed with grain handling equipment and weighbridge. Historical aerial imagery suggests that the grain shed was constructed in the early 1970s (1978, QAP34992800).</p> <p>The weighbridge is a metal structure surrounded by low, rubble course stone walls. The first weighbridge at the station was installed c1916, but has since been replaced twice. It seems likely that the current structure is the 20 ton weighbridge installed by the Wheat Board in 1945 (refer Section 4.2.6) (Kerr 1966:Vol 4).</p>		343422 mE	6924920 mN

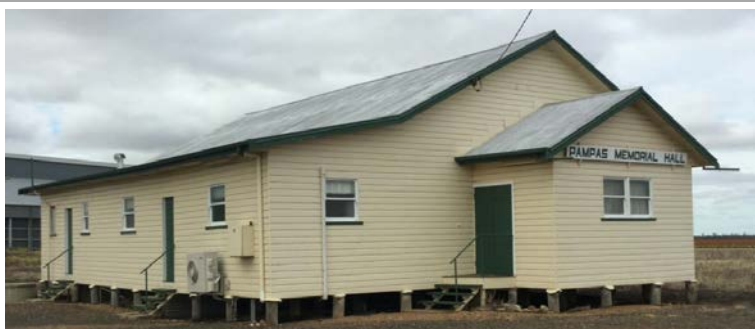
Photograph 6.30 Pampas Memorial Hall (B2G-19-H25)

Memorial Hall	Easting (GDA94 Z56)	Northing (GDA94 Z56)
<p>The Hall was constructed in 1954 to commemorate all those who had served in conflict. The money to build the hall was raised by the community, and the construction carried out by locals in a series of 'working bees' (<i>Pittsworth Sentinel</i> 1 October 1954:3).</p> <p>The structure is a simple chamferboard clad hall on low timber stumps with a corrugated iron gabled roof that extends into a skillion roof on the eastern facade. Windows are single-paned sashes, and doors are timber plank. Entrance to the building is via an enclosed gabled porch.</p>	343427 mE	6924895 mN

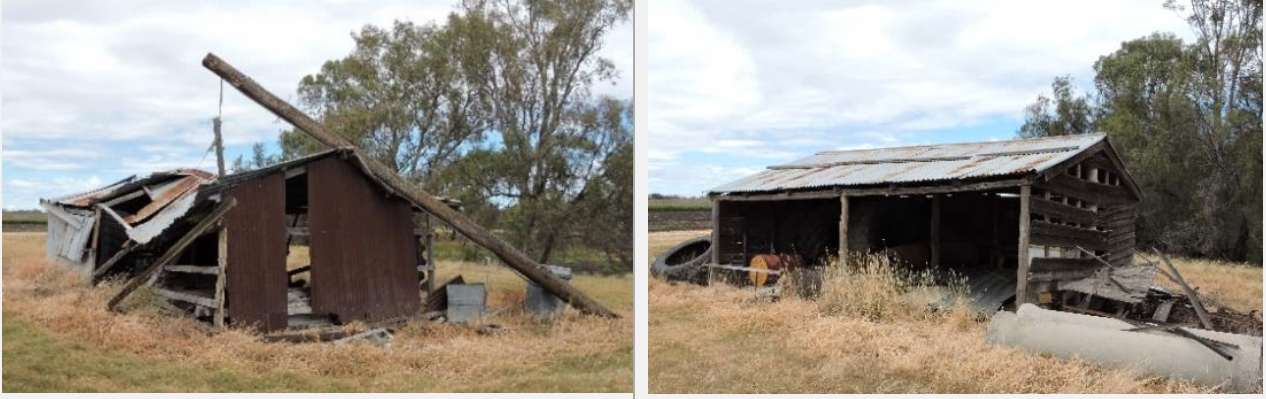
Photograph 6.31 Sheds (B2G-19-H26)

Key elements		
Sheds	Easting (GDA94 Z56)	Northing (GDA94 Z56)
Two dilapidated timber framed sheds, one clad entirely in corrugated iron, the other with weatherboard walls and corrugated iron roof. Historical aerial imagery suggests that the sheds have been in place since the 1950s and were part of a larger complex of buildings, possibly including a house (1954 QAP0493/069). The other buildings were demolished in the late 1990s (2001 QAP5899/070) and their location is now part of a ploughed paddock.	344749 mE	6926060 mN

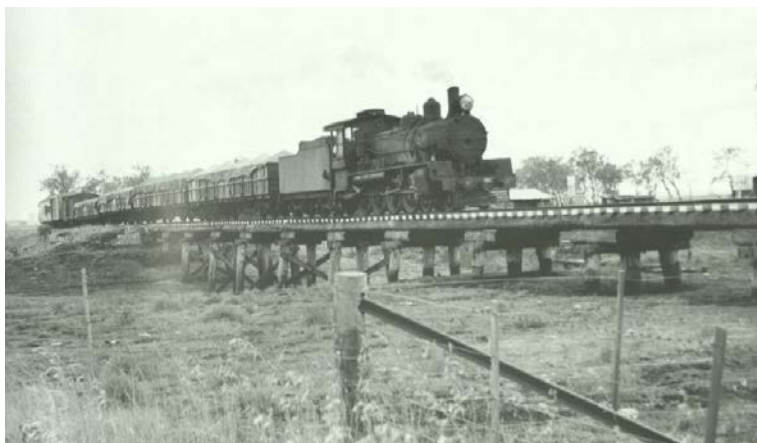
Photograph 6.32 Bridge 1967 (B2G-19-H27) (Uebergang 2011:121)

Key elements		
Bridge	Easting (GDA94 Z56)	Northing (GDA94 Z56)
Timber girder rail bridge with precast concrete abutments over the Condamine River (North Branch).	344686 mE	6926056 mN

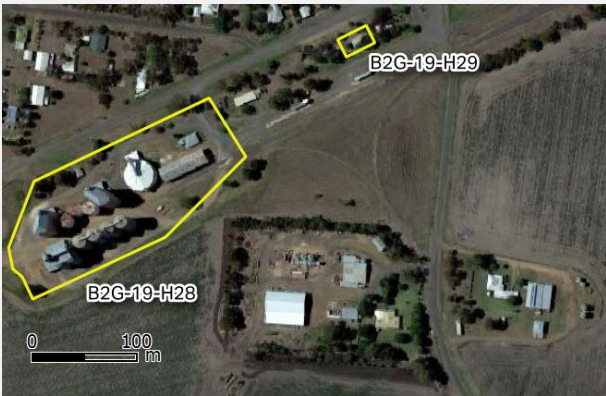
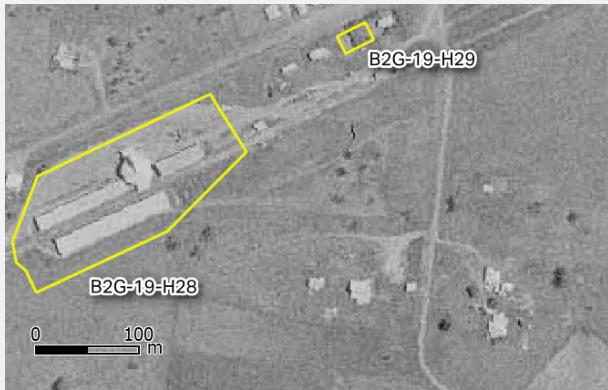
Table 6.29 Inspection results – Brookstead Station (B2G-19-H28)

Description			
Location of c1911station on the Millmerran Branch Line (Lot 121 SP104977). All original station buildings have been removed (refer B2G-19-H29), and the key elements of the complex are mid-late 20 <sup>th</sup> century silos. This site could not be inspected.			
Listings			
CHIMS (non-statutory)			
Current imagery		Historical imagery (1954 QAP0448/058)

Key elements			
Brookstead Station		Easting (GDA94 Z56)	Northing (GDA94 Z56)
Complex of grain silos. The largest of the silos was constructed by the State Wheat Board in 1953 with the remainder added in stages in 1961 and 1975 (Uebergang 2011).		346748 mE	6928362 mN
No photograph available

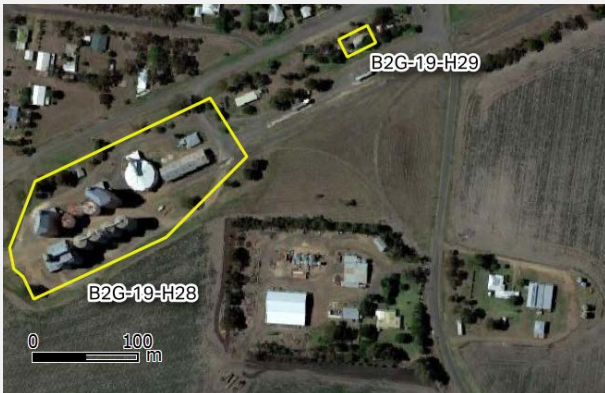
**Table 6.30 Inspection results – Brookstead Station Building (relocated) (B2G-19-H29)**

Description			
Early 20th century timber railway platform building in a park on Ware Street, Brookstead (13 SP112652). Relocated from the adjacent Brookstead Station (Buchanan Architects 2002).			
Listings			
CHIMS (non-statutory)			
Current imagery		Historical imagery (1954 QAP0448/058)

Key elements			
Brookstead Station Building		Easting (GDA94 Z56)	Northing (GDA94 Z56)
<p>The platform building at Brookstead was erected between 1925 and 1934 (refer Photograph 6.34) (Kerr 1966:Vol 4), and relocated in the 1990s (Uebergang 2011).</p> <p>A small, rectangular, weatherboard-clad timber building on low stumps with a gabled, corrugated iron roof that extends on the western side to form an awning (refer Photograph 6.35). The southern third of the building is a small office, and the northern section an open-sided shelter. Most windows are original one or two-paned sashes, but some have been boarded up or replaced with louvres. A tin, bullnosed sunhood remains over the southern window. The exterior of the building features decorative elements such as faux rafter ends to hold the station name, and ladder frame brackets with art nouveau style struts supporting the awning, all of which are consistent with the standard designs used by QR in the 1910s (Buchanan Architects 2002). The interior of the building has a wooden floor, tongue and groove wall and ceiling boarding, and a replacement bench.</p>		347008 mE	6928508 mN

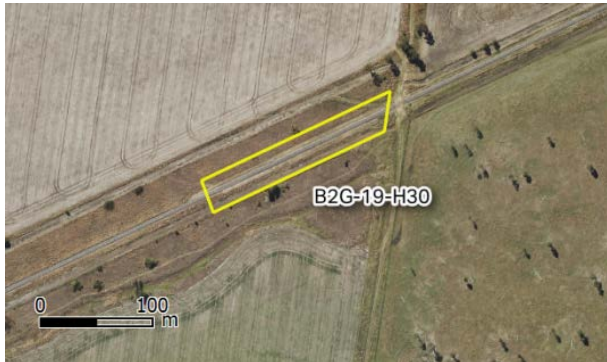
Table 6.31 Inspection results – Cecilvale Station (B2G-19-H30)

Description			
Station established c1911 as a part the Millmerran Branch Line at Cecil Plains (Lot 2 RP14245). No original station buildings remain.			
Listings			
None			
Current imagery		Historical imagery (1954 QAP0448/055)

Key elements			
Former station		Easting (GDA94 Z56)	Northing (GDA94 Z56)
All station elements were removed in the 1940s and the siding closed in the 1950s (Kerr 1966; Uebergang 2011).		352206mE	6930917mN

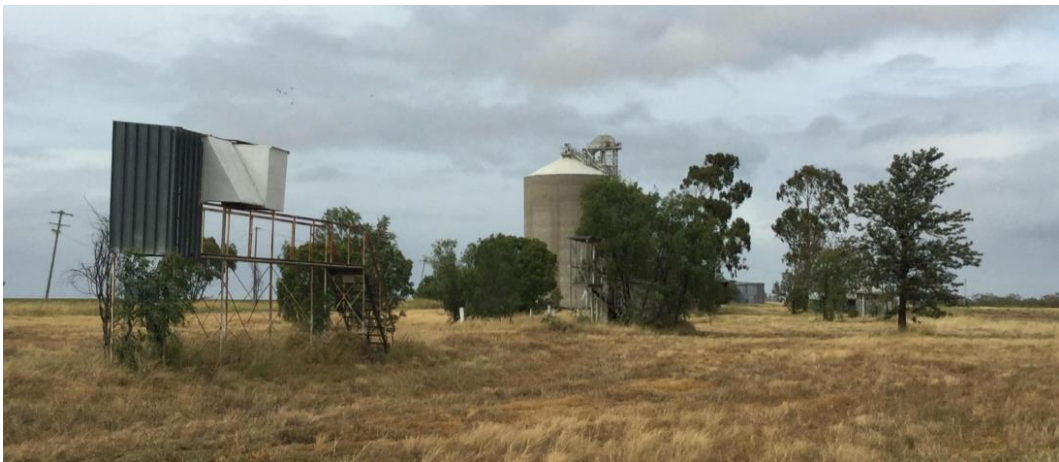
Photograph 6.37 Silo (B2G-19-H31)

Key elements		
Silos and grain shed	Easting (GDA94 Z56)	Northing (GDA94 Z56)
Historical aerial images suggest that the current silos and grain shed date to the early 1970s (1975 QAP3034/056)	354928 mE	6932273 mN

B2G-19-H31	Yarranlea Station	None. No heritage structures remain.	No change
B2G-19-H33	Homestead complex	Dust and vibration from construction and operation may accelerate dilapidation. Some structures are already in a poor condition and are vulnerable to damage.	Medium
Site ID	Description	Potential impact	Likely magnitude of change
B2G-19-H04	Yelarbon & District Soldiers Memorial Hall	Dust and vibration from construction and operation may accelerate dilapidation.	Medium
B2G-19-H05	Anzac Memorial Garden	Dust and vibration from construction and operation may impact gardens.	Medium
B2G-19-H07	Church (former)	Dust and vibration from construction and operation may accelerate dilapidation. Structure is already in a poor condition and is vulnerable to damage.	Medium
B2G-19-H08	Yelarbon Mill 1	Dust and vibration from construction and operation may accelerate dilapidation. However, buildings are already subject to such impacts as part of an operating industrial site.	Negligible

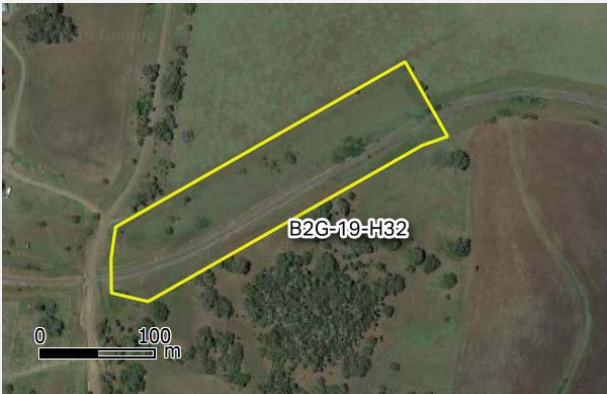
<b>Description</b>
Railway station established in 1911 as a part the as a part the Millmerran Branch Line (Lot 2 RP7479). All original station buildings have been removed.
<b>Listings</b>
None

Former station	Easting (GDA94 Z56)	Northing (GDA94 Z56)
Station closed in the 1980s and all elements removed (Uebergang 2011) (Section 4.2.10).	359428 mE	6933508 mN

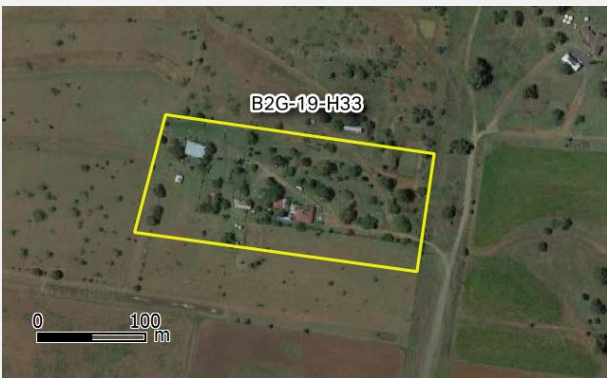
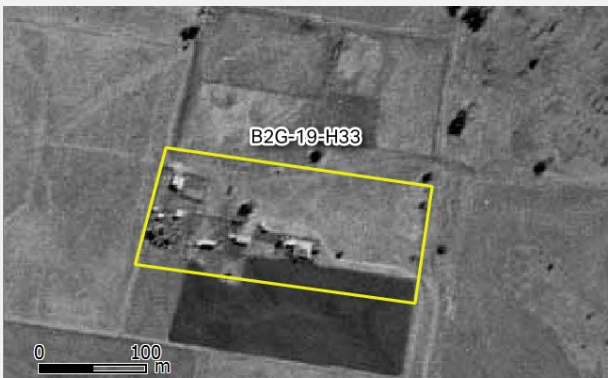
Table 6.34 Inspection results – Homestead Complex (B2G-19-H33)

Description	
Late 19 <sup>th</sup> century homestead located on French Road, Yarranlea (Lot 1 RP7470). Key elements include the current dwelling and a ruined former dwelling. There are also multiple outbuildings and other structures.	
Listings	
None	
Current imagery	Historical imagery (1955 QAP0485/011)

Key elements		
Homestead	Easting (GDA94 Z56)	Northing (GDA94 Z56)
The house is a weatherboard clad colonial dwelling on low stumps with a corrugated iron hipped roof and a stepped, bullnose roofed verandah on all sides. All but the front verandah has since been enclosed. The landholder reports that this house was built in 1902, replacing an earlier dwelling located to the north east (refer below) (Murray French, pers. comm. 7 February 2019).	361831 mE	6933772 mN

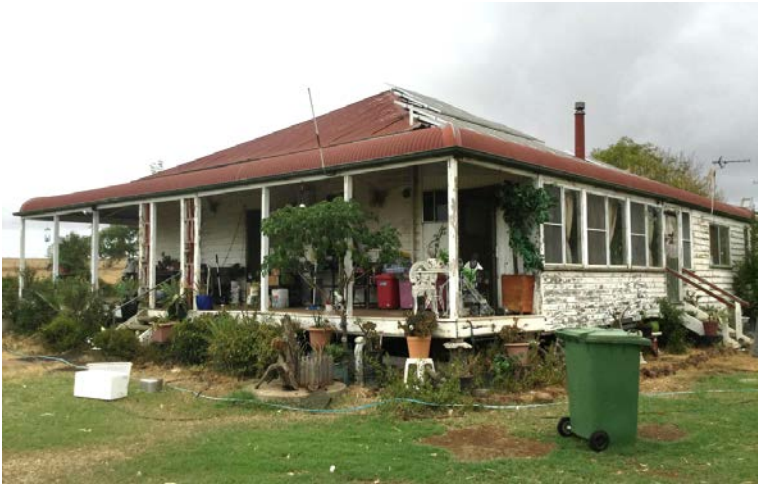
Photograph 6.39 Homestead (B2G-19-H33)		
Homestead Ruin	Easting (GDA94 Z56)	Northing (GDA94 Z56)
The homestead ruin consists of a series of stumps and other timber structural elements, surrounded by domestic and farming detritus. The homestead is understood to have collapsed in place (Murray French, pers. comm. 7 February 2019), and so there is high potential for archaeological remains in and around the structure.	361821 mE	6933765 mN

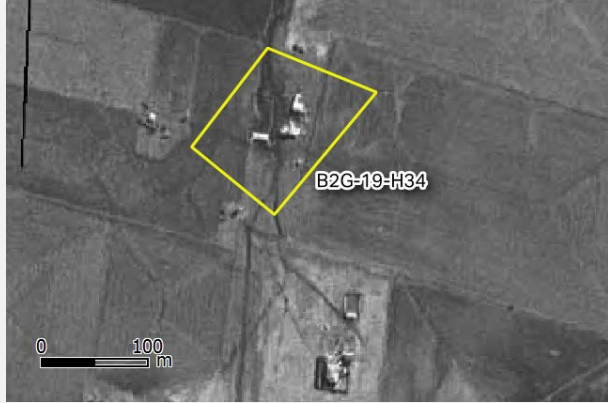
Description
Potential archaeological site located north of the Warrego Highway, Kingsthorpe (Lot 11 SP285307).
Listings
None

Key elements			
Possible archaeological site		Easting (GDA94 Z56)	Northing (GDA94 Z56)
Landholder reports presence of a now-demolished house slightly to the north of the current dwelling. Aerial imagery shows structures in this location in the 1950s (1955 QAP0483/016), but their size and configuration is more suggestive of farm outbuildings than a homestead. The buildings were removed in the 1980s (1984 QAP4395/070), and the area has since been extensively ploughed.		383573 mE	6957986 mN
No photograph available
