APPENDIX A

Borrow Pits—Supporting Technical Information

BORDER TO GOWRIE REVISED DRAFT ENVIRONMENTAL IMPACT STATEMENT

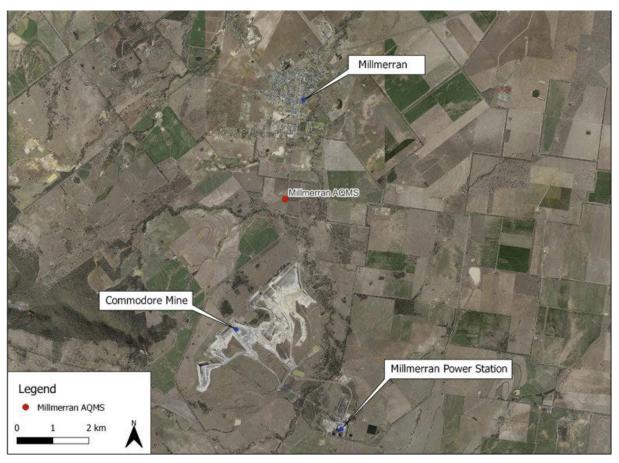
LOCATION OF MILLMERRAN AIR QUALITY MONITORING STATION FIGURE 3-1

A baseline air quality monitoring program was conducted for the B2G Project to inform the revised draft EIS; this included establishment of an air quality monitoring station (AQMS). The AQMS was set up at Millmerran on a private property associated with the Millmerran Power Station and near the Commodore Mine (located 1 km north of the mine) (Figure 3-1). The results of the monitoring are presented in Chapter 12: Air Quality and Appendix R: Air Quality Technical Report and are referred to in this assessment.

The Millmerran AQMS included two beta-attenuation particulate monitors (BAMs) measuring PM10 and PM2.5 particle size fractions.

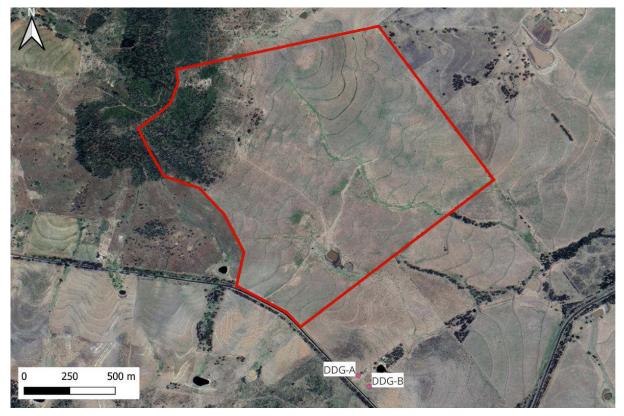
LOCATION OF DUST DEPOSITION GAUGES (DDG-A AND DDG-B) ON LOT 111 PLAN DY182 NEAR HECKENDORF ROAD FIGURE 3-2

In addition to the Millmerran AQMS, two dust deposition gauges were established on Lot 111 Plan DY182, on Heckendorf Road, Millwood QLD on borrow pit site 6B. The location of these gauges is shown on Figure 3-2. The sites were selected as there are no nearby sources of dust, making it a suitable representative of the other borrow pit locations.

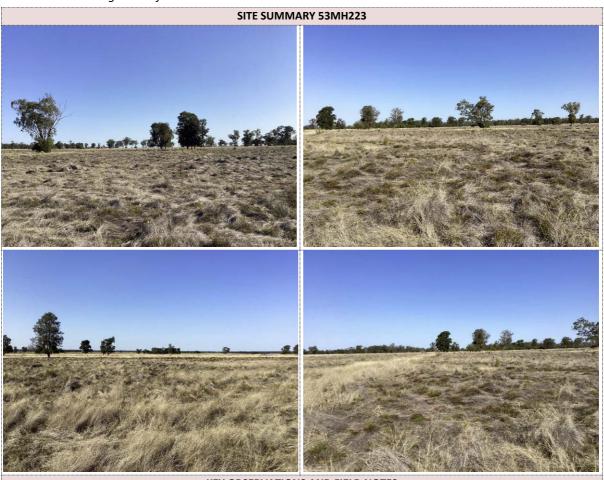
Table 3-2 Monitoring results for 53MH233

The site is a cleared non-remnant (Category X) paddock dominated by exotic grass such as *Eragrostis curvulua* (African lovegrass) and forbs including *Sclerolaena* spp., *Calotis* spp. along with scattered *Eucalyptus populnea*. Restricted invasive species *Opuntia tomentosa* (velvety tree pear) and *Harissia martinii* (harissia cactus) were also recorded at the site. No MNES or MSES were recorded. See Appendix 1C for mapping of this site.

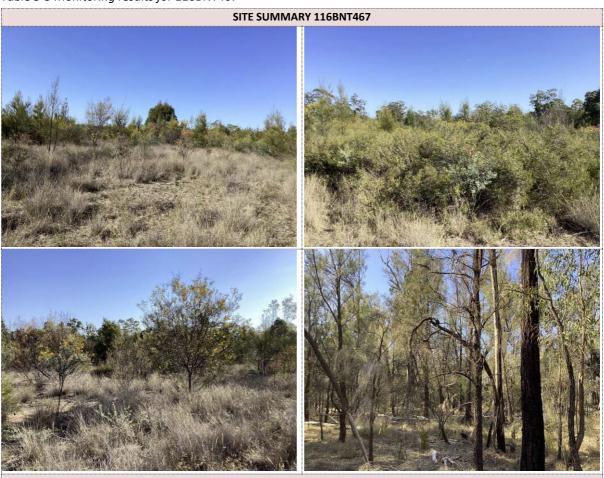
Table 3-3 Monitoring results for 116BNT467

The site contains shrubby non-remnant RE 11.9.13 (Category X), dominated by *Allocasuarina leuhmanii, Acacia polybotrya, Daviesia ulicifolia,* and *Leptospermum* sp. The ground layer consists predominantly of the native grass *Aristida caput-medusae*, with some cover of exotic forb species *Gladularia aristigera*.

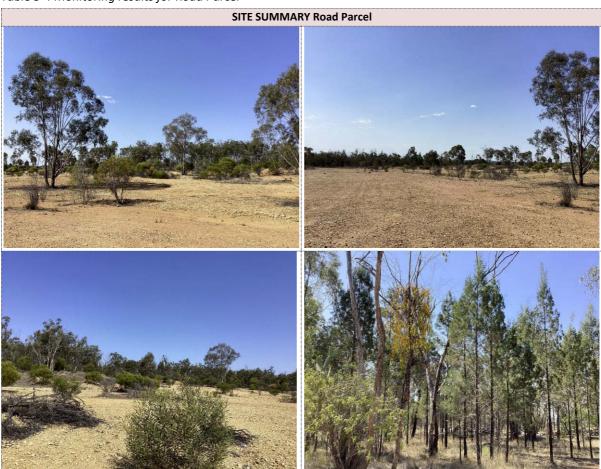
Table 3-4 Monitoring results for Road Parcel

The site is mostly cleared, with scattered mature *Eucalyptus crebra* and *Eucalyptus woollsiana*, and sparse shrubs including *Acacia shirleyi*, and *Acacia decora*.

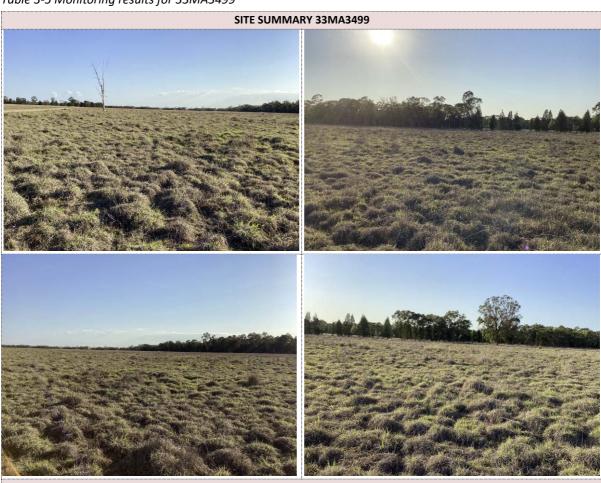
Table 3-5 Monitoring results for 33MA3499

The site is a cleared paddock pilled mainly with *Chloris gayana*. A mix of native forbs such as *Sclerolaena muricata* and *Wahlenbergia gracilis* were also recorded. No MNES or MSES were recorded. See Appendix 1F for mapping of this site.

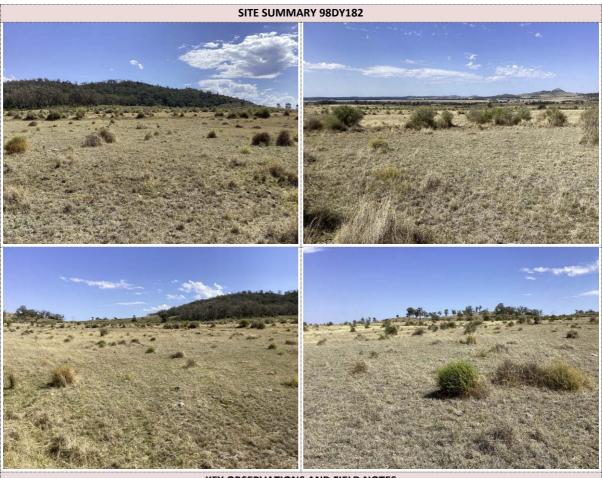
Table 3-6 Monitoring results for 98DY182

The site is a grazed non-remnant (Category X) cleared paddock comprising of mainly exotic pasture grasses including *Chloris gayana* with a mix of native forbs such as *Sclerolaena muricata* and *Wahlenbergia gracilis*. No MNES or MSES were recorded. One specimen of *Santalum lanceolatum*, listed as Special Least Concern under the *Nature Conservation Act 1992* (NC Act) was recorded at the site. See Appendix 1G for mapping of this site.
