APPENDIX Z

Non-Indigenous Cultural Heritage Survey Report

BORDER TO GOWRIE REVISED DRAFT ENVIRONMENTAL IMPACT STATEMENT

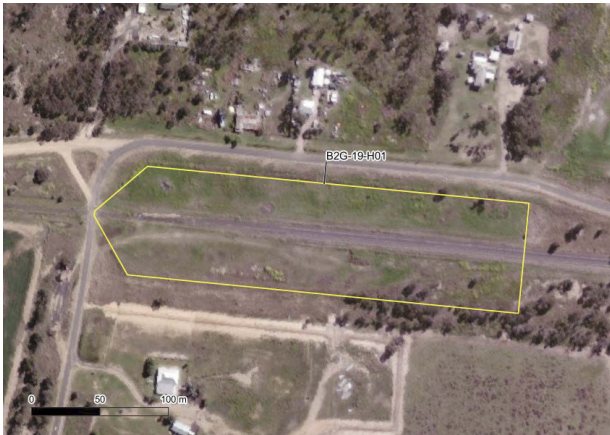
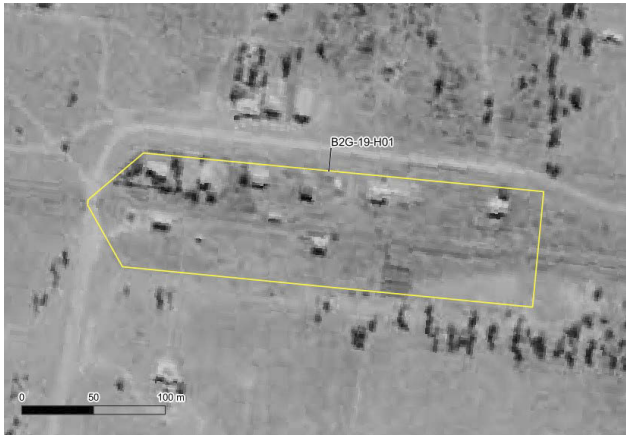
Description			
Location of 1908 station on the South Western Line (Lot 481 SP119198) (Section 4.3.1). All station buildings have been removed, and much of the area graded to remove debris. The only extant elements are a series of stumps and a concrete-faced earthen loading bank.			
Listings		Distance to Project	Condition
None		Majority located within permanent Project footprint with the north-eastern extent located in the temporary Project footprint	Ruin
Most recent imagery (2021)		Historical imagery (1949 QAP0009/107)

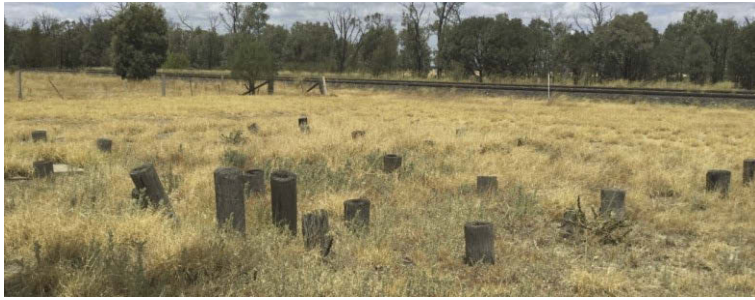
Photograph 6.1 Building stumps (B2G-19-H01)

Key elements			
Building stumps		Easting (GDA94 Z56)	Northing (GDA94 Z56)
Historical aerials from 1949 (QAP0009/107) – 1981 (QAP3996/100) show five main structures ranged along the northern side of the Kurumbul Station, on Georges Lane. The size and shape of these buildings are suggestive of houses, and the stumps noted at B2G-19-H01 are in the location of the easternmost structure.		261183 mE	6832205 mN

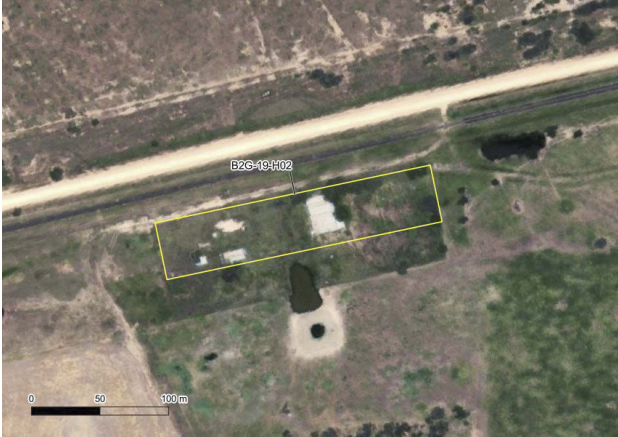
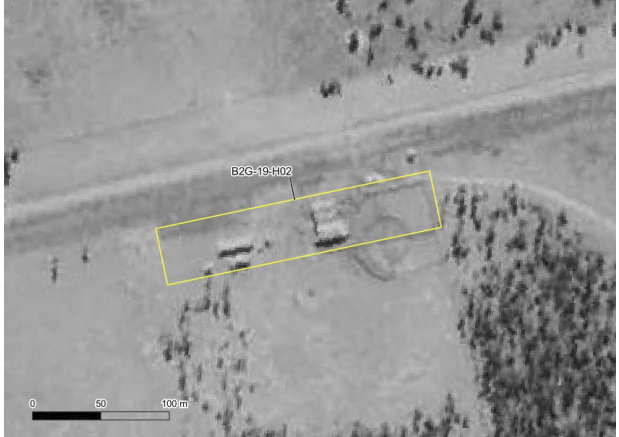
Description		
Shearing complex located adjacent to the Gibinbell Siding, on Lot 31 MH567. Consists of a large shearing shed, yards, and shearers' quarters. Comparison of historical and current aerial imagery suggests that a third building was located to the north of the quarters but has since been demolished. The site could not be accessed but was visually inspected from a nearby public area.		
Listings	Distance to Project	Condition
None	Located within permanent Project footprint	Poor

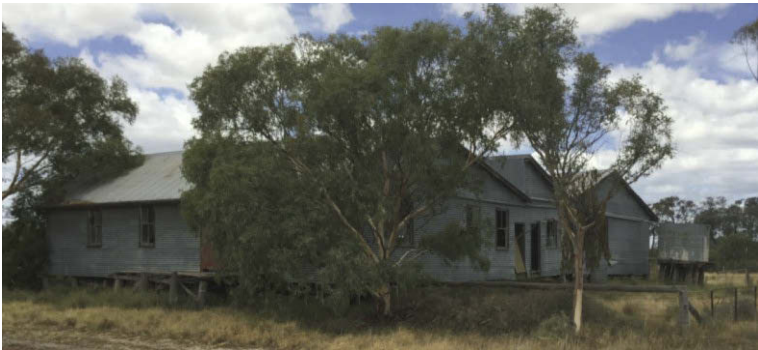
Shearing Shed	Easting (GDA94 Z56)	Northing (GDA94 Z56)
<p>Historical aerial images suggest that shearing shed has been in place since at least 1949 (QAP0009/113). The shed consists of two gabled buildings which have been joined by two narrow, skillion roofed structures, creating a 'sawtooth' roofline in the middle of the building. The northern elevation of this sawtooth insert features a row of windows to improve light and air circulation.</p> <p>The exterior of the building is clad entirely with corrugated iron, and widows are two-paned sash. Parts of shearing apparatus and stalls are visible through the windows.</p> <p>The two-paned sash windows used in the shed generally date to before the 1920s (Rechner, 1998), suggesting it was built in the early 20th century. However, the unusual construction of the shed indicates it may have been built from repurposed structures or scavenged materials and so may date to a later period.</p>	271620 mE	6834397 mN

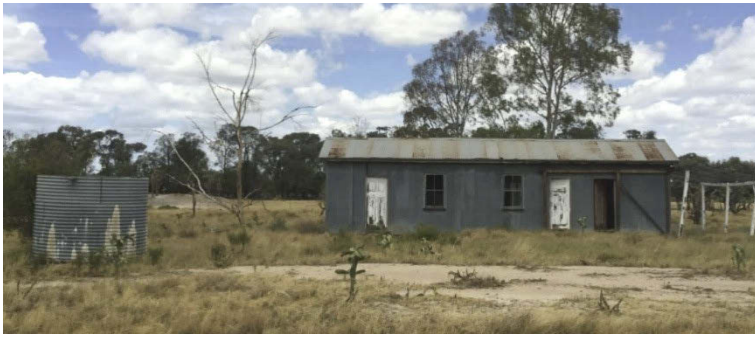
Photograph 6.4 Shearers' quarters (B2G-19-H02)

Photograph 6.3 Gibinbell shearing shed (B2G-19-H02)		
Shearers' Quarters	Easting (GDA94 Z56)	Northing (GDA94 Z56)
<p>Like the shearing shed, the shearers' quarters have been in place since at least 1949. The structure consists of a long gabled building with a skillion verandah roof on the northern side, and is clad entirely with corrugated iron. Windows are two-paned sash, and doors are a mixture of three and four panel timber, both of which generally date to before 1920 (Rechner, 1998). However, it is possible that the complex was built with scavenged materials, and so may date to a later period.</p>	271560 mE	6834362 mN

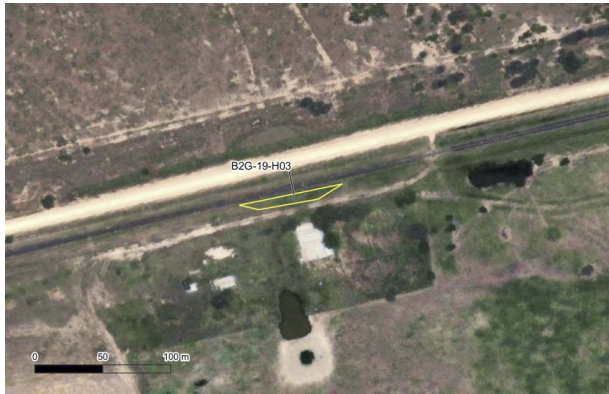
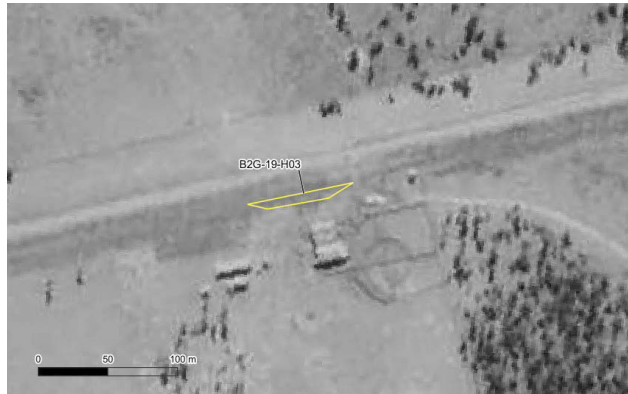
Description			
Railway siding established in 1908 as a part the South Western Line (Lot 413 SP119197). All station buildings have been removed, and much of the area graded to remove debris. The only extant element is an earthen loading bank.			
Listings		Distance to Project	Condition
None		Located within permanent Project footprint	Poor
Most recent imagery (2021)		Historical imagery (1949 QAP0009/113)

Key elements			
Loading bank		Easting (GDA94 Z56)	Northing (GDA94 Z56)
The loading bank is a short earthen bund faced with a pre-cast concrete wall. A loading bank has been on site since 1916 (Section 4.3.2), but this would appear to be a much more modern structure.		271601 mE	6834423 mN

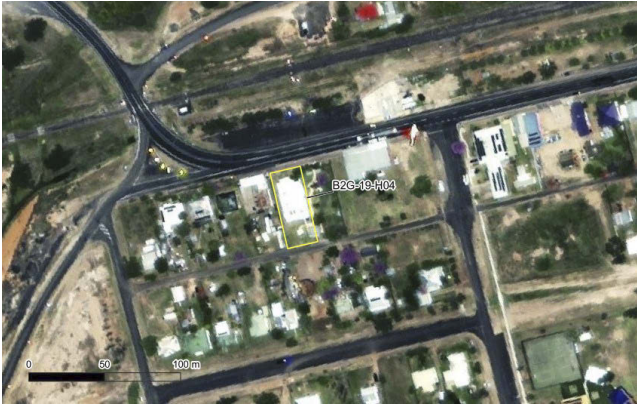
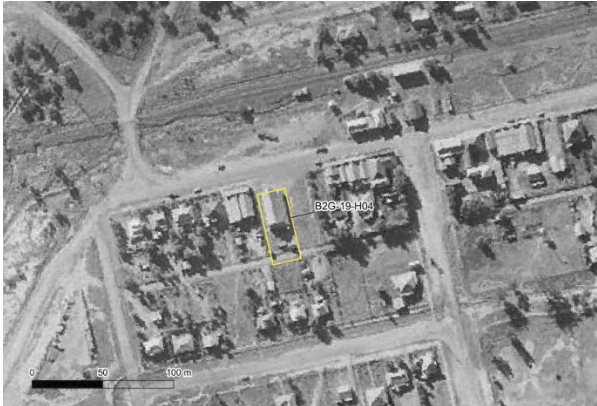
Description		
Memorial hall located on Taloom Street, Yelarbon (Lot 106 Y5691).		
Listings	Distance to Project	Condition
GRC LHR	Located outside of the permanent Project footprint, directly adjacent to the temporary Project footprint.	Good
Most recent imagery (2021)		Historical imagery (1962 QAP1260/095)

Key elements		
Hall	Easting (GDA94 Z56)	Northing (GDA94 Z56)
<p>The Yelarbon & District Soldiers Memorial Hall was constructed in 1920 to commemorate locals who had served in World War I. The endeavour was funded by public subscription at a cost of just over £1,000 (<i>Warwick Daily News</i> 12 August 1920:4).</p> <p>The design of the chamferboard clad building is consistent with the decorative carpenter styles of the Federation period (Apperly et al. 1994). The corrugated iron roof is gabled on the main building, extending to a hip over what appears to be an original annex on the eastern façade. The entrance porch features a flying gable, and both it and the main gable have projecting screens and finials.</p> <p>The original multi-pane windows have been replaced with louvres and doors, but the building otherwise appears to be in largely original condition.</p>	280106 mE	6837259 mN

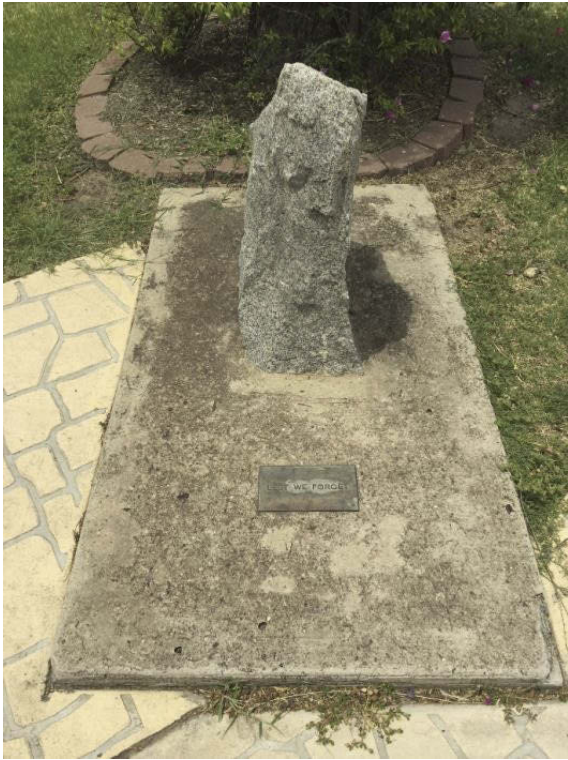
Photograph 6.8 Original war memorial (B2G-19-H05)

Key elements		
War Memorials	Easting (GDA94 Z56)	Northing (GDA94 Z56)
There are two main memorials in the park. The first is a simple block of undressed, granitic stone set in concrete with a plaque inscribed with 'lest we forget' (Photograph 6.8). This is understood to be the original war memorial, but its dedication date is unknown (Monument Australia, 2019). The second memorial was dedicated in 1996, and consists of a polished black granite obelisk set on a two-tiered dressed sandstone base (Photograph 6.9) (Monument Australia, 2019).	280123 mE	6837273 mN

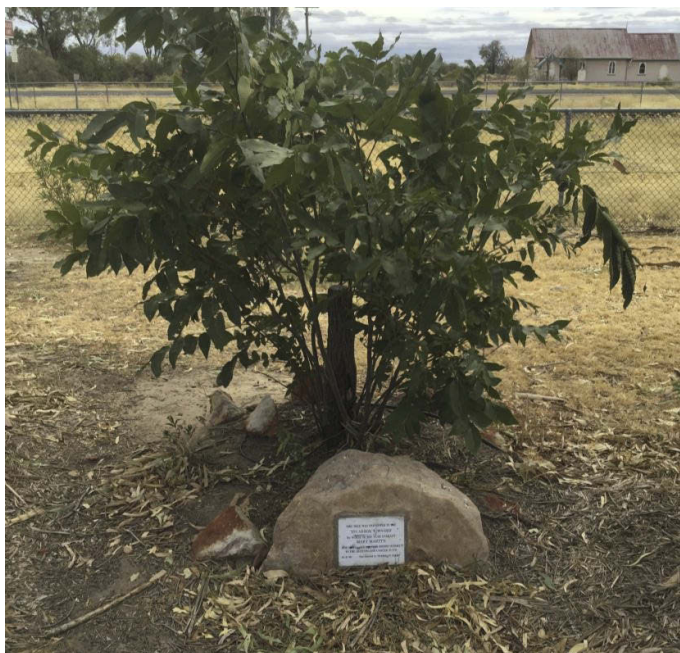
Photograph 6.10 Planting and Plaque (B2G-19-H06)

Key elements		
Planting and Plaque	Easting (GDA94 Z56)	Northing (GDA94 Z56)
Commemorative tree with small plaque mounted on an undressed sandstone block.	280121 mE	6837325 mN

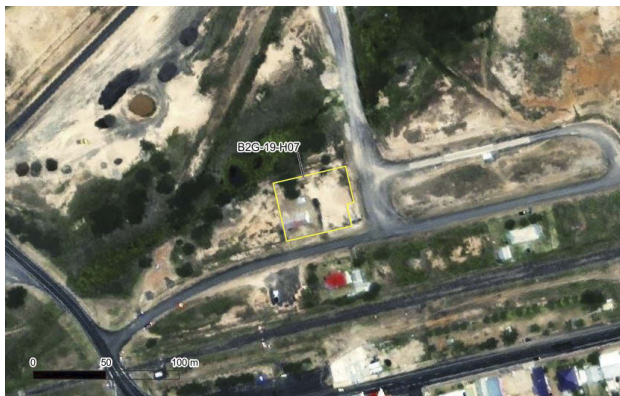
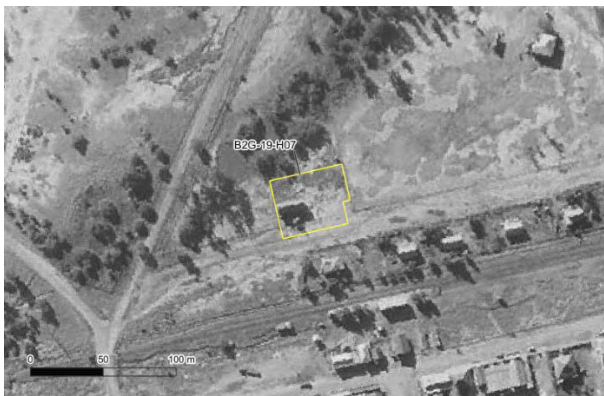
Description		
Early 20 th century timber church located on Railway Parade, Yelarbon (Lot 2 RP120829). The site could not be accessed, but was visually inspected from a nearby public area.		
Listings	Distance to Project	Condition
None	Located 12 m north-east of the temporary Project footprint	Moderate
Most recent imagery (2021)		Historical imagery (1962 QAP1260/095)

Key elements		
Church	Easting (GDA94 Z56)	Northing (GDA94 Z56)
The church was constructed by the Australian Presbyterian Church and dedicated to St Andrew in 1932 (<i>Brisbane Courier</i> 19 November 1932:5). The chamferboard clad building is a simple gable design, with entrance via a gabled southern porch. The windows and doors are all gothic arches, and plain finials are mounted on some of the gables. The western half of the building is slightly smaller than the eastern half, with differently sized windows, suggesting it may be a later extension.	280118 mE	6837421 mN

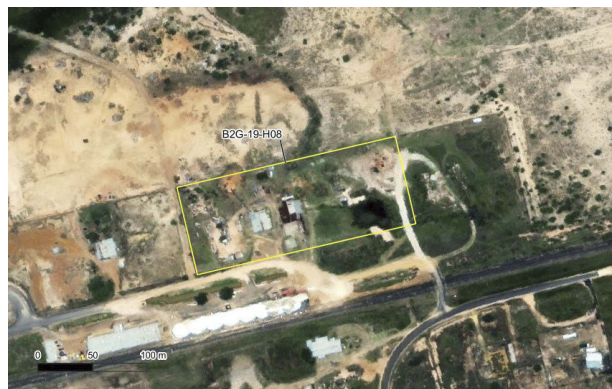
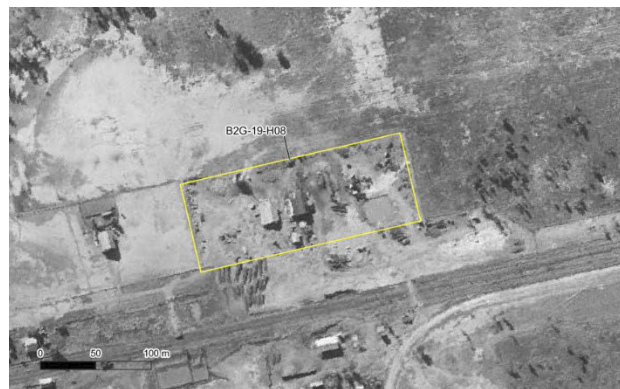
Description		
Part of a timber mill complex (refer also B2G-19-H09) established in 1917 by the Girle family and located on the northern side of the Yelarbon Station (1 RP62008) (Table 6.12). A number of structures are located in the complex, with the main buildings consisting of two large timber sheds. The site could not be accessed but was visually inspected from a nearby public area.		
Listings	Distance to Project	Condition
None	Located 21 m north of the temporary Project footprint	Poor
Most recent imagery (2021)		Historical imagery (1962 QAP1260/095)

Key elements		
Timber Shed (West)	Easting (GDA94 Z56)	Northing (GDA94 Z56)
The westernmost of the main buildings is a large, timber framed structure with a gabled roof and skillion expansion, clad in horizontal weatherboards (Photograph 6.12). Historical aerial imagery suggests that this shed has been in place since at least the late 1940s, although it is unclear if it is one of the original structures (1949 QAP0009/086).	280558 mE	6837592 mN

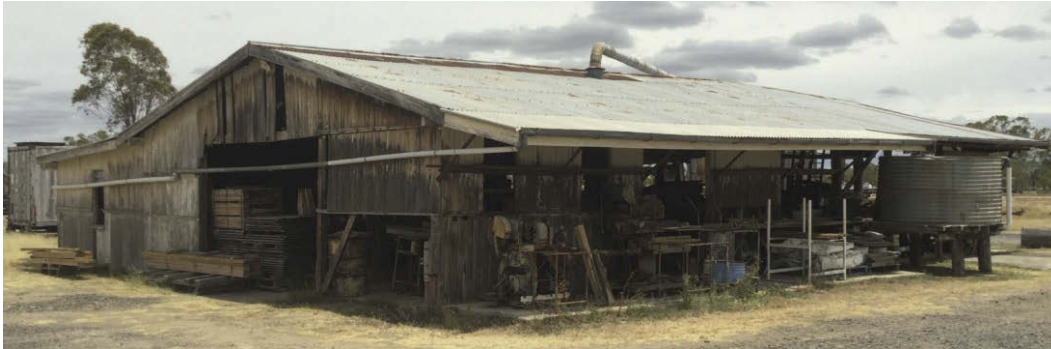
Photograph 6.13 Timber shed (east)(B2G-19-H08)

Timber Shed (East)	Easting (GDA94 Z56)	Northing (GDA94 Z56)
The second large building is located on the east of the complex, and is of similar design, with a timber frame, main gable roof and skillion expansion, but clad with vertical boards (Photograph 6.13). This structure appears to date to the 1950s (1962 QAP1260/095).	280533 mE	6837585 mN

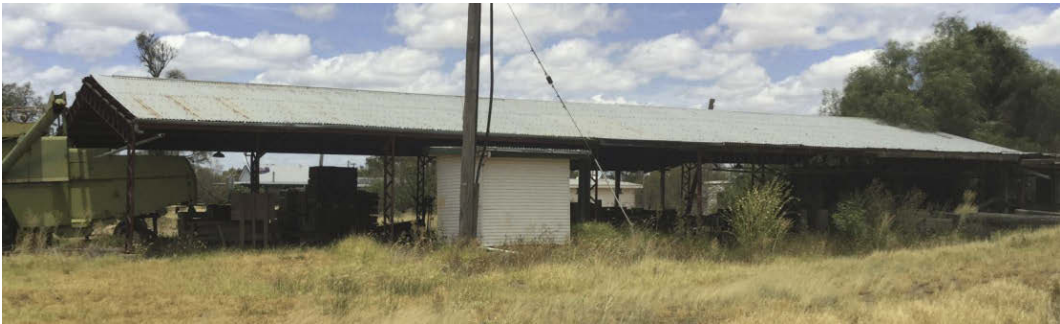
Photograph 6.14 Metal shed (B2G-19-H09)

Key elements		
Metal shed	Easting (GDA94 Z56)	Northing (GDA94 Z56)
A large shed with an iron clad gable roof, and open sides. Frame consists of metal lattice beams, trusses and posts. Interior contains lumber and remnants of sawmilling equipment, including rails. Historical aerial imagery suggests that this shed has been in place since at least the early 1960s (1962 QAP1260/095).	280601 mE	6837478 mN

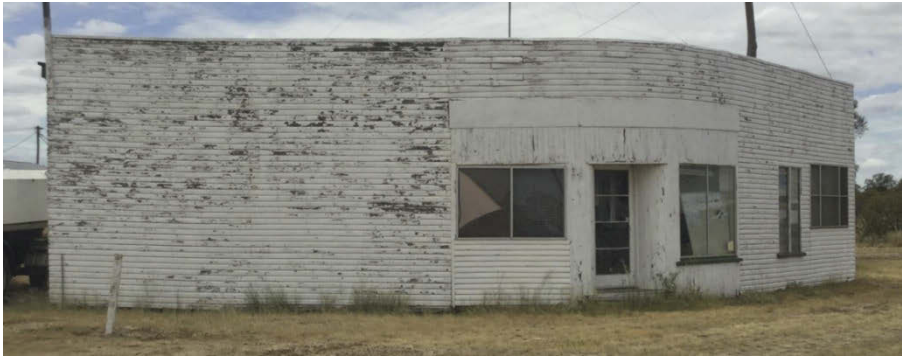
Photograph 6.15 Commercial building (B2G-19-H10)

Key elements		
Commercial Building	Easting (GDA94 Z56)	Northing (GDA94 Z56)
The commercial building features a convex façade which is shaped to the corner block on which the structure is located. The building is clad predominately with horizontal chamferboards, with some weatherboards and vertical tongue and groove, and features a skillion roof with a plain palisade wall. The building appears to have been constructed in at least two stages, with two wings added to the small shopfront that now makes up the centre of the building. This is borne out by aerial imagery which shows a small square structure at the location until the early 1970s (1972 QAP2416/017).	280555 mE	6837427 mN

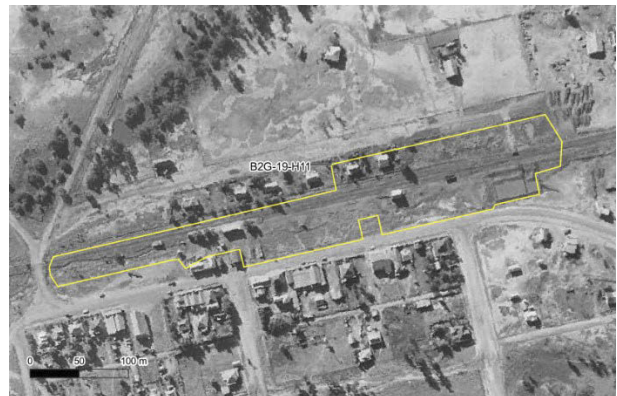
Description			
Railway station established c1908 as a part the South Western Line (Lots 20 SP120712, 21 SP120712). No original station buildings remain. Main features consist of a late 20 th century grain shed and silo complex. Silos have recently been painted with a mural representing life in Yelarbon.			
Listings		Distance to Project	Condition
None		Silos and grain shed in temporary footprint. Remainder in permanent footprint.	Moderate
Most recent imagery (2021)		Historical imagery (1962 QAP1260/095)

Key elements			
Grain shed and silos		Easting (GDA94 Z56)	Northing (GDA94 Z56)
Large, corrugated iron grain shed and a series of concrete grain silos. Historical aerial imagery suggests that the shed and the four white silos were constructed in the late 1960s (1972 QAP2416/017), with the remaining silos added in the 1970s (1981 QAP3966/120). In June 2019, the silos were painted with a mural entitled 'When the rain comes'. The mural depicts a boy playing with paper boats in the Yelarbon Lagoon.		280465 mE	6837482 mN

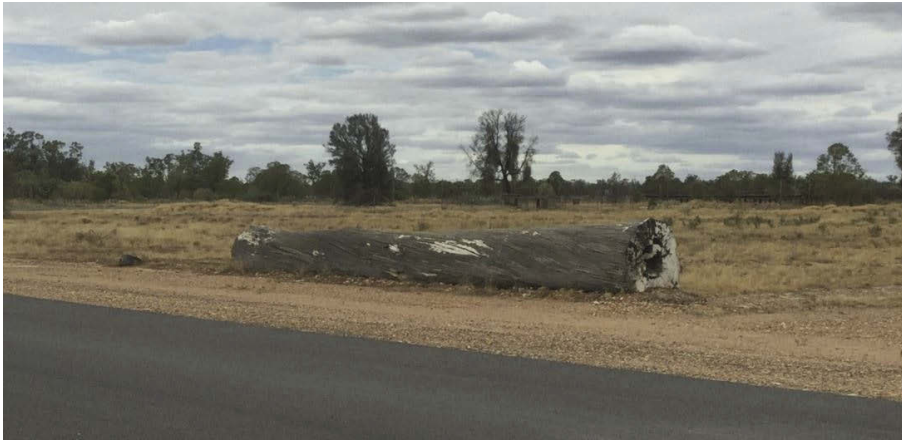
Photograph 6.18 Tree Trunk (B2G-19-H12)

Key elements			
Large Tree Trunk		Easting (GDA94 Z56)	Northing (GDA94 Z56)
Trunk of a large felled tree. Appears to have previously painted white, suggesting it may have been used as a sign or bollard.		280669 mE	6837415 mN

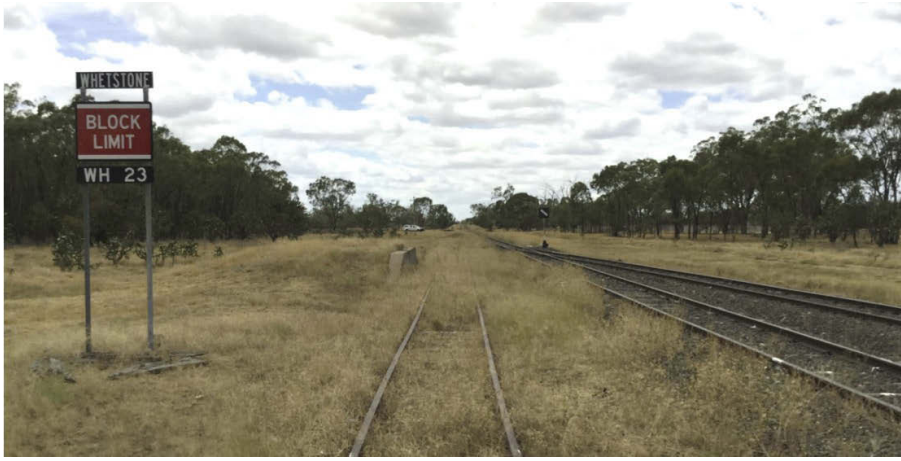
Photograph 6.19 Whetstone Siding (B2G-19-H13)

Key elements		
Loading bank	Easting (GDA94 Z56)	Northing (GDA94 Z56)
The loading bank is a short earthen bund faced with a pre-cast concrete wall.	297484 mE	6845990 mN

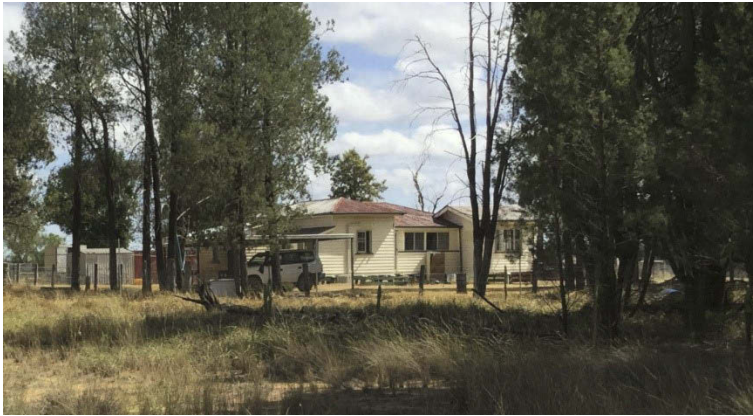
Photograph 6.20 Homestead Complex (B2G-19-H14)

Key elements		
Homestead	Easting (GDA94 Z56)	Northing (GDA94 Z56)
The dwelling visible from the road appears to be a mid-20 th century, weatherboard clad building with a hipped roof. A smaller, gabled structure has been added to the western side. Analysis of aerial images, however, suggests the presence of bungalow at the rear of the block that may date to the early 20 th century (1949 QAP0031/049).	301947 mE	6853233 mN

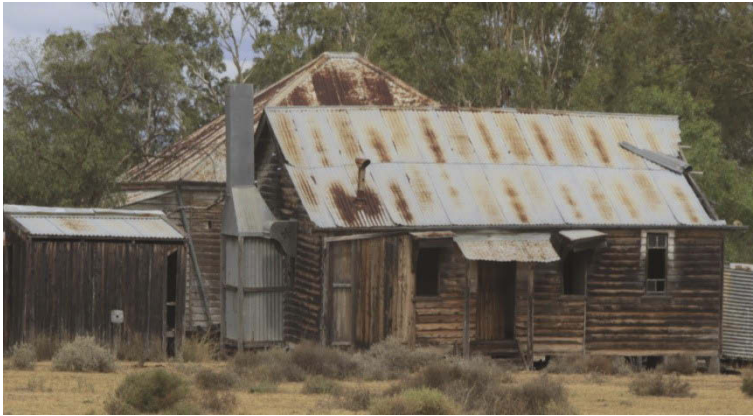
Photograph 6.21 Homestead (B2G-19-H15)

Key elements		
Homestead	Easting (GDA94 Z56)	Northing (GDA94 Z56)
<p>The homestead consists of two joined structures. The rear appears to be a weatherboard clad dwelling with a hipped roof and a stepped verandah on three sides, likely dating to the late colonial period. The front building potentially dates to the mid-colonial period (prior to 1880) and is a weatherboard clad gable roofed dwelling, with a corrugated iron chimney breast on the northern façade (National Trust of Queensland, 1976; Rechner, 1998).</p> <p>It is likely that the gabled building was the original dwelling, converted into a separate kitchen wing when the larger house was constructed to the east, oriented to the river.</p>	322109 mE	6885035 mN

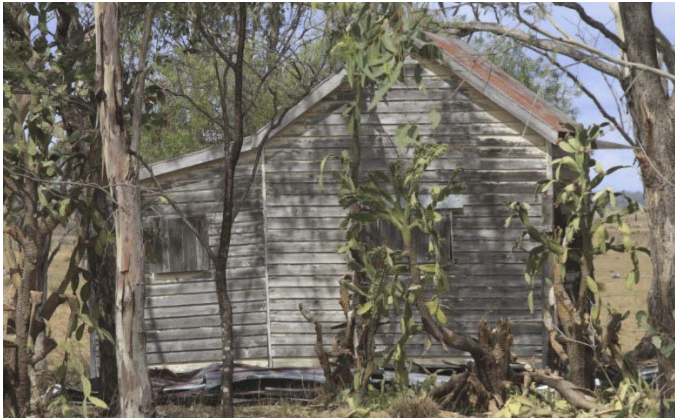
Photograph 6.22 Structure (B2G-19-H16)

Key elements		
Structure	Easting (GDA94 Z56)	Northing (GDA94 Z56)
A small, weatherboard clad gabled building with an enclosed skillion-roofed verandah. Windows have been replaced by wooden shutters. May have been an outbuilding or worker accommodation for the adjacent cattle property.	322109 mE	6886672 mN

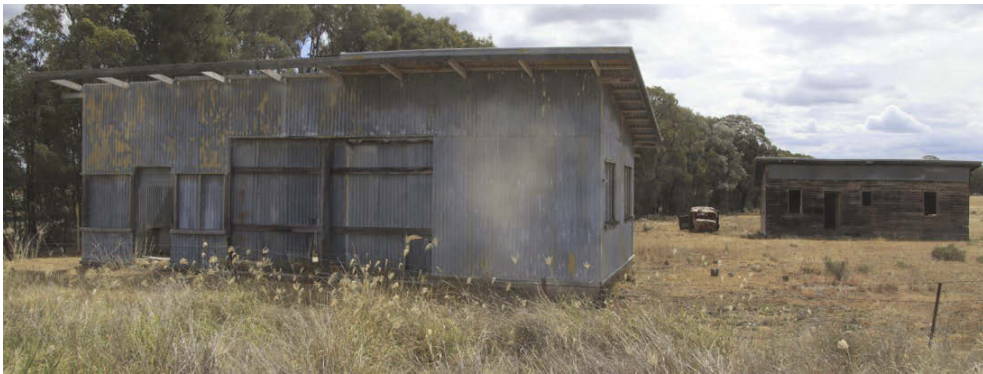
Photograph 6.23 Sheds (B2G-19-H17)

Key elements			
Sheds		Easting (GDA94 Z56)	Northing (GDA94 Z56)
Two skillion roofed sheds, one clad with corrugated iron, and one with weatherboards. Windows and doors have been removed or boarded over. Historical aerials suggest that the corrugated iron building has been in place since the 1950s (1959 QAP0969/067), with the weatherboard building added in the 1960s (1971 QAP2174/011). The function of these buildings is unknown.		322615 mE	6889642 mN

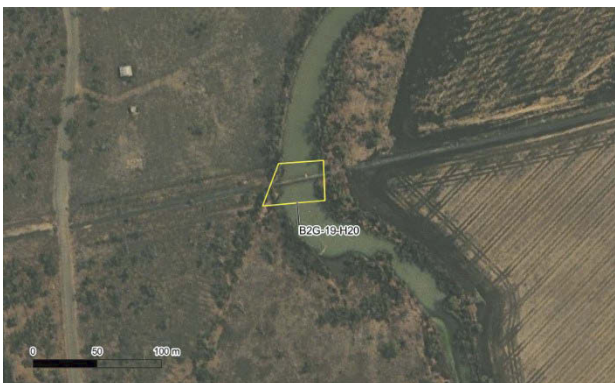
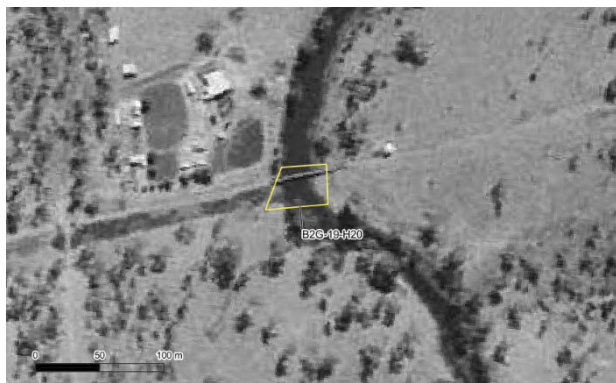
Description		
Rail bridge over Grass Tree Creek, Yandilla, adjacent to Lot 4 RP16058. Built as part of the Millmerran Branch Line c1911.		
Listings	Distance to Project	Condition
None	Located within permanent Project footprint	Fair
Most recent imagery (2021)		Historical imagery (1959 QAP0966/141)

Key elements		
Rail Bridge	Easting (GDA94 Z56)	Northing (GDA94 Z56)
Low timber girder rail bridge.	338099 mE	6918596 mN

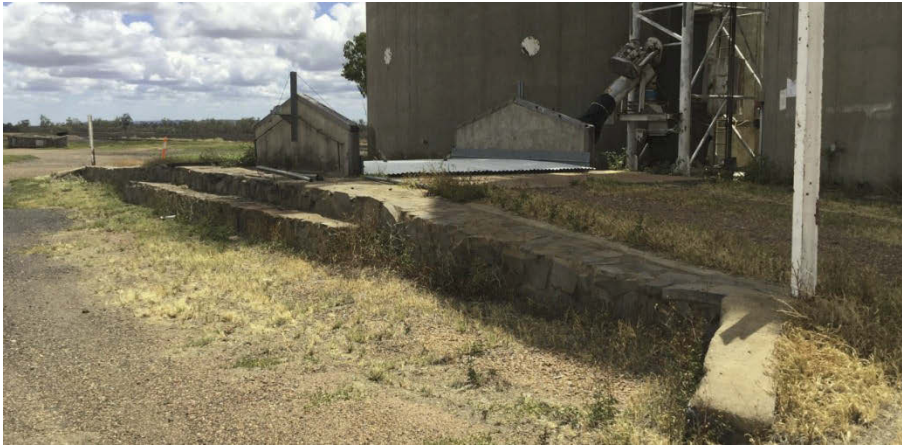
Photograph 6.26 Weighbridge (B2G-19-H21)

Description		
Location of c1911 station on the Millmerran Branch Line (Lot 202 SP124721). All original station buildings have been removed, and the key elements of the complex are mid-late 20 th century silos, grain shed and weighbridge.		
Listings	Distance to Project	Condition
None	North-western extent located within the permanent Project footprint and north-western and central extents located within the temporary Project footprint	Moderate
Most recent imagery (2021)		Historical imagery (1959 QAP0966/111)
Key elements		
Weighbridge and silos	Easting (GDA94 Z56)	Northing (GDA94 Z56)
<p>Large, corrugated iron grain shed and a series of concrete grain silos. Historical aerial imagery suggests that the row of four silos were added in 1960s (1971 QAP2160/009), with the remaining silos and the grain shed added in the 1970s (1984 QAP4351/131).</p> <p>The weighbridge is a metal structure surrounded by low, rubble course stone walls. The first weighbridge at the station was installed c1916 but has since been replaced twice. It seems likely that the current structure is the 20 ton weighbridge installed by the Wheat Board in 1945 (Section 4.3.5) (Kerr 1966:Vol 4).</p>	339166 mE	6919433 mN

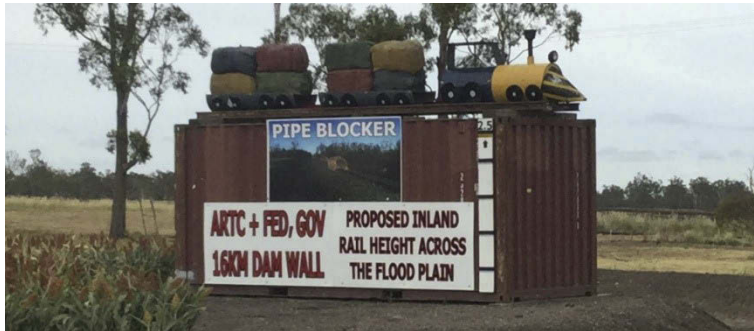
Photograph 6.27 Public Protest Artwork (B2G-19-H22) (2019)

Key elements		
Public Artwork	Easting (GDA94 Z56)	Northing (GDA94 Z56)
<p>Art installation by the local Millmerran Rail Group, who are protesting Inland Rail on the grounds that the alignment across the Condamine River floodplain will dam floodwaters, posing an unacceptable risk to life and property (The Millmerran Rail Group, 2019). Although there are various examples of protest art along the Condamine River floodplain, this example is the best known and most elaborate.</p> <p>The installation comprises a model train placed on a shipping container, indicating an assumed height at which the track will be raised above the surrounding Condamine River floodplain, and describes the Project as a '16 km dam wall'. The train is constructed from elements readily found on agricultural properties and reflects the strong tradition in the country of manufacturing items from locally sourced materials. It is unclear from the available information whether this was predominately the work of an individual artist or a collective output. An image of the artwork is used as the Facebook profile picture of the Millmerran Rail Group (Photograph 6.27). The condition of the installation has deteriorated in the intervening years (Photograph 6.28).</p>	339311 mE	6919527 mN

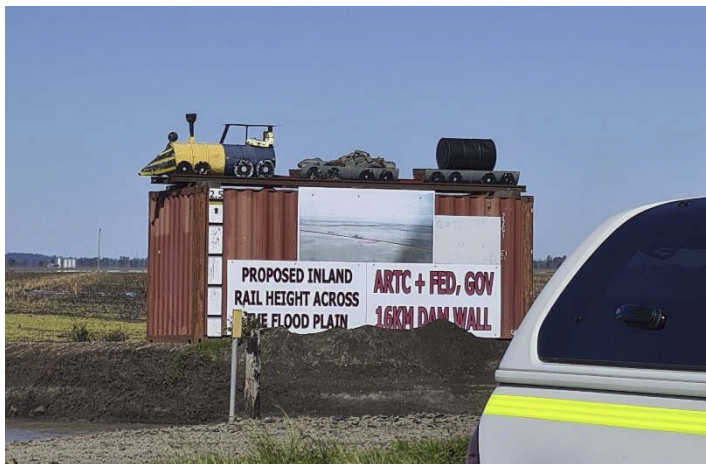
Photograph 6.28 Deteriorated Public Protest Artwork (B2G-19-H22) (2022)

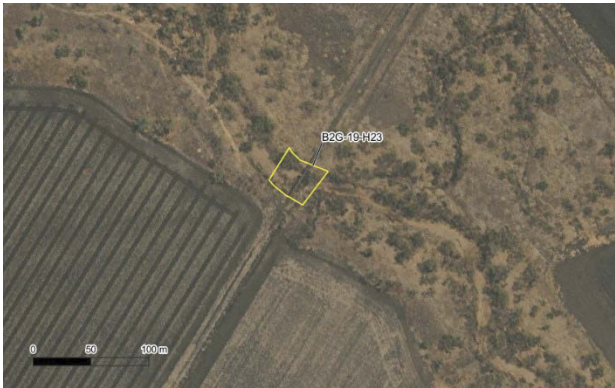
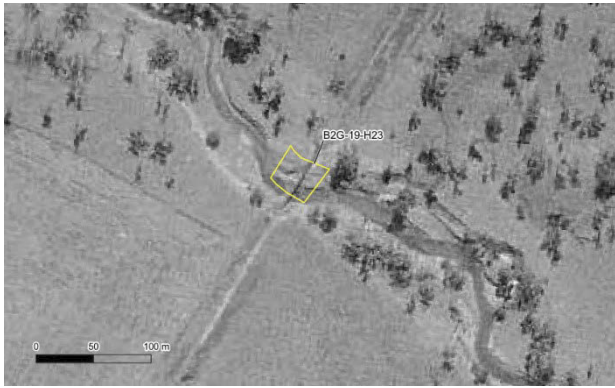
Description		
Rail bridge over the Condamine River, Yandilla, adjacent to Lot 114 SP113906. Originally built as part of the Millmerran Branch Line c1911.		
Listings	Distance to Project	Condition
None	Located wholly within permanent Project footprint	Fair

Key elements			
Bridge		Easting (GDA94 Z56)	Northing (GDA94 Z56)
Timber girder rail bridge with pre-cast concrete abutments over the Condamine River (North Branch).		340554 mE	6922077 mN

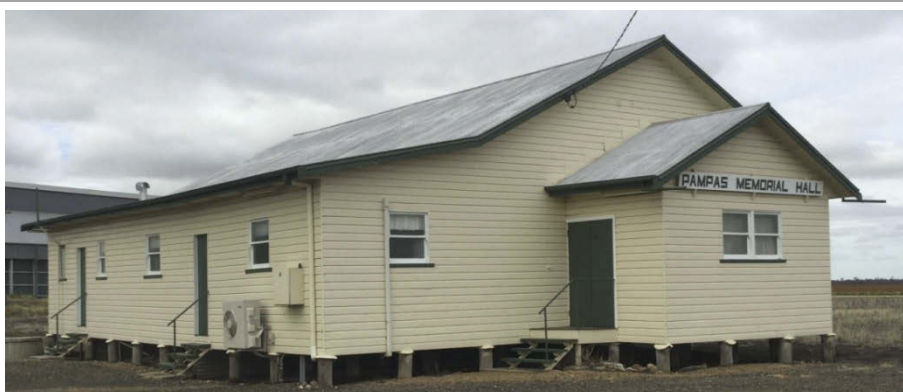
Photograph 6.31 Pampas Memorial Hall (B2G-19-H25)

Memorial Hall	Easting (GDA94 Z56)	Northing (GDA94 Z56)
<p>The Hall was constructed in 1954 to commemorate all those who had served in conflict. The money to build the hall was raised by the community, and the construction carried out by locals in a series of 'working bees' (<i>Pittsworth Sentinel</i> 1 October 1954:3).</p> <p>The structure is a simple chamferboard clad hall on low timber stumps with a corrugated iron gabled roof that extends into a skillion roof on the eastern facade. Windows are single-paned sashes, and doors are timber plank. Entrance to the building is via an enclosed gabled porch.</p>	343427 mE	6924895 mN

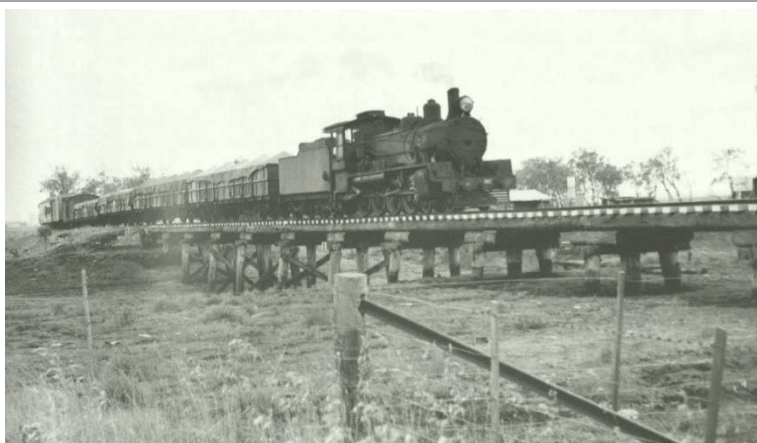
Photograph 6.33 Bridge 1967 (B2G-19-H27) (Uebergang 2011:121)

Bridge	Easting (GDA94 Z56)	Northing (GDA94 Z56)
Timber girder rail bridge with precast concrete abutments over the Condamine River (North Branch).	344686 mE	6926056 mN

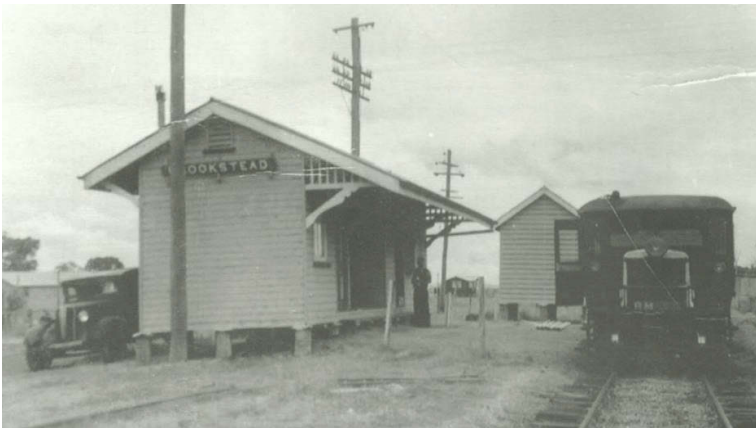
Photograph 6.35 Station building in original location c1957 (B2G-19-H29) (Uebergang 2011:120).

Key elements		
Brookstead Station Building	Easting (GDA94 Z56)	Northing (GDA94 Z56)
<p>The platform building at Brookstead was erected between 1925 and 1934 (refer Photograph 6.35) (Kerr 1966:Vol 4), and relocated in the 1990s (Uebergang, 2011).</p> <p>A small, rectangular, weatherboard-clad timber building on low stumps with a gabled, corrugated iron roof that extends on the western side to form an awning (Photograph 6.36). The southern third of the building is a small office, and the northern section an open-sided shelter. Most windows are original one or two-paned sashes, but some have been boarded up or replaced with louvres. A tin, bullnosed sunhood remains over the southern window. The exterior of the building features decorative elements such as faux rafter ends to hold the station name, and ladder frame brackets with art nouveau style struts supporting the awning, all of which are consistent with the standard designs used by QR in the 1910s (Buchanan Architects, 2002). The interior of the building has a wooden floor, tongue and groove wall and ceiling boarding, and a replacement bench.</p>	347008 mE	6928508 mN

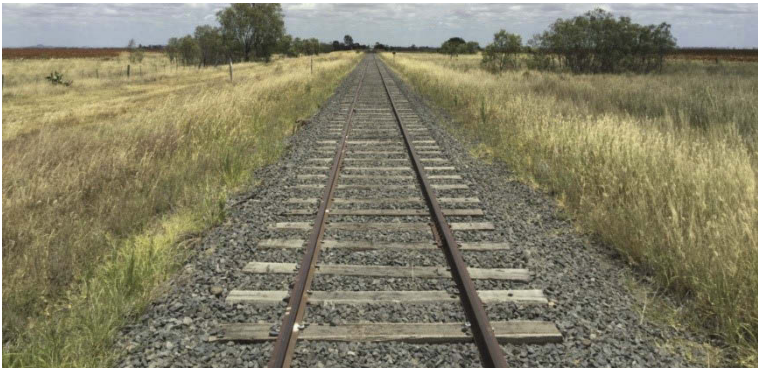
Photograph 6.37 Cecilvale Station (former) (B2G-19-H30)

Former station	Easting (GDA94 Z56)	Northing (GDA94 Z56)
All station elements were removed in the 1940s and the siding closed in the 1950s (Kerr, 1966; Uebergang, 2011).	352206mE	6930917mN

B2G-19-H30	Cecilvale Station	None	<ul style="list-style-type: none"> ■ Recommended for inclusion in heritage interpretation plan to be developed during detailed design.
B2G-19-H31	Yarranlea Station	None	<ul style="list-style-type: none"> ■ Recommended for inclusion in heritage interpretation plan to be developed during detailed design.

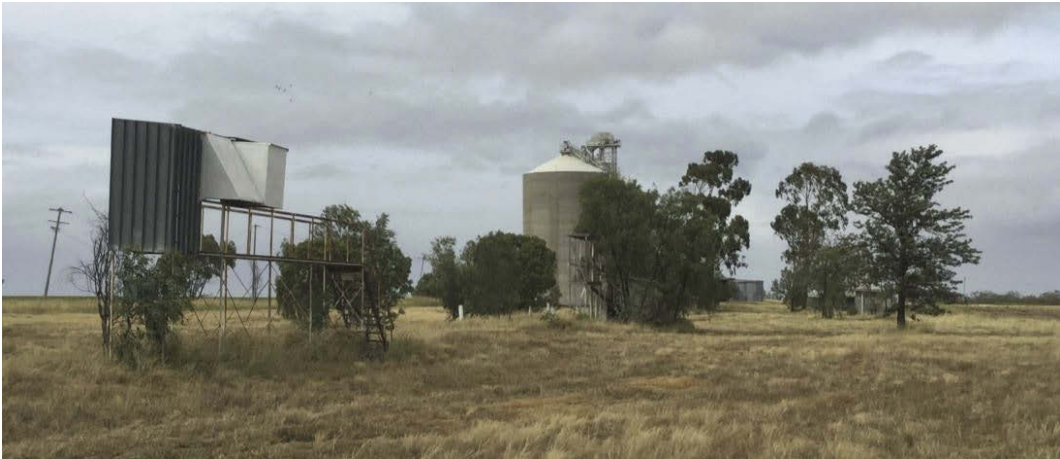
Photograph 6.38 Silo (B2G-19-H31)

Key elements		
Silos and grain shed	Easting (GDA94 Z56)	Northing (GDA94 Z56)
Historical aerial images suggest that the current silos and grain shed date to the early 1970s (1975 QAP3034/056)	354928 mE	6932273 mN

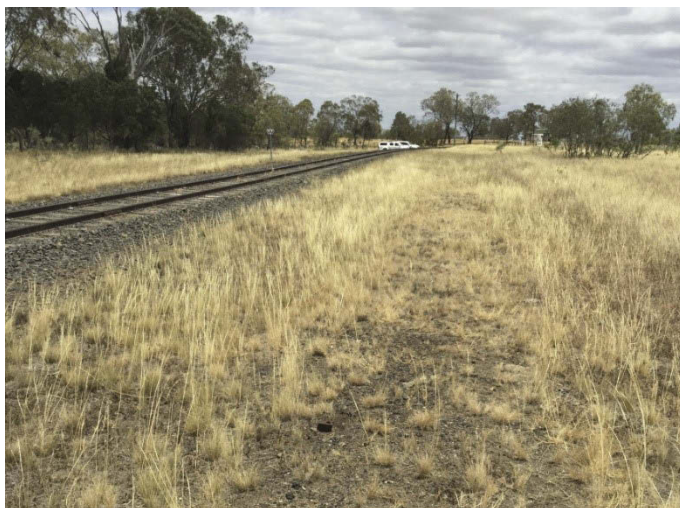
Photograph 6.39 Former station (B2G-19-H32)

Key elements		
Former station	Easting (GDA94 Z56)	Northing (GDA94 Z56)
Station closed in the 1980s and all elements removed (Uebergang, 2011) (Section 4.3.10).	359428 mE	6933508 mN

Site ID	Description	Listings	Management and mitigation measures
B2G-19-H32	Murlaggan Station	None	<ul style="list-style-type: none"> Recommended for inclusion in heritage interpretation plan to be developed during detailed design.
B2G-19-H33	Homestead complex	None	<ul style="list-style-type: none"> Manage indirect impacts in accordance with measures in Table 9.1. <p>If indirect impacts cannot be appropriately managed:</p> <ul style="list-style-type: none"> Archival recording of built elements Consider relocation of dwelling to a residential area with heritage or character protection provisions. <p>If any direct impacts are anticipated:</p> <ul style="list-style-type: none"> Archaeological survey to identify extent of heritage features If warranted by results of survey, conduct archaeological monitoring or excavation
B2G-21-H02	Yelarbon Cemetery	None	<ul style="list-style-type: none"> Manage indirect impacts in accordance with measures in Table 9.1 Where possible, plan works to avoid disruption to funereal or commemorative events.

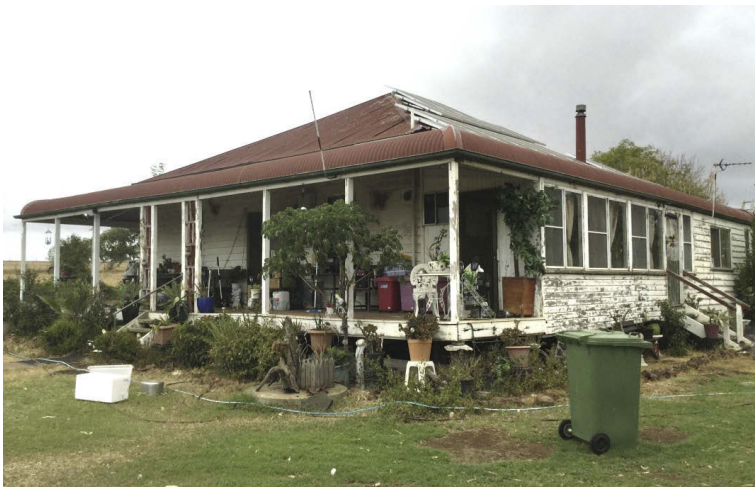
Photograph 6.40 Homestead (B2G-19-H33)

Key elements		
Homestead	Easting (GDA94 Z56)	Northing (GDA94 Z56)
The house is a weatherboard clad colonial dwelling on low stumps with a corrugated iron hipped roof and a stepped, bullnose roofed verandah on all sides. All but the front verandah has since been enclosed. The landholder reports that this house was built in 1902, replacing an earlier dwelling located to the north-east (refer below) (Murray French, pers. comm. 7 February 2019).	361831 mE	6933772 mN

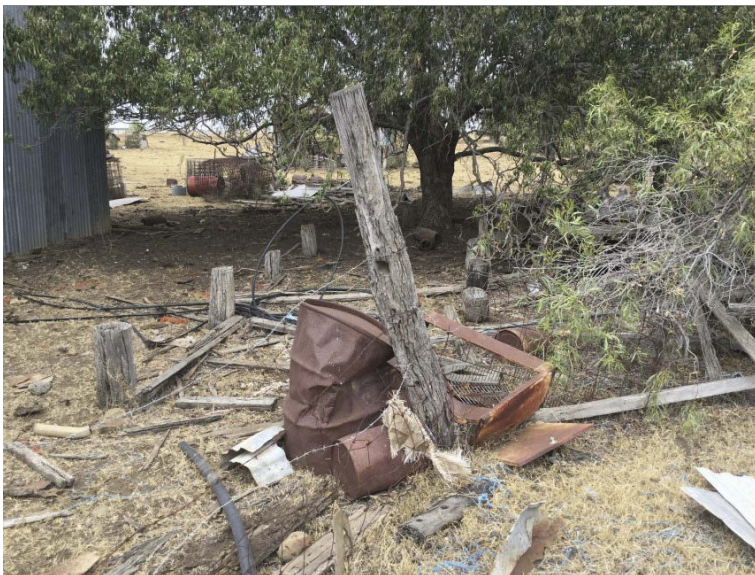
Photograph 6.41 Homestead ruin (B2G-19-H33)

Homestead Ruin	Easting (GDA94 Z56)	Northing (GDA94 Z56)
The homestead ruin consists of a series of stumps and other timber structural elements, surrounded by domestic and farming detritus. The homestead is understood to have collapsed in place (Murray French, pers. comm. 7 February 2019), and so there is high potential for archaeological remains in and around the structure.	361821 mE	6933765 mN

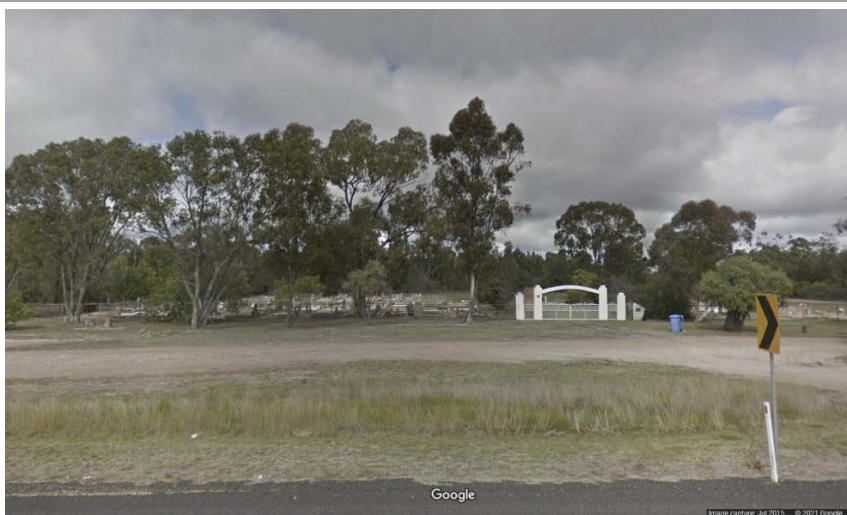
Photograph 6.42 Yelarbon Cemetery (B2G-21-H02)

Description			
Yelarbon Cemetery includes an archway and entrance gates adjacent to the Cunningham Highway and contains three distinct areas with graves. The cemetery is located within Lot 16 MH288 and is administered by GRC. Yelarbon Cemetery is an active cemetery containing current and reserved plots. A white archway and gates exist at the cemetery entrance, but are not visible in the 1962 aerial image (QAP1260/095). Three distinct areas containing graves are visible in current aerial imagery. Of these, only the northeast and northwest areas are visible and showing as established in the 1962 aerial image (QAP1260/095).			
Listings	Distance to Project		Condition
None	Located 25 m south of the temporary Project footprint, partially within the impact assessment area		Good
Most recent imagery (2021)		Historical imagery (1962 QAP1260/095)

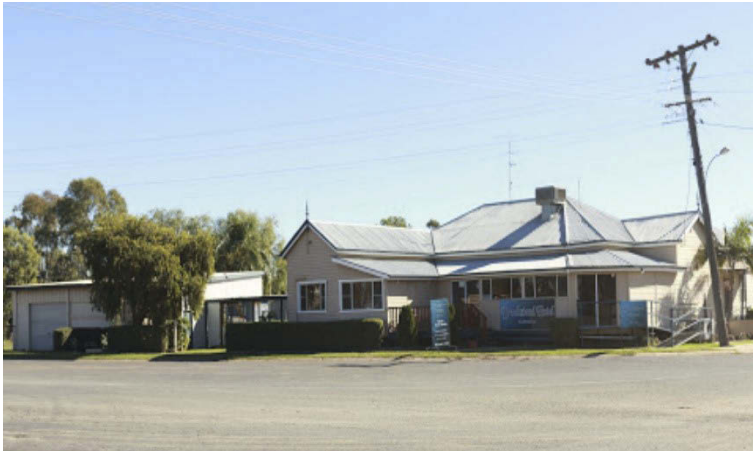
Photograph 6.43 Brookstead Hotel

Description		
<p>Brookstead Hotel located within Brookstead on Lot 141 RP14234 situated on Ware Street, Lord Street and Daphne Street. Includes reception, bar and accommodation. Historical aerial imagery from 1954 (QAP0448/058) indicates the presence of the main hotel building. Google Street View imagery shows that the main hotel building is a weatherboard clad timber building with a gabled and hipped roof likely dating to the early 20th century. Brookstead was established in 1911 with the construction of the railway line and the Brookstead Hotel was likely constructed around that time. The hotel was established by at least 1913 (<i>Brisbane Courier</i> 1913:4) and would have been central to the development of the town.</p>		
Listings	Distance to Project	Condition
None	Adjoining northern boundary of temporary Project footprint	Good
Most recent imagery (2021)		Historical imagery (1954 QAP0448/058)

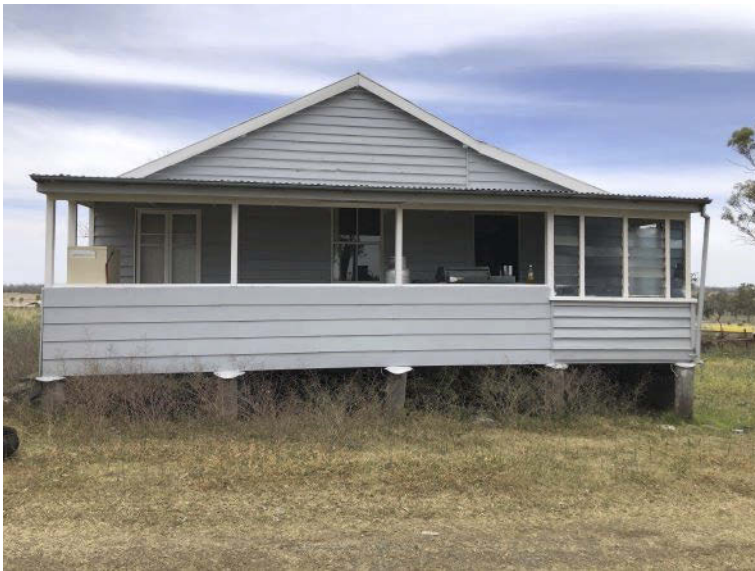
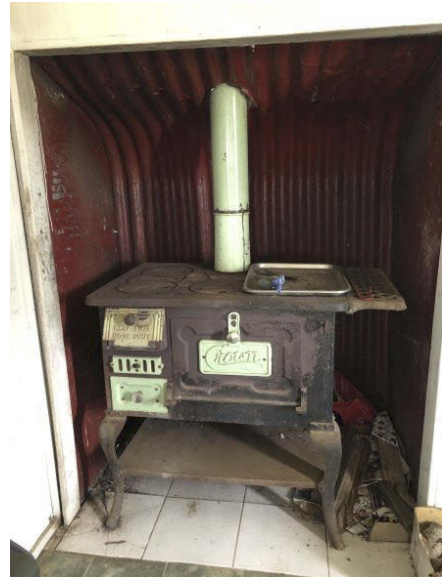
Photograph 6.45 Cottage (B2G-21-H13)

Photograph 6.44 Artefact scatter (B2G-21-H13)		
Cottage	Easting (GDA94 Z56)	Northing (GDA94 Z56)
<p>The cottage comprises a weatherboard clad structure with a gable roof and north-facing verandah. Interior arrangement and design of elements suggests two main periods of construction: a two room core built in the mid-late 19th century (National Trust of Queensland, 1976), and an extension that enclosed the original verandahs in the mid-20th century. It is possible that this cottage is contemporaneous with the Green Hills Hotel, and may be the house constructed by the Tibbs. This structure is outside of the impact assessment area.</p>	370235 mE	6937581 mN

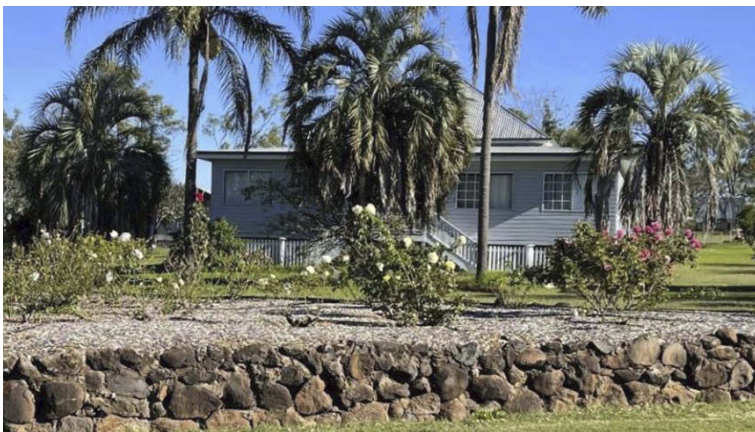
Photograph 6.46 House (B2G-21-H13)

House	Easting (GDA94 Z56)	Northing (GDA94 Z56)
The house is weatherboard with a short ridge hipped roof and a stepped verandah. All verandahs have been enclosed and there is a rectangular extension to the rear, north-western corner that may previously have been a semi-detached kitchen. The house is consistent with the design styles of the late colonial period (1880 to 1900) (National Trust of Queensland, 1976). As such, it may post-date the Green Hills Hotel and relate to subsequent rural use of the land. This structure is within the impact assessment area.	370338 mE	6937581 mN

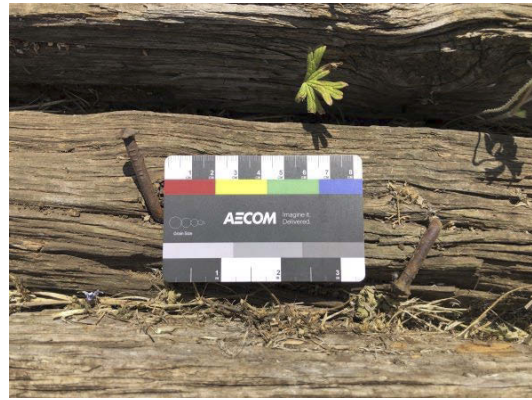
Photograph 6.47 Roseheaded wire nails in fence remnants (B2G-21-H13)

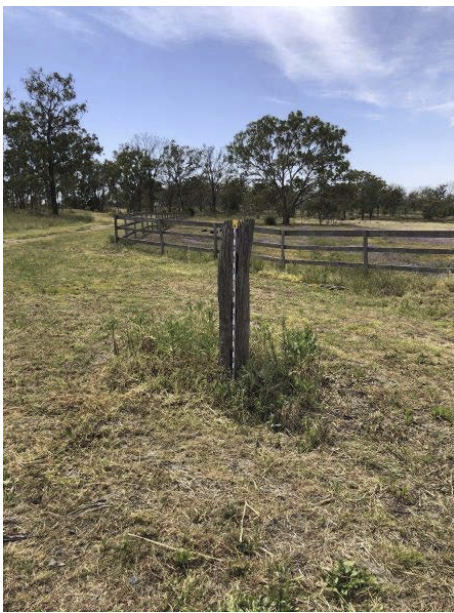
Photograph 6.52 Upright timber post (B2G-21-H13)

Single post	Easting (GDA94 Z56)	Northing (GDA94 Z56)
Single upright unhewn timber post. Appears to align with the post and rail enclosure, and may be part of the larger Green Hills Hotel stables.	370582 mE	6937637 mN
