APPENDIX Z

Non-Indigenous Cultural Heritage Survey Report

BORDER TO GOWRIE REVISED DRAFT ENVIRONMENTAL IMPACT STATEMENT

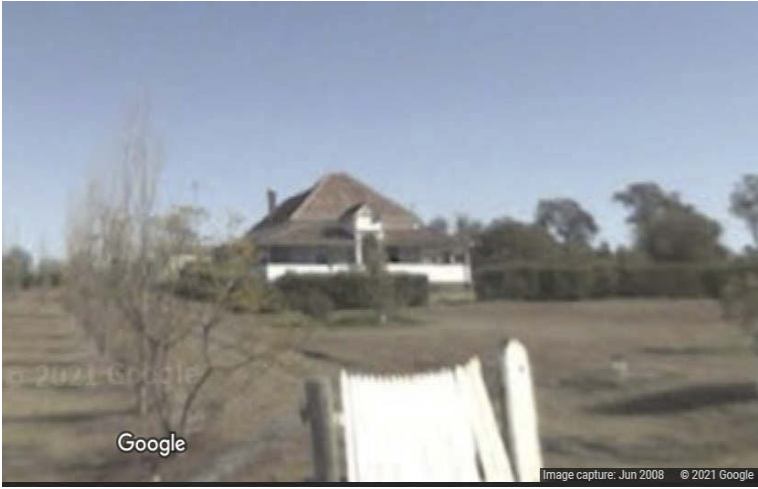
Photograph 6.53 Fairvale homestead complex (B2G-21-H14)

Description		
Homestead complex located within Lot 2 RP110779. Recent aerial drone imagery from Nearmap suggests a house and at least four sheds visible in historical aerial imagery from 1955 (QAP0484/097) are extant at the site. Google Street View imagery shows that the house is likely a weatherboard clad timber building with a hip and pyramid roof stepping to a separately roofed verandah on four sides, including a brick chimney. The house likely dates to the late colonial period.		
Listings	Distance to Project	Condition
None	Located 39 m south of the temporary Project footprint	Good
