AMEC 2013: TARGETED SURVEYS FOR THE BOGGOMOSS SNAIL
(*Adclarkia dawsonensis*)

Nathan Dam and Pipelines

**Targeted Surveys for the Boggomoss Snail
(*Adclarkia dawsonensis*)**

Document No. 6613130105-ENV-RPT-0001

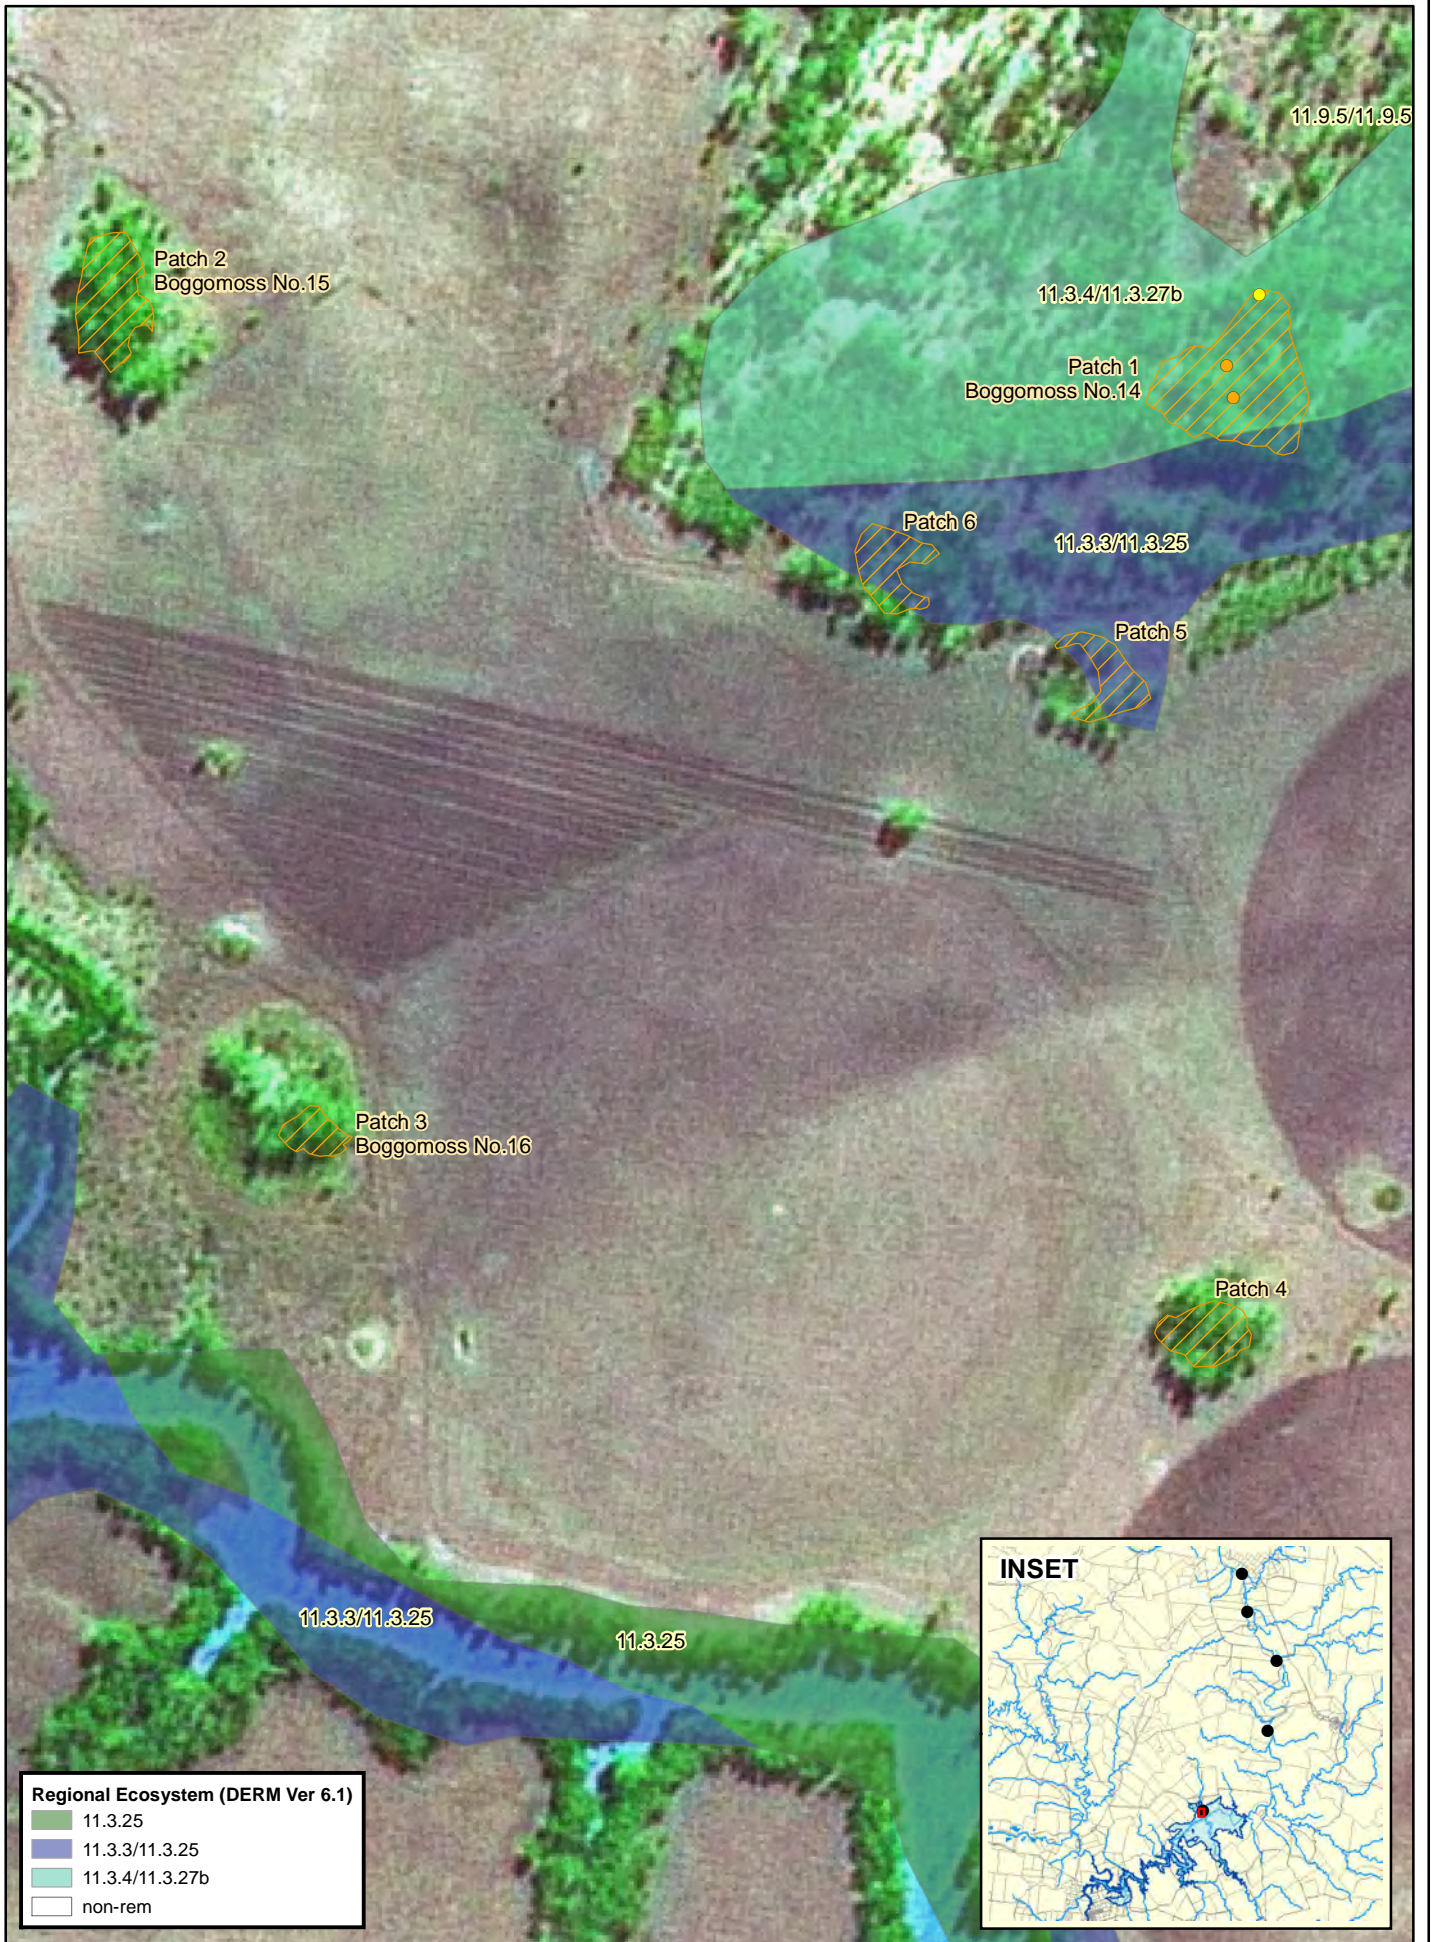
NATHAN DAM AND PIPELINES
SUPPLEMENTARY EIS REPORT
Mt Rose -
Habitat Patches Surveyed

- Live Snails Found
- Dead Snails Found
- Shells Found
- ▨ Suitable Habitat, Searched

The snails recorded at Mt Rose were found under flood debris on the highest point of the mound spring. Two were under a single pile of leaf litter and one was under a small log amongst accumulated leaf litter and flood debris. These debris piles were not associated with trees or large logs and were effectively out in the open, albeit beneath a blue gum canopy. The availability of suitable microhabitats at Mt Rose has recovered somewhat post flooding, particularly the availability of leaf litter beneath sandpaper figs. The floods however are certainly a major impacting influence on individual boggomoss snails and their habitat.

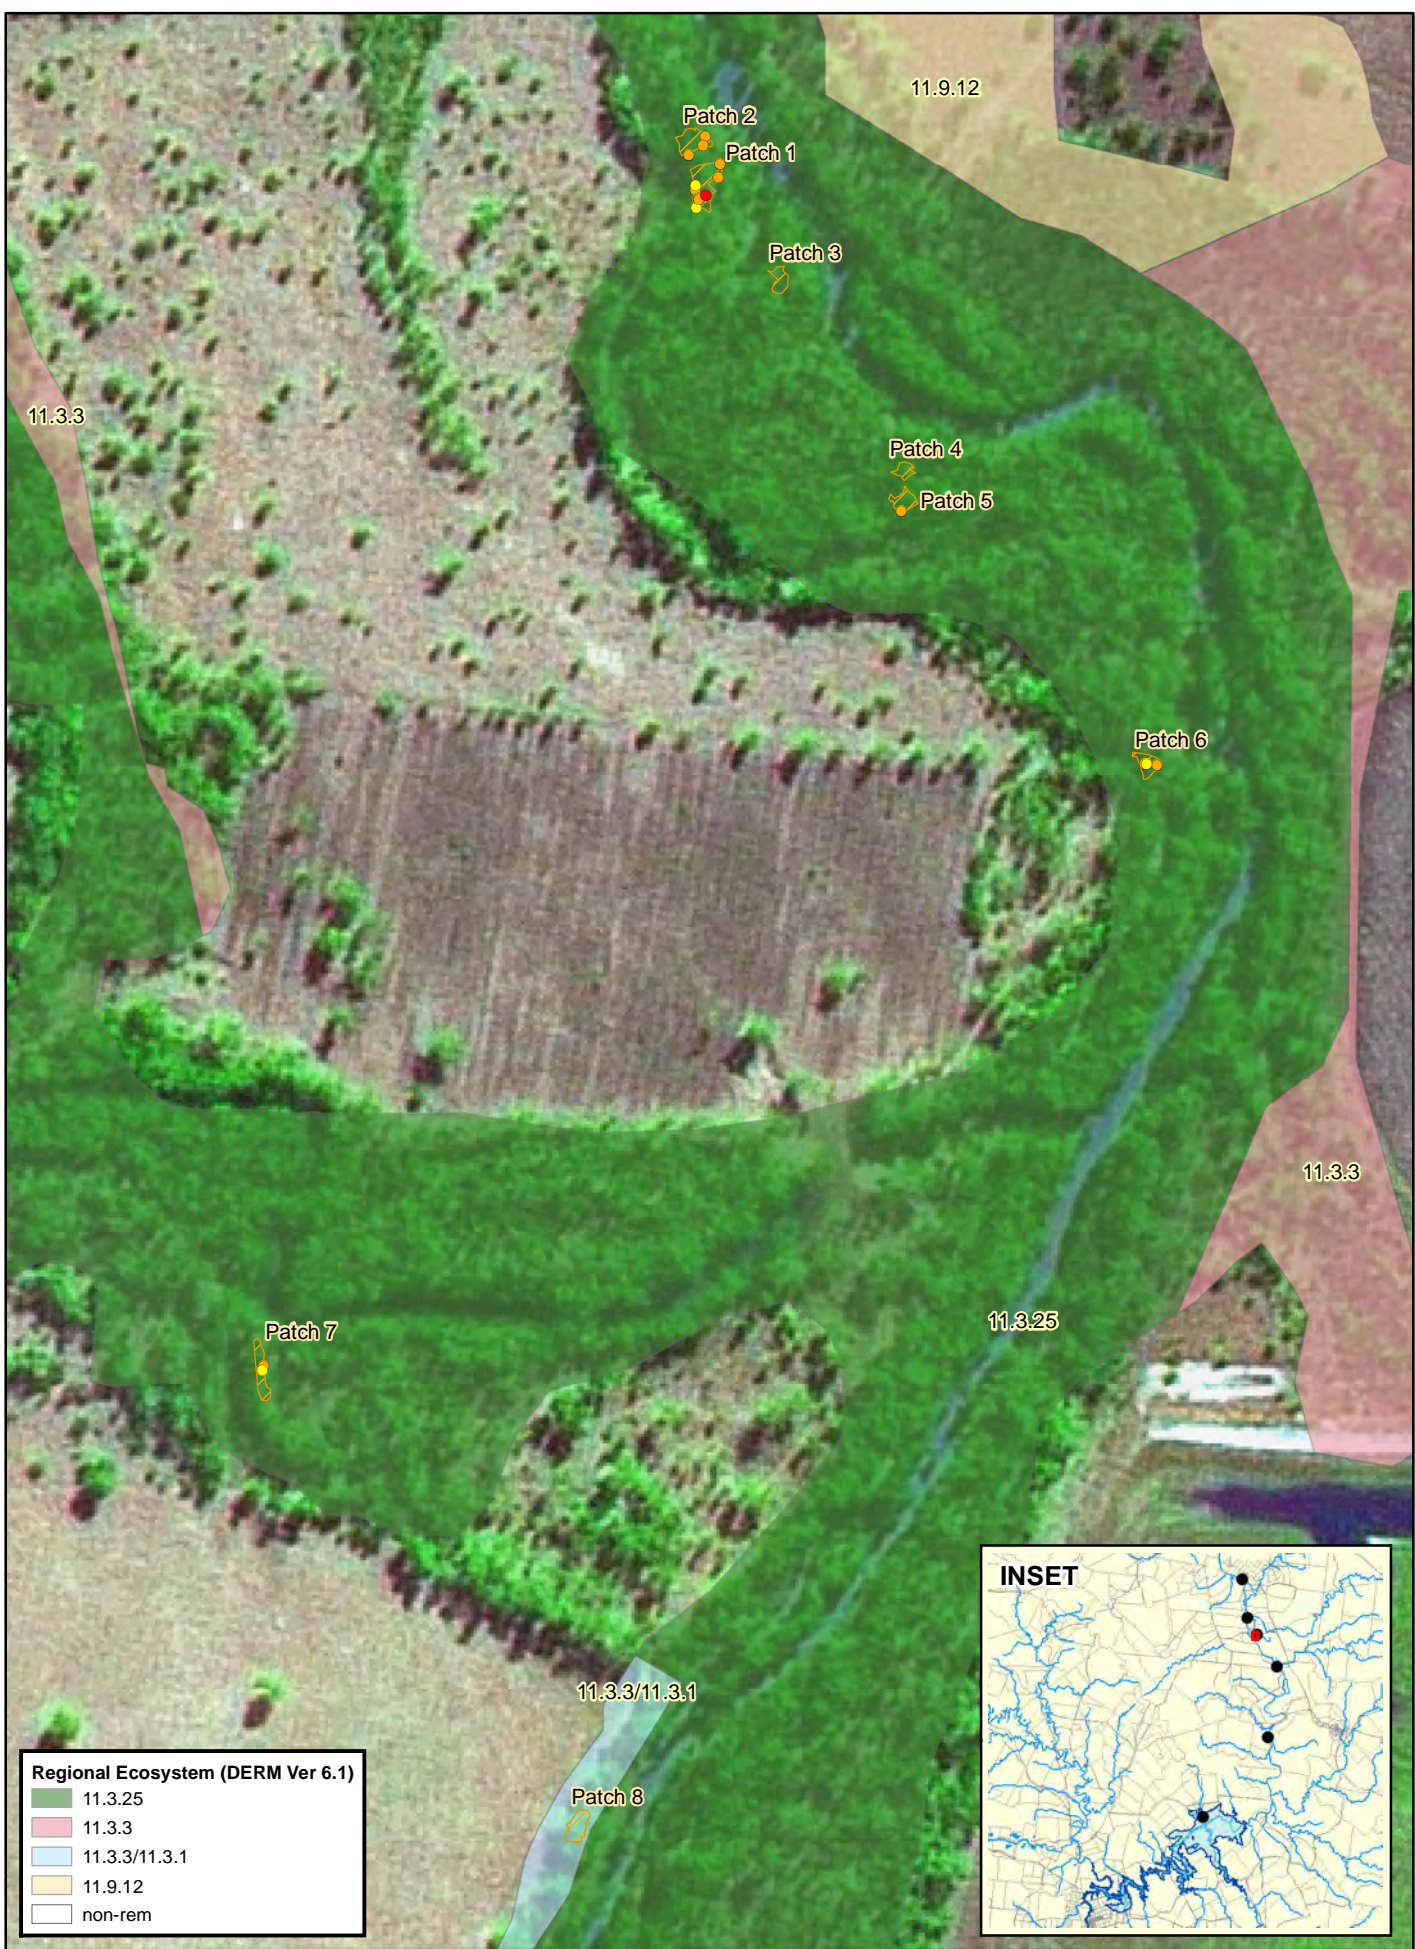
SKM *SunWater*
 Making Water Work
 NATHAN DAM AND PIPELINES
 SUPPLEMENTARY EIS REPORT
Southend -
Habitat Patches Surveyed

LEGEND	
	Live Snails Found
	Dead Snails Found
	Shells Found
	Suitable Habitat, Searched

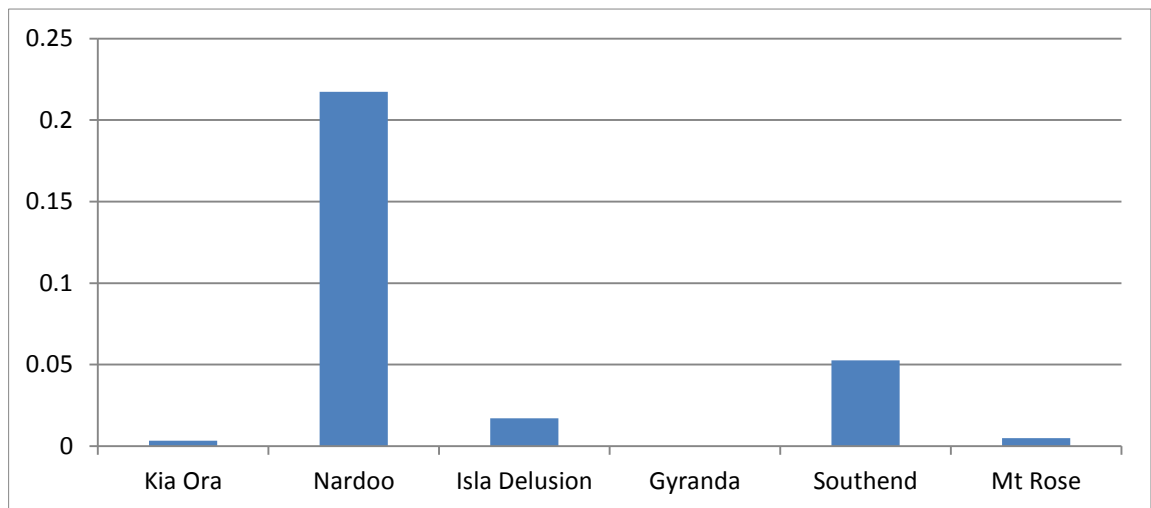
Figure 3.8 Number of Live Snails Per Microhabitat Searched for Each Site

A total of 2316 microhabitats were searched throughout the entire survey. The number of live snails per microhabitat searched per site searched is shown in **Figure 3.8**.

Whilst the number of live snails recorded per microhabitat was clearly significantly higher at Nardoo than at other sites, the magnitude of difference is noteworthy.
