NATHAN DAM AND PIPELINES PROJECT

POST-WET SEASON FIELD SURVEY: AQUATIC FLORA AND FAUNA COMPONENT

August 2008

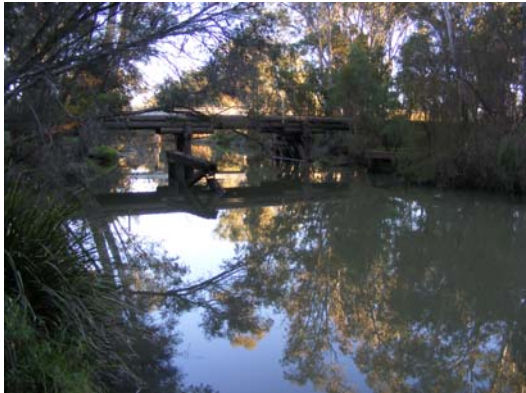
Reach	Description	Photograph
Site 1 Dawson River upstream of inundation area, at the Leichhardt Hwy crossing	This site comprised a relatively narrow (11m) but deep (2m) pool. Both banks were currently stable with gentle sloping banks, good vegetation coverage, and no obvious erosion or slumping present. The riparian vegetation was relatively wide (30m) with Eucalypts and Melaleuca's dominating. No macrophytes were present, however, water clarity was very low. Overhanging vegetation provided some shade and a source of organic matter to the river.

Facing upstream to old bridge (17/06/2008)
Site 2 Dawson River within of inundation area, at the Bundulla Rd crossing..	This site recorded the greatest diversity of habitats across all sites, including slow flowing pool environments, fast flowing riffle/run/glide zones, and backwaters. Some erosion was evident around fallen logs within the river, and along the banks where stock have access. The riparian zone was narrow (avg. 5m both sides) and was dominated by a variety of Eucalypts and Melaleuca's. Few macrophyte species and the presence of filamentous algae were recorded at this site. There were a variety of substrate classes including boulders and cobbles in the riffle section, to sand and silt deposits along the edges and in the backwater zones.

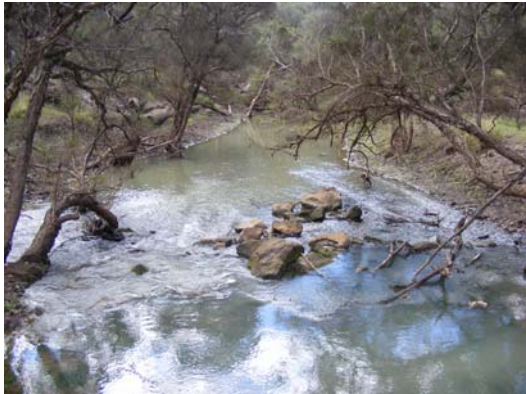
Facing downstream at riffle zone (21/06/2008)

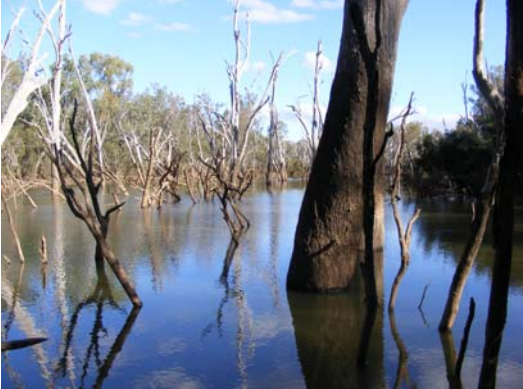
Reach	Description	Photograph
<p>Site 3 Dawson River within the inundation area, at 'The Bend'</p>	<p>This site comprised a large (estimated 50m wide) deep (+3.5m) pool habitat and small backwater. Moderate disturbance was recorded at this site due to much of the adjacent land cleared for grazing. Although there is a general reduction of natural vegetation, the gentle slope of the banks reduces the degree of instability and erosion potential at this site. There was a general lack of a range of aquatic habitat types at this site.</p>

<p>Facing downstream (18/06/2008)</p>
<p>Site 4 Dawson River within the inundation area, at Glebe Weir</p>	<p>Essentially a pool habitat with relatively stable water levels existed at this site due to the impoundment from the weir. The banks showed slight signs of degradation around fallen trees, and aggradation along the bank edges. A boat ramp exists at this site suggesting a popular recreational area, therefore the site may be regularly impacted by visitors. No macrophytes were recorded from this site within the water column although water clarity was very poor.</p>

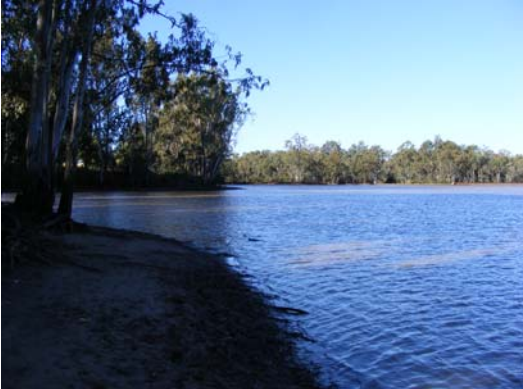
<p>Facing downstream (22/06/2008)</p>

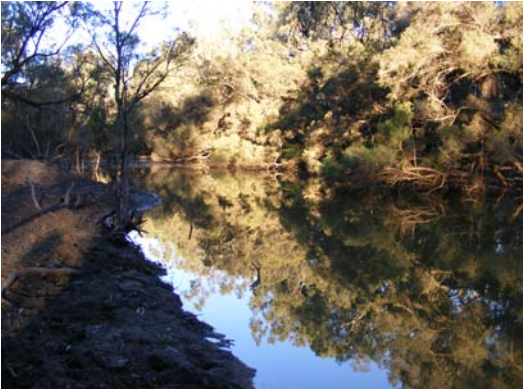
<p>Site 5 Dawson River within the inundation area at Becker Property, downstream of Glebe Weir.</p>	<p>Downstream of the weir there was a large pool habitat of approximately 9m wide. Essentially most of the riparian vegetation had been cleared, more so on the left bank than the right, leaving much of the banks bare of vegetation. Evidence of erosion and aggradation was observed at irregular points along the site and around fallen trees and branches instream. Water clarity was poor, and only rushes/sedges were observed growing along the edge in a small patch, no other macrophyte species.</p>

<p>Facing downstream (23/06/2008)</p>

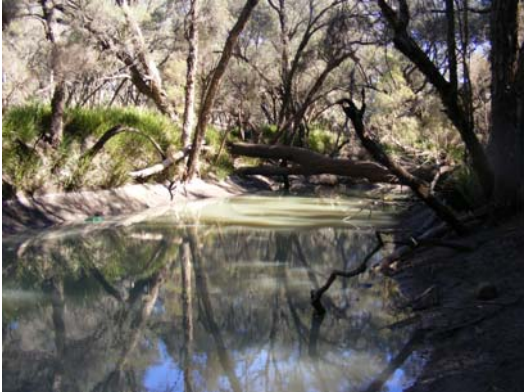
Reach	Description	Photograph
<p>Site 6 Dawson River within the inundation area at Forrest Site</p>	<p>A pool environment exists at this site, with a large section of the reach as a backwater. The banks support Eucalypts and Meleleuca species reducing the potential for erosion, and providing some canopy cover and shade over the river channel. No macrophyte species were recorded for the site, although fallen branches and logs provide some aquatic habitat.</p>

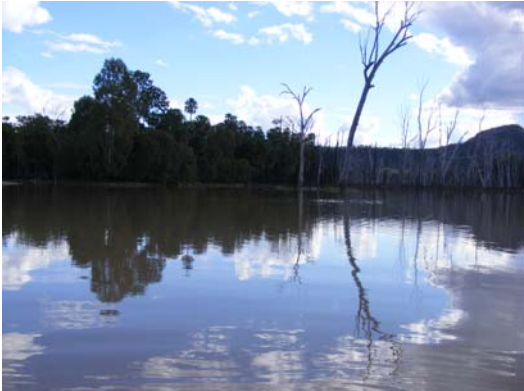
<p>Site 7 Dawson River downstream of proposed dam site at Gylanda Weir</p>	<p>This site comprised of a large (80m wide) and very deep (+6m) pool, with a lack of a variety of aquatic habitats. Many dead tree trunks are standing within the pooled water. The banks remained stable, with gentle slopes and a high cover of Eucalypt and Meleleuca species. Very limited macrophyte growth was observed at this site.</p>

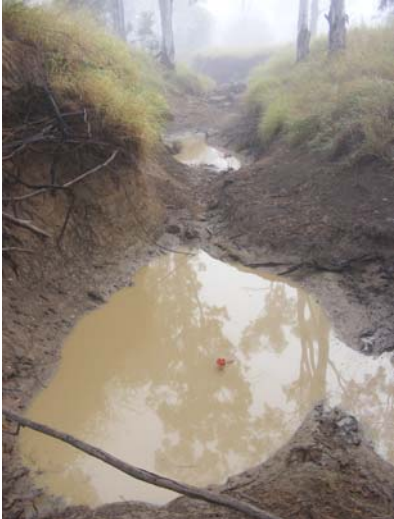
<p>Site 8 Blackboy Creek at Cracow Rd</p>	<p>This site recorded two isolated drying pools only during the post-wet survey. Very poor habitat instream exists at this site, although exposed tree roots, fallen logs, cobble/pebble substrates observed above the existing water mark would provide habitat during higher water levels. Grasses dominate the understorey in the riparian zone.</p>

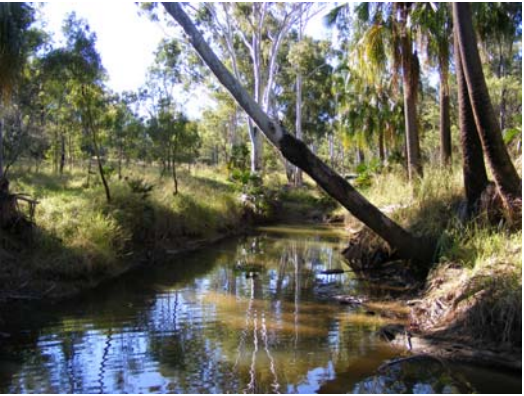
Reach	Description	Photograph
Site 9 Spring Creek at Becker Property	The site was not flowing at the time of the post-wet survey, with only an isolated pool recorded. Eucalypts and Casuarinas dominate the riparian vegetation at this site, providing some canopy cover to the channel. Some erosion was evident, although this appeared to be isolated to the lower bank region.

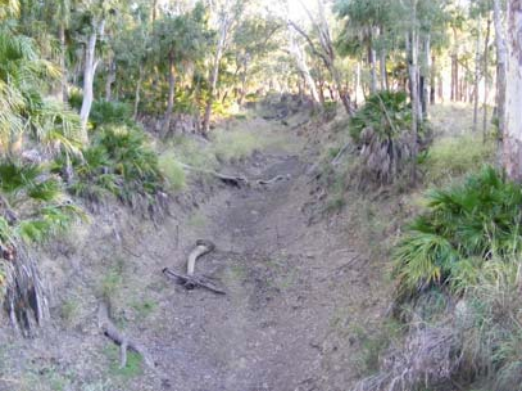
Facing upstream (24/06/2008)		
Site 10 Palm Tree Creek at Leichhardt Hwy	This site was dry during the post-wet sampling program.

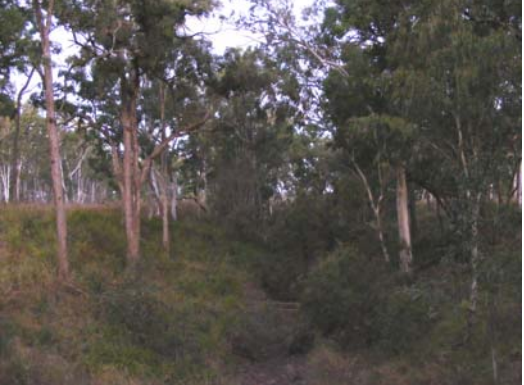
Facing upstream (18/06/2008)		
Site 11 Cockatoo Creek at Nathan Rd	This site was dry during the post-wet sampling program.

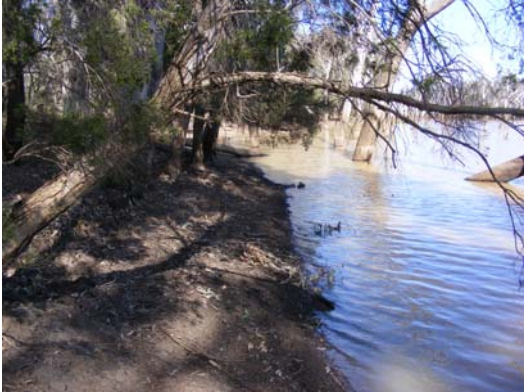
Reach	Description	Photograph
Site 12 Cockatoo Creek within current inundation area from Glebe Weir, upstream confluence with Dawson River	A large pool environment exists at this site which is the result of the impounded water from Glebe Weir, with many dead tree trunks scattered throughout the pool. A high percentage of the lower bank is devoid of vegetation, although most of this section of bank was observed to have minimal evidence of erosion. No macrophytes were recorded from this site.

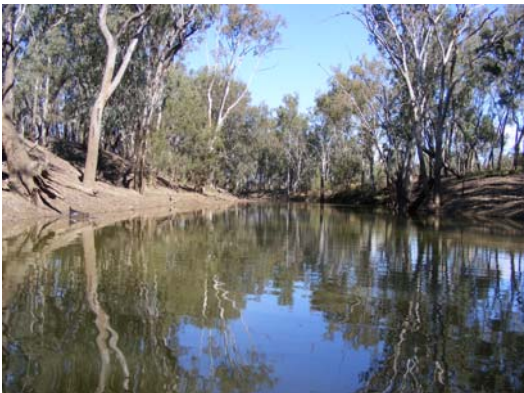
Site 13 Bentley Creek within inundation area at Bentley Property	A large long pool existed at this site with no restriction to fish passage observed during the field survey. Limited riparian vegetation existed adjacent to the site, dominated by Eucalypt species. No macrophyte species were recorded, and overall aquatic habitat assessment was poor.

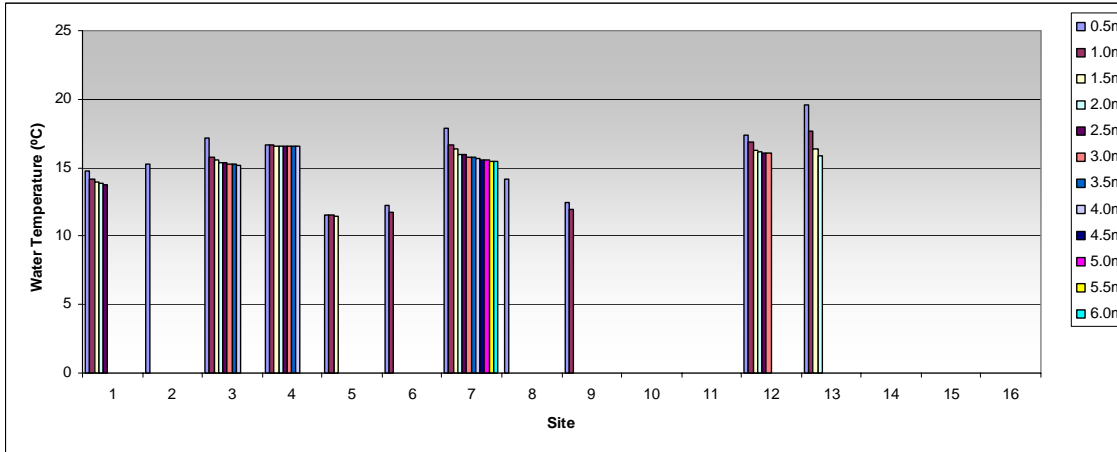
Water temperature was recorded between 12°C and 19°C at the sites surveyed during the post-wet field sampling program. All sites recorded a decreasing trend in water temperature through the vertical profiles. A slight decrease in water temperature was recorded at each site when logged overnight.

Figure 2: Water temperature at each site, recorded in 0.5m depth increments.

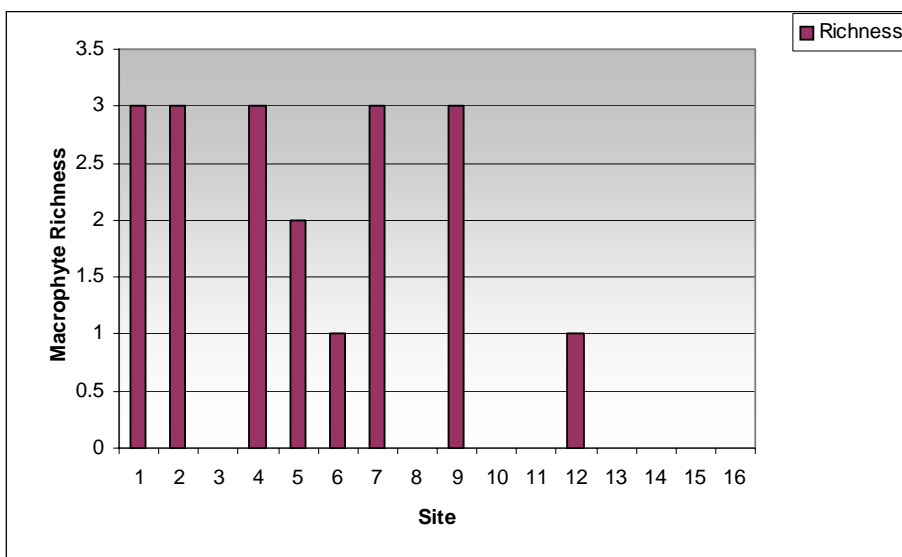
A total of 7 different macrophyte species were observed during the post-wet sampling program, of which no more than 3 were recorded at any 1 site.

Figure 14: Number of aquatic macrophyte species observed at each site.

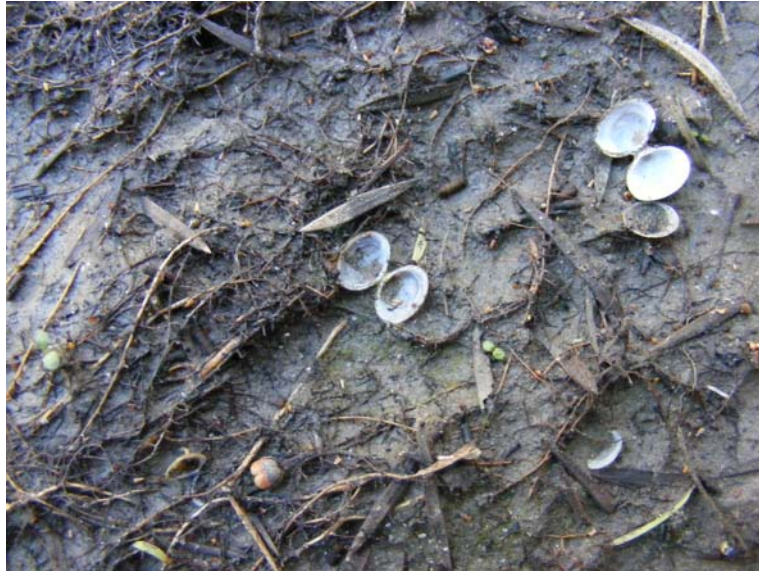
Freshwater mussels were observed as shells on the banks (Family: Hyriidae and Corbiculidae) at Site 6 only.

Figure 19: Corbiculidae shells (Freshwater Bivalves) observed at Site 6 along the bank.
