Olive Downs Coking Coal Project

Environmental Impact Statement

Technical Study Report

Geomorphology

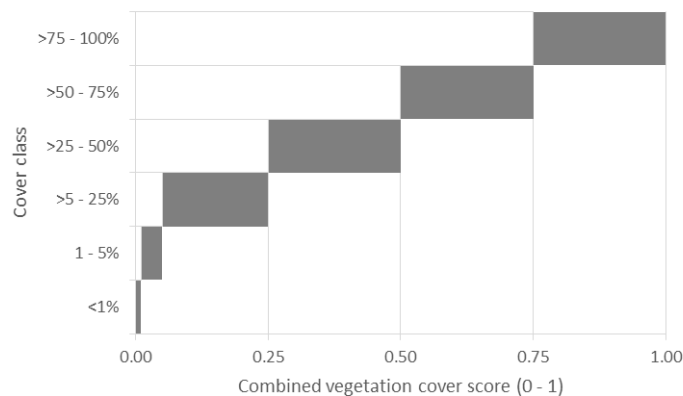
Figure 4. Scale for conversion of combined riparian vegetation cover index score to class.

An index score of at least 1.0 would be achieved if tree, shrub and ground cover were all in the 50 – 75% or >75% cover classes. A very well vegetated site might achieve a combined factored score exceeding 1.0, in which case the score would be rounded down to 1.0. The index scores were converted to combined cover classes equivalent to the classes used to collect the original data (Figure 4).

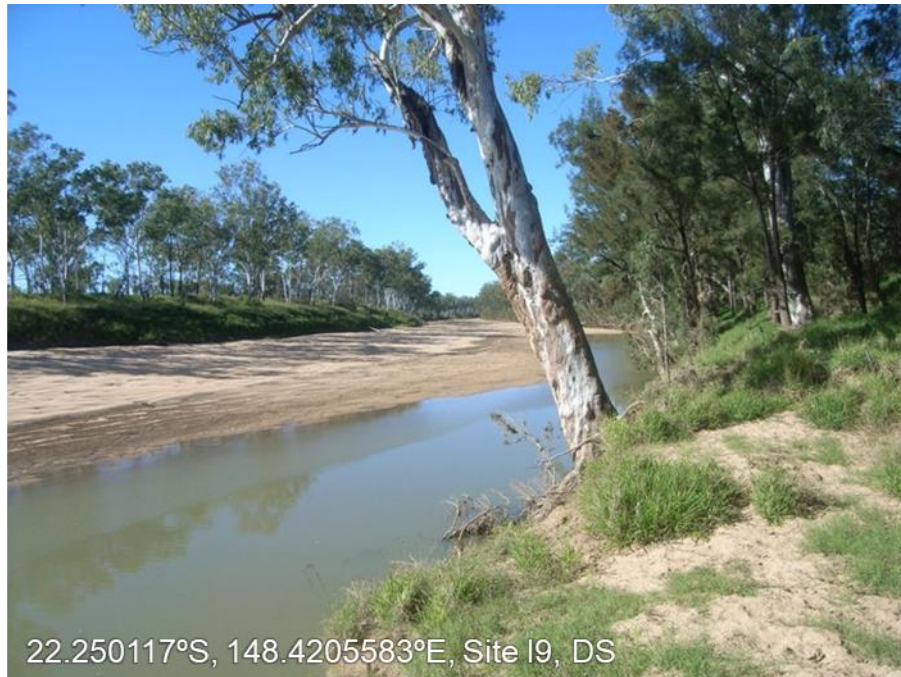
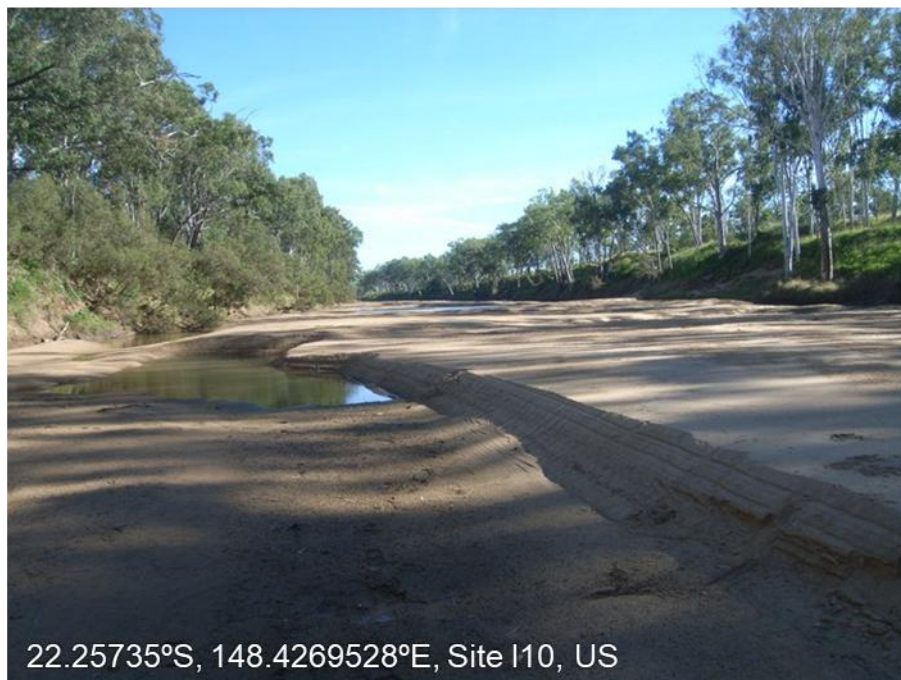
Figure 18. Isaac River, typical cross-section and bed morphology at two sites in the upper reaches of the Study Area.

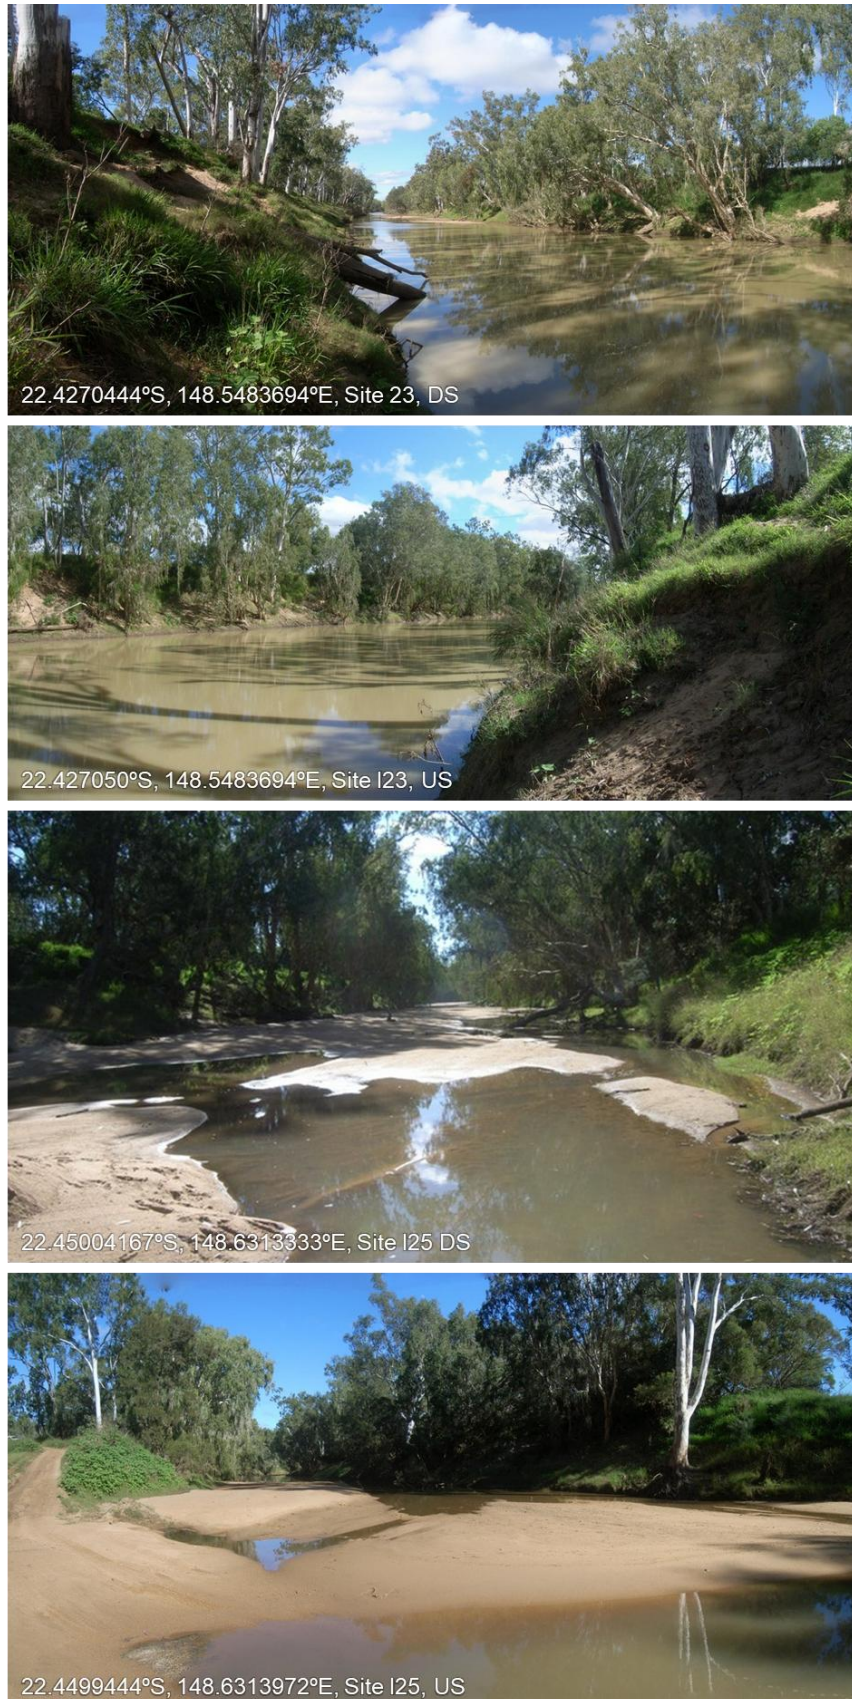
Figure 19. Isaac River, typical cross-section and bed morphology at two sites in the lower reaches of the Study Area.

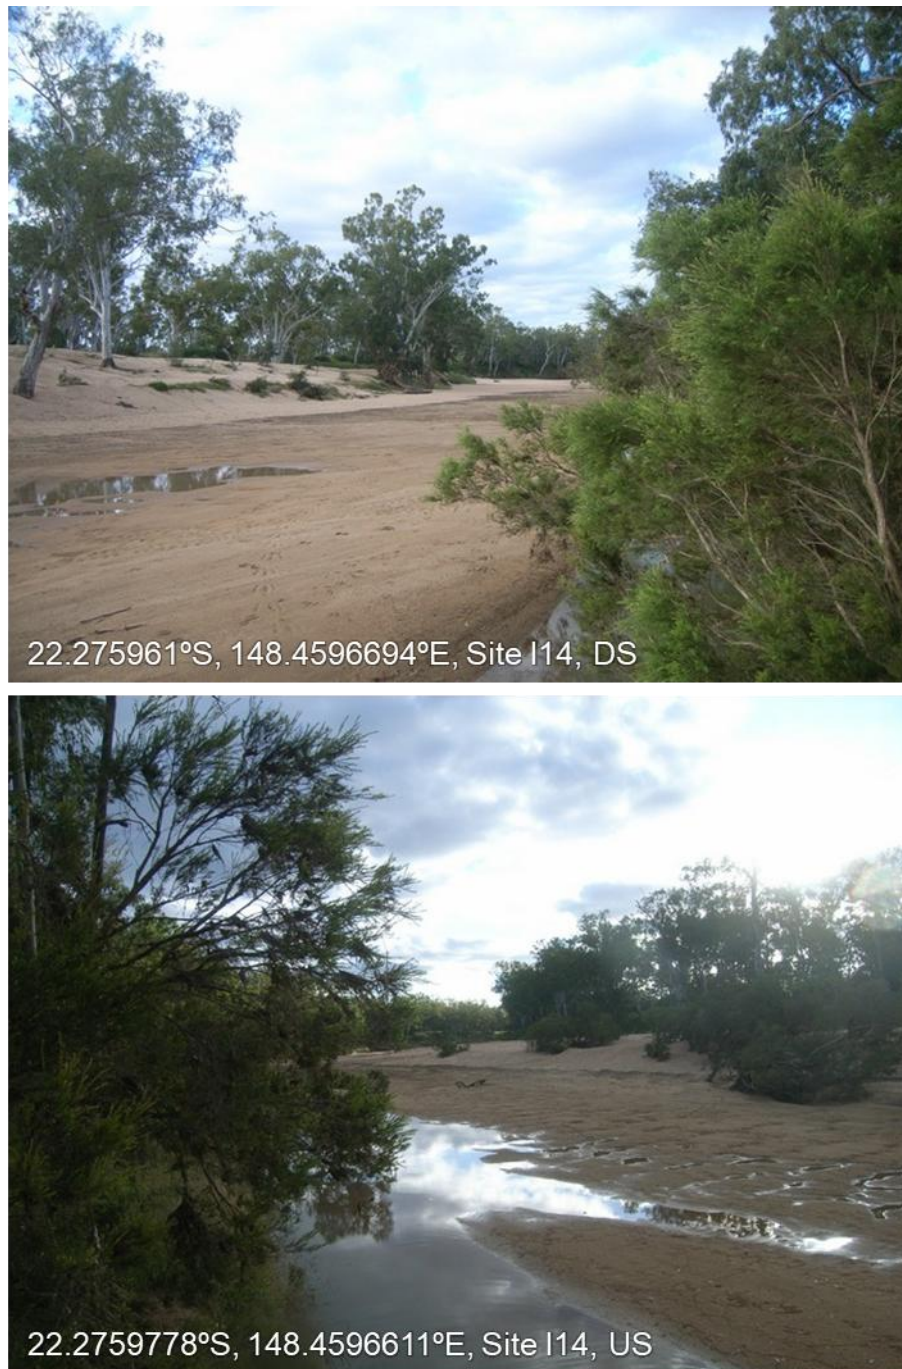
Figure 20. Isaac River, example of mid-channel vegetated island.

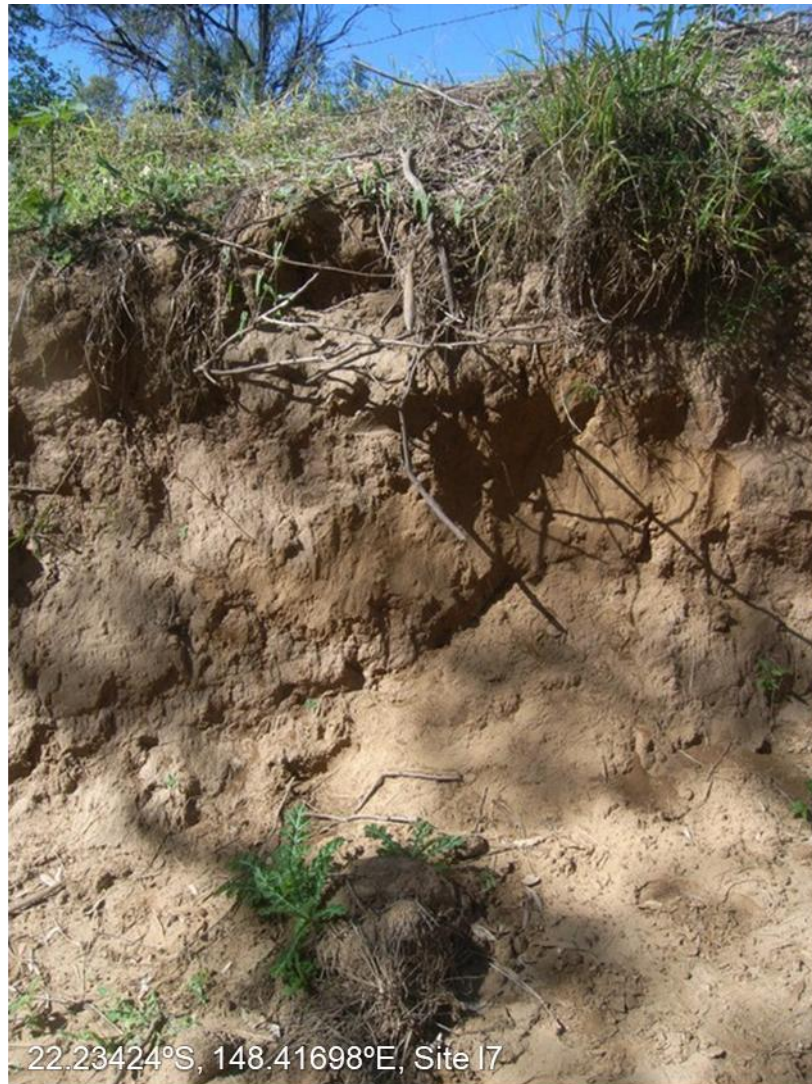
Figure 21. Isaac River, exposed clayey, silty, sand bank material at a cutting.

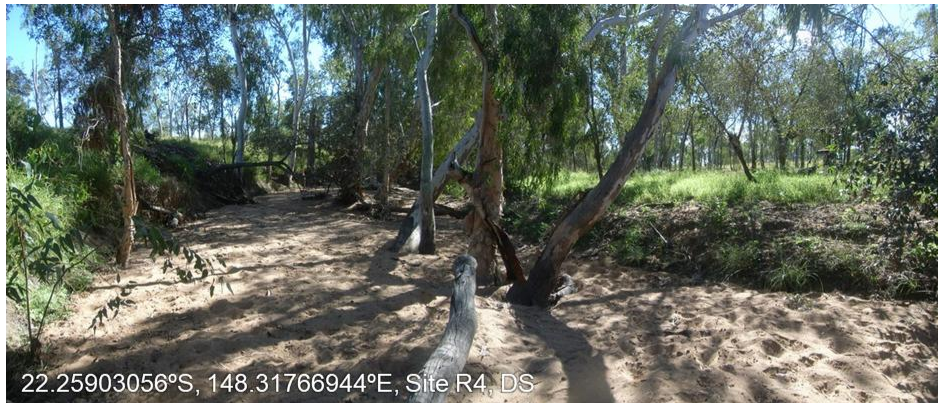
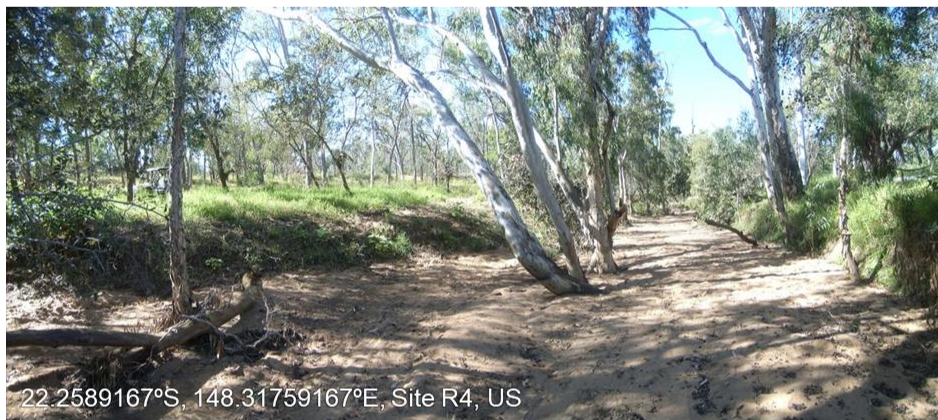
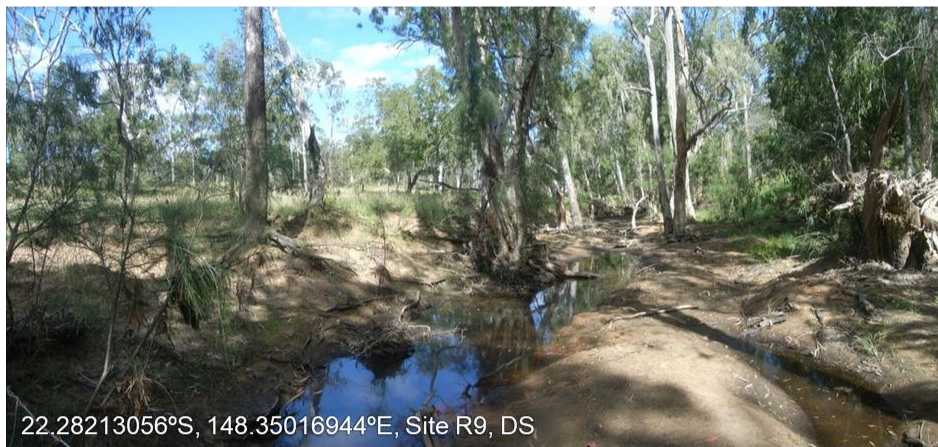
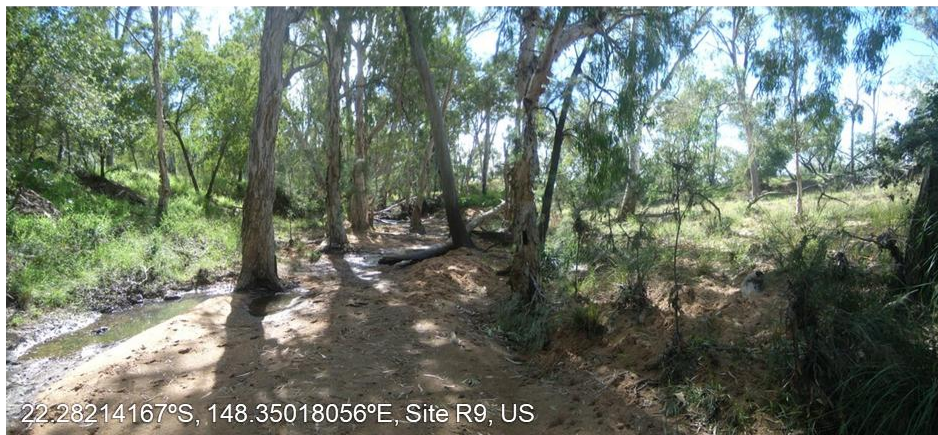
Figure 22. Typical sites on upper Ripstone Creek.

Ripstone Creek narrowed in its lower reaches (Figure 31) (compare Figure 22 and Figure 23). This suggests that the floodplain is likely to be more hydraulically connected to the channel in the lower reaches, although it becomes less connected in the lowest reach where it incises into the floodplain towards its junction with Billabong Creek (Figure 24). Channel dimensions were highly variable along Ripstone Creek (Figure 31).

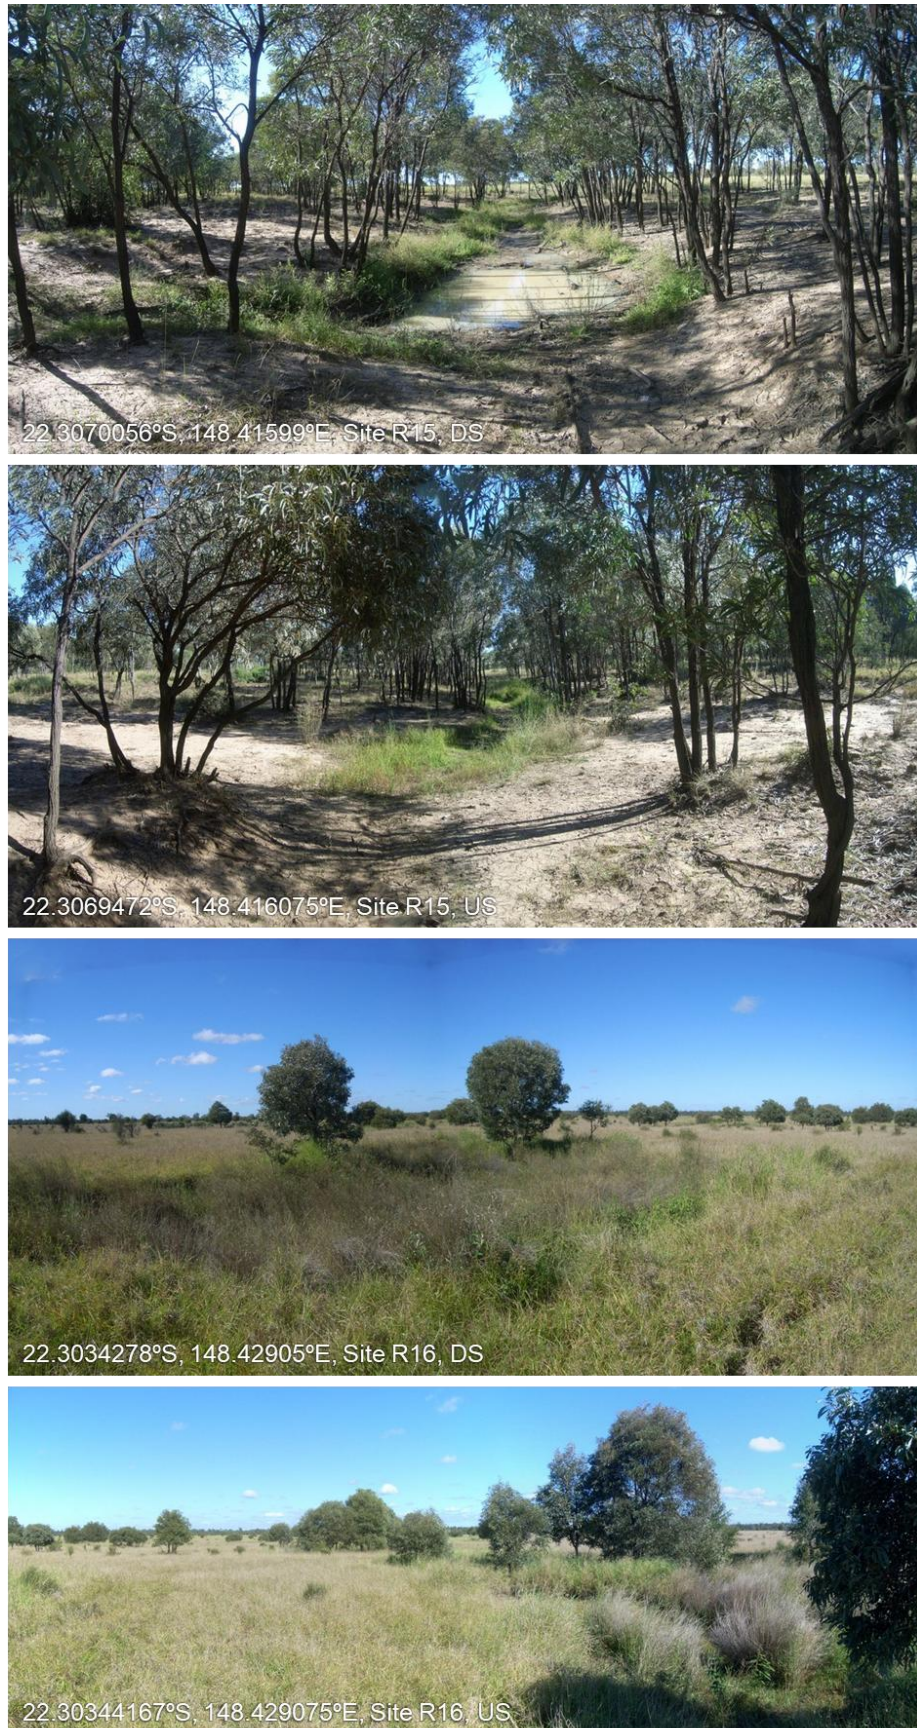
Figure 23. Two sites on lower Ripstone Creek.

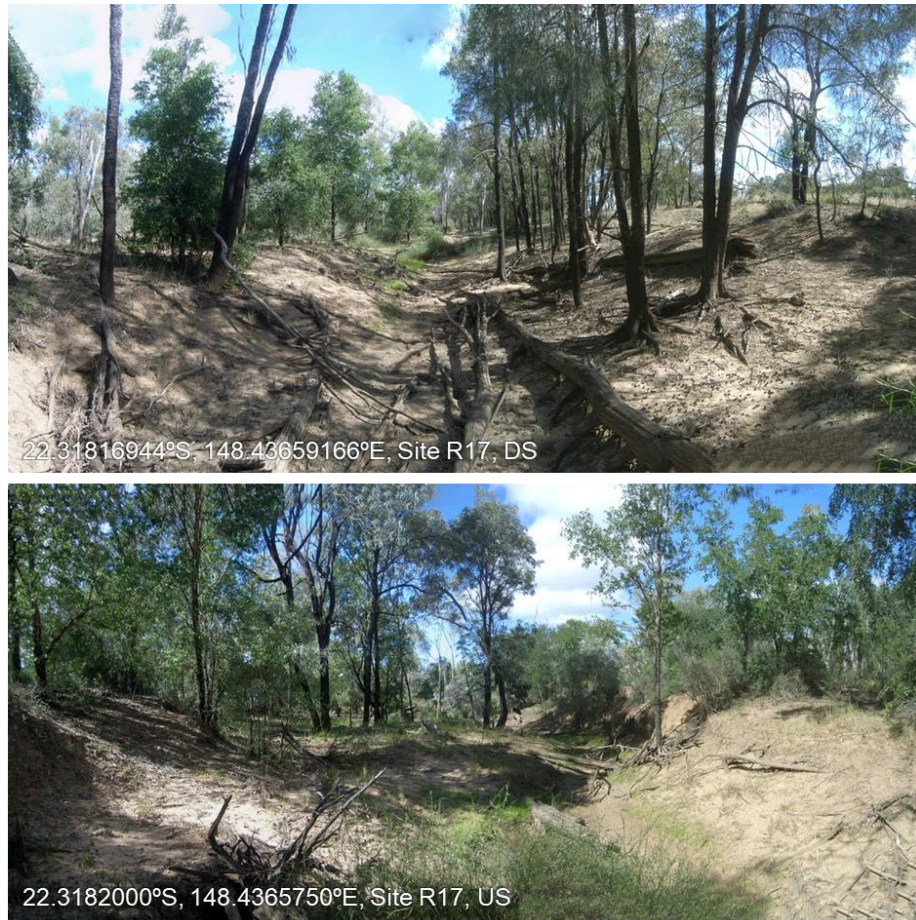
Figure 24. The lowest surveyed site on Ripstone Creek.

The upper section of Ripstone Creek, from R1 to R7, is partly confined with extensive floodplain connection. Downstream of R7 to R14 the floodplain connection is less extensive. This upper part of Ripstone Creek down to R14 (Figure 22) is Planform Controlled Meandering Sand. The lower section of Ripstone Creek from R15 to R16 emerges from a confined valley and fans out over the lateral zone of the Isaac River floodplain (Figure 33). The mapped 1:100,000 blue line in this area should not be interpreted as a major flow path, as flood flow is likely to spread widely over this area. Here, the observed channel changed from sand bed to fine-grained bed and became an unconfined flow path characterised by discontinuous deep pools (Figure 23). At the local scale the creek had characteristics of chain-of-ponds geomorphic stream type, but it did not fit the usual upland valley setting, or lowland setting confined by a palaeochannel. Thus, it was more accurately classified as Floodout type (Figure 33). At the most downstream section from R17, where Ripstone Creek starts incising to meet Boomerang Creek bed level, the channel becomes longitudinally continuous and more defined in cross-section form (Figure 24). Here the creek was classified as Meandering Fine Grained type.

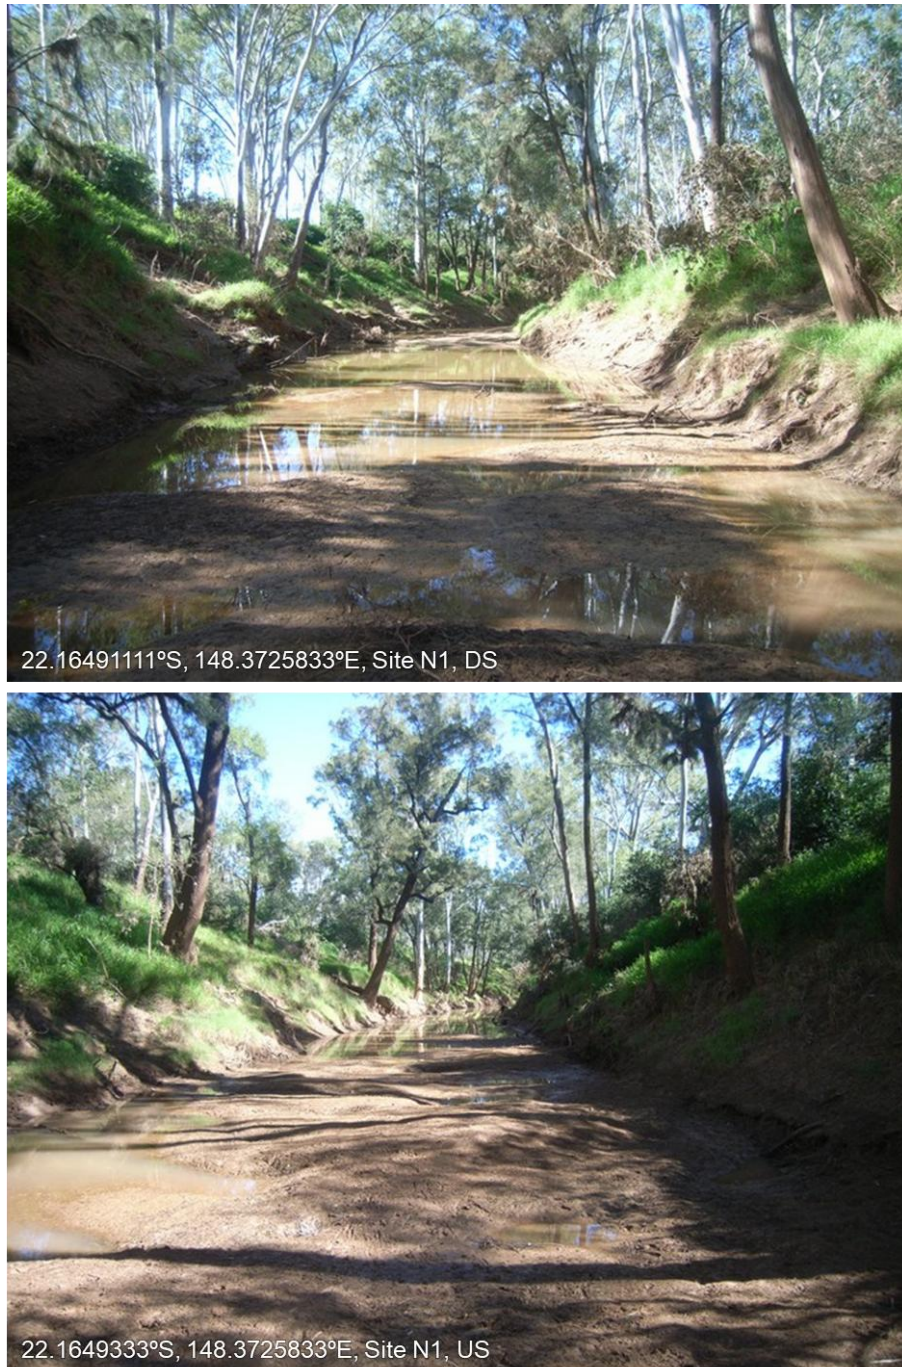
Figure 25. Lower reach of North Creek near its junction with the Isaac River.

North (Figure 25), Boomerang (Figure 26) and Phillips (Figure 27) creeks were similar in geomorphic character. These creeks were similar in character to Isaac River, but at a smaller scale (Table 18, Table 19).

Isaac River (Figure 18, Figure 19, Figure 20) and North Creek (Figure 25), being laterally unconfined with extensive floodplain connection, belong to the Low Sinuosity Sand type. The lowland reaches of Boomerang Creek (Figure 26) and Phillips Creek (Figure 27) are a similar type at a smaller scale, but by virtue of their higher sinuosity are Meandering Sand type.

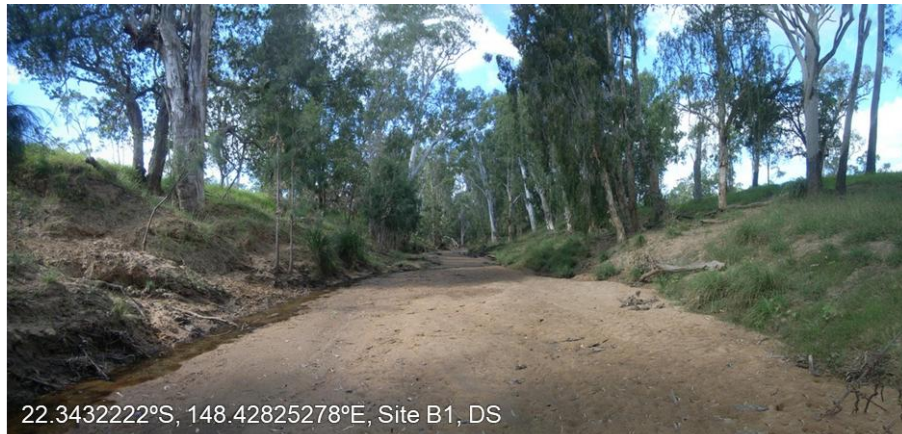
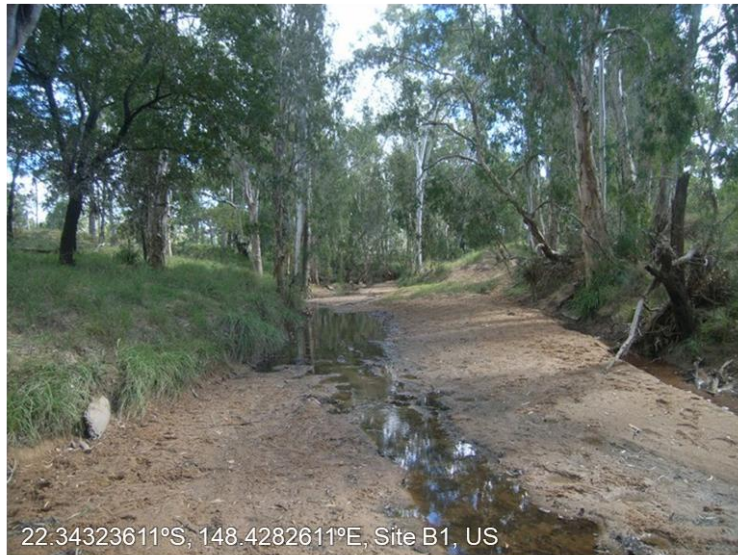
Figure 26. Most upstream surveyed site on Billabong Creek.

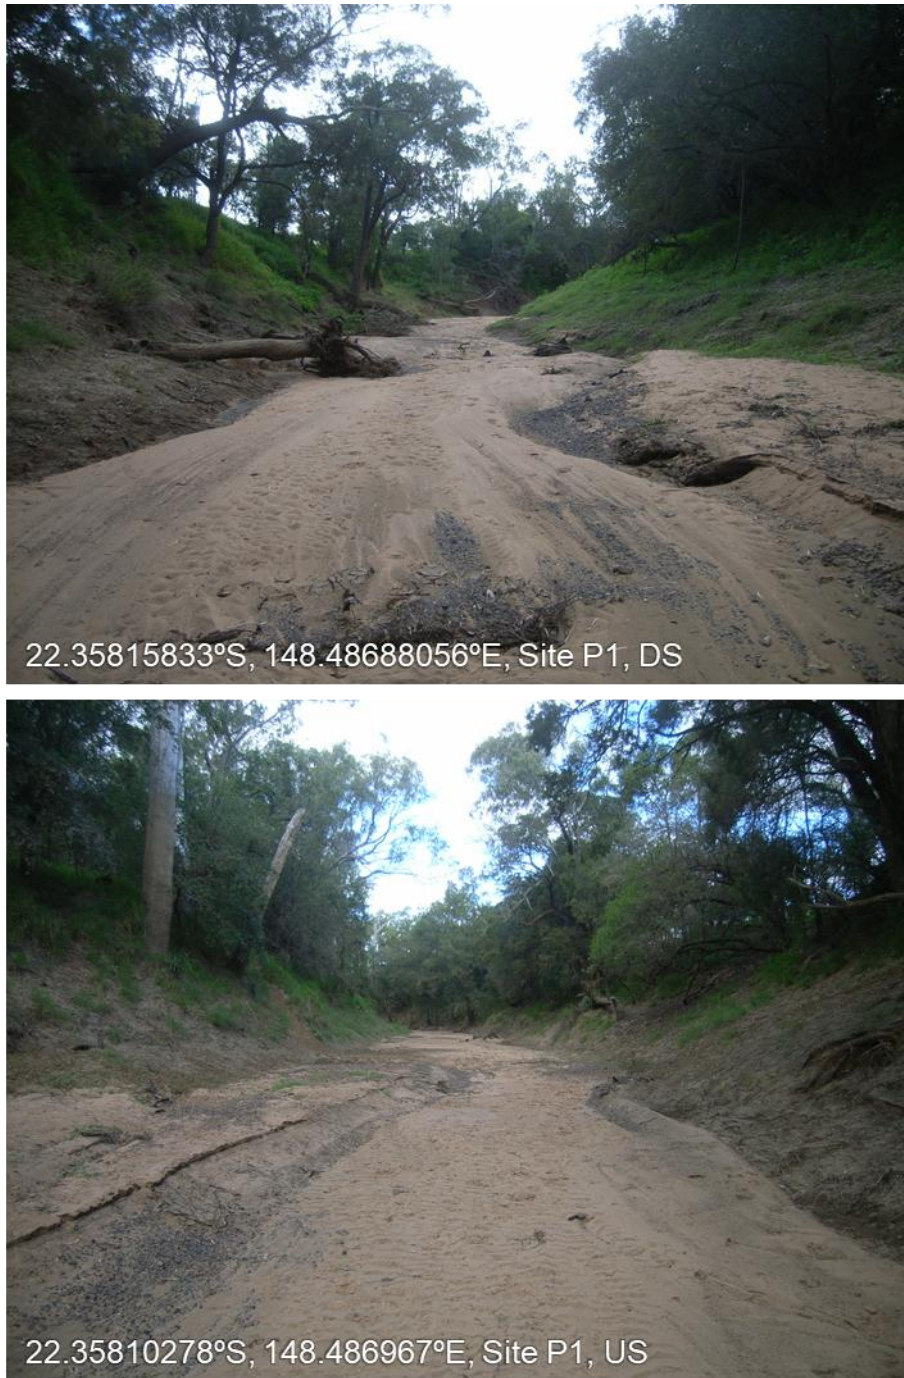
Figure 27. Most upstream surveyed site on Phillips Creek.

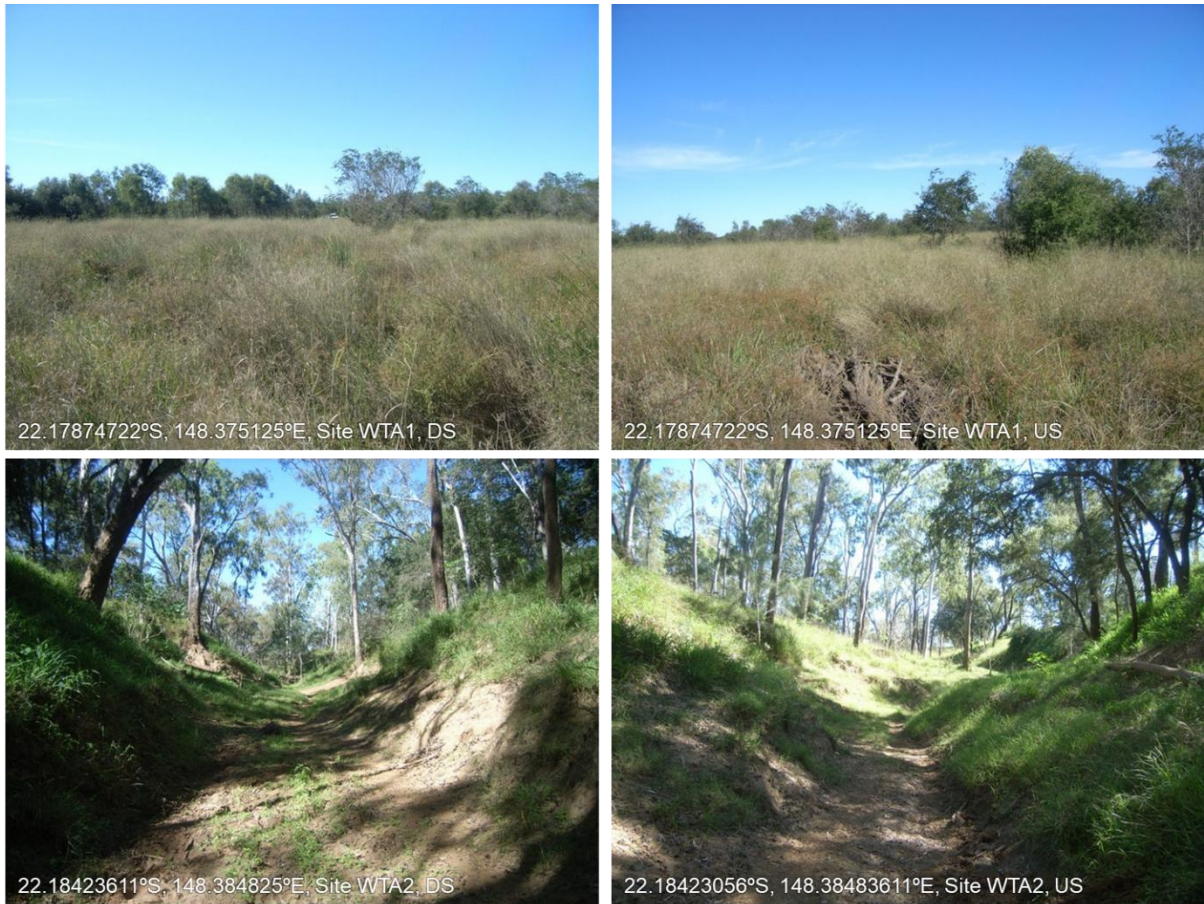
Figure 28. Western Tributary A upper (top) and lower (bottom) sites.

Western Tributaries A and B were small scale streams, with channel form alternating between ill-defined, weakly defined or well-defined (Table 18). Western Tributary A was ill-defined over most of its course, but became well-defined as it incised into the Isaac River floodplain as it neared its junction with the river (Figure 28). Western Tributary B Site 1 had a larger catchment area than at Site 2 on a small tributary. At Site 1 the stream comprised a series of well-defined pools strung along an otherwise ill-defined drainage line, while Site 2 had ill-defined morphology and lacked pools (Figure 29). Western Tributaries A and B were low gradient, with areas of ponded water and moist bed material that encouraged the growth of emergent macrophytes and grass in the bed (Table 19). Trees were not common in the riparian zones and there was very little large wood in the channels (Table 18, Table 19).

Western Tributary streams were sampled on lowland locations where they are proximal to or on the Isaac River floodplain. Here, the channels are small, varying from continuous to discontinuous. Western Tributary A, at WTA1 and further upstream (Figure 28), is an ill-defined Low Sinuosity Fine Grained stream draining low relief terrain. Further downstream, the channel starts incising towards the Isaac River (Figure 28). In this section the sandy bed material means WTA was classified as Low Sinuosity Sand type.

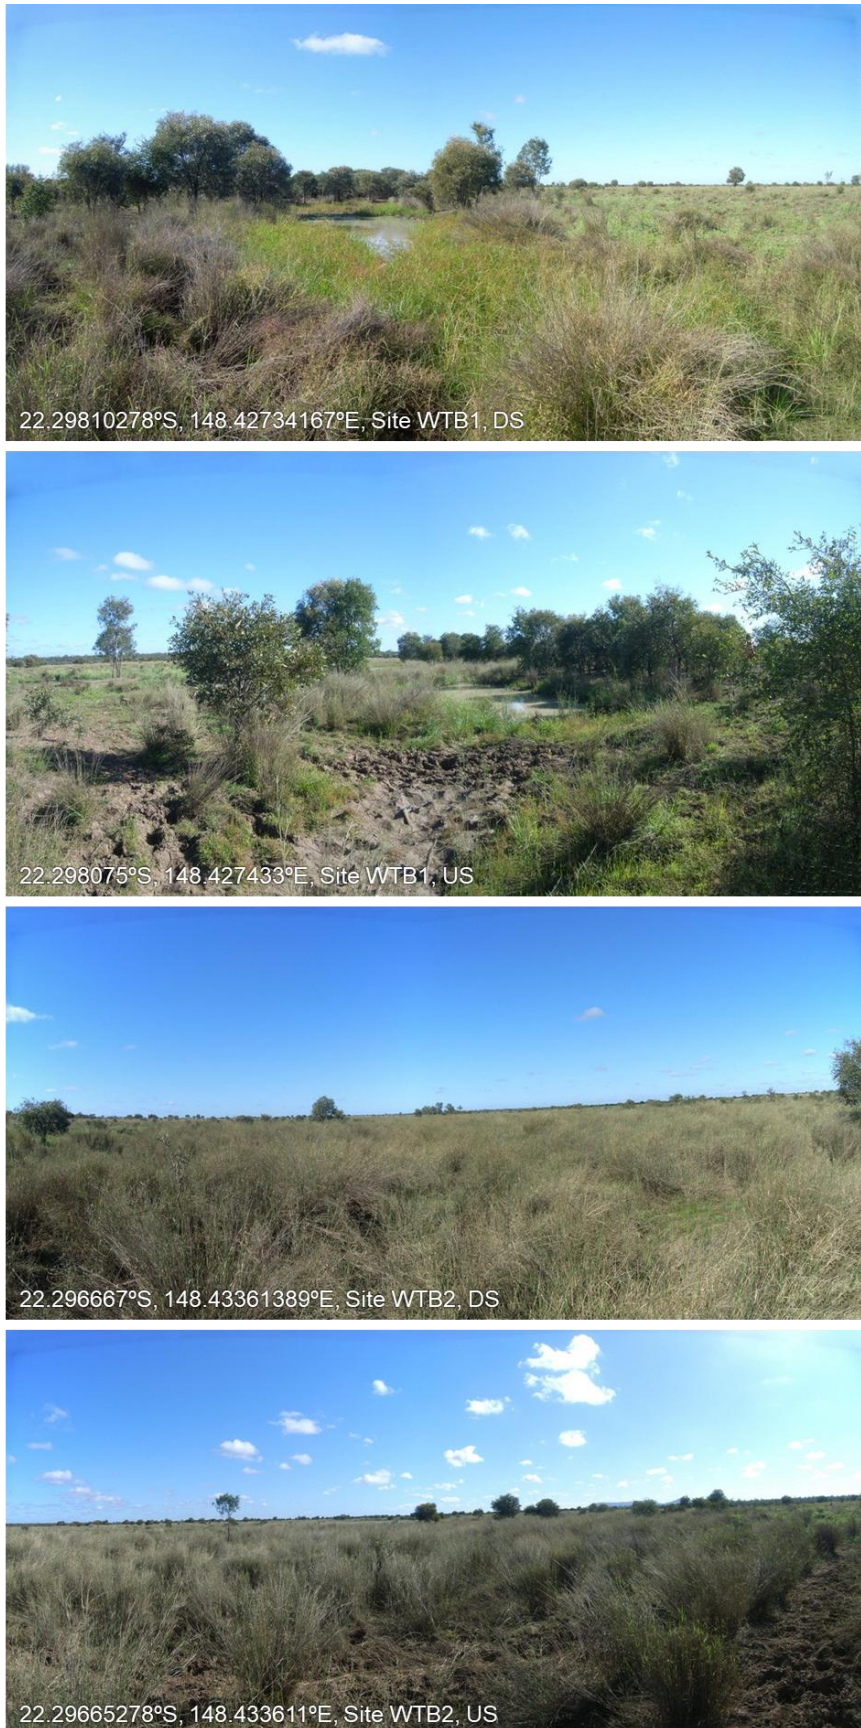
Figure 29. Western Tributary B sites.

Site WTB1 is on a drainage line that has a much bigger catchment than at the site WTB2 on a small ill-defined Low Sinuosity Fine Grained tributary drainage line. The channel at WTB1 is better defined, also formed in mud, with a sequence of pools linked by short shallow well-vegetated sections (Figure 29), also of Low Sinuosity Fine Grained type.

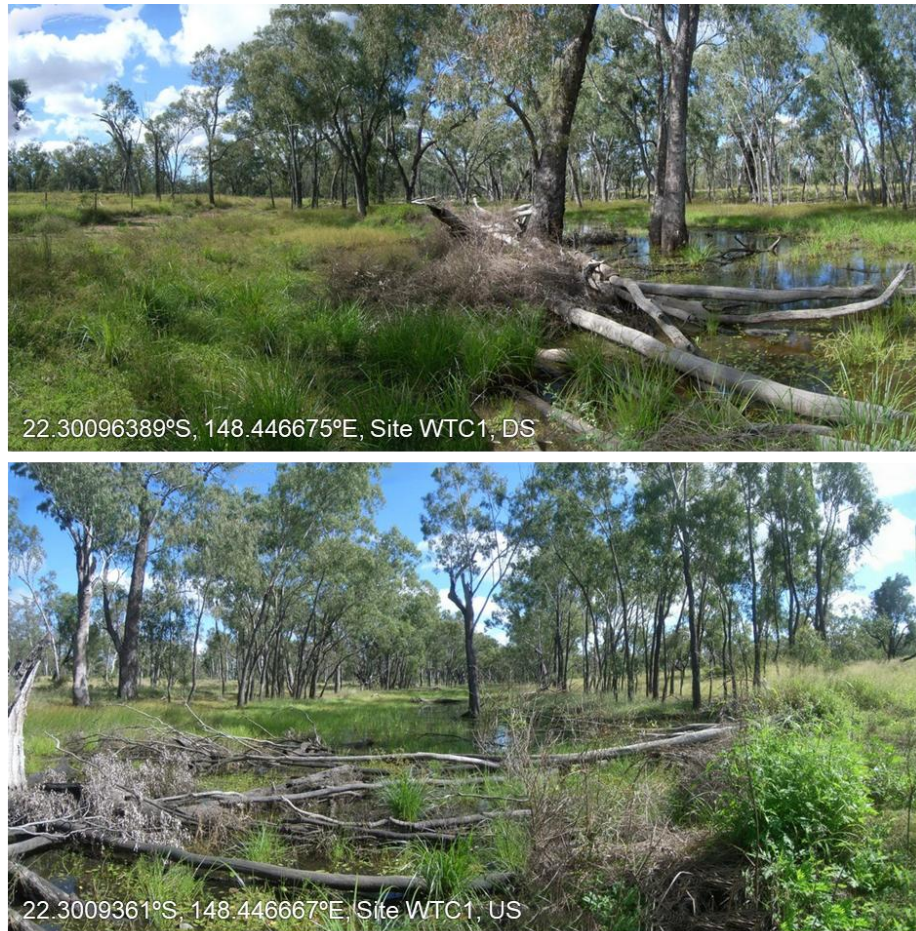
Figure 30. Western Tributary C, an in-filled former course of the Isaac River.

Western Tributary C is a cutoff meander loop on the margin of the Isaac River floodplain (Figure 30, Figure 33). It is infilled with sediment and of a smaller scale than the current Isaac River channel. As such, it was not classified as belonging to a geomorphic stream type, rather, it was considered a geomorphic unit of the Isaac River.

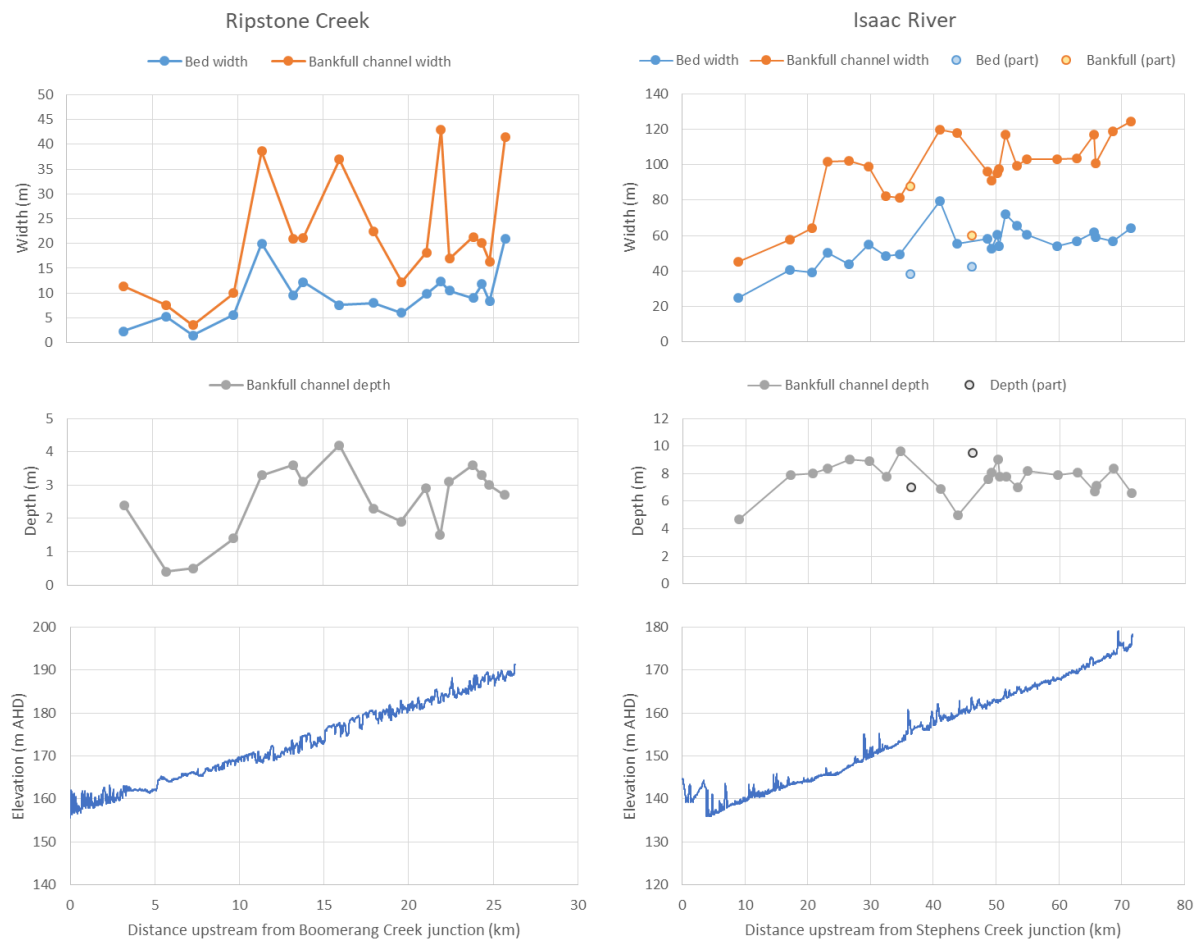
Figure 31. Downstream pattern of field-measured channel width and depth, and DEM-derived elevation of Isaac River and Ripstone Creek in the Study Area. Elevation is along 1:100,000 watercourse lines at 5 m intervals from 5 × 5 m DEM. Substantial islands were present at two sites labelled 'part' on Isaac River. Data refer to the main channel only.

The downstream slope of Ripstone Creek was relatively constant, falling 33.2 m over 26.2 km (Figure 31) for an average slope of 0.001275. Sinuosity of the creek in the Study Area was 1.51.

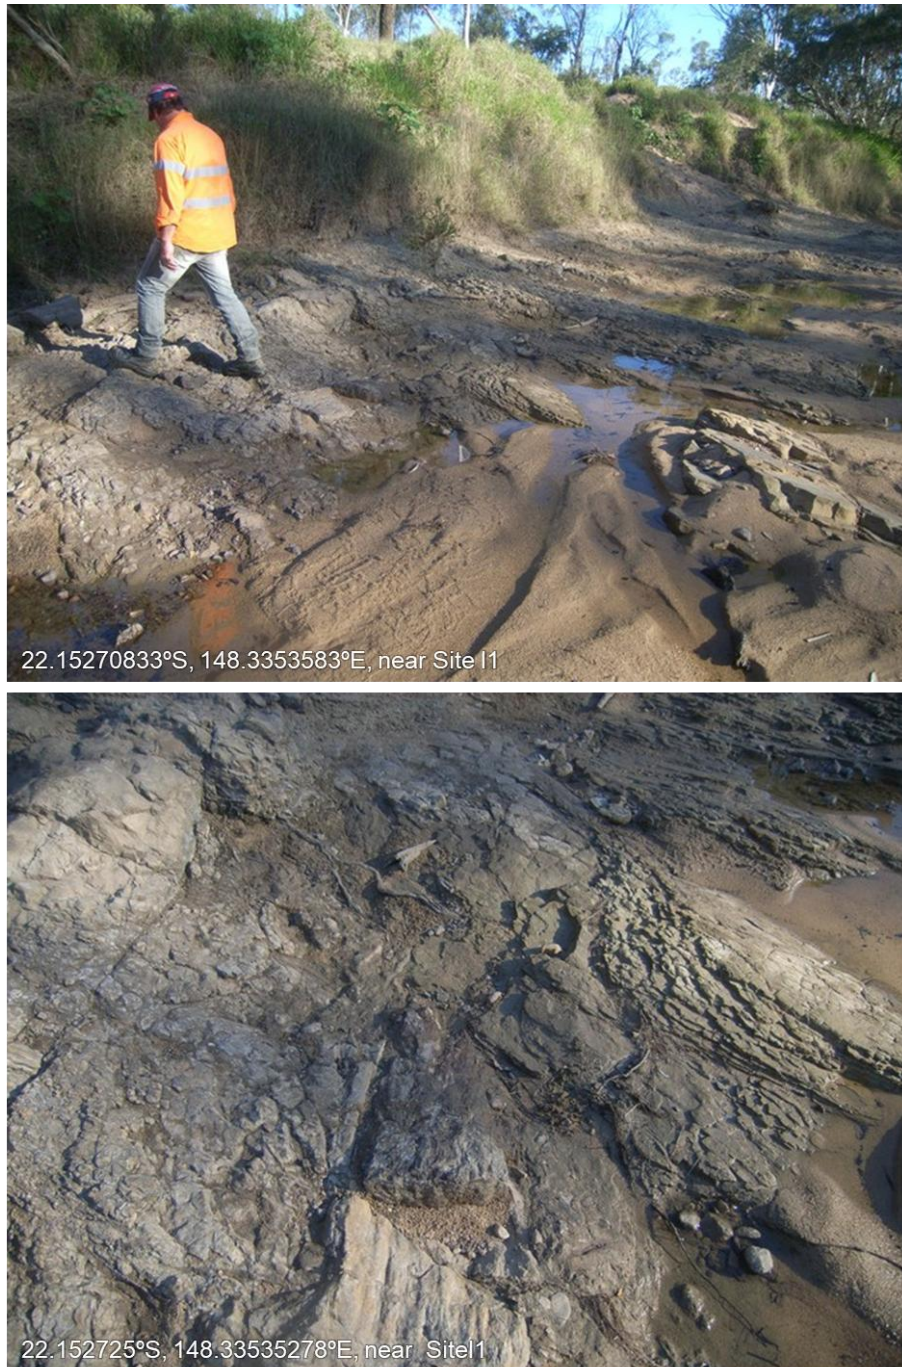
Figure 34. Isaac River, localised outcrop of bedrock containing pieces of silicified wood. Lower photograph is close-up view of centre of scene of upper photograph.

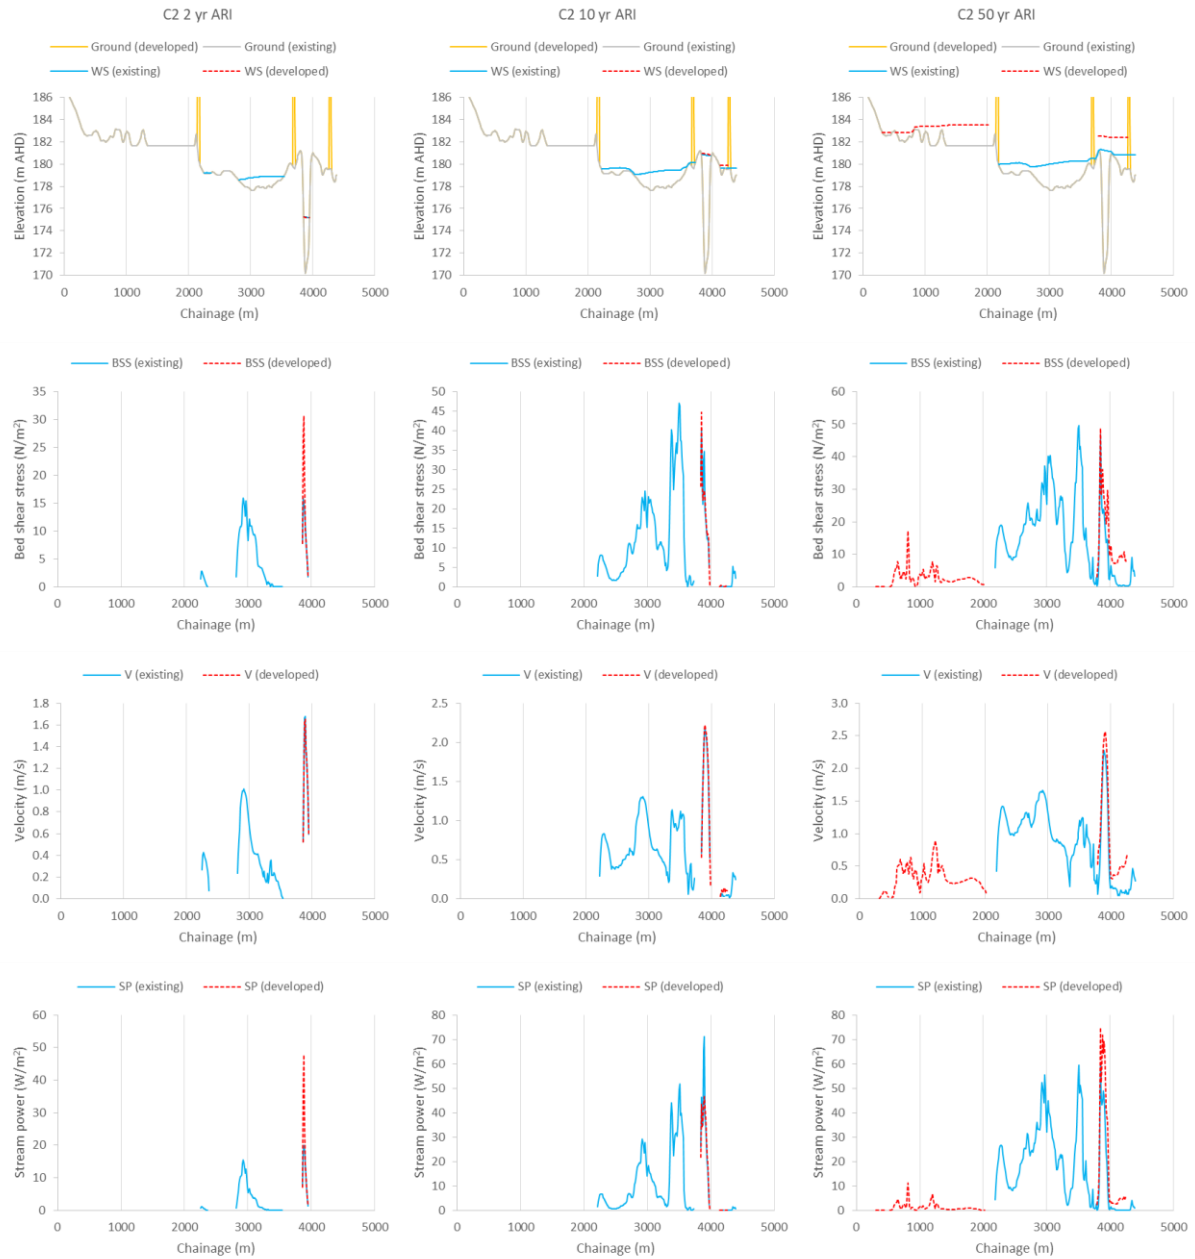
Figure 38. Cross-section 2 hydraulic character for 2 year, 10 year and 50 year ARI events. Note that Y-axis scales vary between flow scenarios.

Under the developed case, a 50 yr ARI event would cause inundation of a left-bank terrace at Cross-section 2; this area would not be inundated under existing conditions. However, the bed shear stress on this terrace would be low, with most areas having less than 10 N/m^2 , and all areas less than 20 N/m^2 . In comparison, under existing conditions the bed shear stress on the left floodplain mostly exceeded 10 N/m^2 and reached up to 50 N/m^2 (this area of floodplain would be removed from the flow path under the developed case). A similar situation is represented by Cross-section 5, where the right bank floodplain was not inundated by the 50 yr ARI event under existing conditions, but would experience widespread inundation under the developed case. However, under the 50 yr ARI event for the developed case, the bed shear stress on the floodplain would be relatively low, with most areas having less than 20 N/m^2 , and all areas less than 30 N/m^2 .
