Olive Downs Coking Coal Project

Environmental Impact Statement

Technical Study Report

Geomorphology

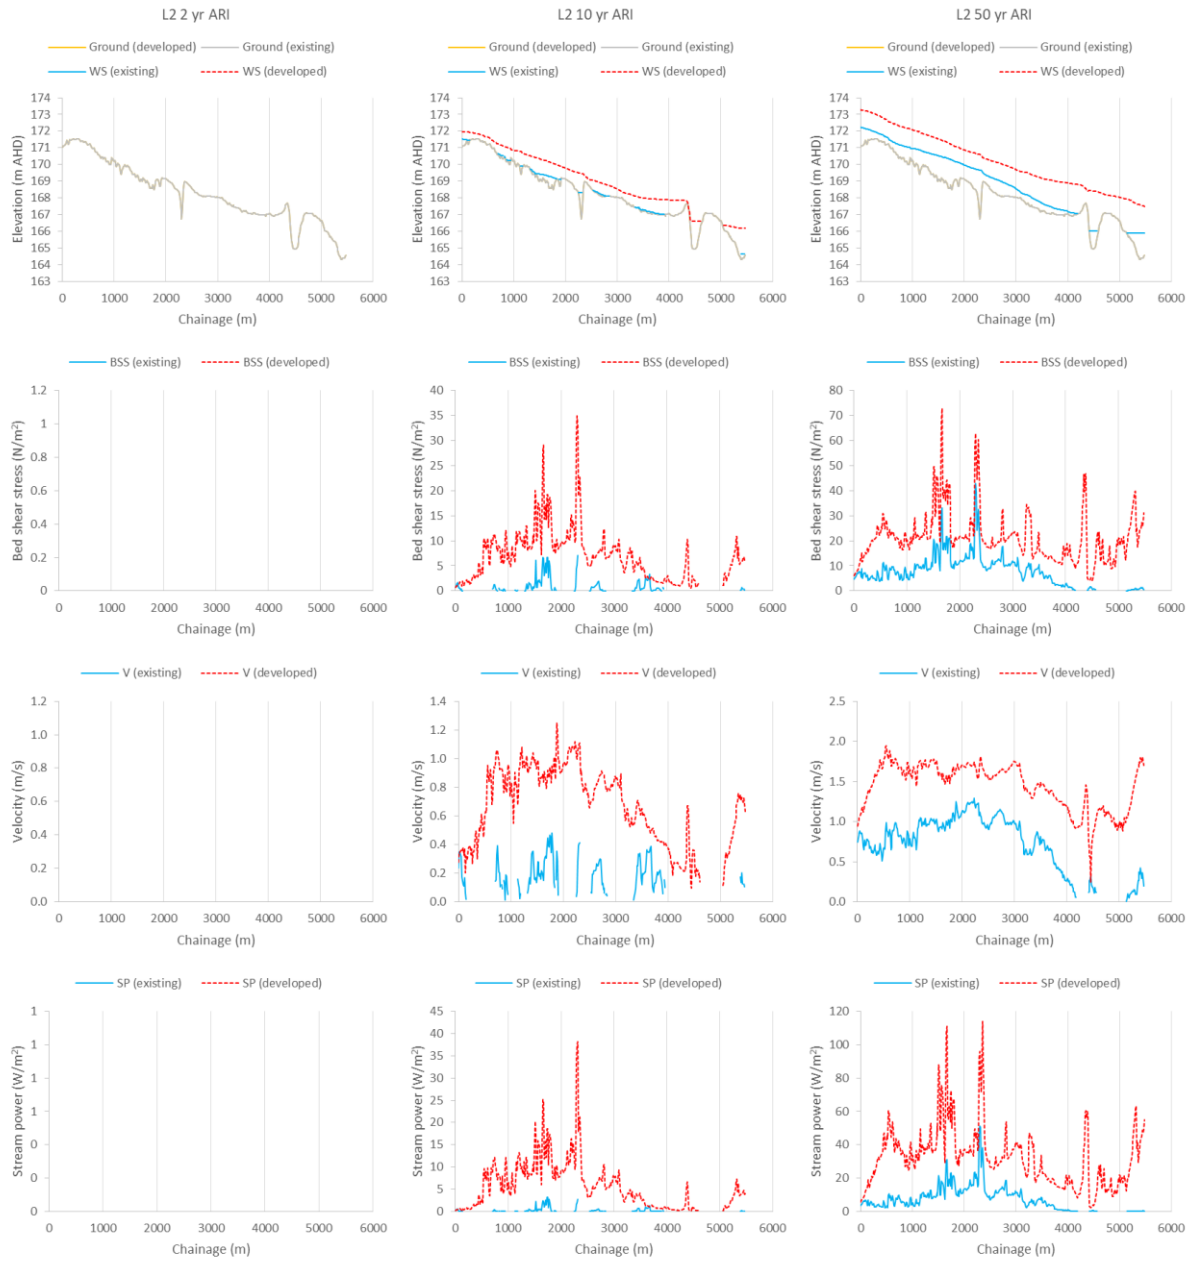
Figure 44. Long-profile 2D hydraulic character for 2 year, 10 year and 50 year ARI events. Note that Y-axis scales vary between flow scenarios.
