Olive Downs Coking Coal Project

Additional Information to the
Environmental Impact Statement

**Additional Information on
the Rehabilitation Strategy**

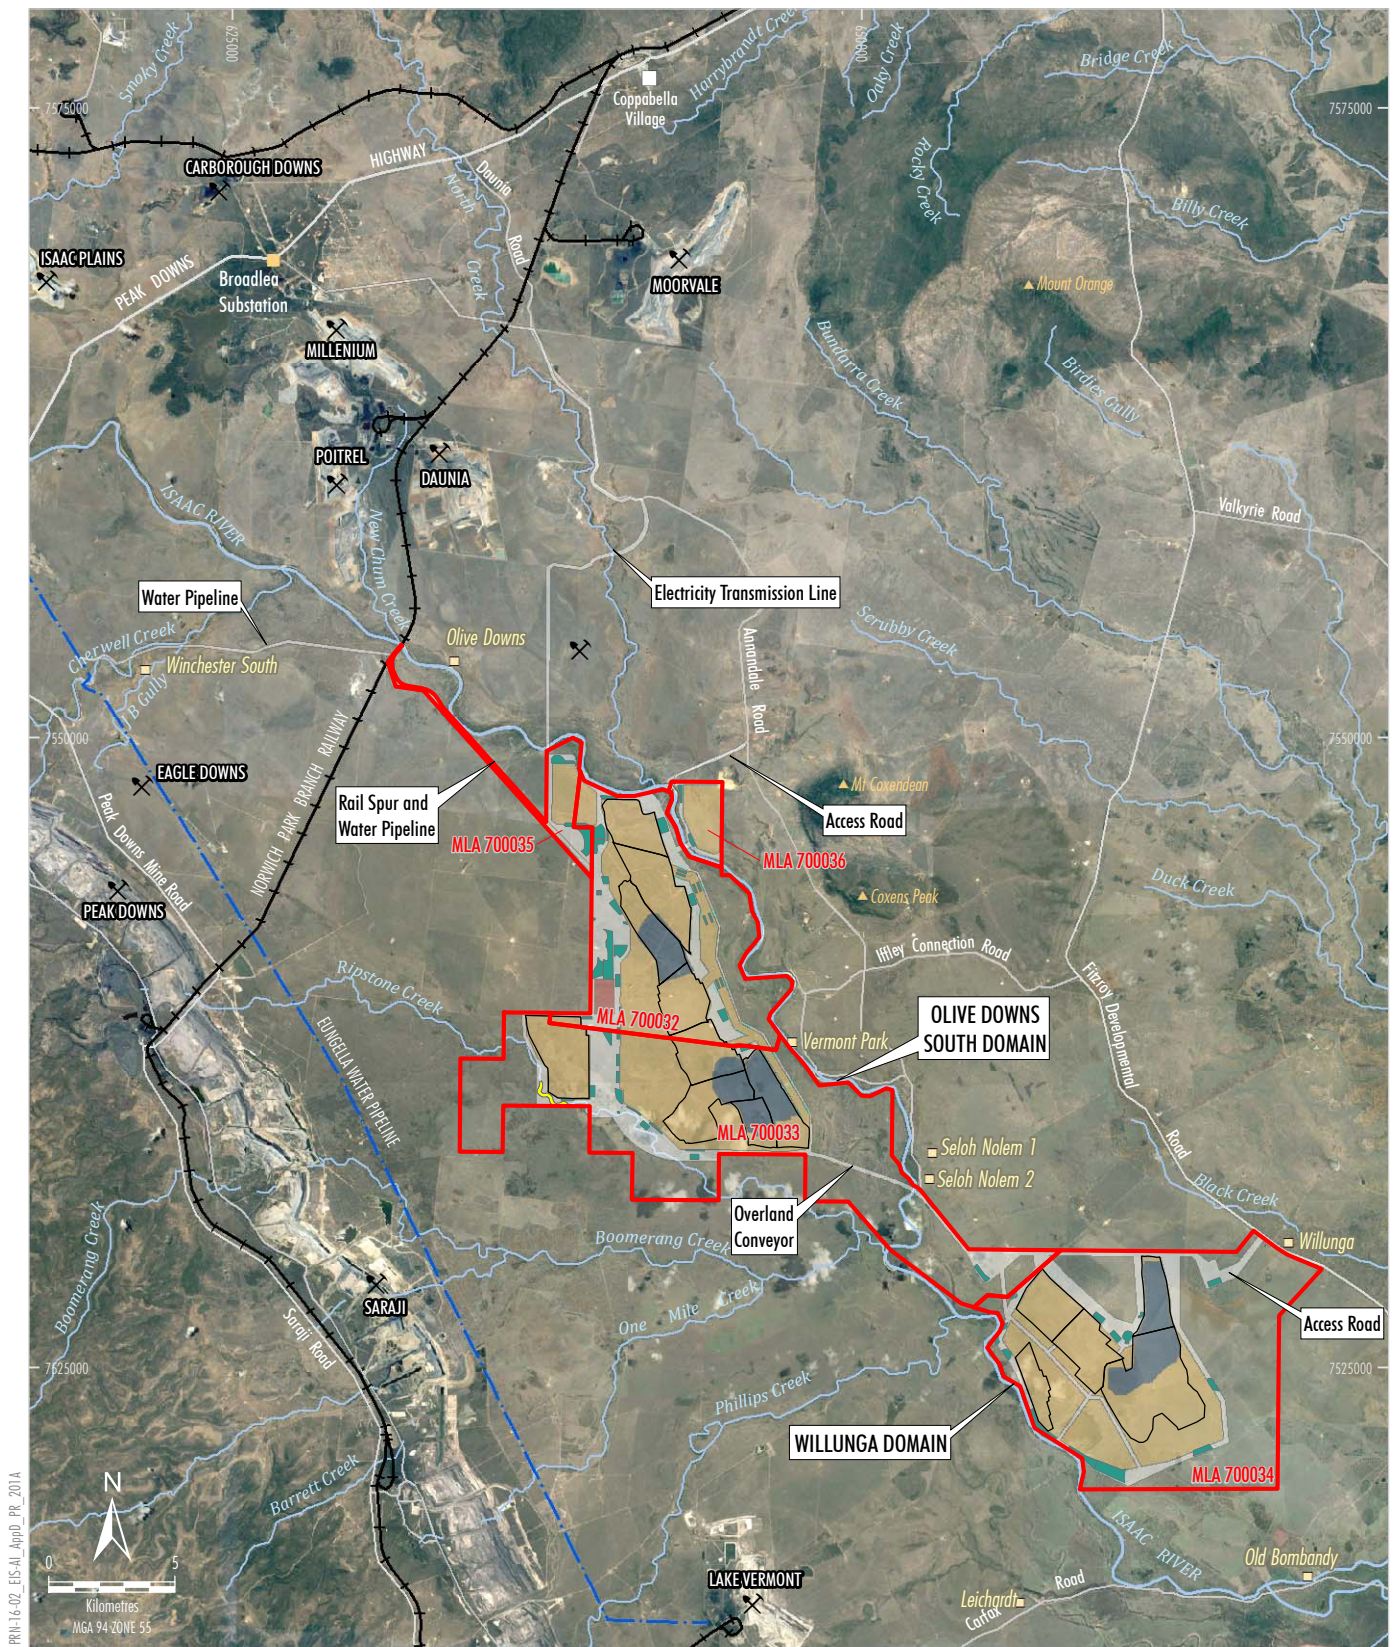
Figure 1

OLIVE DOWNS COKING COAL PROJECT Rehabilitation Domains

The revised Project rehabilitation domains are shown on Figure 1.

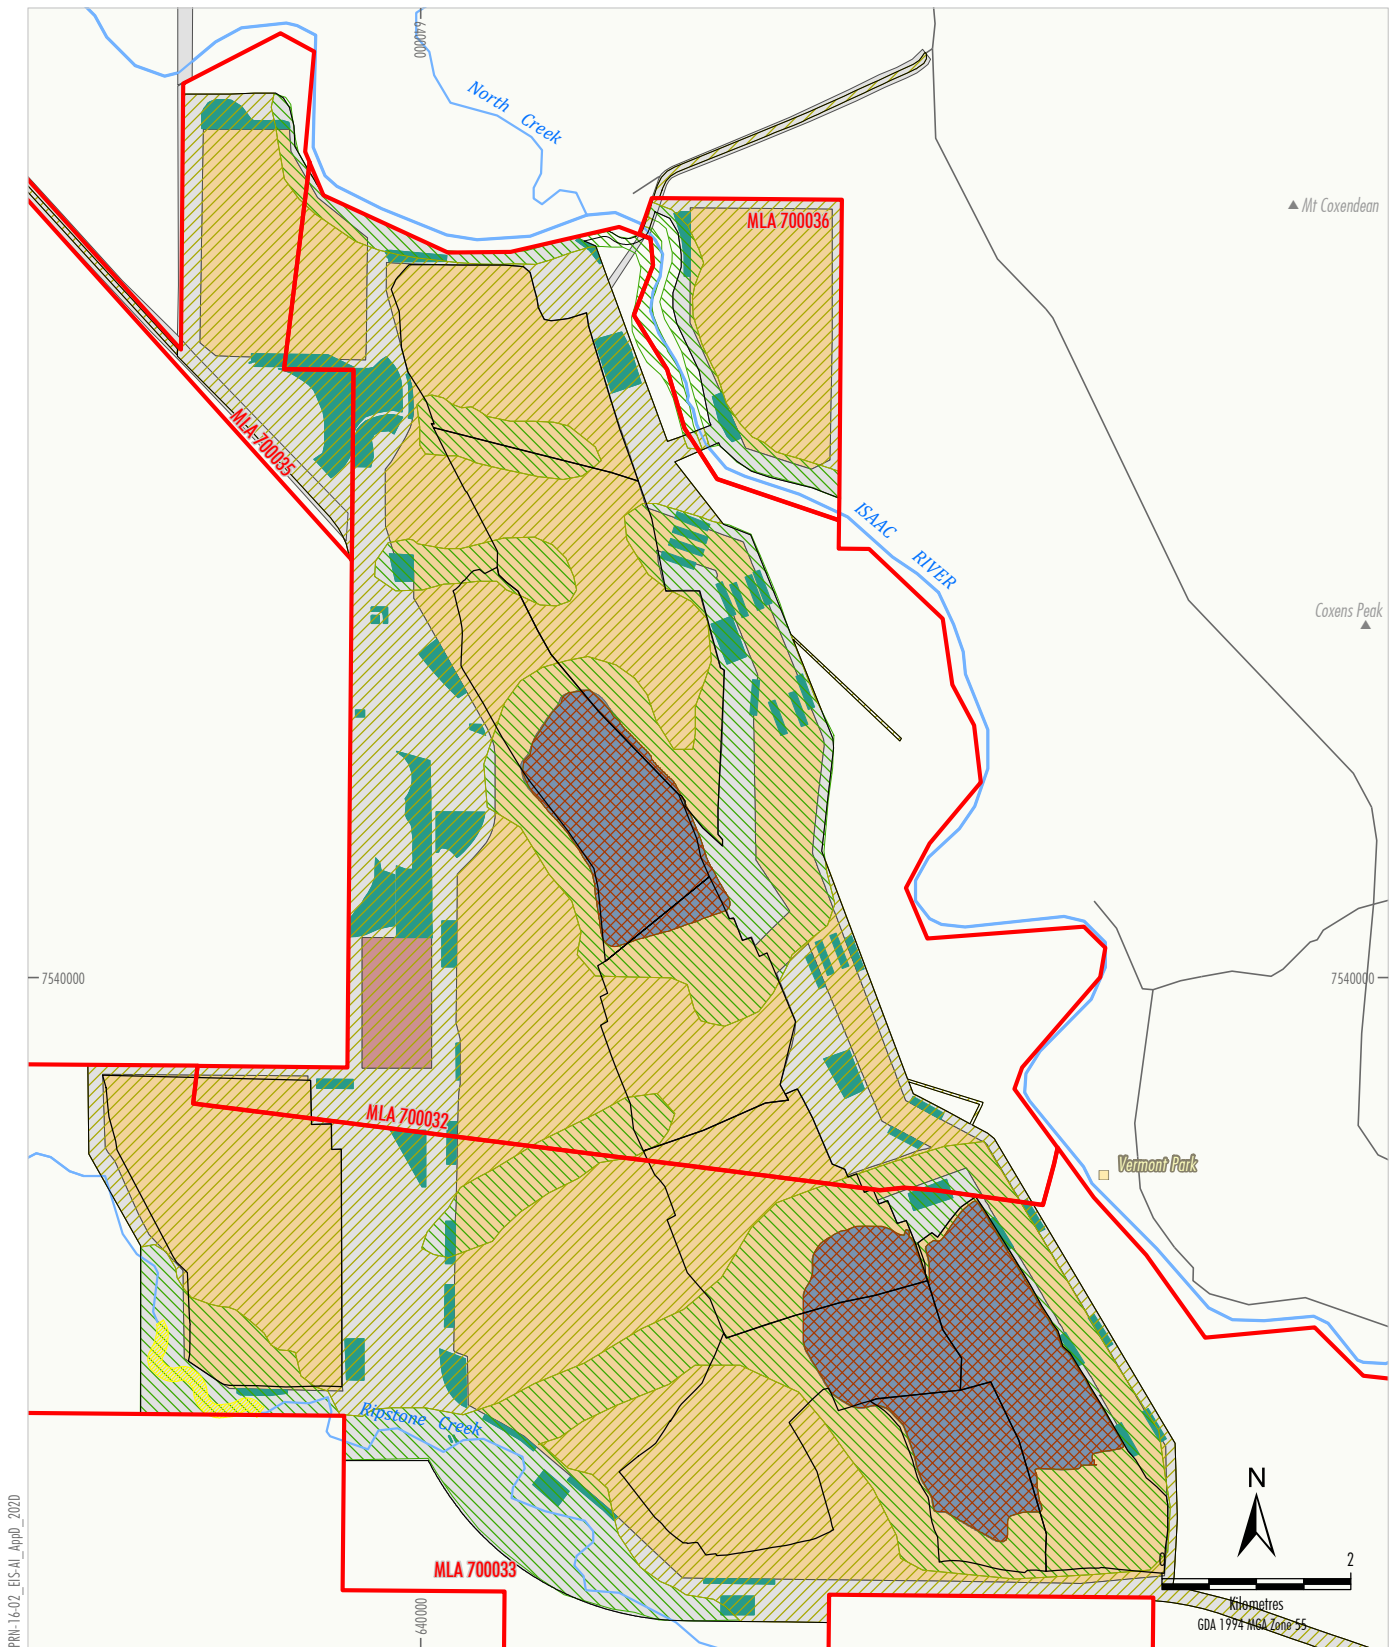
Figure 2a

OLIVE DOWNS COKING COAL PROJECT
Conceptual Post-mining Land Use
Olive Downs South Domain

Areas of the Project site would be rehabilitated to an agriculture (low intensity cattle grazing) post-mining land use (Figure 2 and Table 2). No agriculture (cropping) or forestry land uses are proposed.

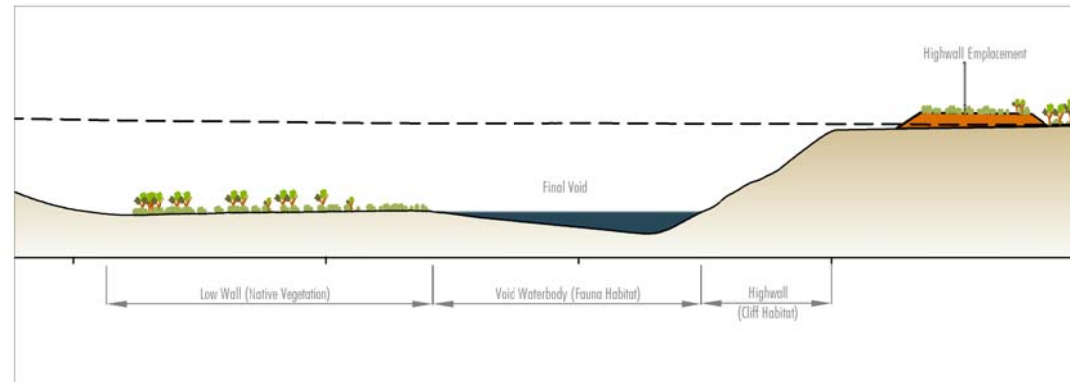
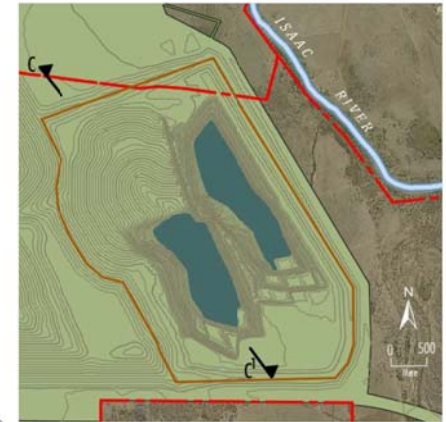
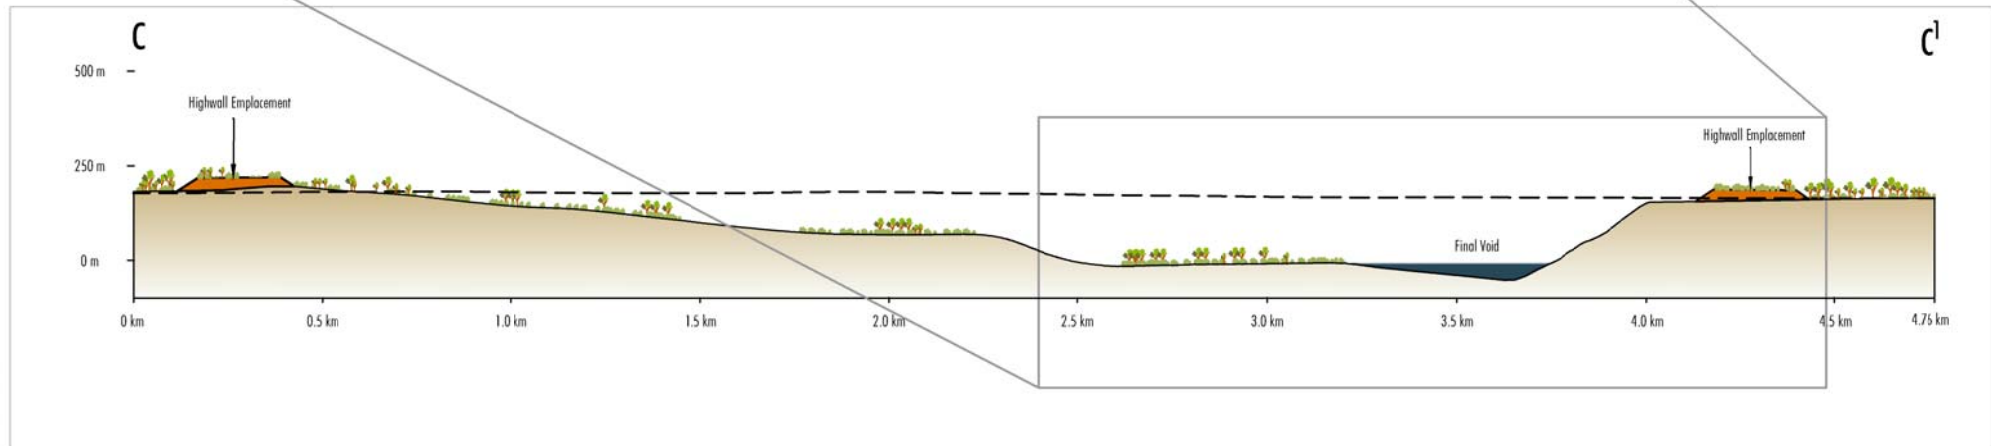
The final voids would comprise of low wall, highwall and a void water body landform components. Pembroke has investigated the likelihood that the final void would provide suitable native fauna habitat (Table 3). The final voids would provide suitable habitat for a range of native fauna, including species recorded within the Project site by DPM Envirosciences (2018a) such as the Strip-faced Dunnart (*Sminthopsis macroura*), Hoary Wattled Bat (*Chalinolobus nigrogriseus*) and Australian Grey Teal (*Anas gracilis*) (Table 3).

The final voids at the Project would be rehabilitated to a fauna habitat post-mining land use (Figures 2 and 3 and Table 2).

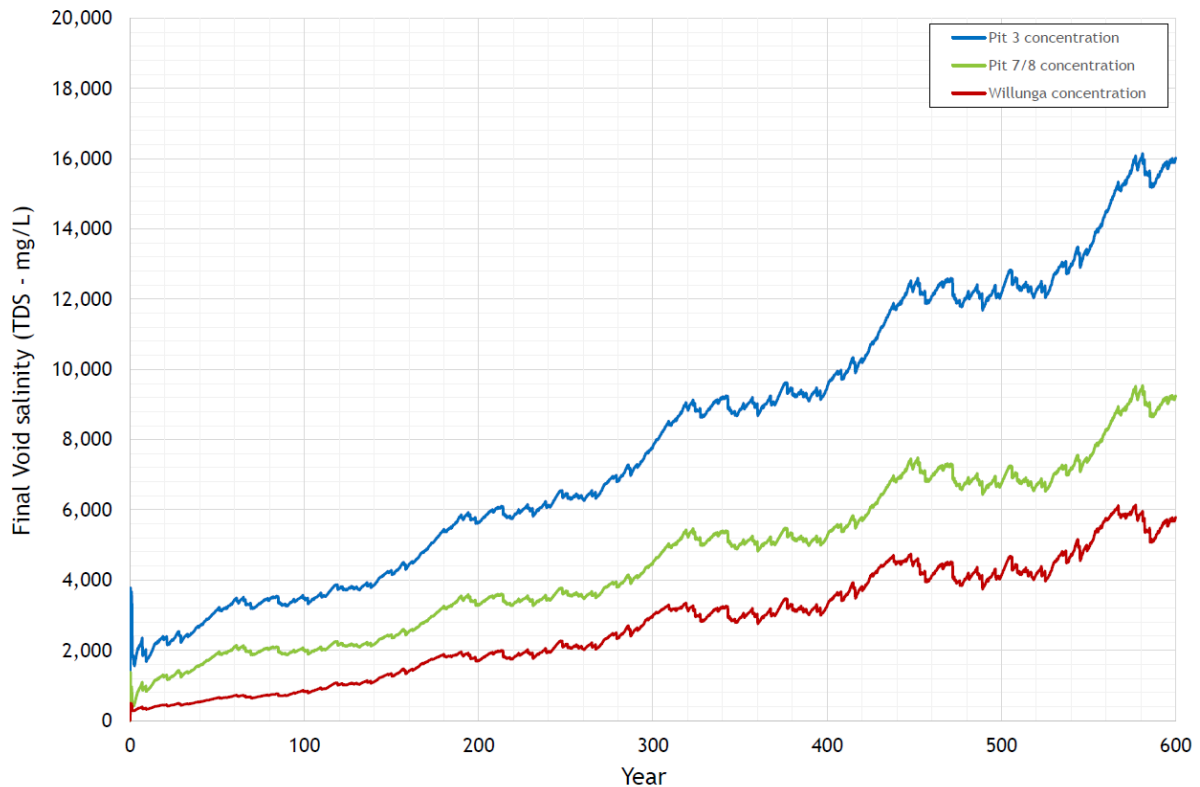
Chart 1
Revised Final Void Salinity Balance

The final void salinity balance presented in the draft EIS has been revised incorporating the commitment to remove basement coal. The simulated long-term salinity levels in the final voids based on the revised modelling are shown in Chart 1. The results indicate that the rate of salinity increase is significantly lower if all coal is removed from the final void floor at the end of mining. For example, under the revised balance, the salinity of the ODS7/8 and WIL5 final void water bodies are predicted to remain brackish (i.e. <5,000 mg/L TDS) for approximately 300 to 550 years. The ODS3 final void water body is predicted to remain brackish for approximately 150 to 200 years.

As described in Table 3, water bodies with salinity levels <4,000 mg/L TDS are able to provide habitat for a variety of freshwater aquatic plants and invertebrates. Some ducks, such as the Australian Grey Teal (recorded on-site as part of the EIS Ecology Assessment [DPM, 2018a]) are known to use permanent brackish and saline habitats.

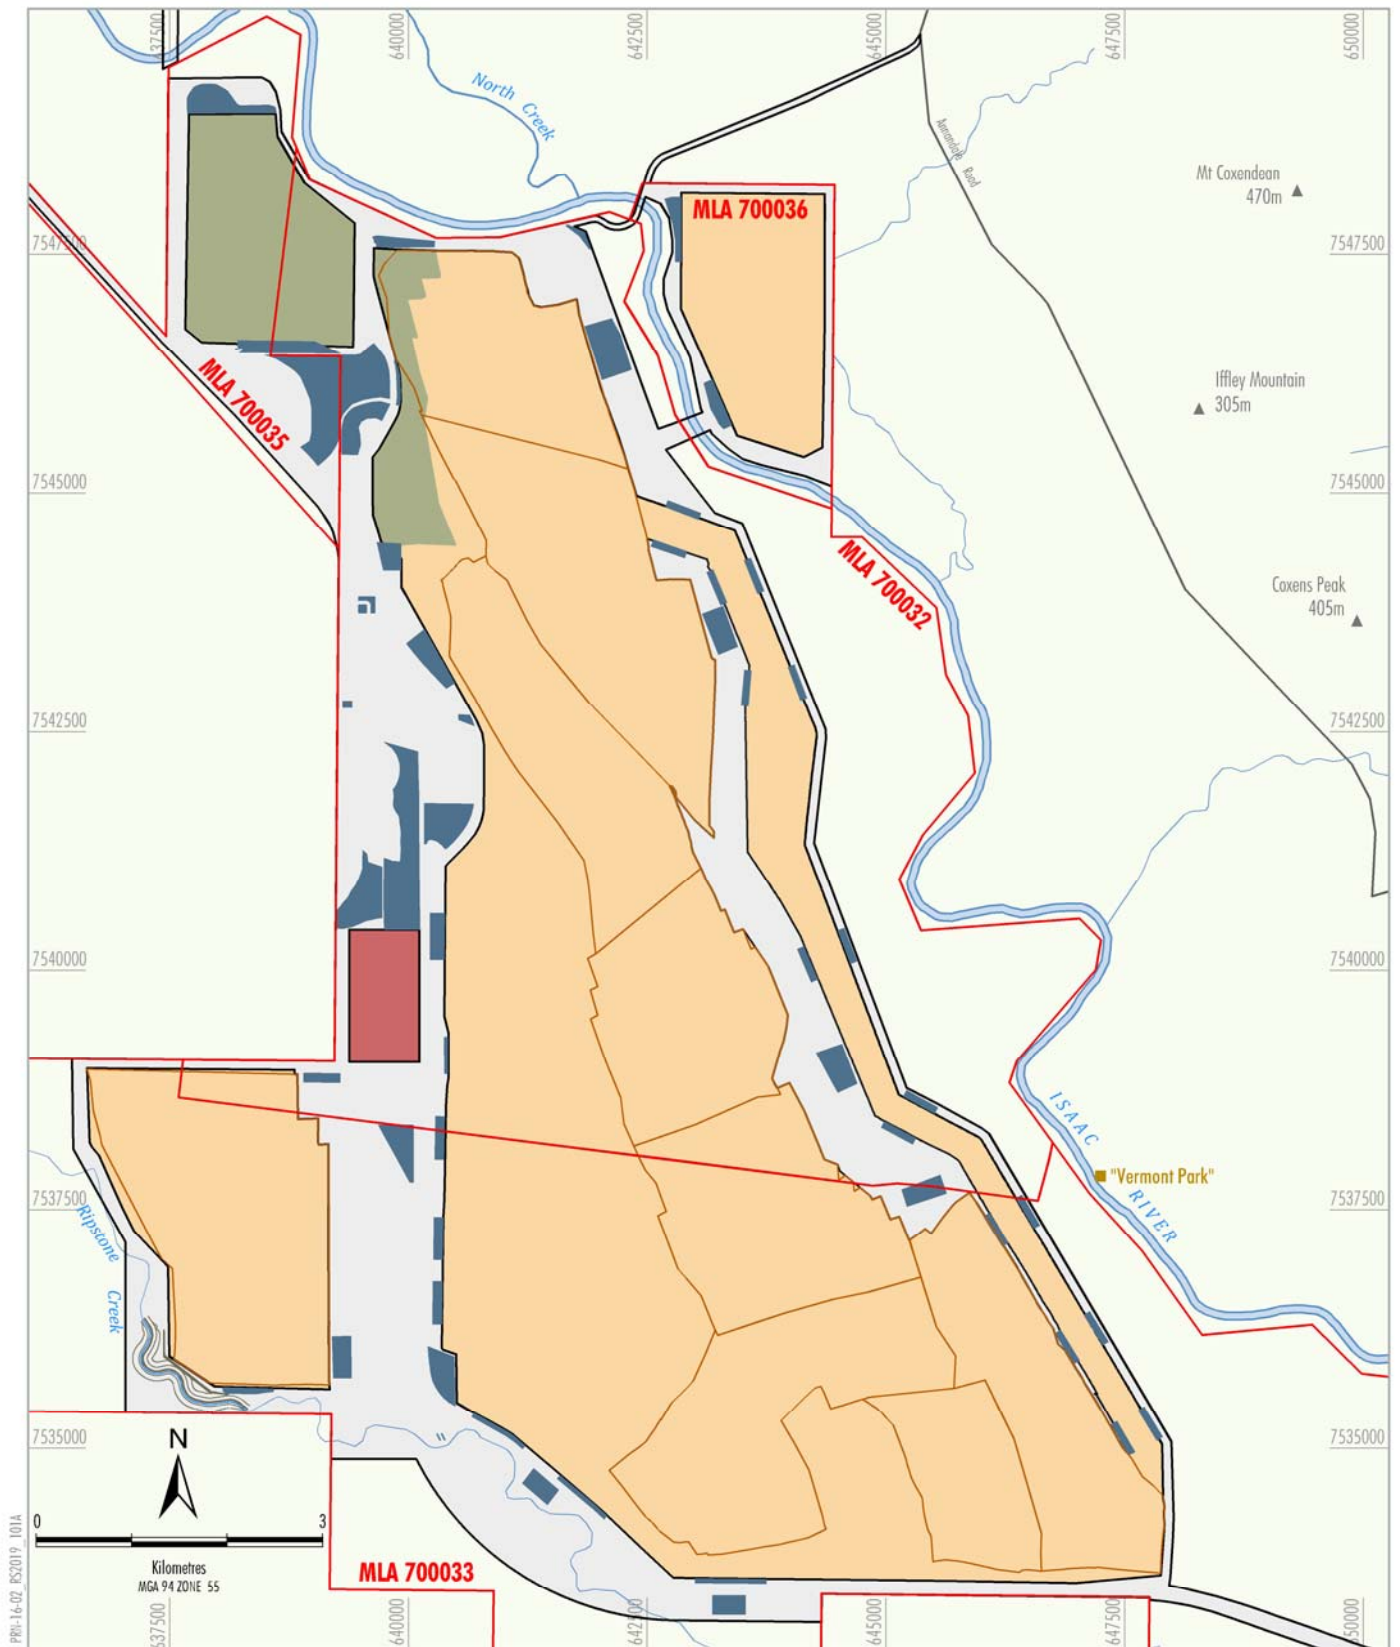
Figure 1

PEMBROKE
OLIVE DOWNS COKING COAL PROJECT
 Olive Downs South Domain
 Progressive Rehabilitation - 2027

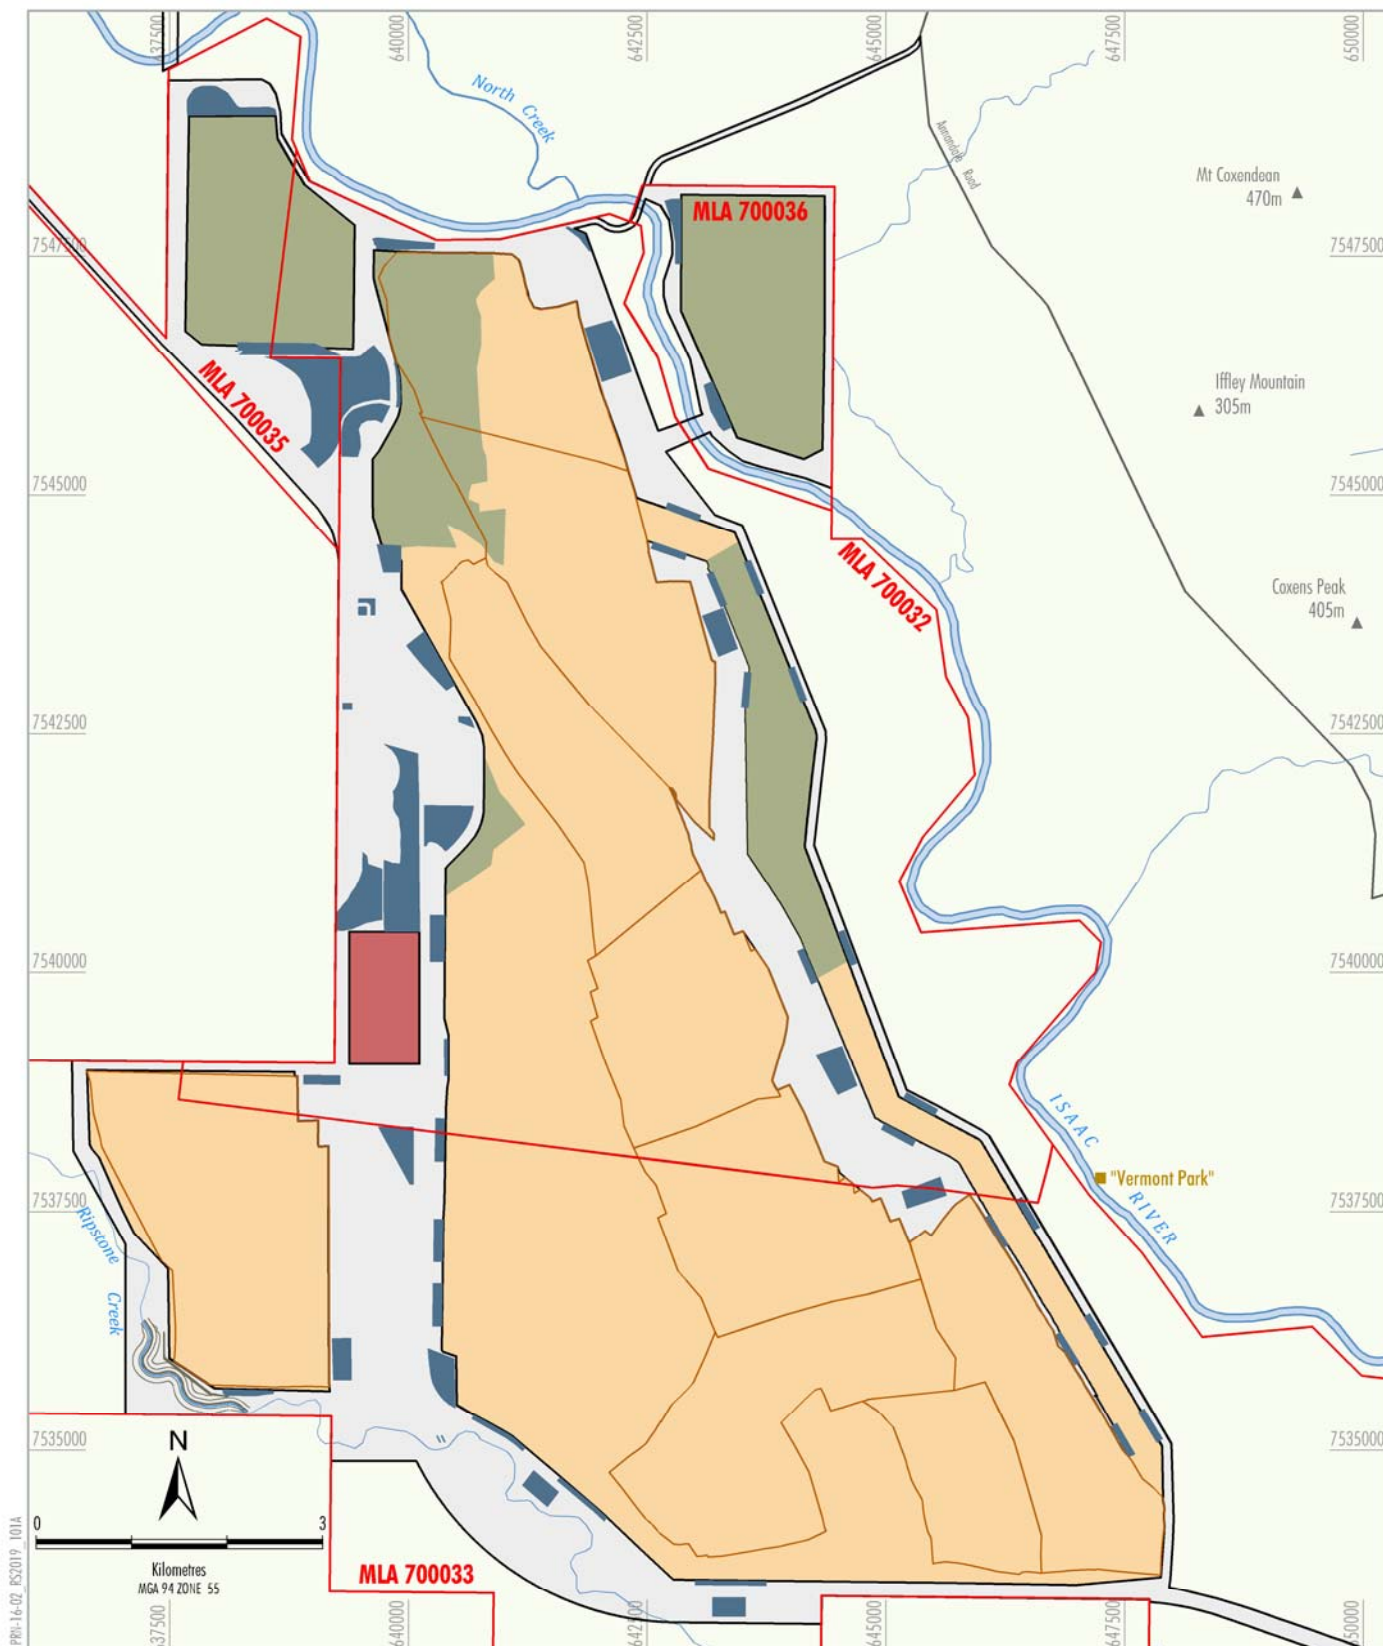
Figure 2

PEMBROKE
OLIVE DOWNS COKING COAL PROJECT
 Olive Downs South Domain
 Progressive Rehabilitation - 2030

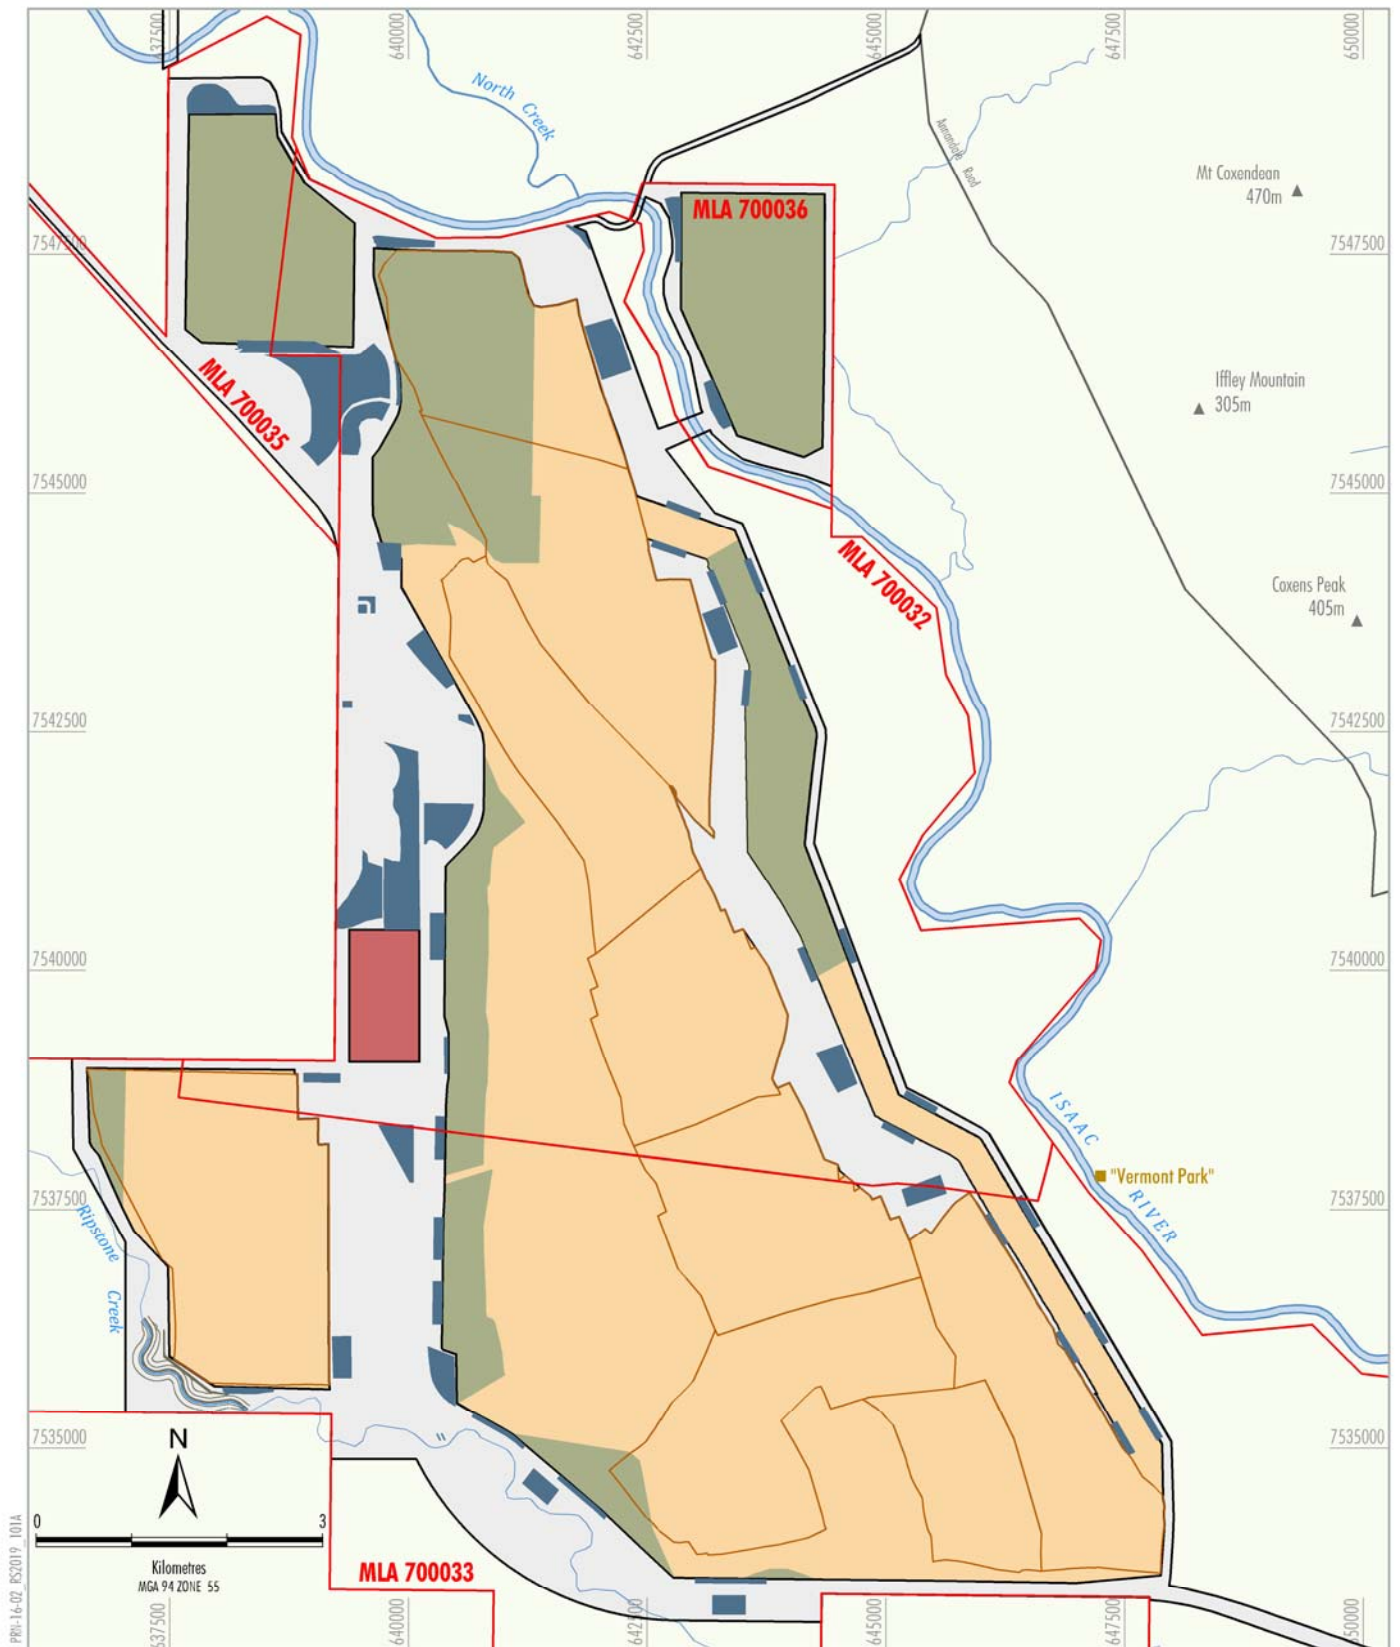
Figure 3

PEMBROKE
OLIVE DOWNS COKING COAL PROJECT
 Olive Downs South Domain
 Progressive Rehabilitation - 2035

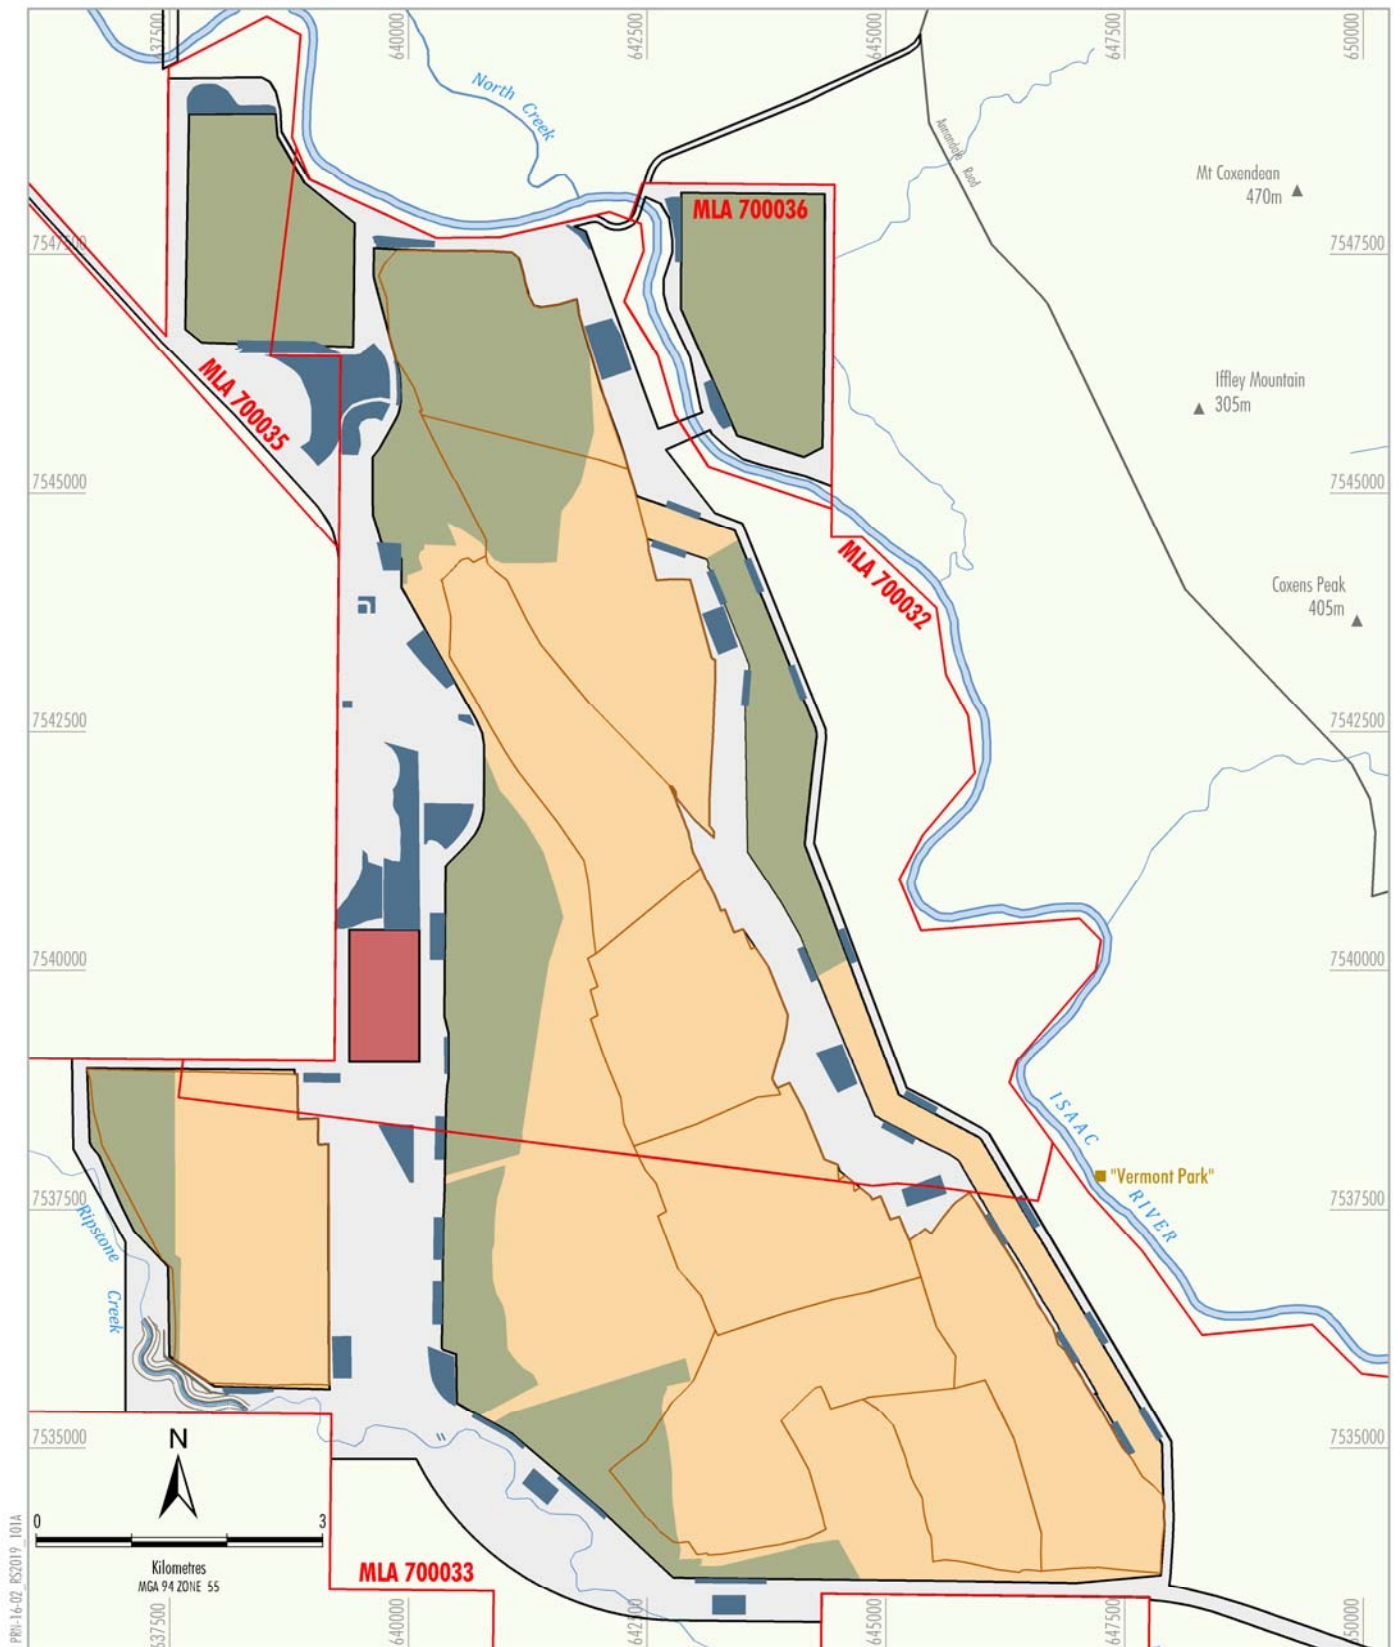
Figure 4

OLIVE DOWNS COKING COAL PROJECT
Olive Downs South Domain
Progressive Rehabilitation - 2040

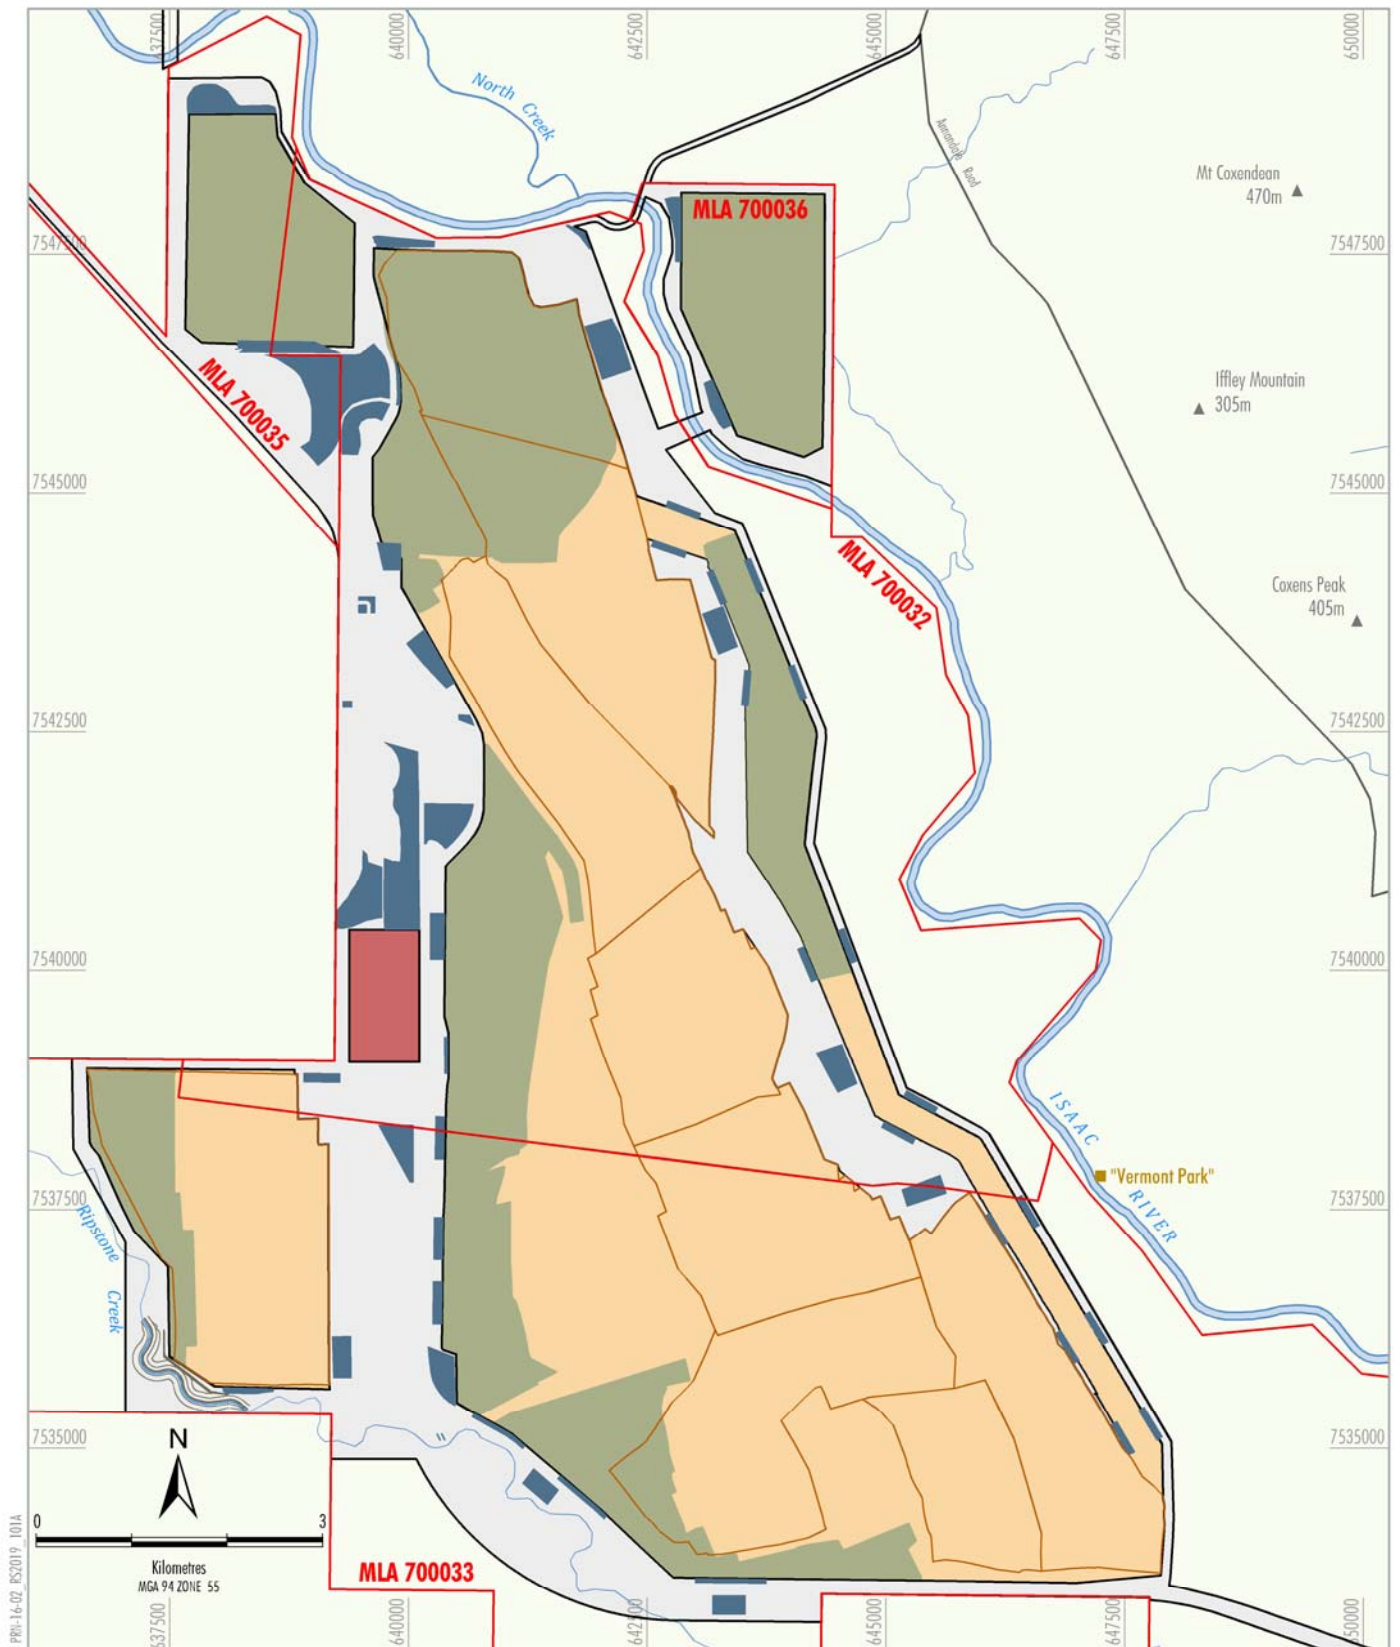
Figure 5

OLIVE DOWNS COKING COAL PROJECT
Olive Downs South Domain
Progressive Rehabilitation - 2045

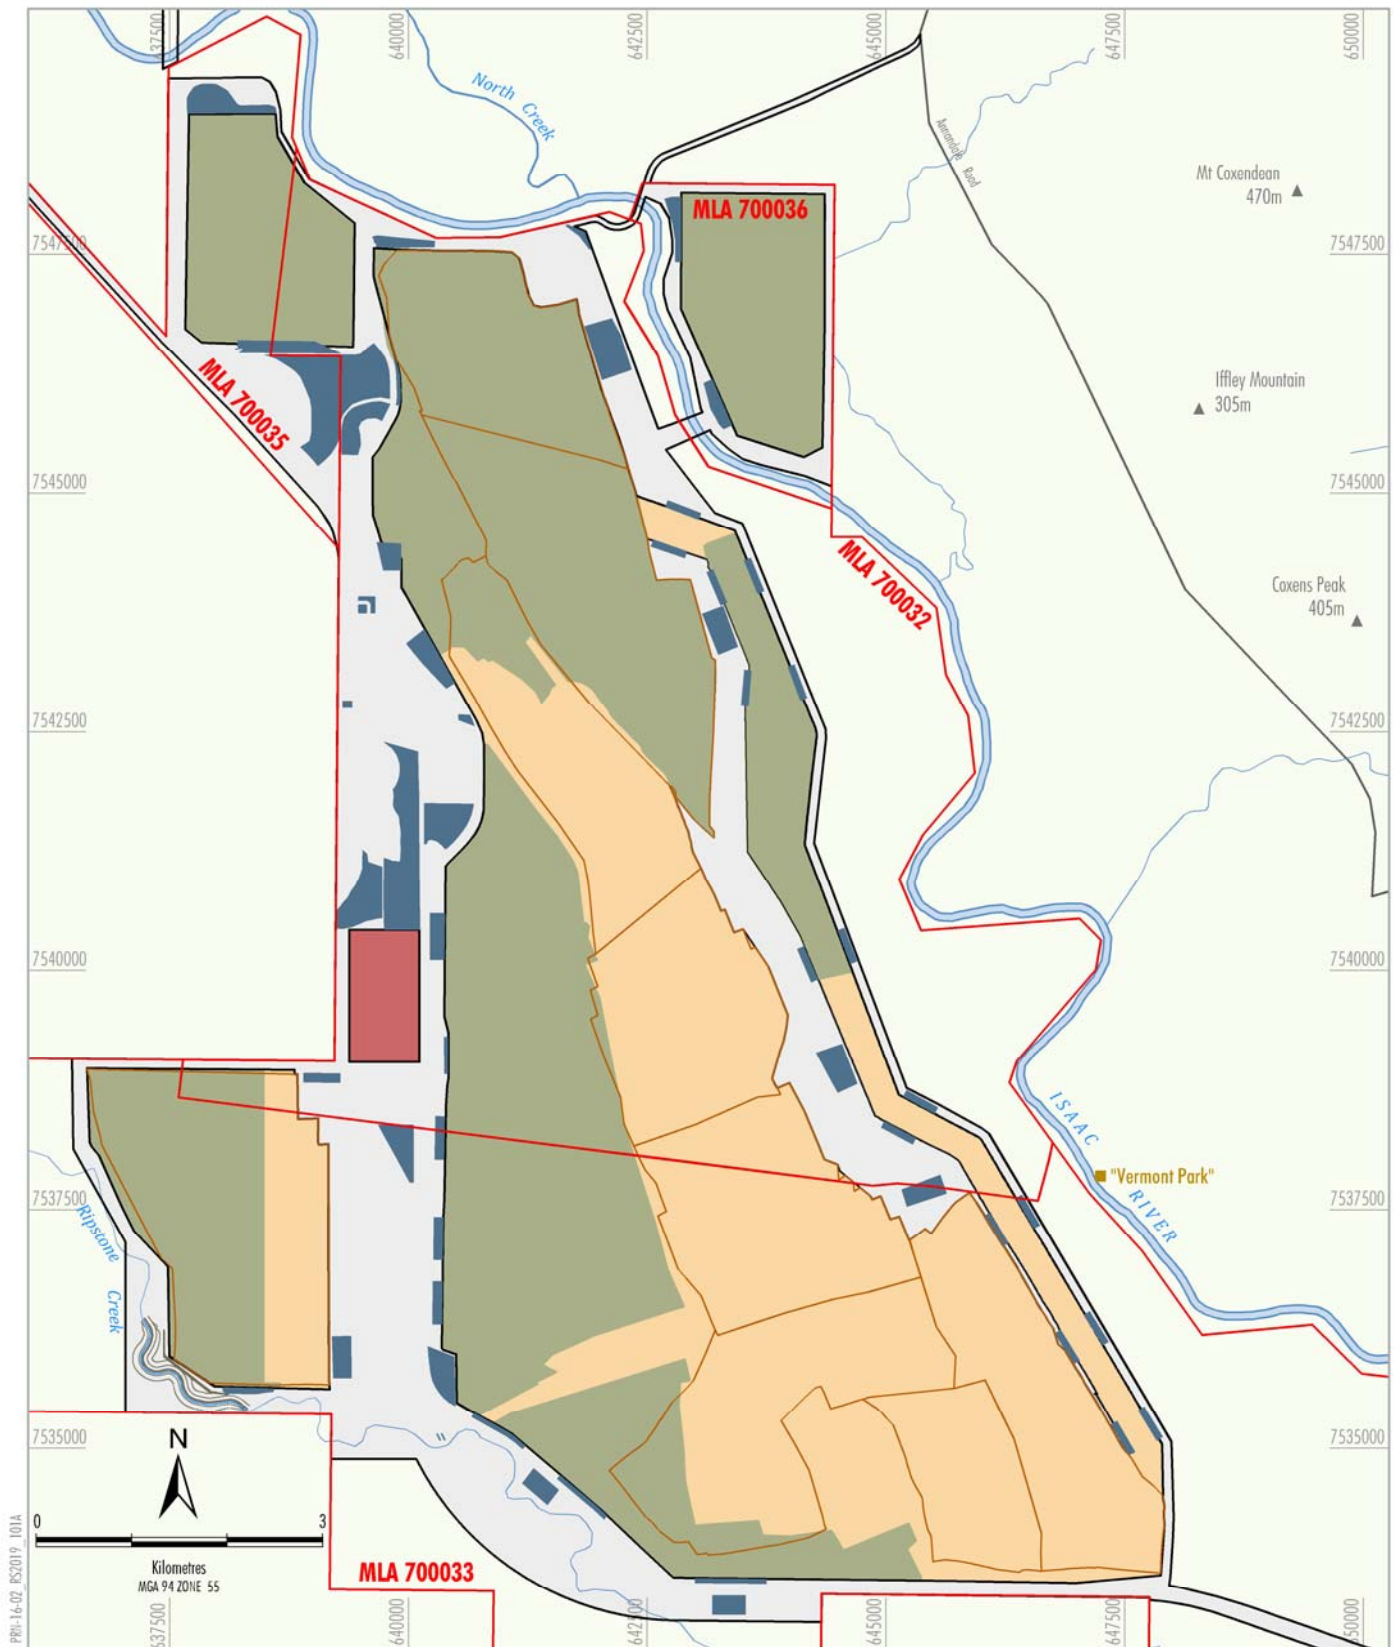
Figure 6

PEMBROKE
OLIVE DOWNS COKING COAL PROJECT
 Olive Downs South Domain
 Progressive Rehabilitation - 2050
