Olive Downs Coking Coal Project

Additional Information to the
Environmental Impact Statement

**Additional Information on
the Rehabilitation Strategy**

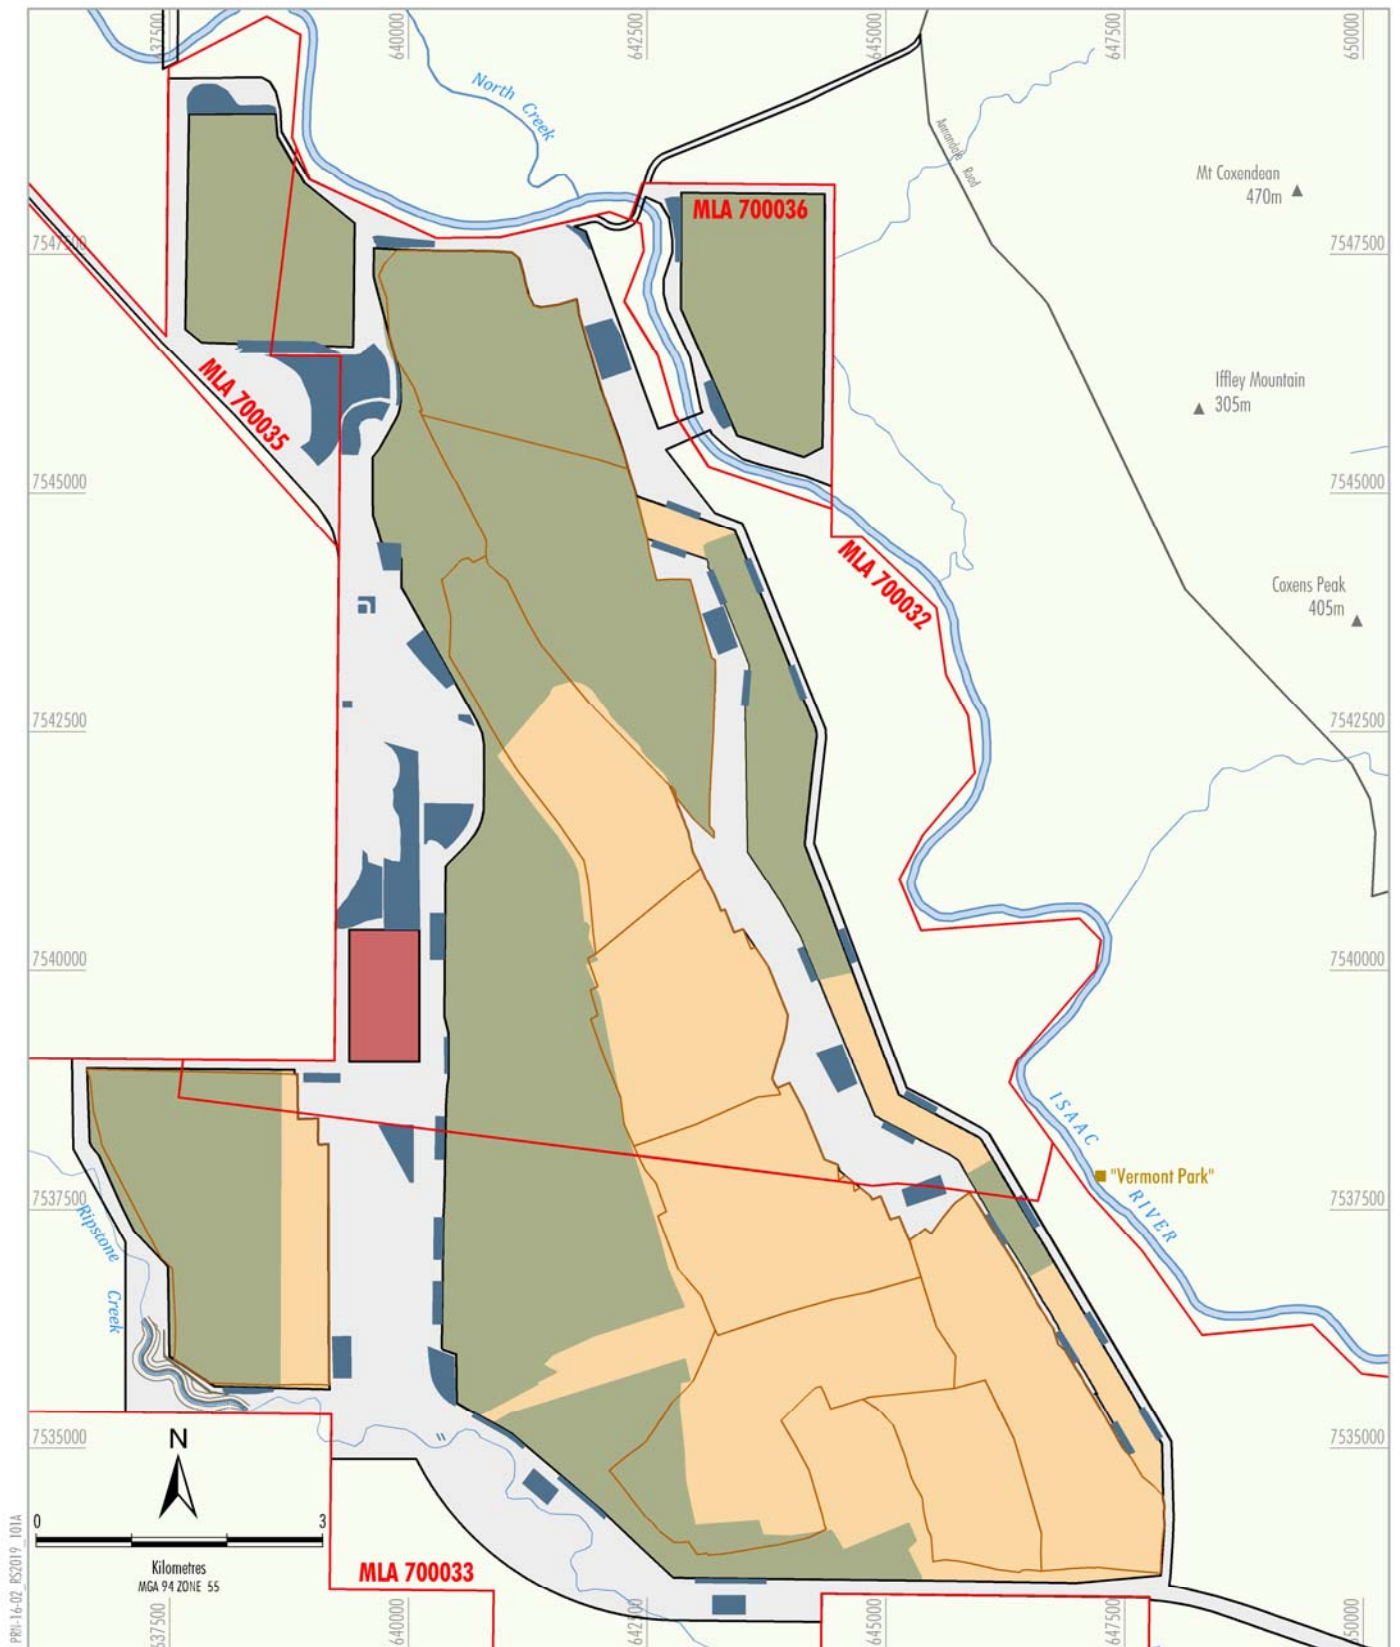
Figure 7

PEMBROKE
OLIVE DOWNS COKING COAL PROJECT
 Olive Downs South Domain
 Progressive Rehabilitation - 2055

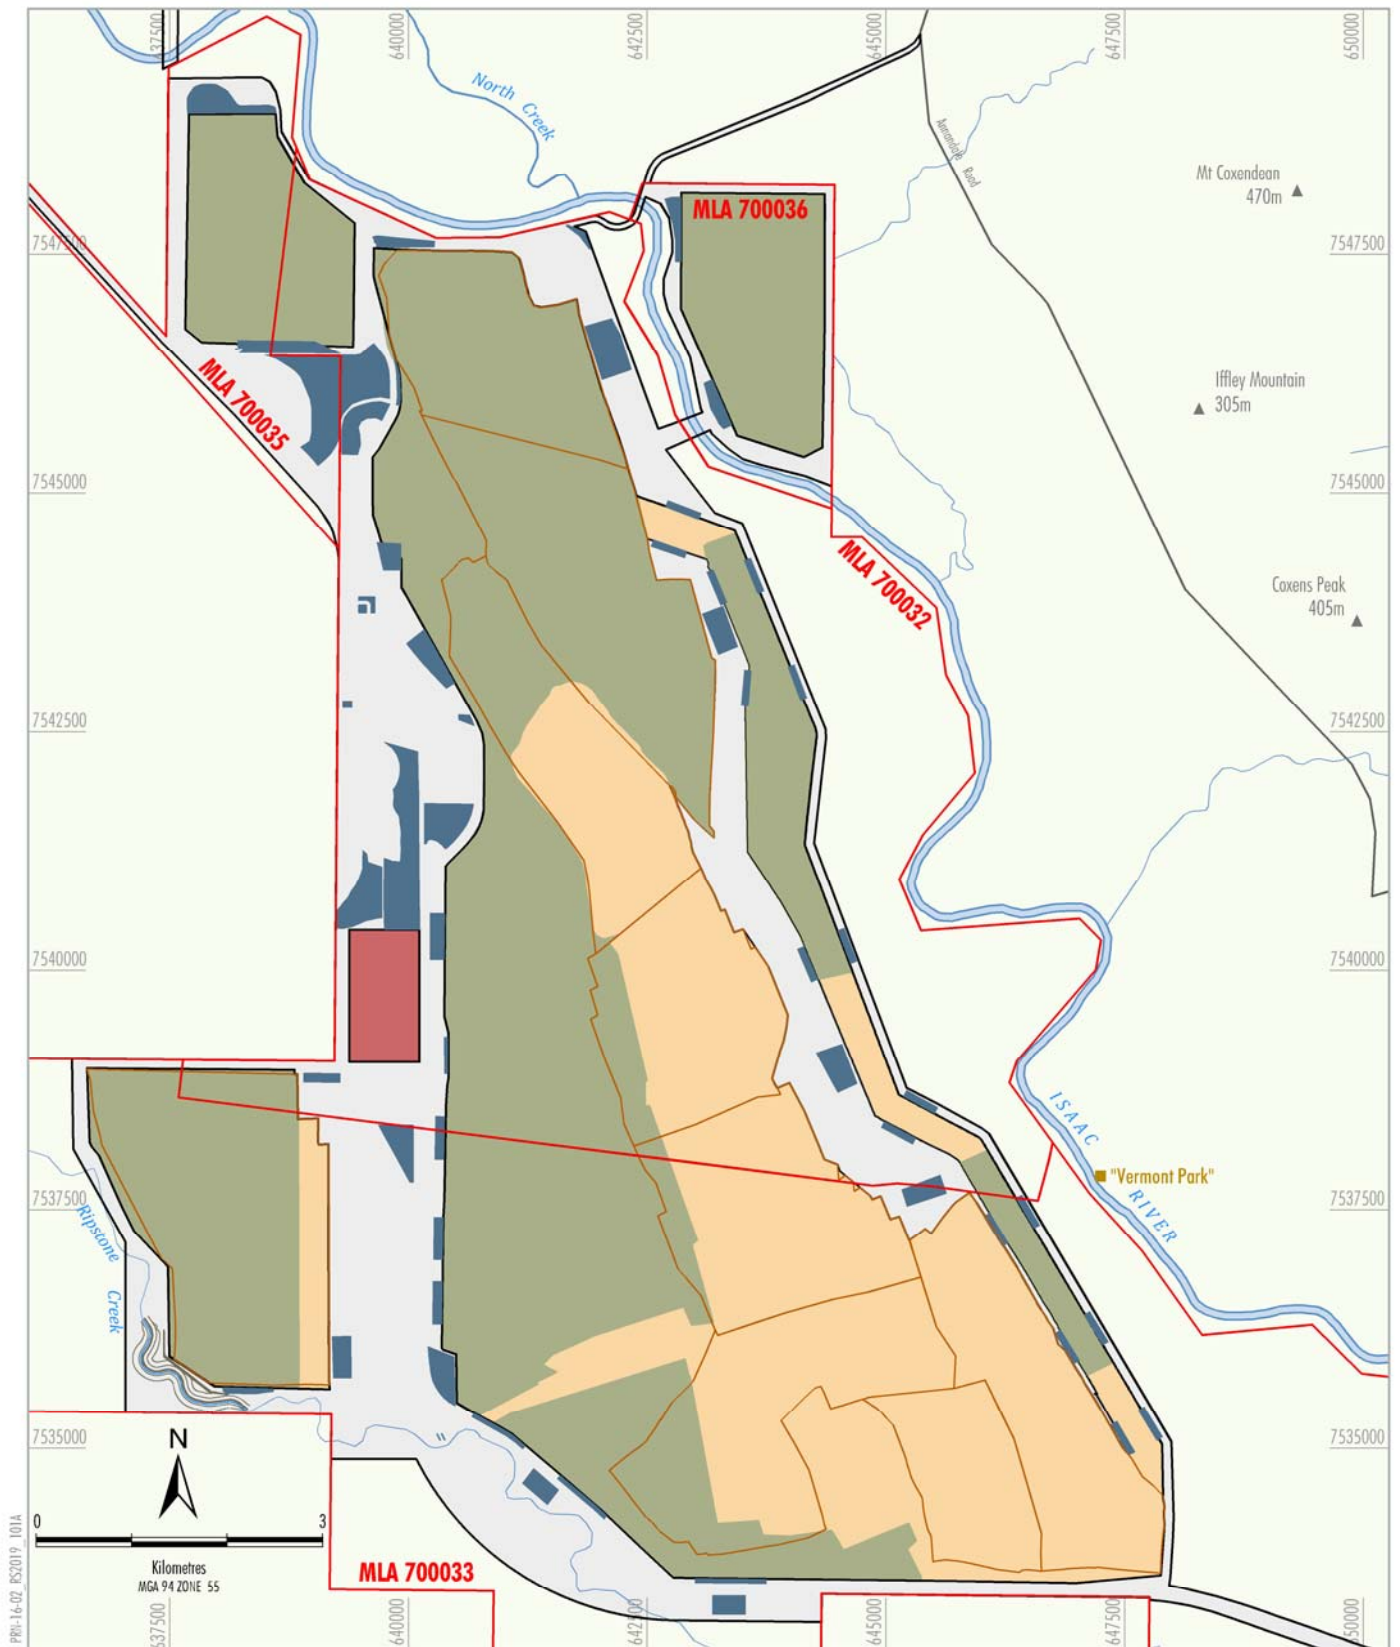
Figure 8

OLIVE DOWNS COKING COAL PROJECT
Olive Downs South Domain
Progressive Rehabilitation - 2060

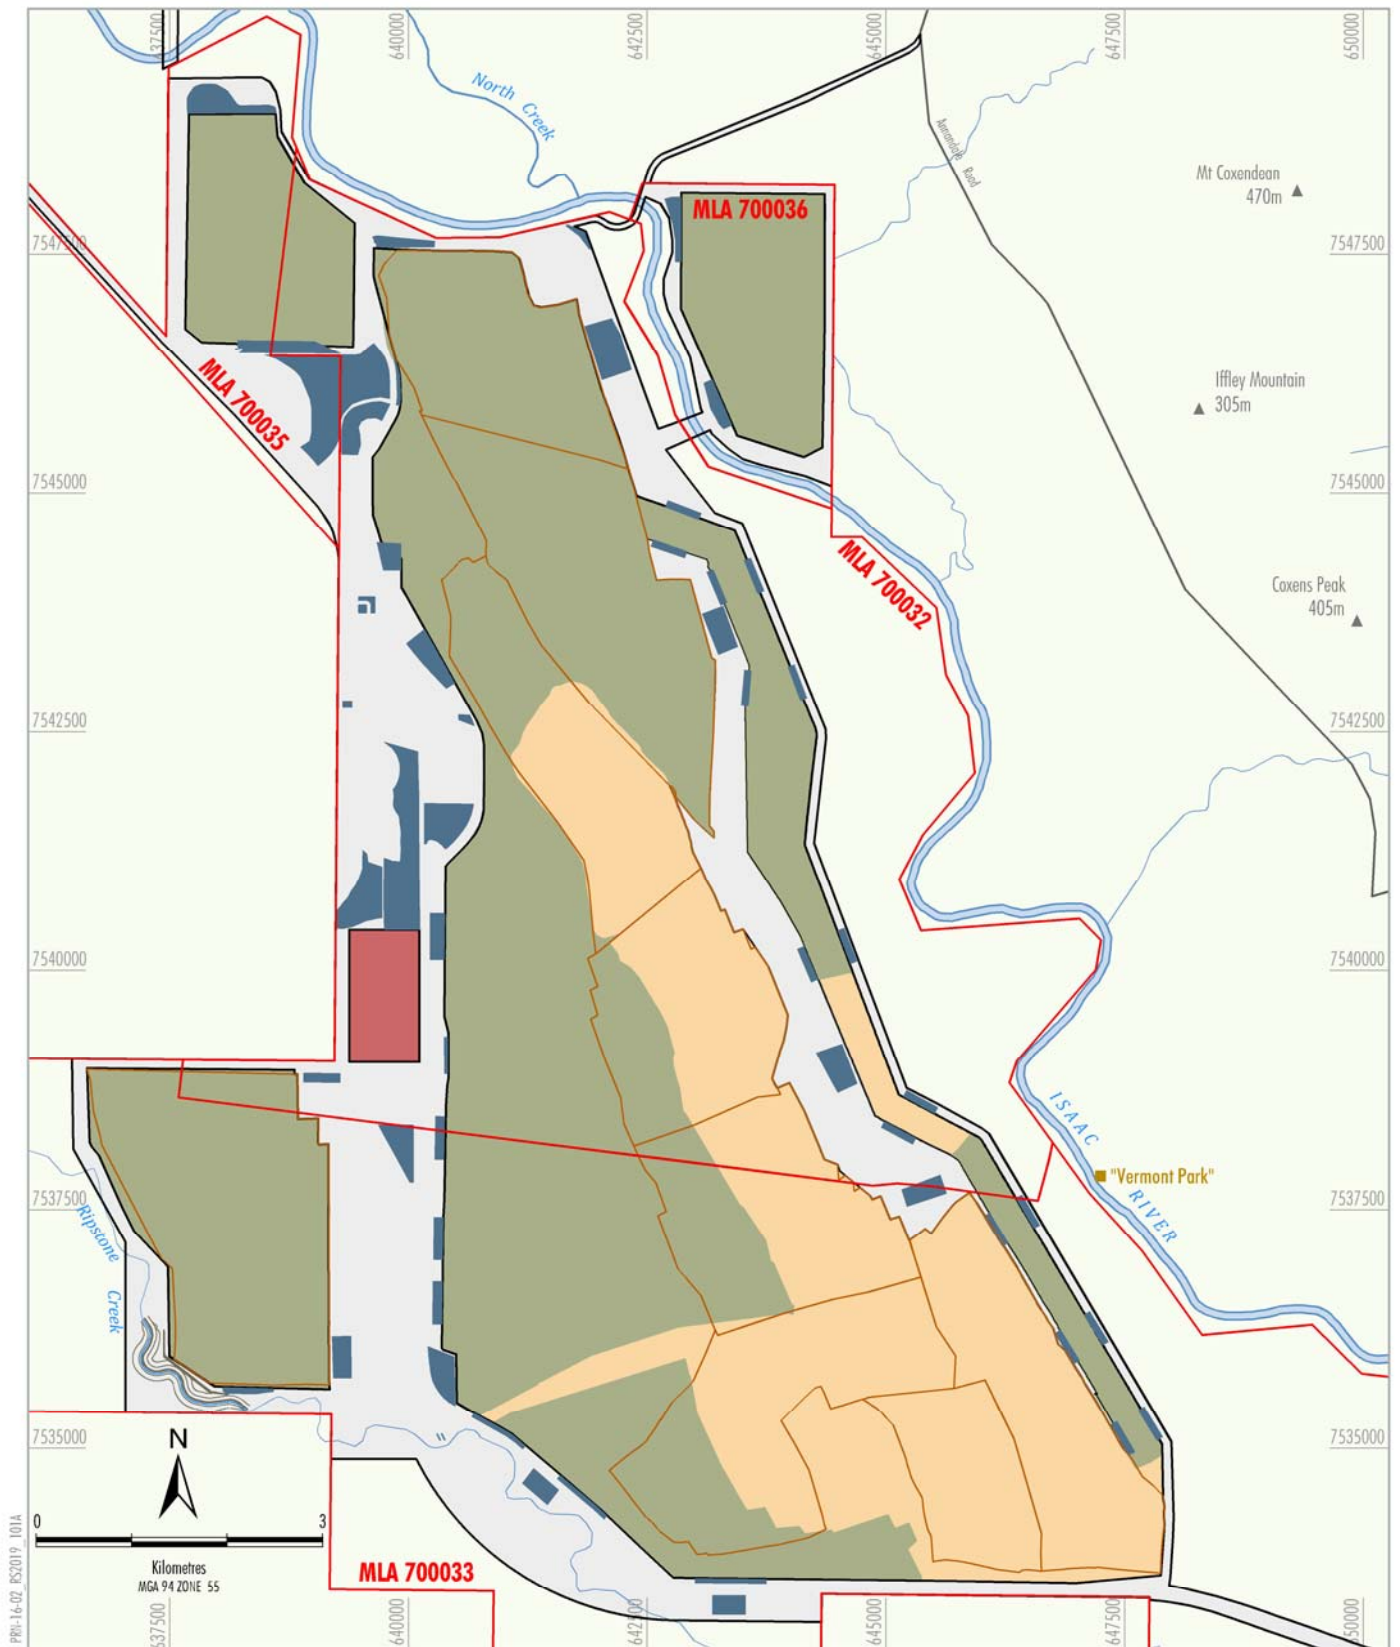
Figure 9

PEMBROKE
 OLIVE DOWNS COKING COAL PROJECT
 Olive Downs South Domain
 Progressive Rehabilitation - 2065

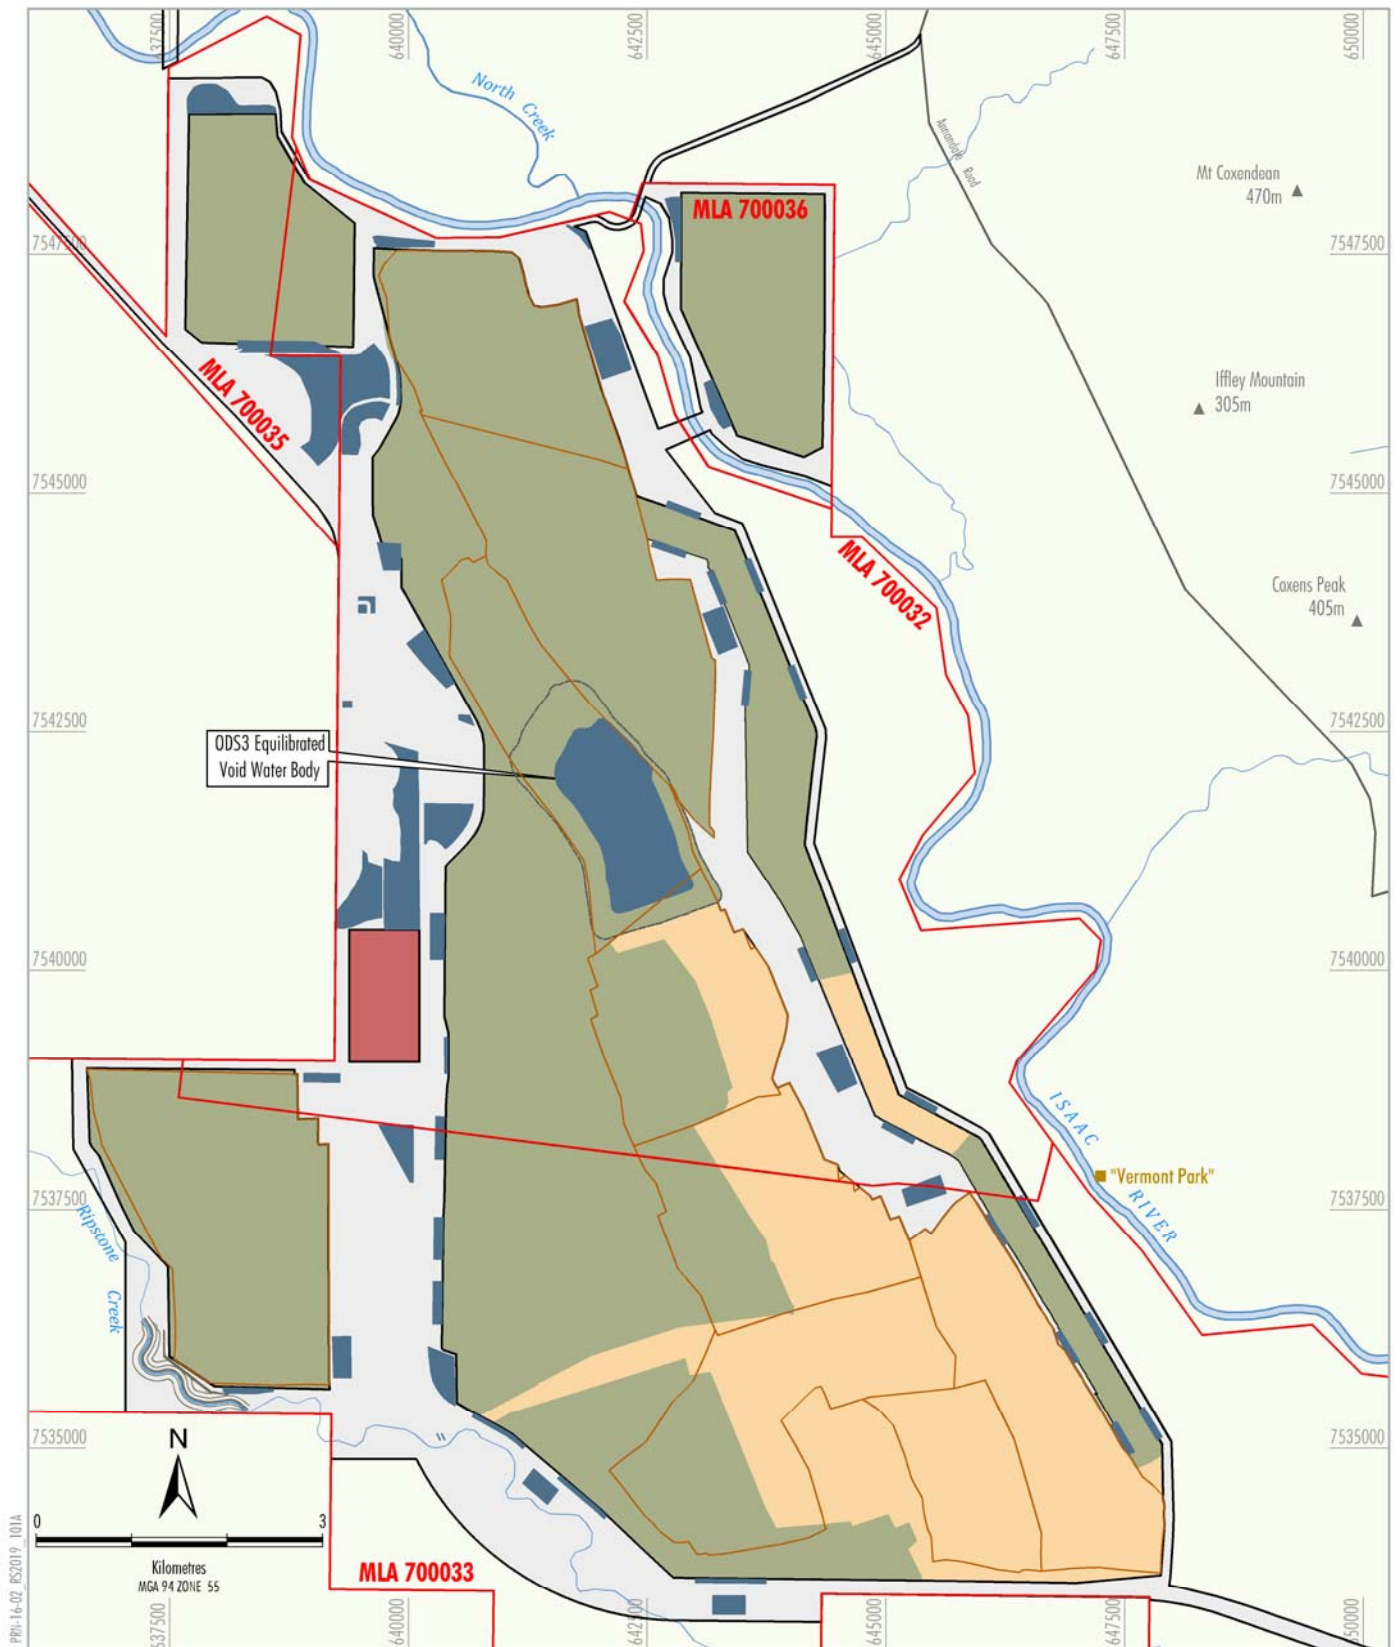
Figure 10

**PEMBROKE**
OLIVE DOWNS COKING COAL PROJECT
 Olive Downs South Domain
 Progressive Rehabilitation - 2072

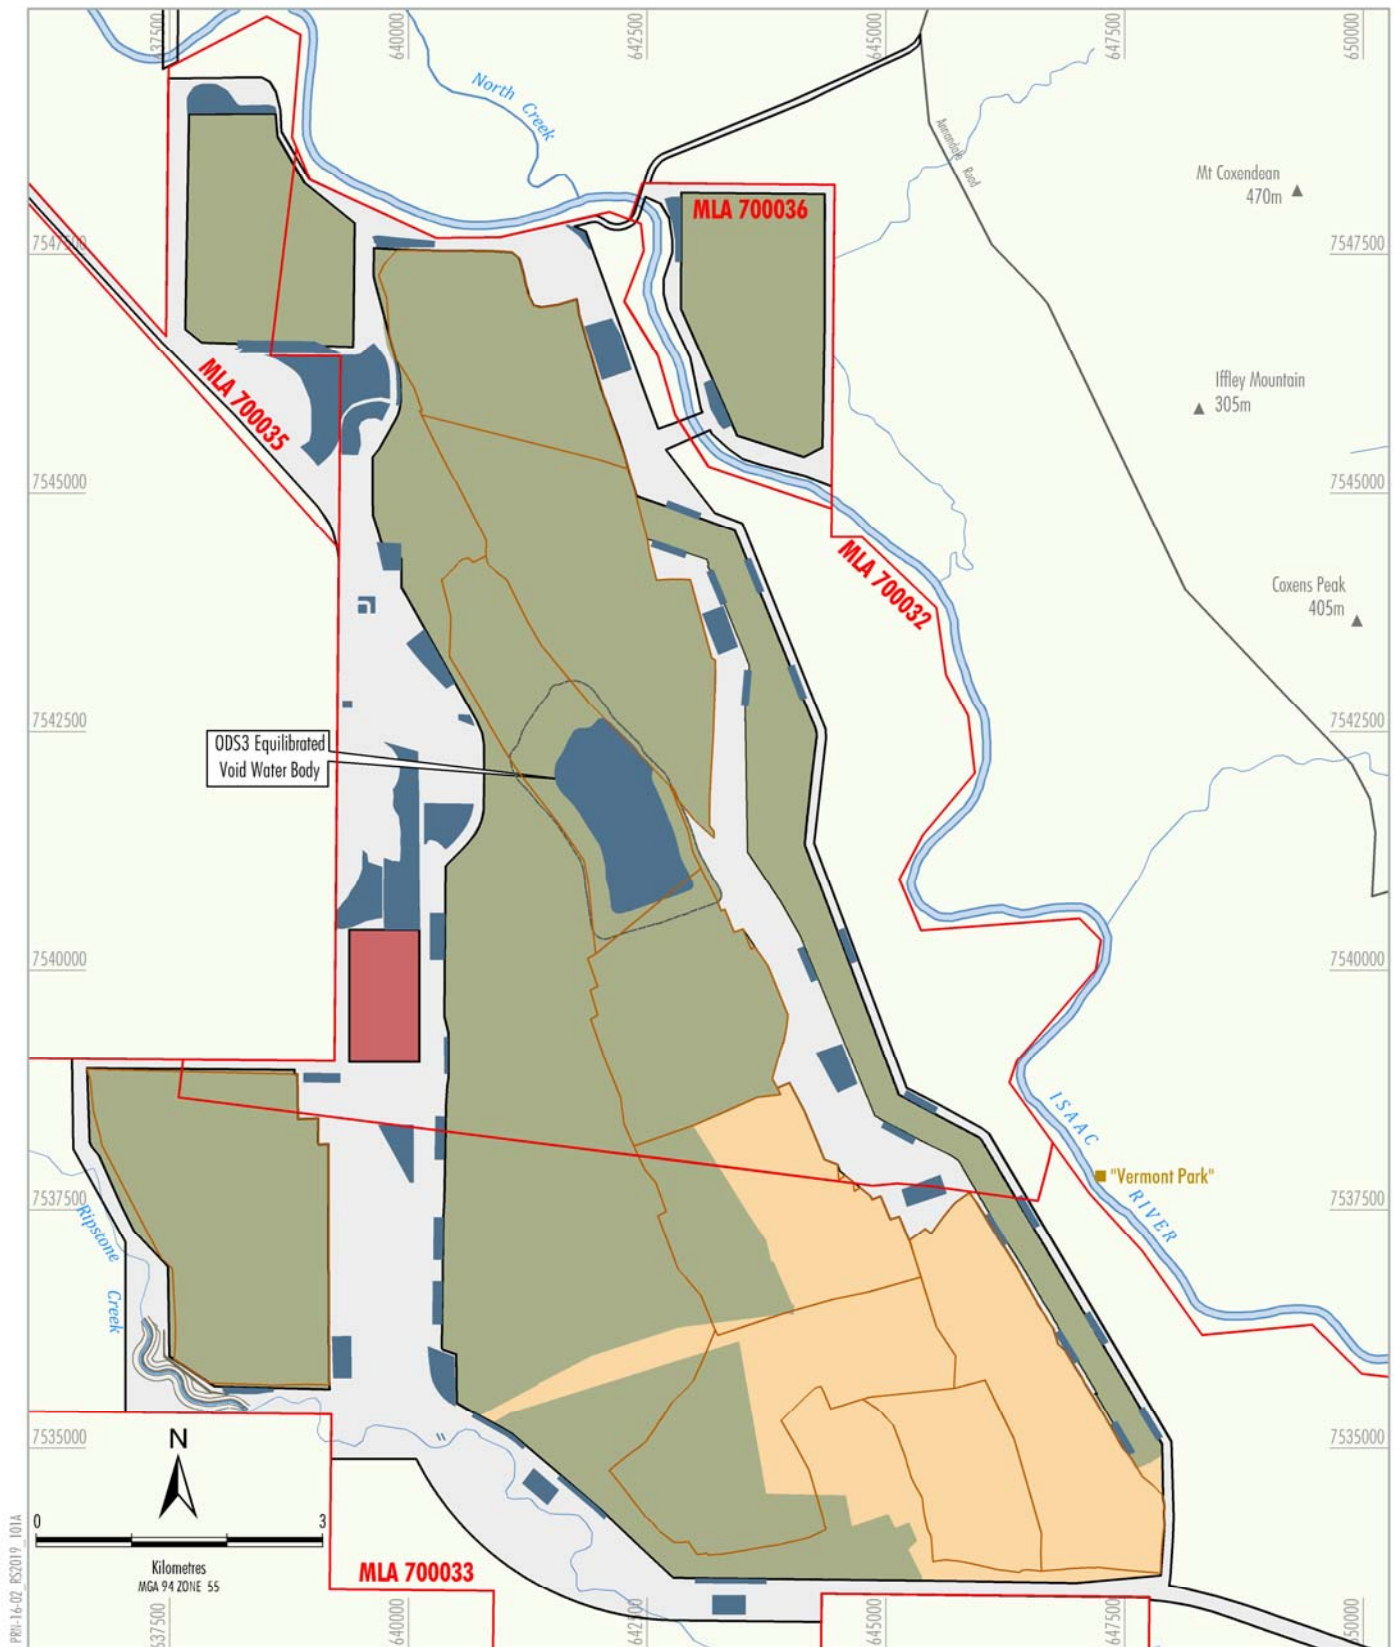
Figure 11

**PEMBROKE**
OLIVE DOWNS COKING COAL PROJECT
 Olive Downs South Domain
 Progressive Rehabilitation - 2078

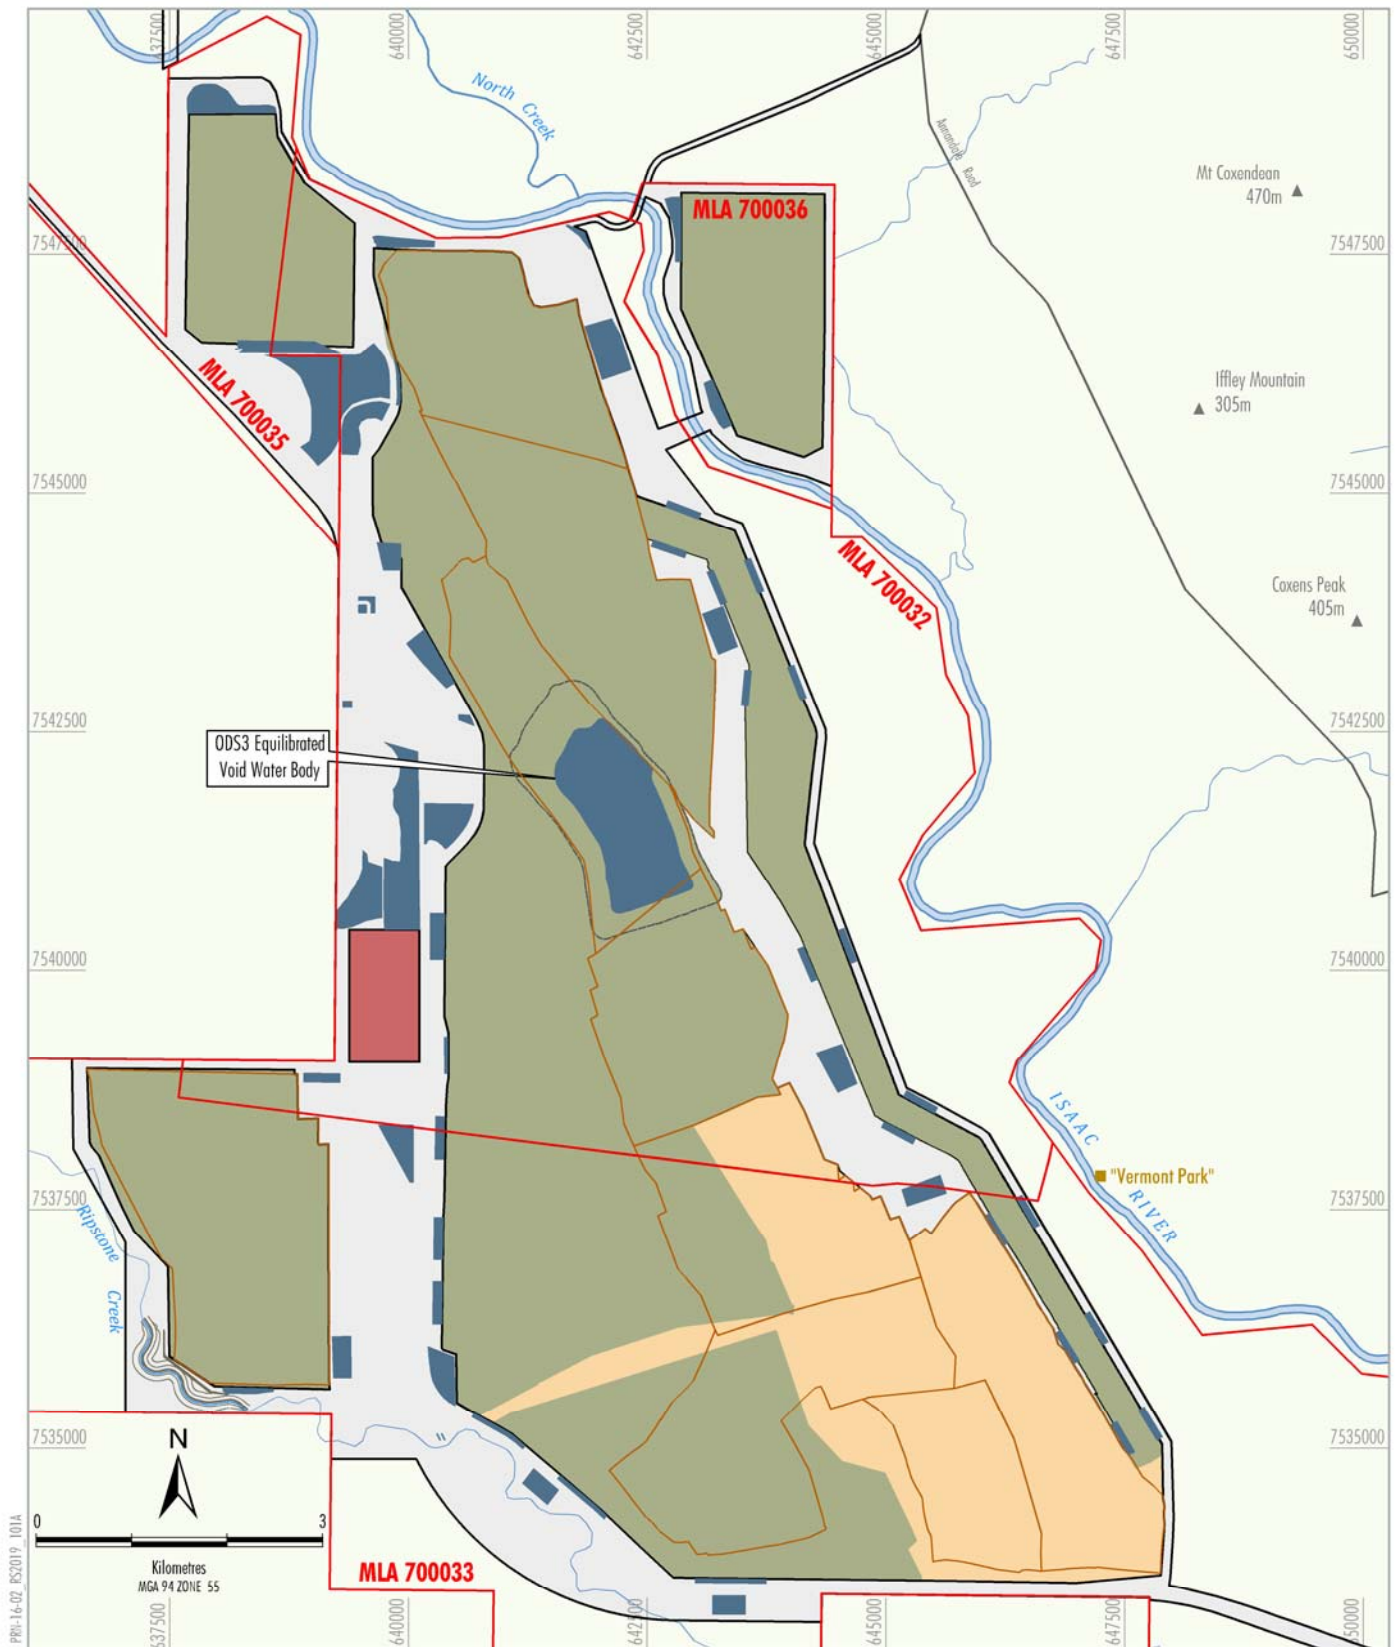
Figure 12

PEMBROKE
OLIVE DOWNS COKING COAL PROJECT
 Olive Downs South Domain
 Progressive Rehabilitation - 2085

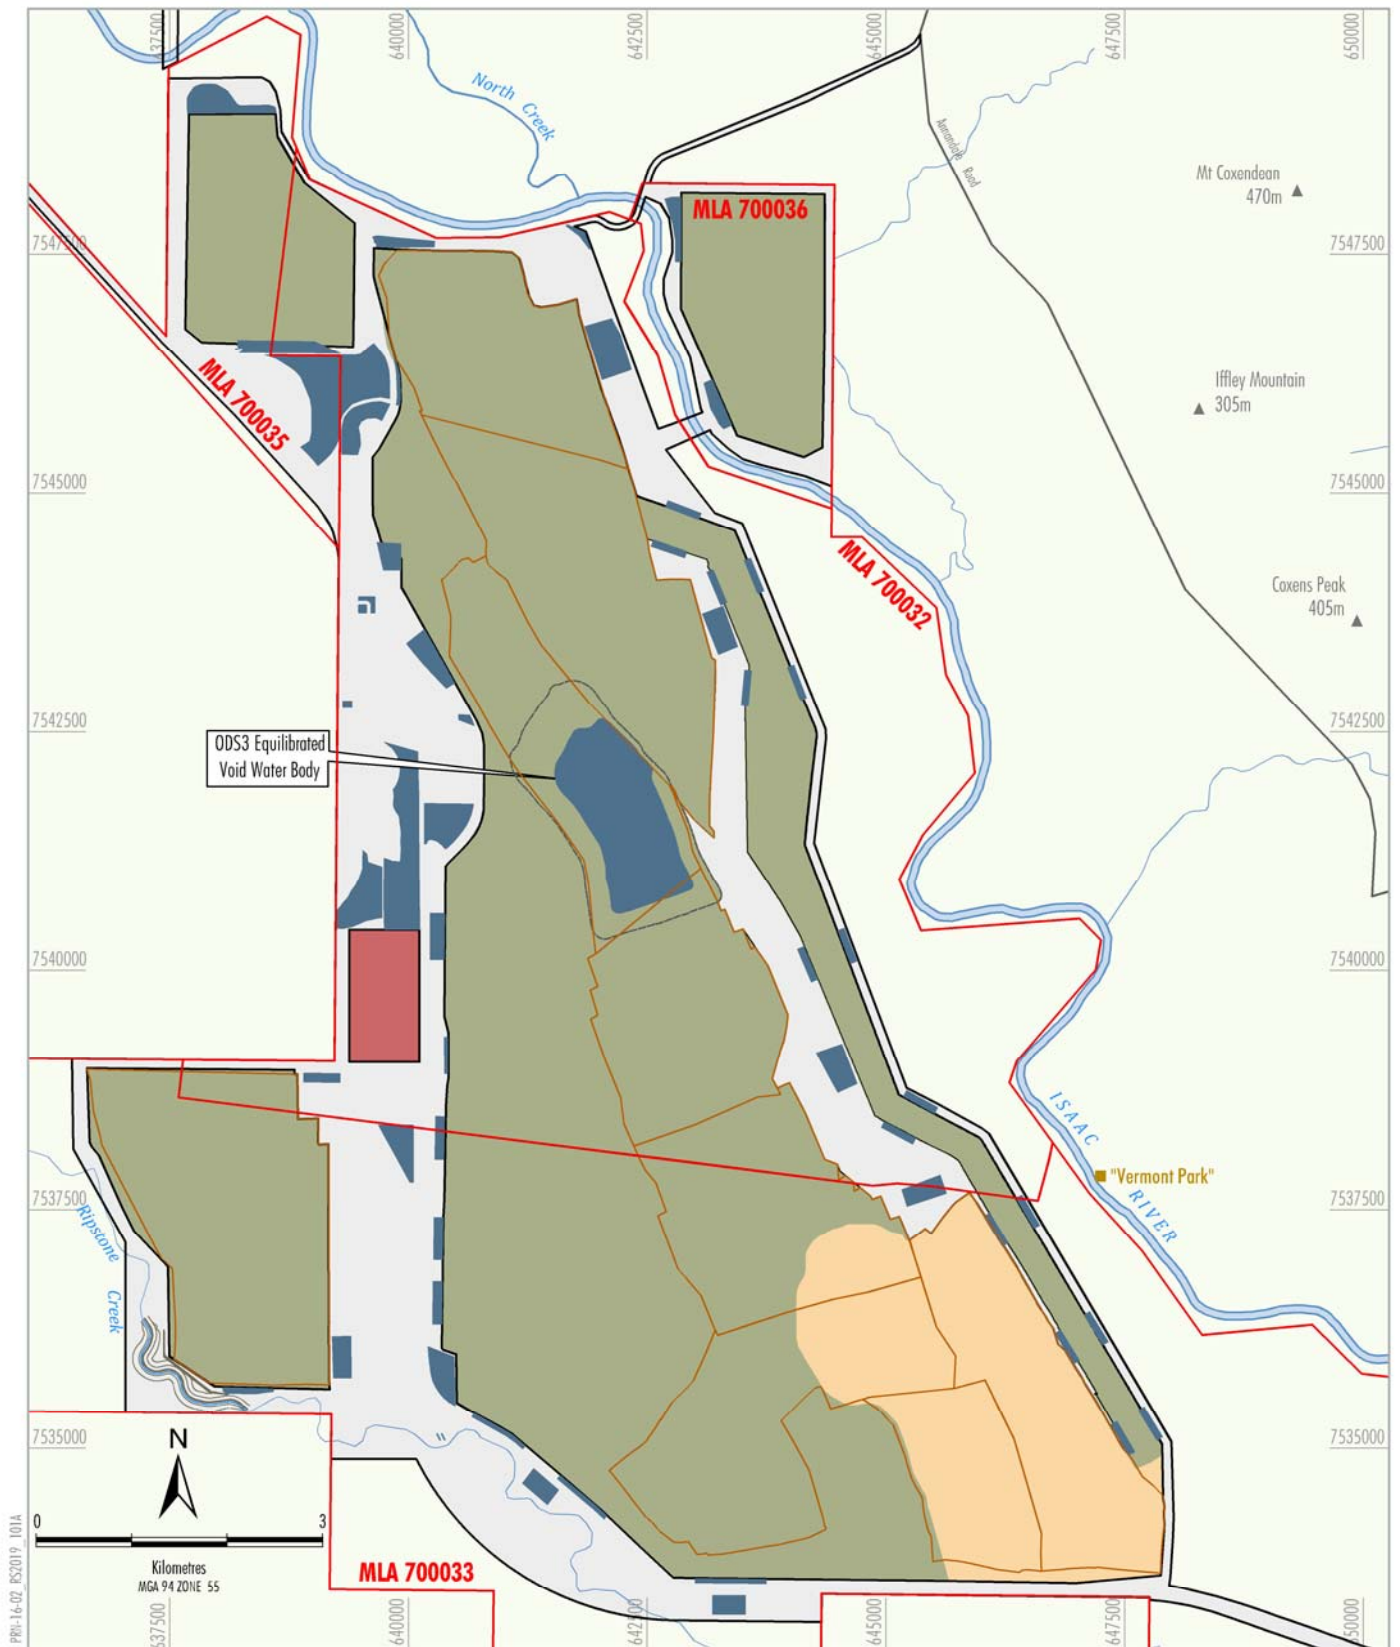
Figure 13

PEMBROKE
OLIVE DOWNS COKING COAL PROJECT
 Olive Downs South Domain
 Progressive Rehabilitation - 2092

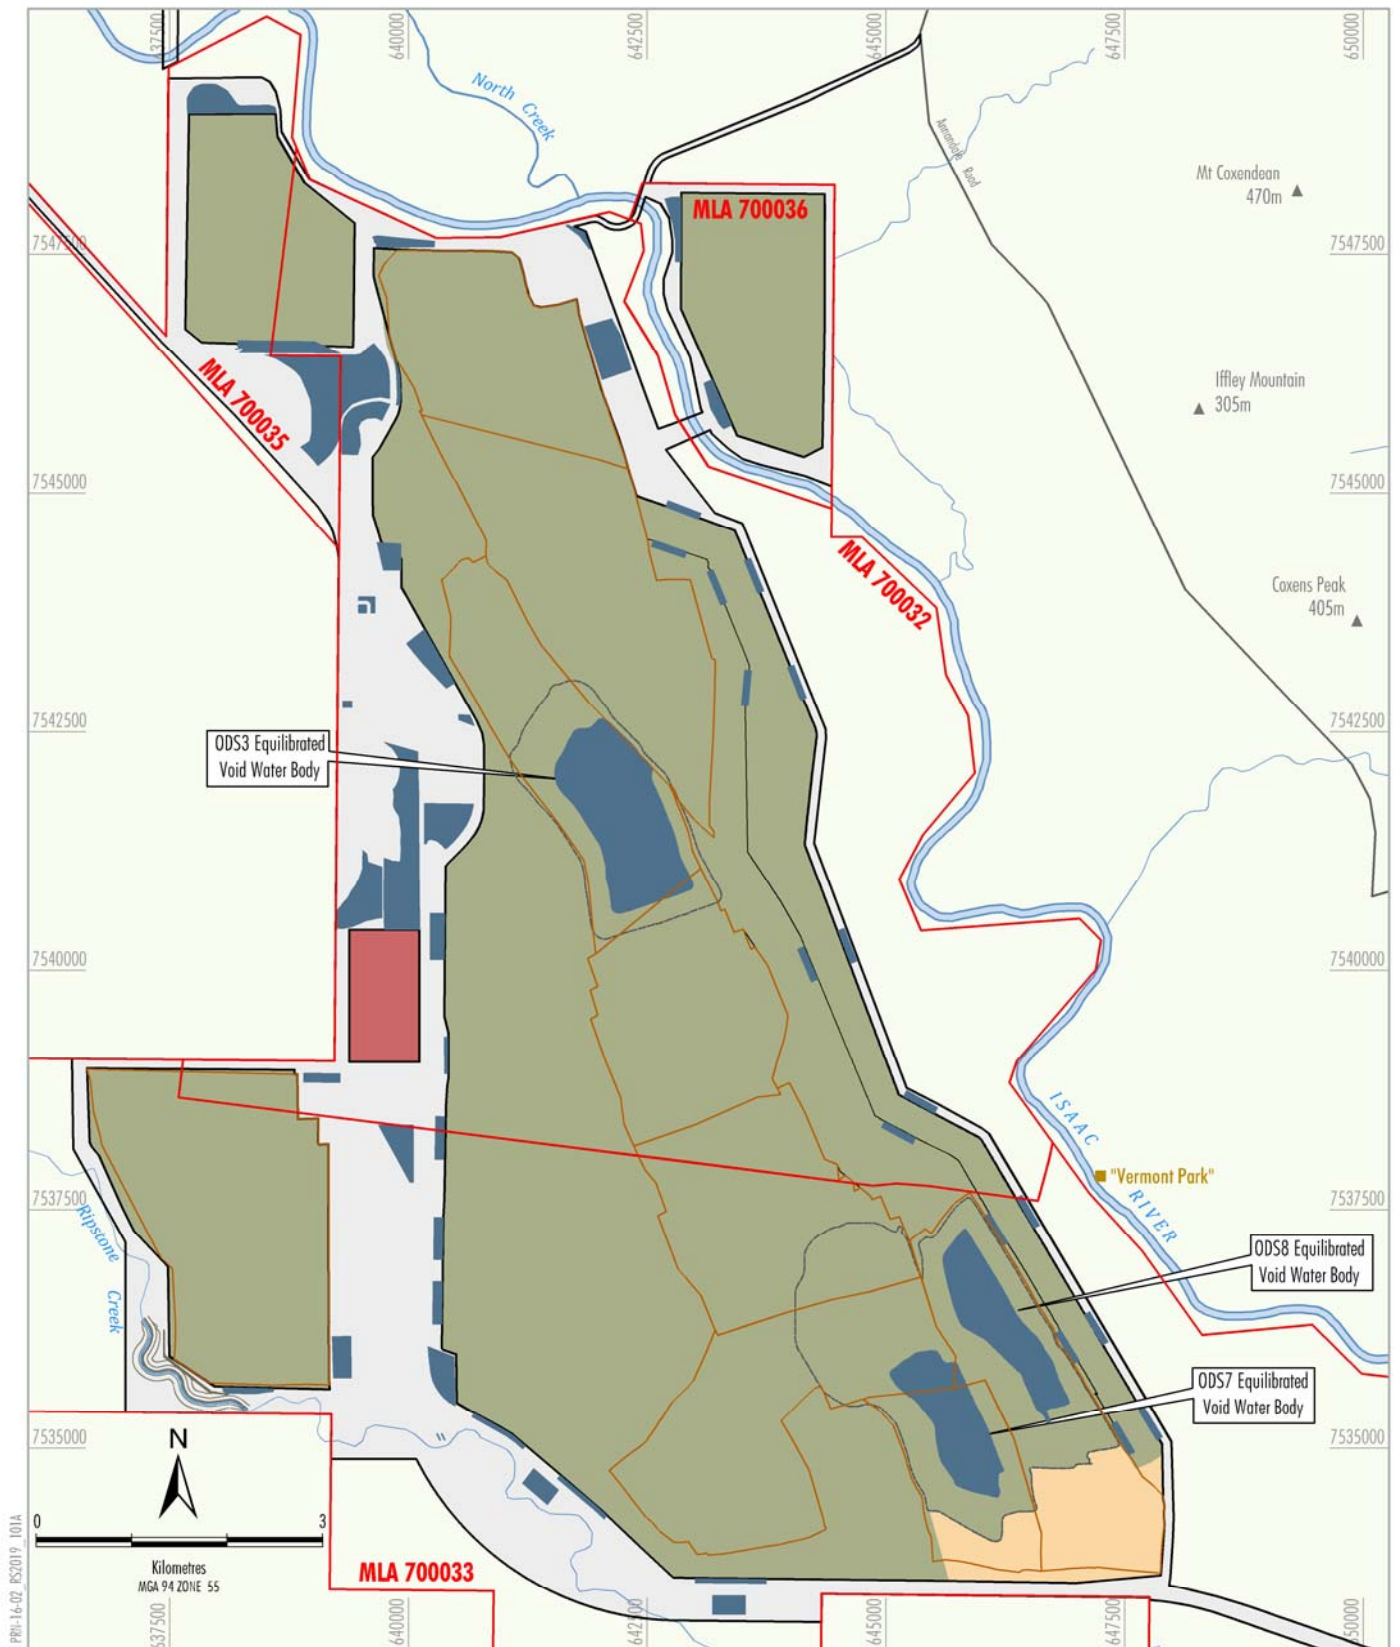
Figure 14

PEMBROKE
OLIVE DOWNS COKING COAL PROJECT
Olive Downs South Domain
Progressive Rehabilitation - 2098

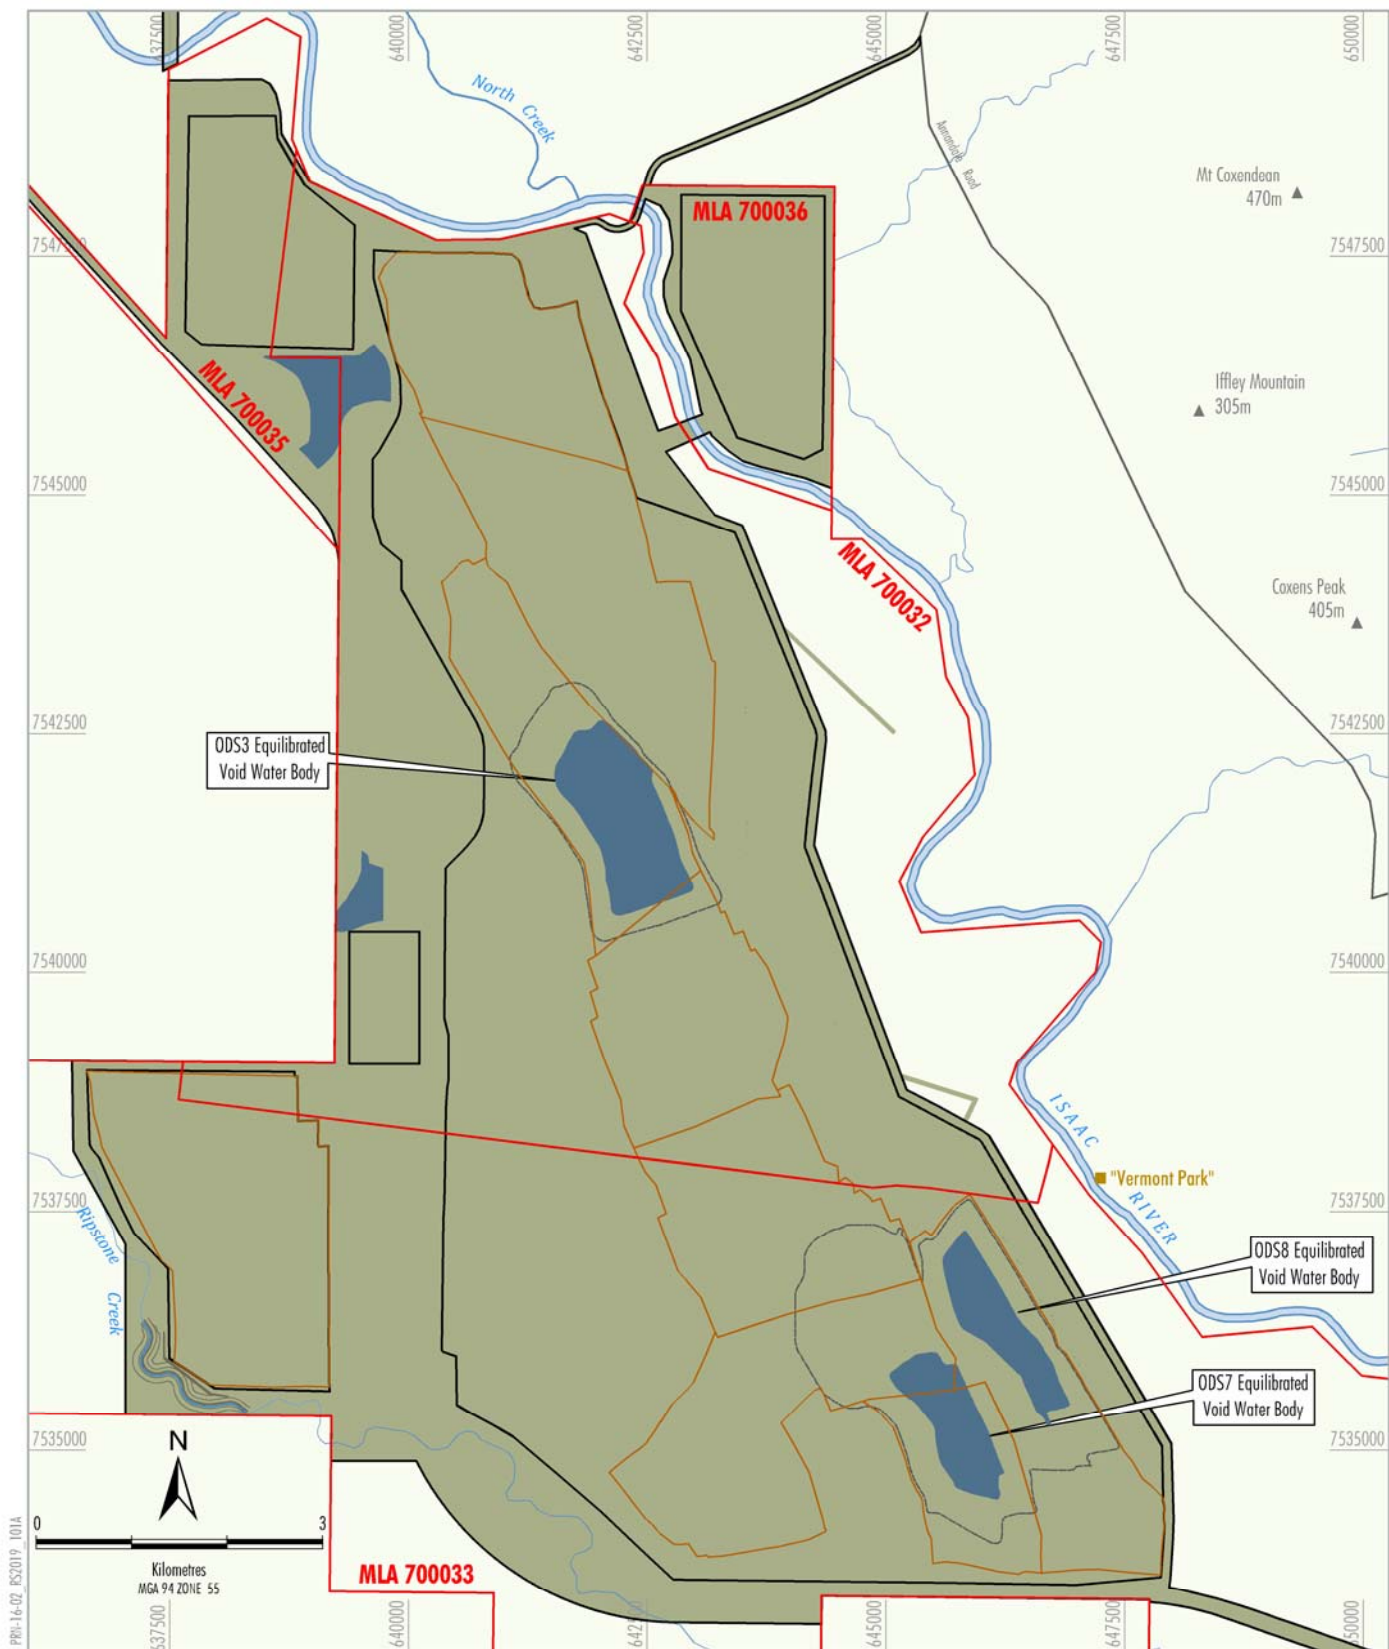
Figure 15

PEMBROKE
OLIVE DOWNS COKING COAL PROJECT
 Olive Downs South Domain
 Progressive Rehabilitation - Final

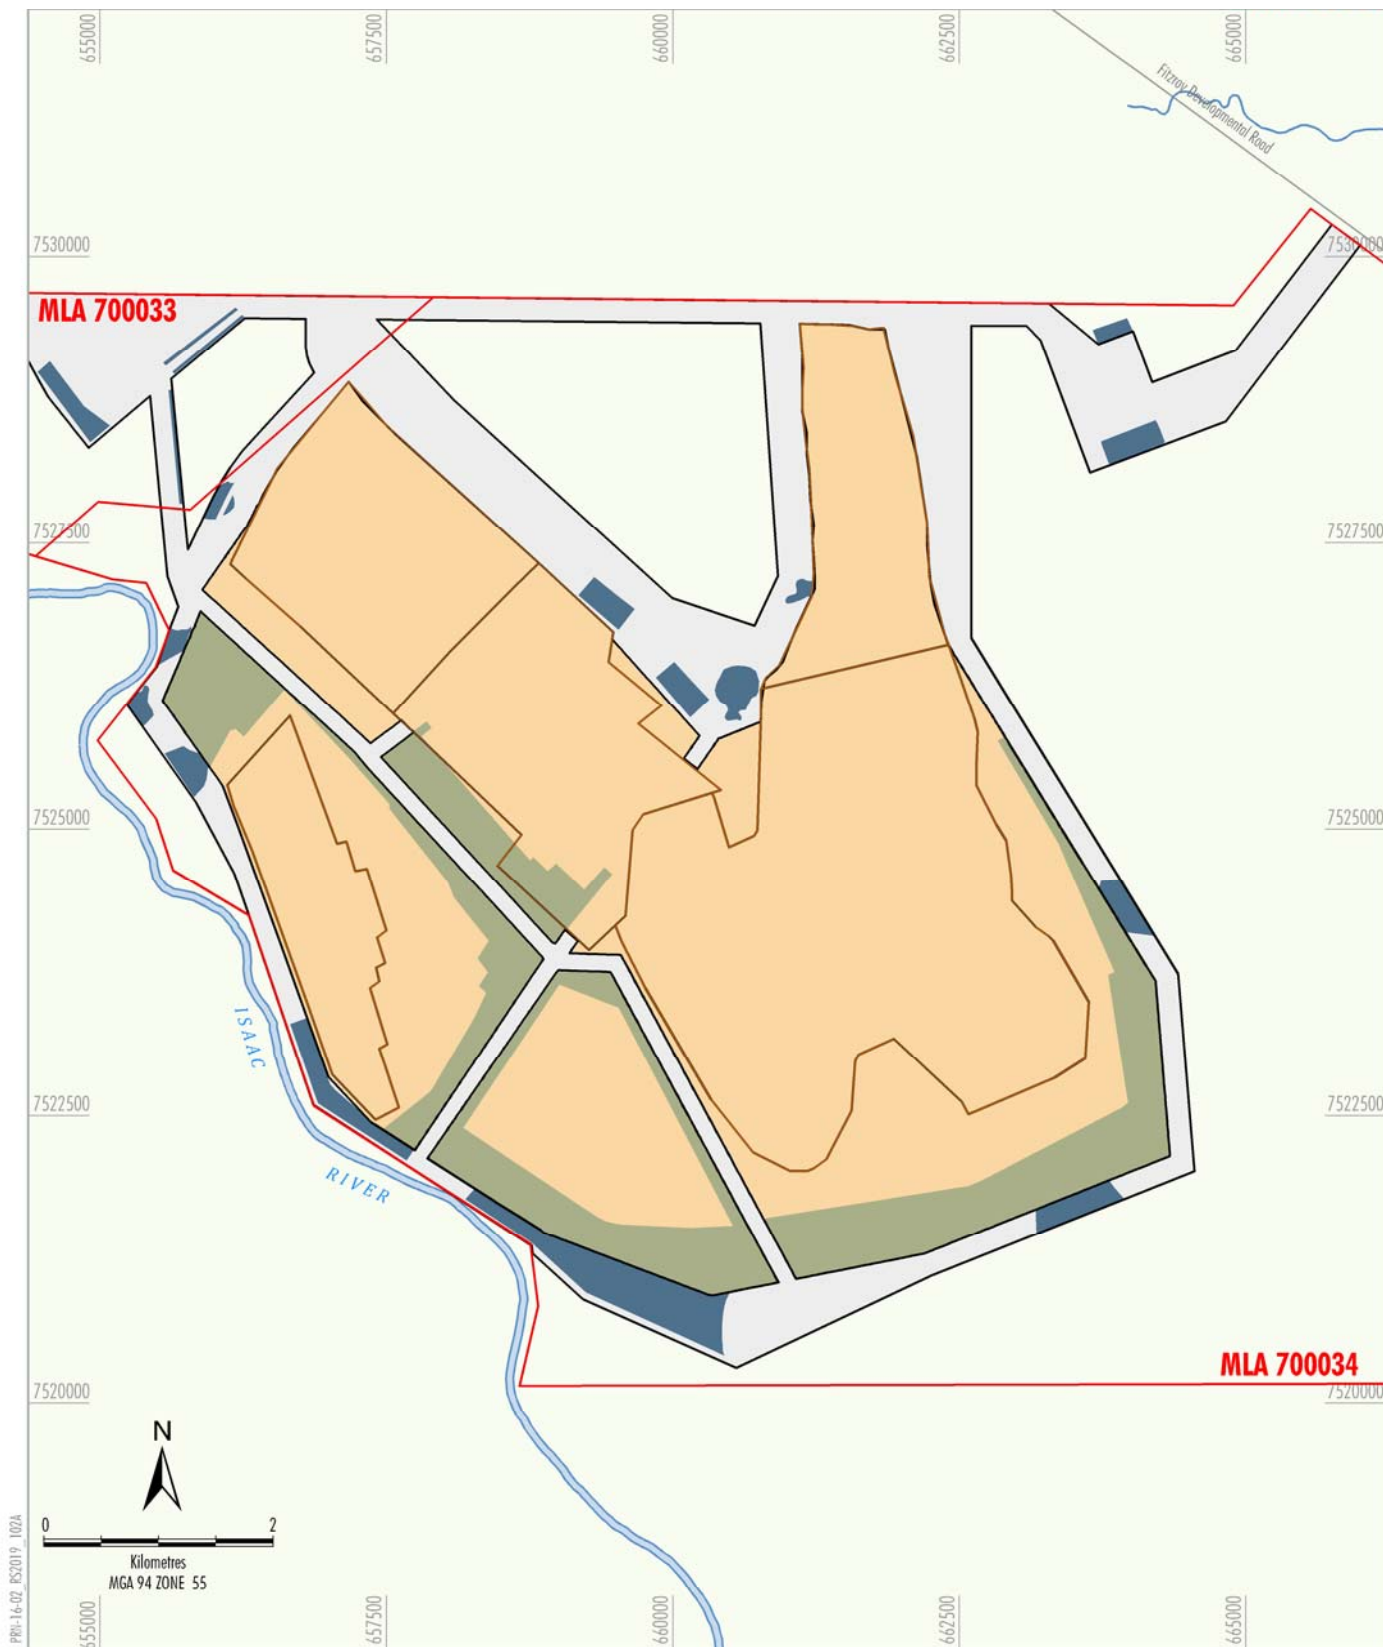
Figure 16

PEMBROKE
OLIVE DOWNS COKING COAL PROJECT
Willunga Domain
Progressive Rehabilitation - 2040
