Olive Downs Coking Coal Project

Additional Information to the
Environmental Impact Statement

**Additional Information on
the Rehabilitation Strategy**

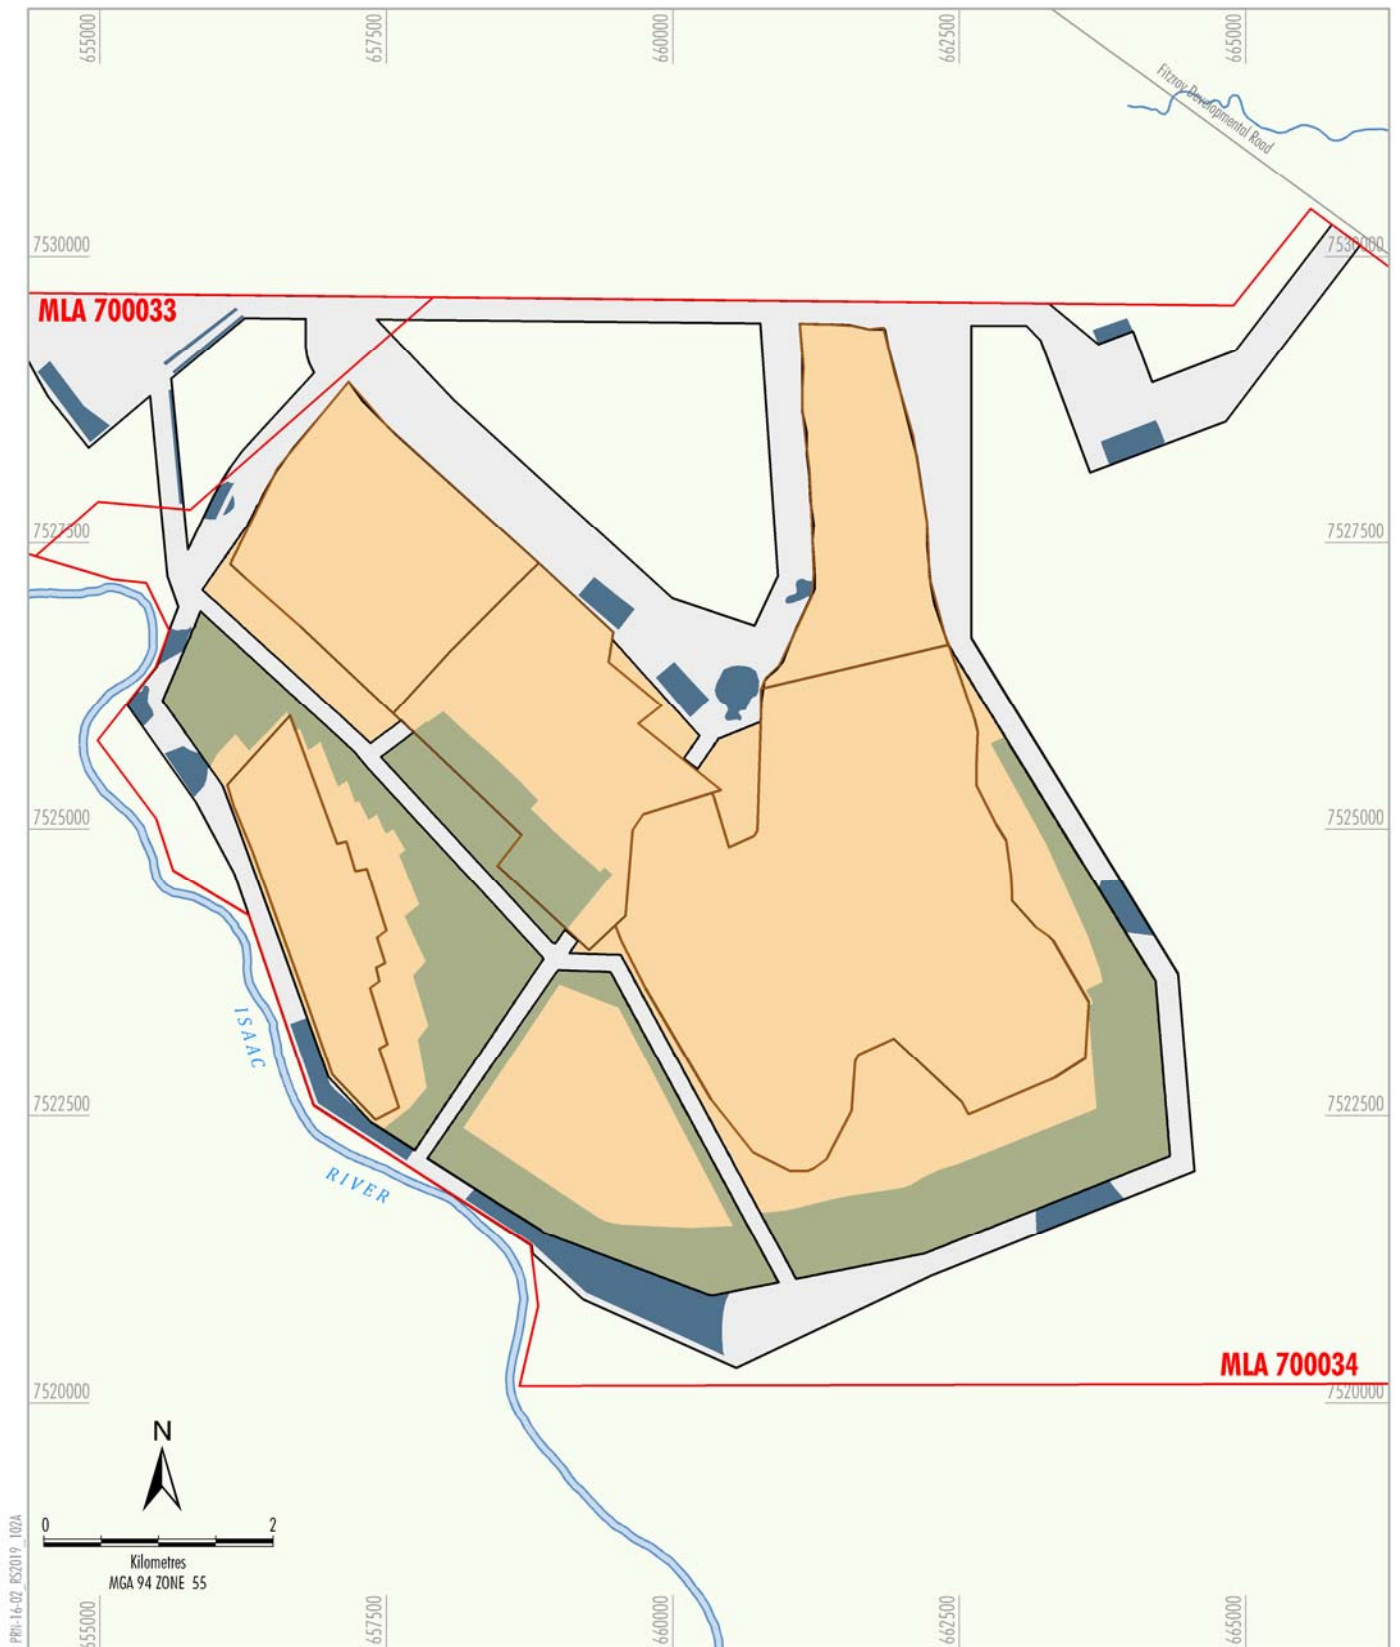
Figure 17

OLIVE DOWNS COKING COAL PROJECT
Willunga Domain
Progressive Rehabilitation - 2045

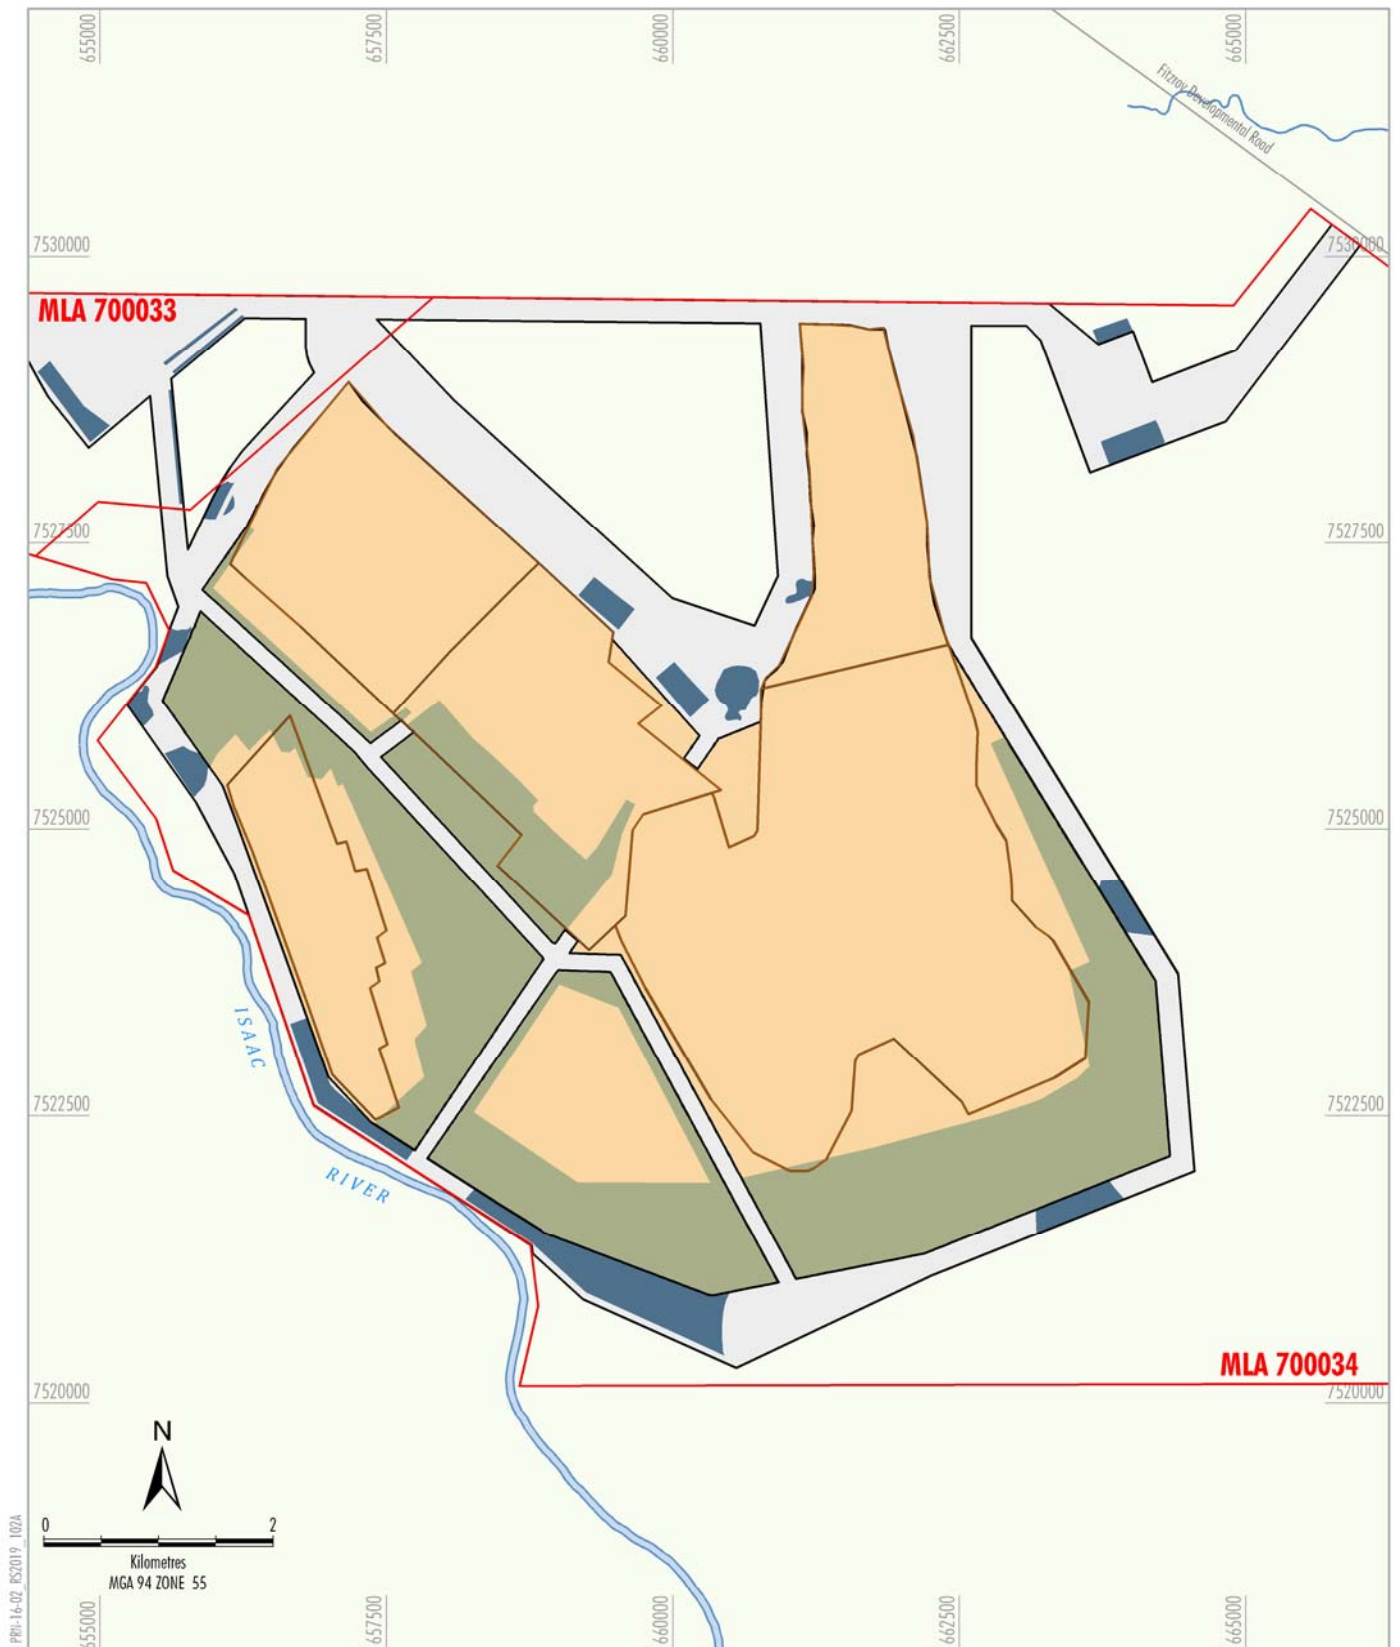
Figure 18

**PEMBROKE**
OLIVE DOWNS COKING COAL PROJECT
Willunga Domain
Progressive Rehabilitation - 2050

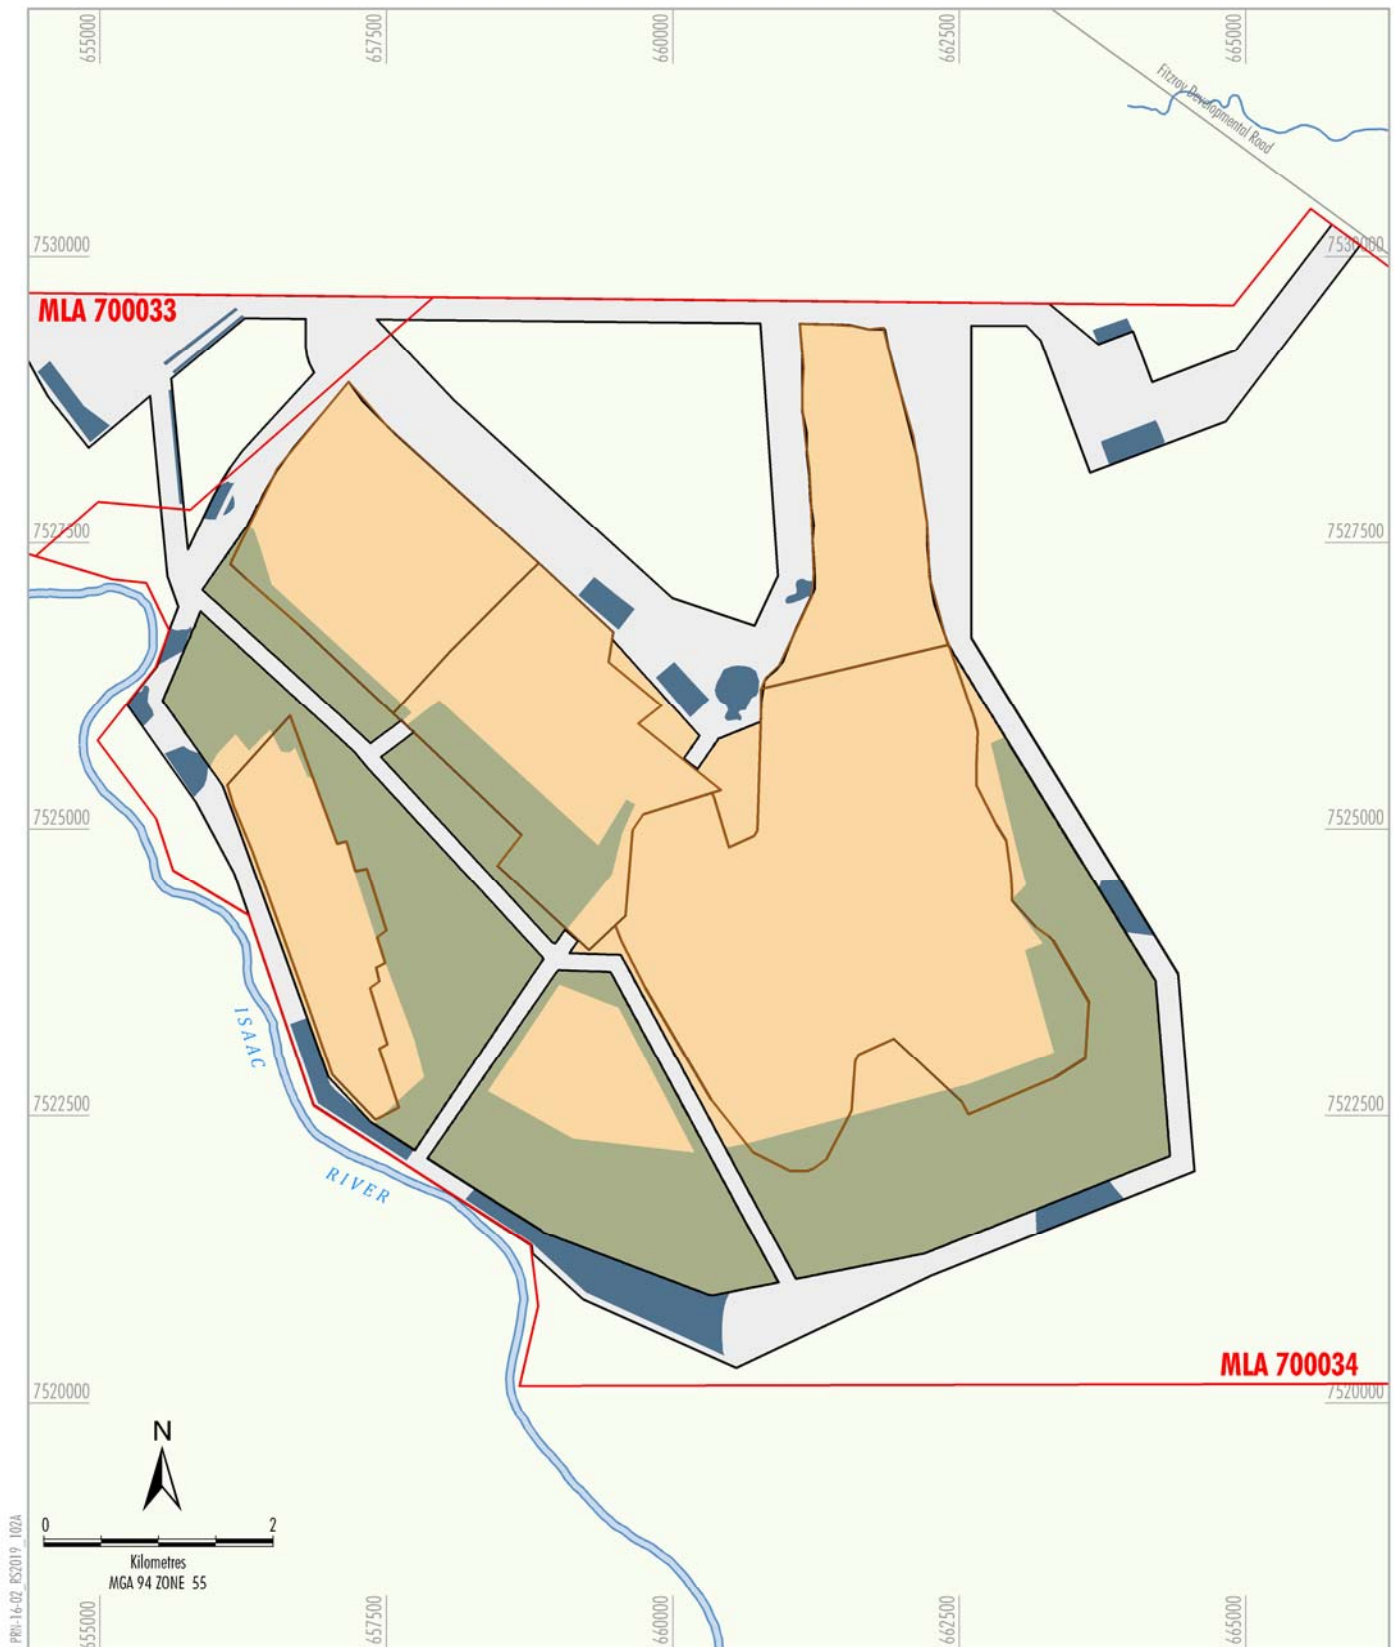
Figure 19

**PEMBROKE**
OLIVE DOWNS COKING COAL PROJECT
Willunga Domain
Progressive Rehabilitation - 2055

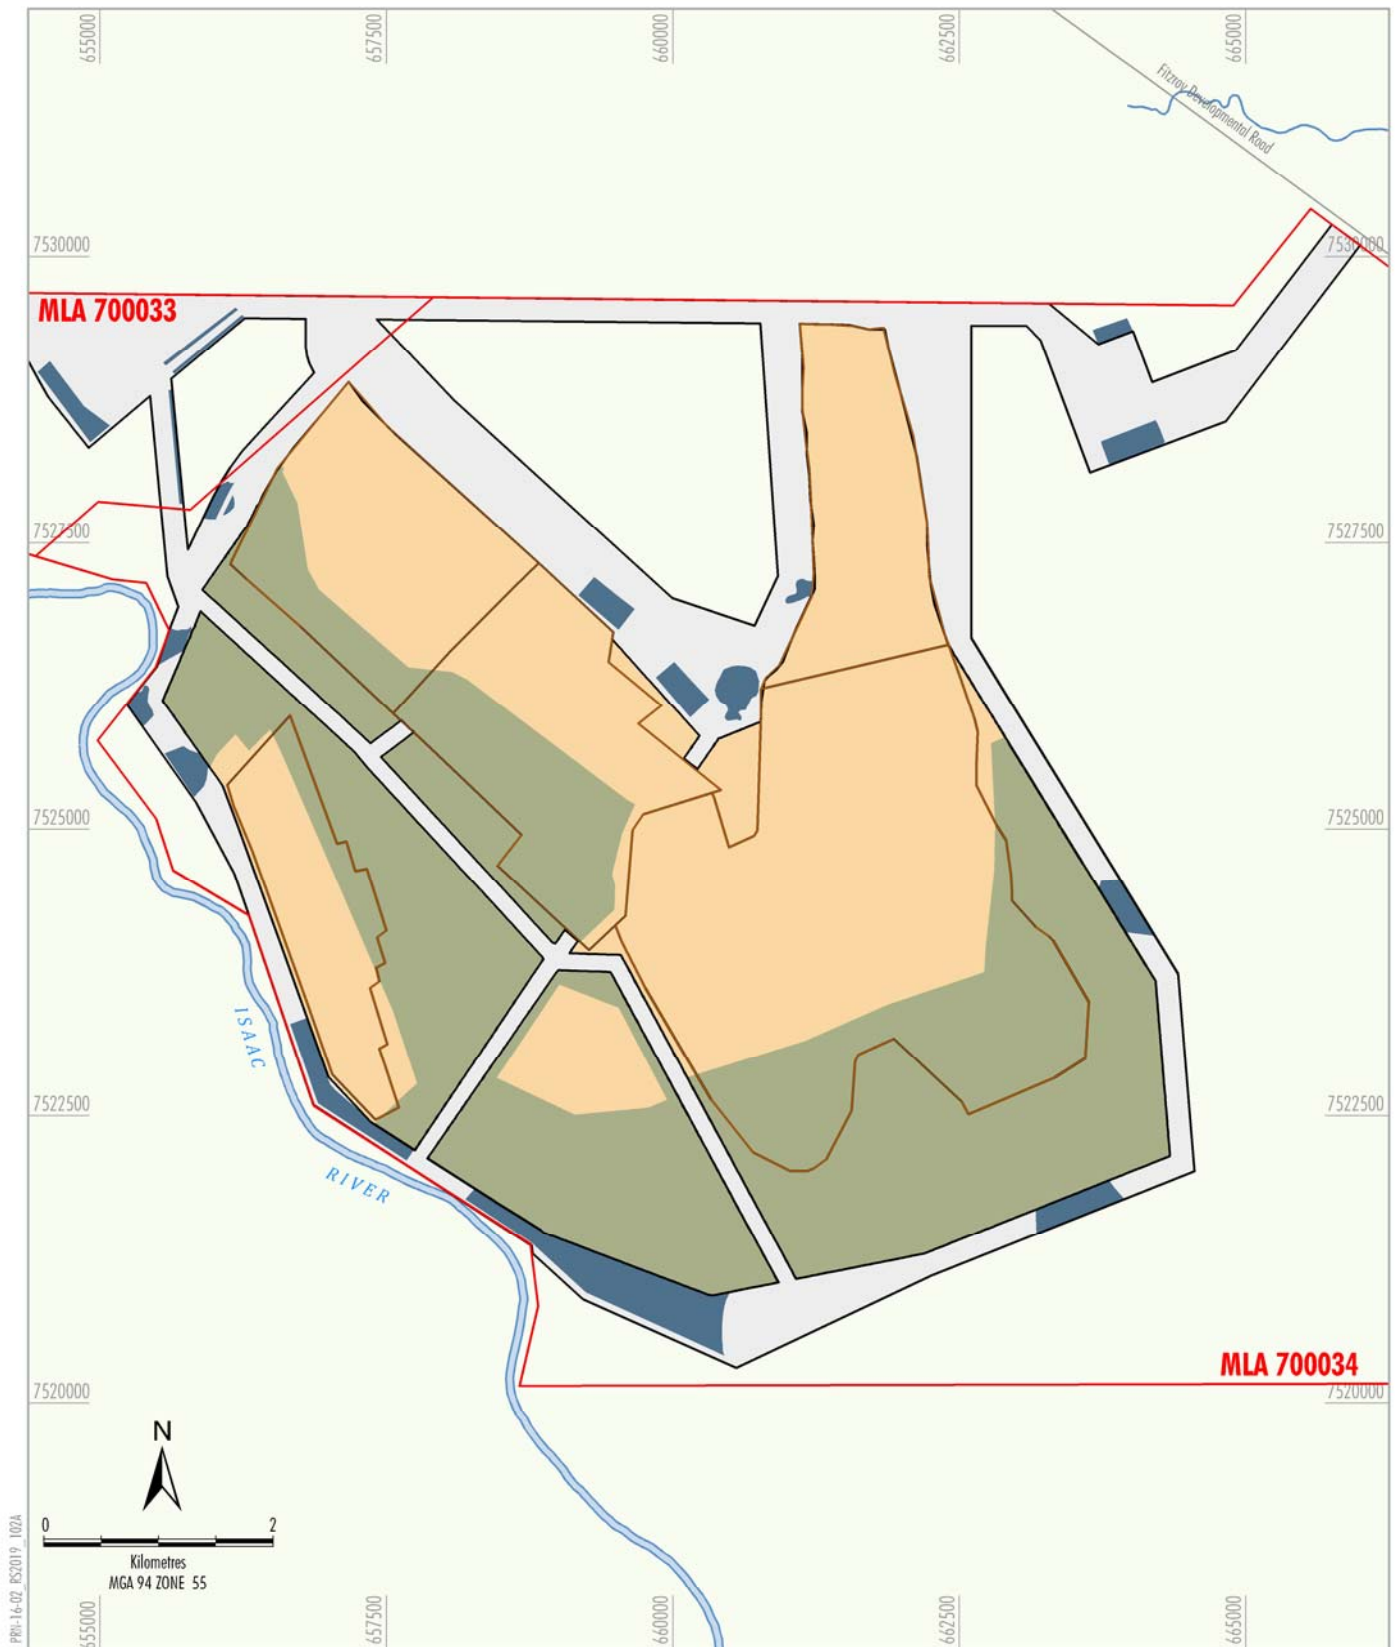
Figure 20

PEMBROKE
OLIVE DOWNS COKING COAL PROJECT
Willunga Domain
Progressive Rehabilitation - 2060

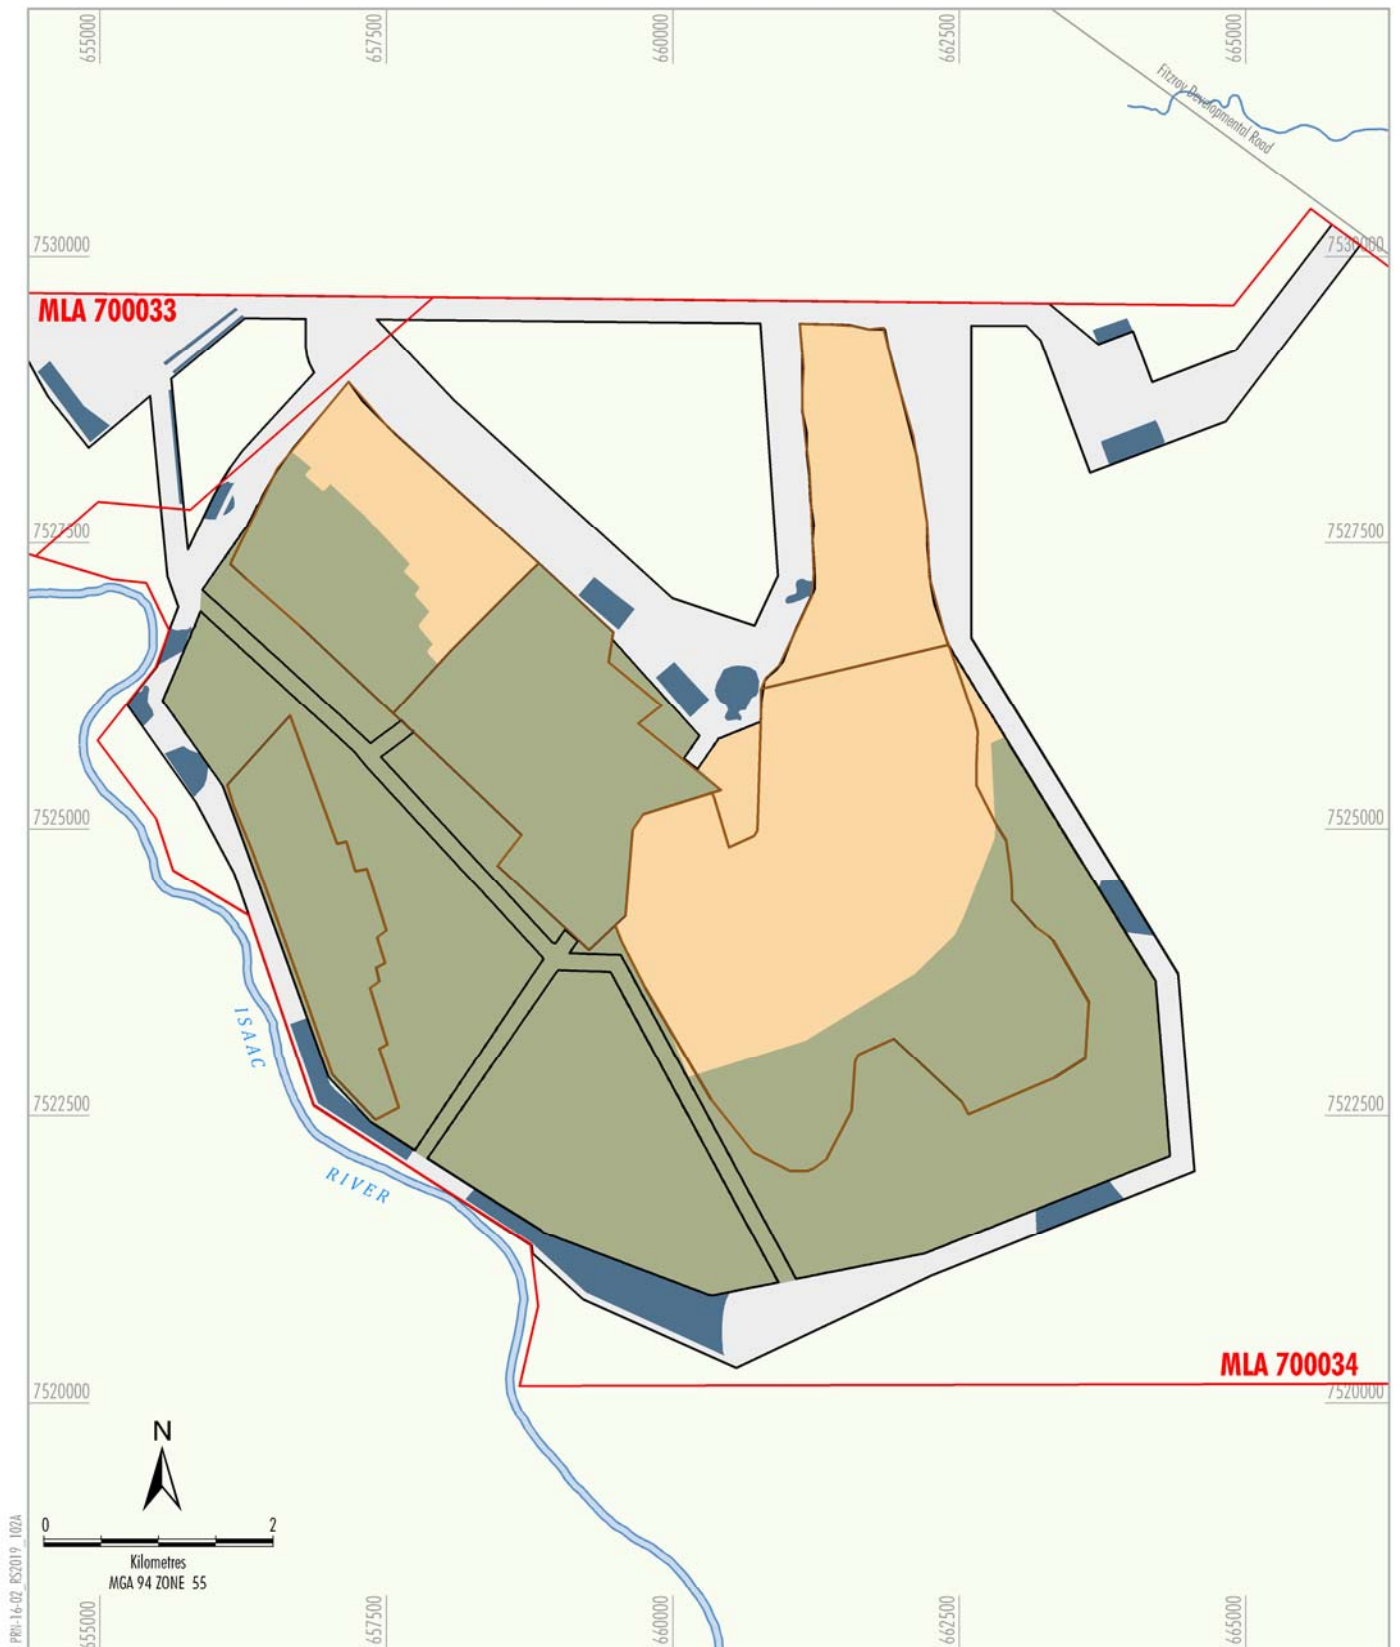
Figure 21

**PEMBROKE**
OLIVE DOWNS COKING COAL PROJECT
 Willunga Domain
 Progressive Rehabilitation - 2065

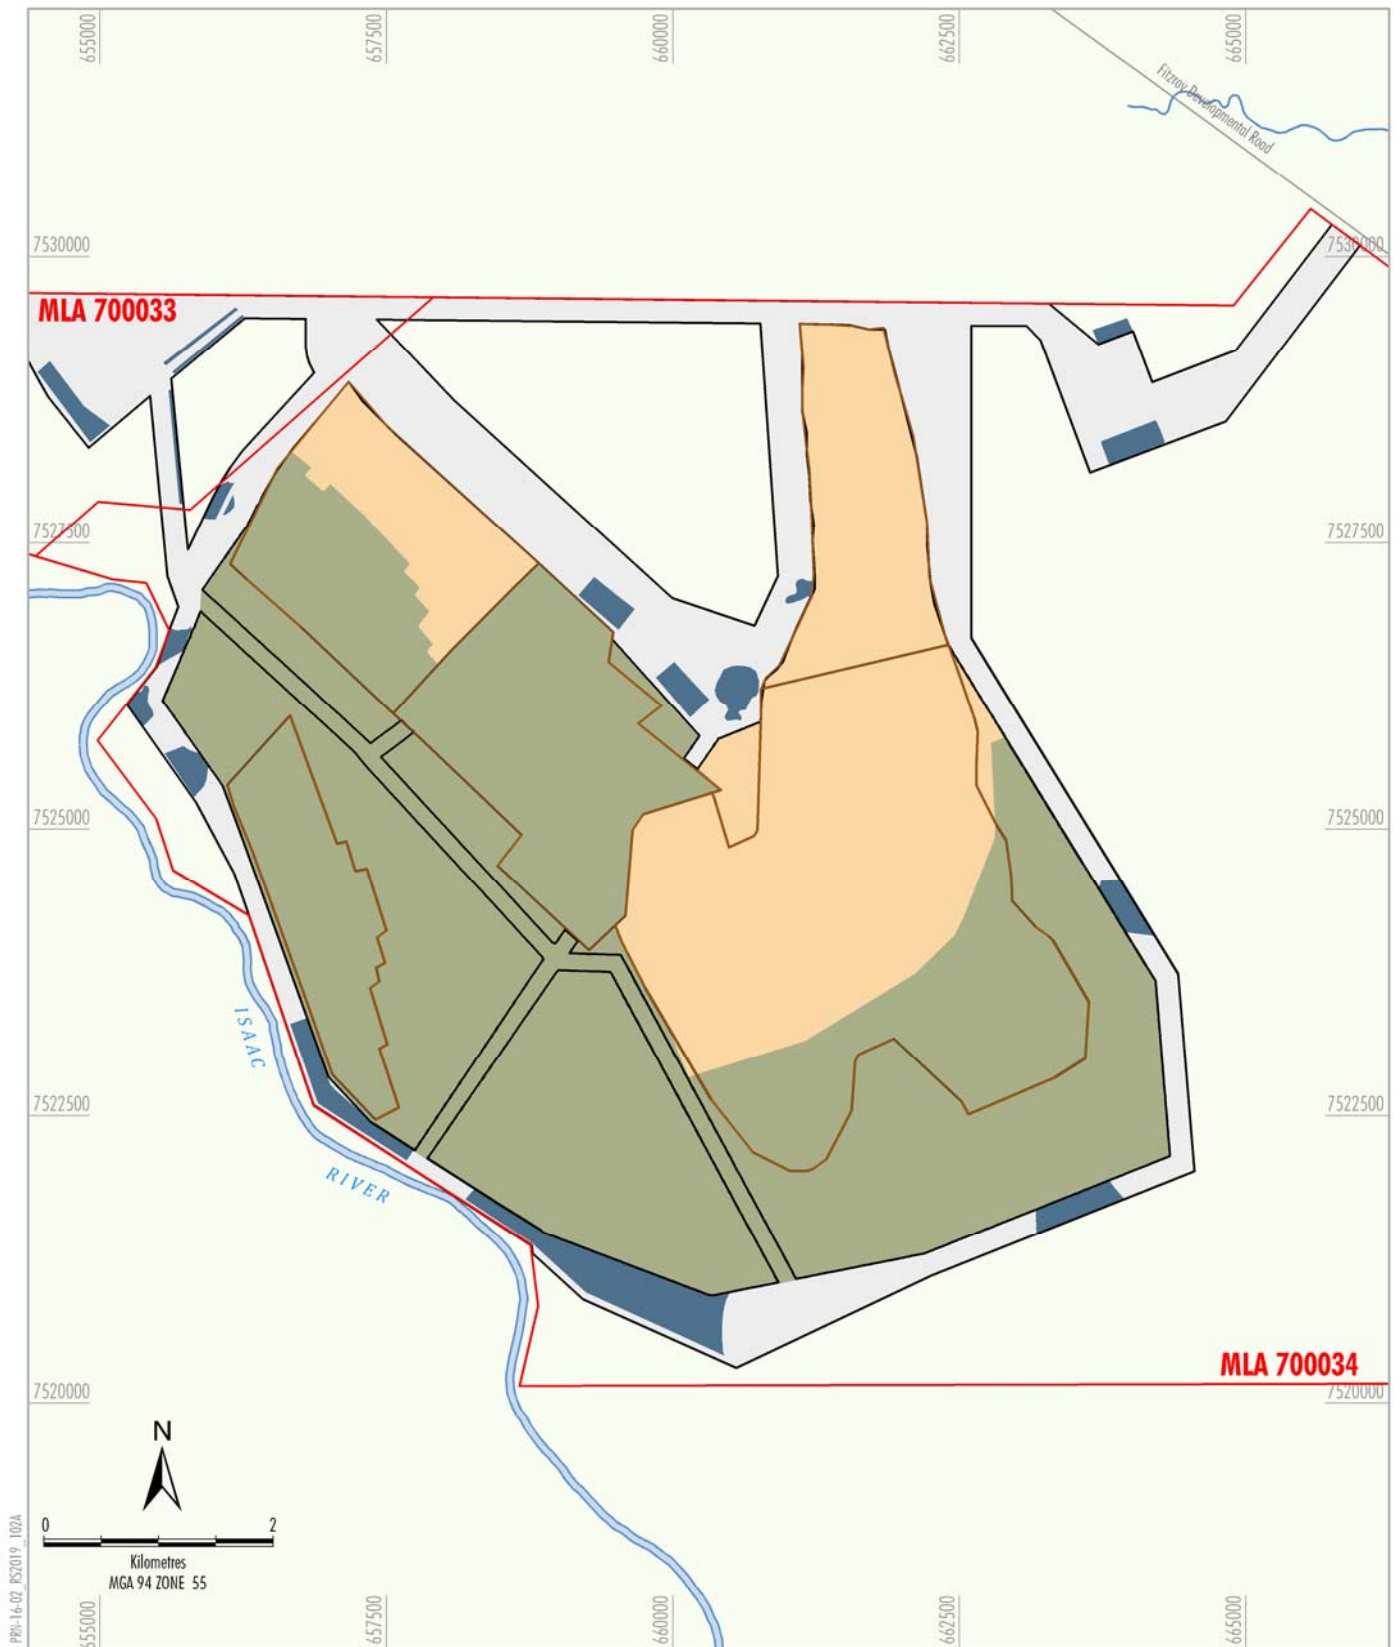
Figure 22

Progressive Rehabilitation - 2072

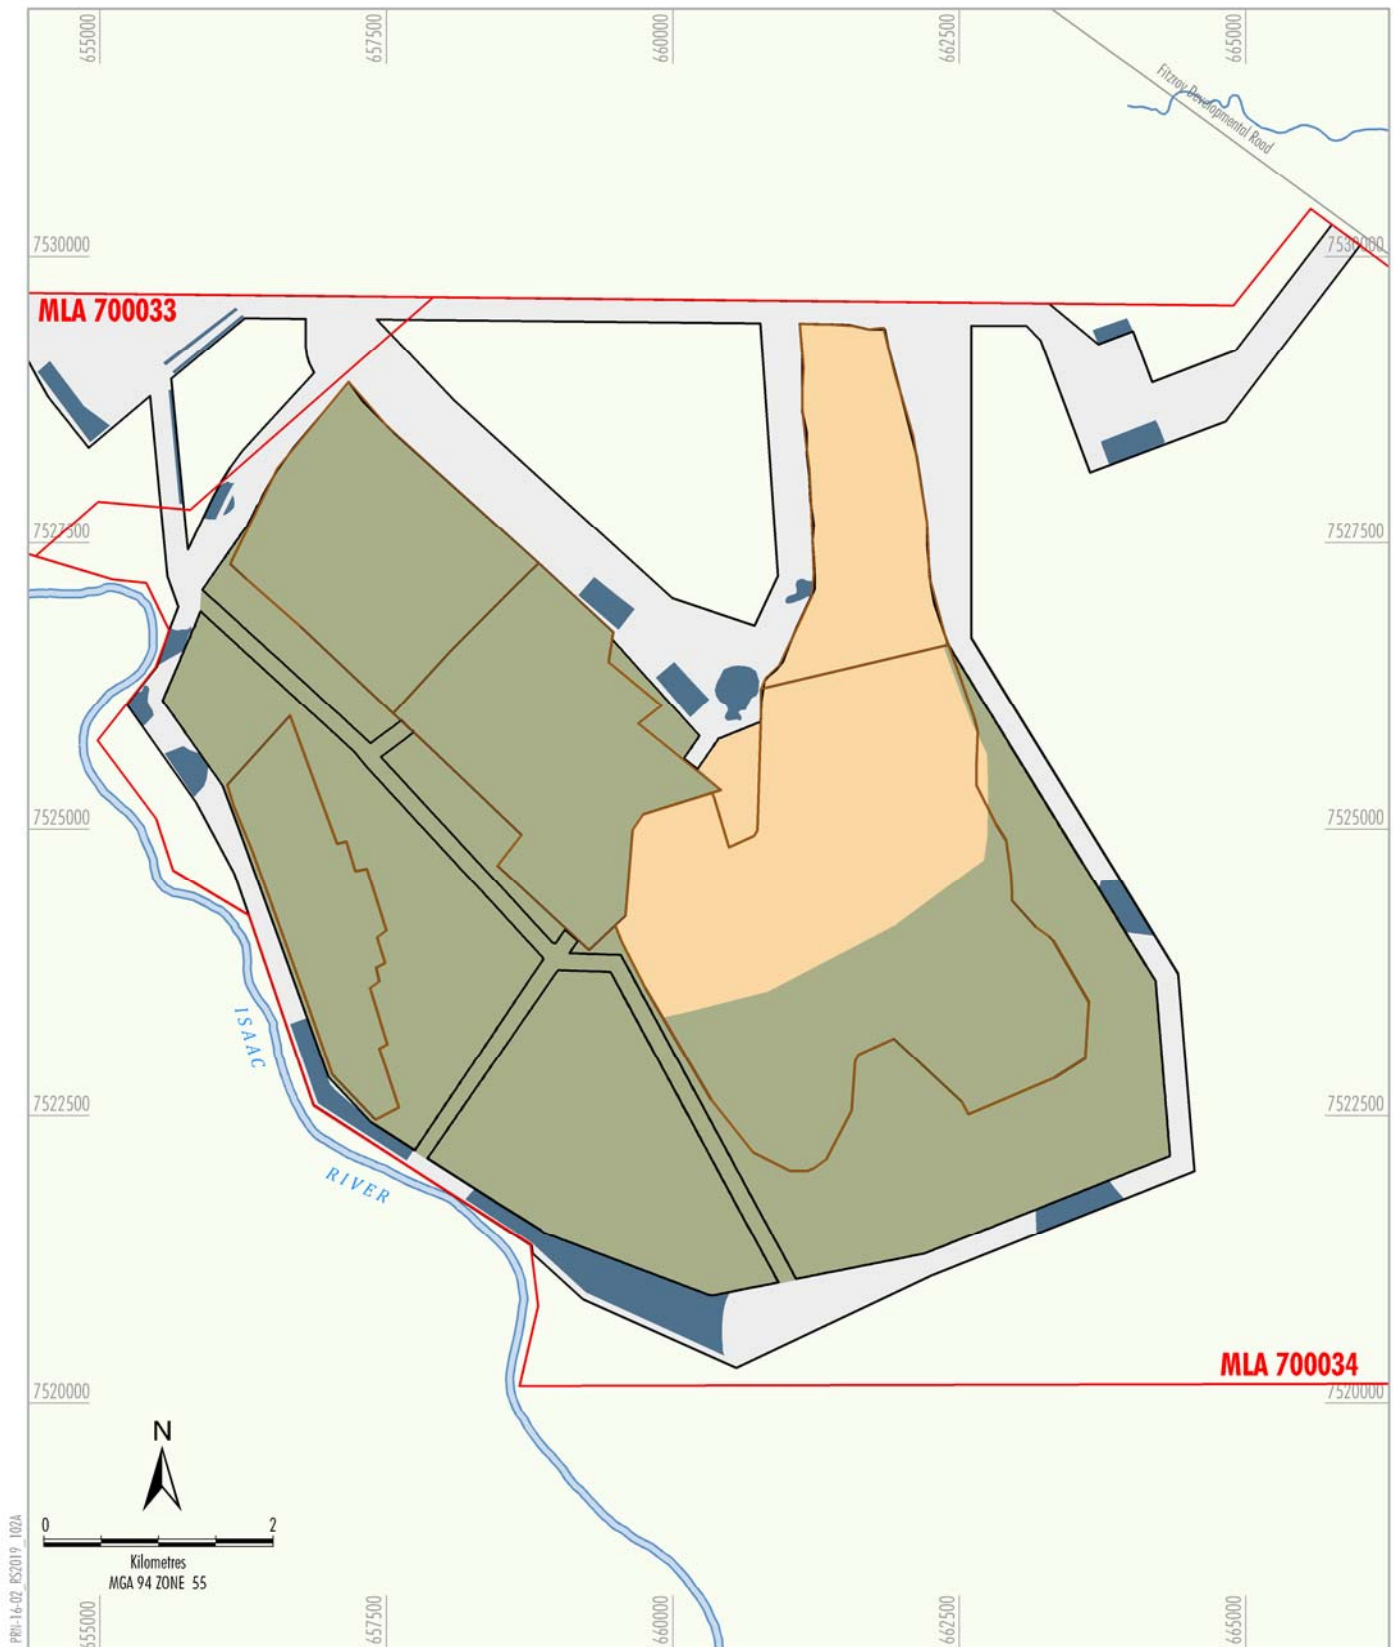
Figure 23

**PEMBROKE**
 OLIVE DOWNS COKING COAL PROJECT
 Willunga Domain
 Progressive Rehabilitation - 2078

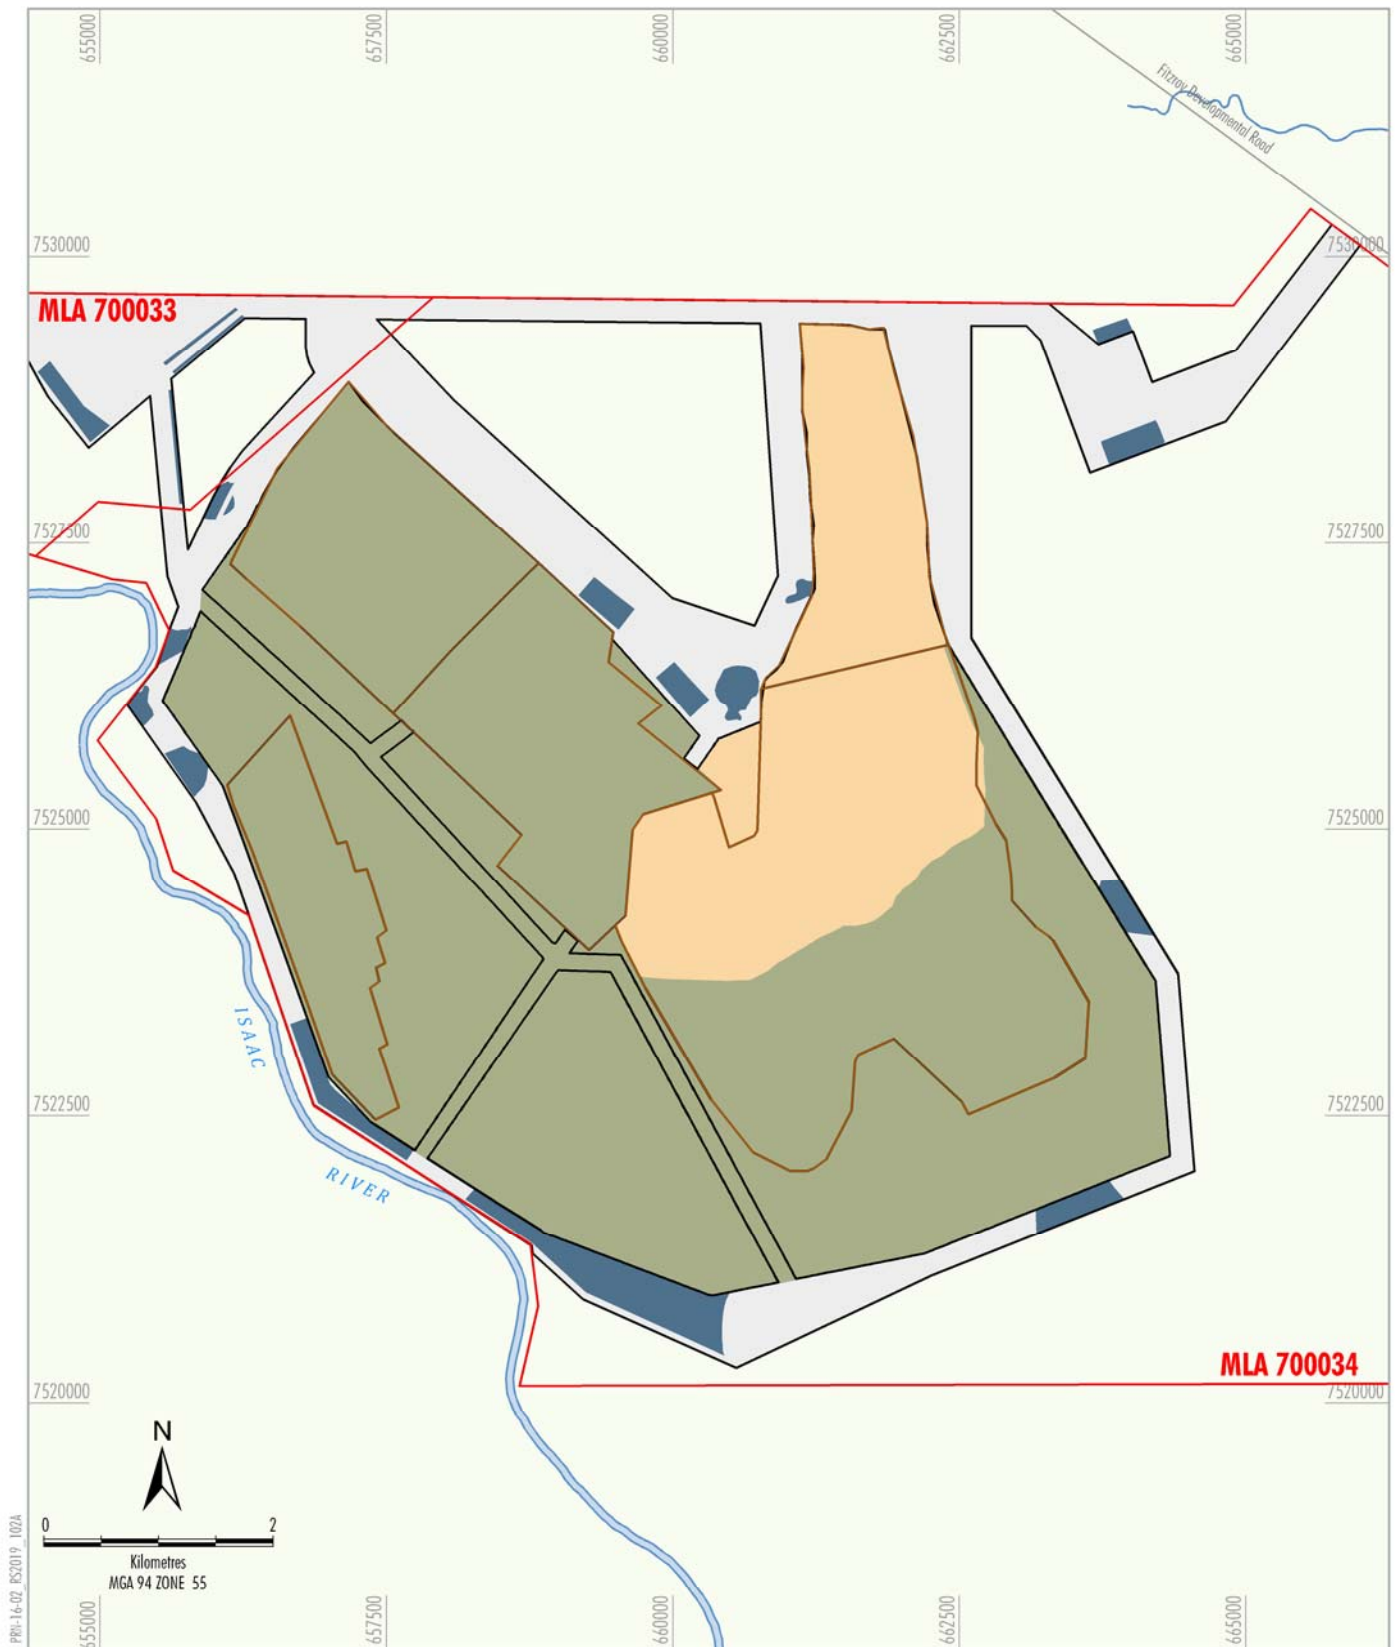
Figure 24

Progressive Rehabilitation - 2085
