**VIEW POINT 3 - ROMA TO BRISBANE GAS PIPELINE MONTROSE ROAD**

**VIEW POINT 4 - MONTROSE ROAD**

**VIEW POINT 5 - CHINCHILLA - TARA ROAD ROMA TO BRISBANE GAS PIPELINE**

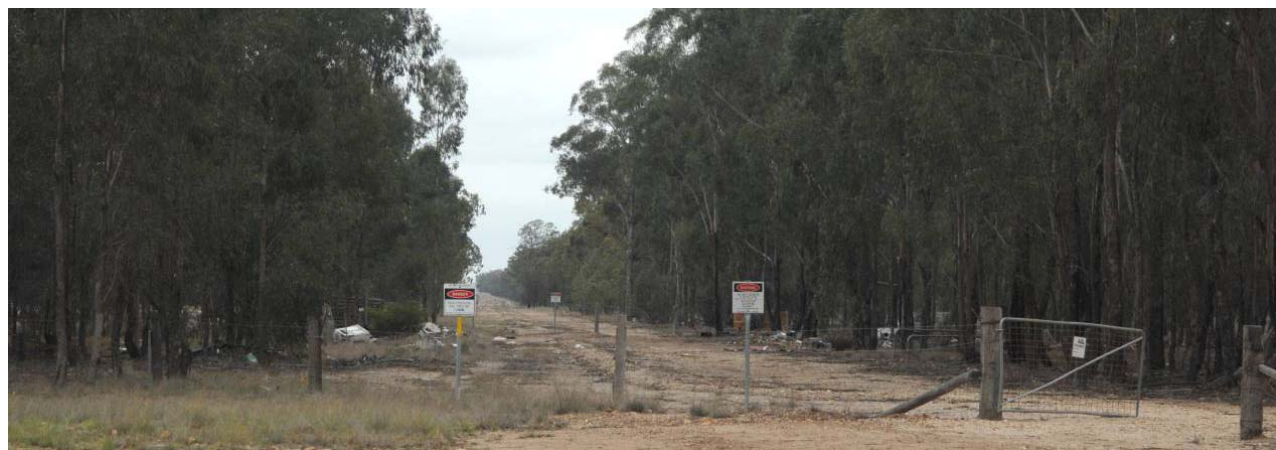
**Figure 6.9** *View Looking East*

The pipeline easement is noticeable due to the existing vegetation that has been removed to create the easement and the warning signs posted on the fence line and gate. In the absence of signage, the pipeline easement would be visually similar to one of the many access tracks found in the surrounding area.

Similar to the view seen in Figure 6.9, when looking west the pipeline easement is also noticeable due the signage located on the fence line and where existing vegetation has been removed to construct the pipeline.

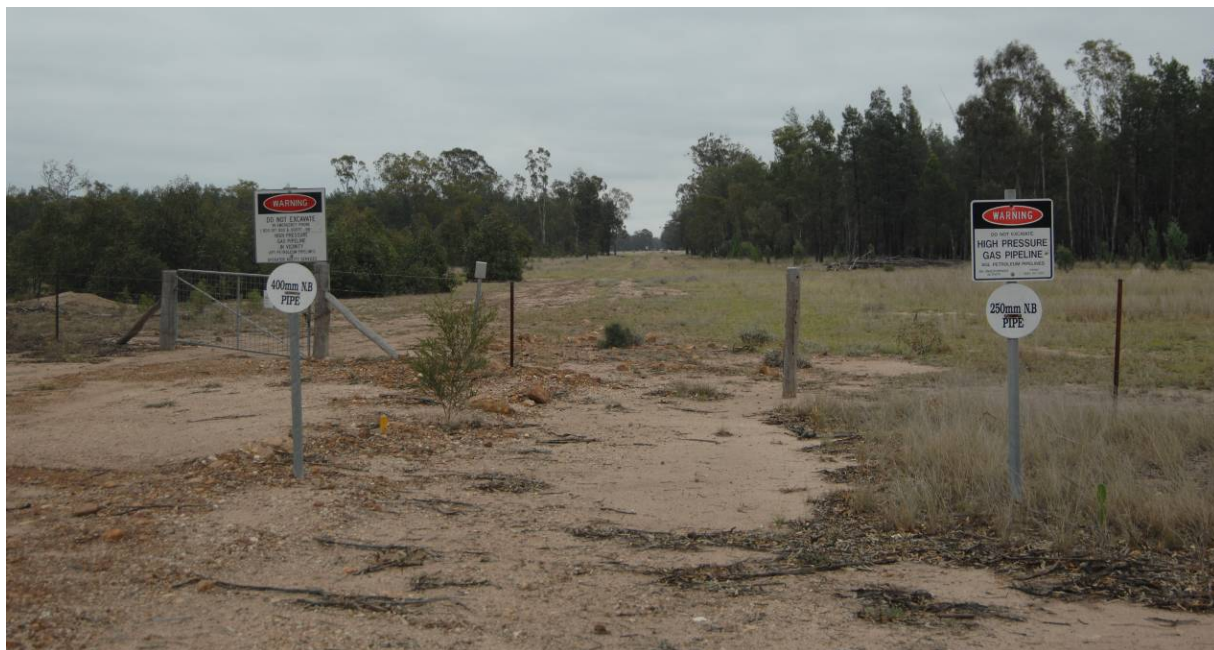
**Figure 6.10 View looking west**

Figure 6.10 shows the view looking west along the same pipeline easement. Looking west from this location, there are large areas that have been cleared for farming purposes. Existing vegetation set back from the Montrose Road.

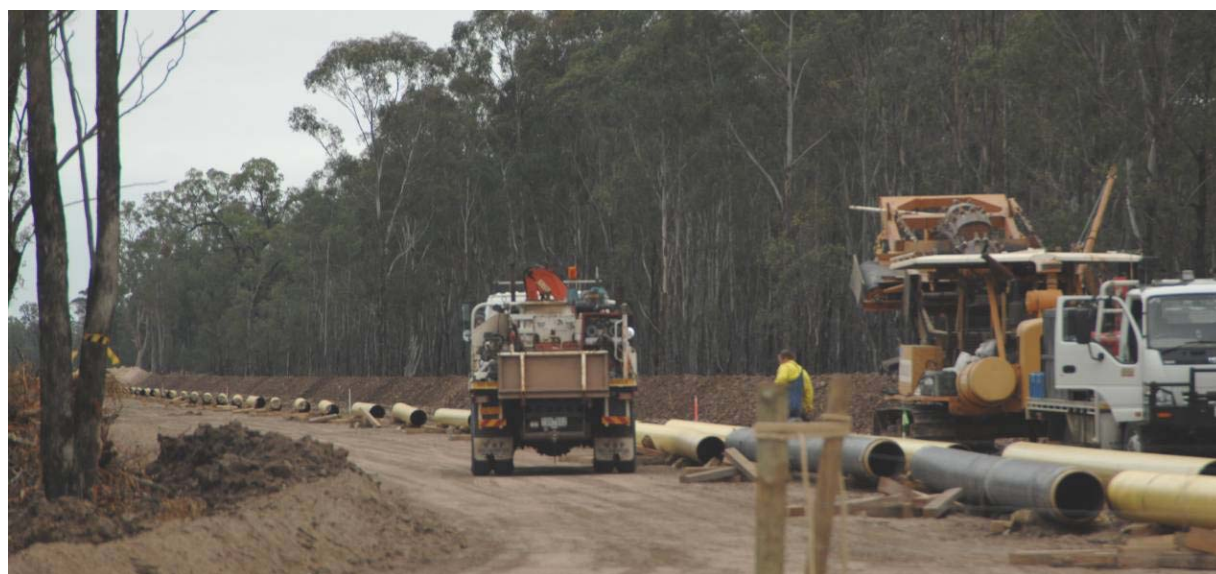
**Figure 6.11** *View looking east along an existing pipeline easement under construction*

Vegetation has been removed to enable the construction and ongoing maintenance of the pipeline easement.

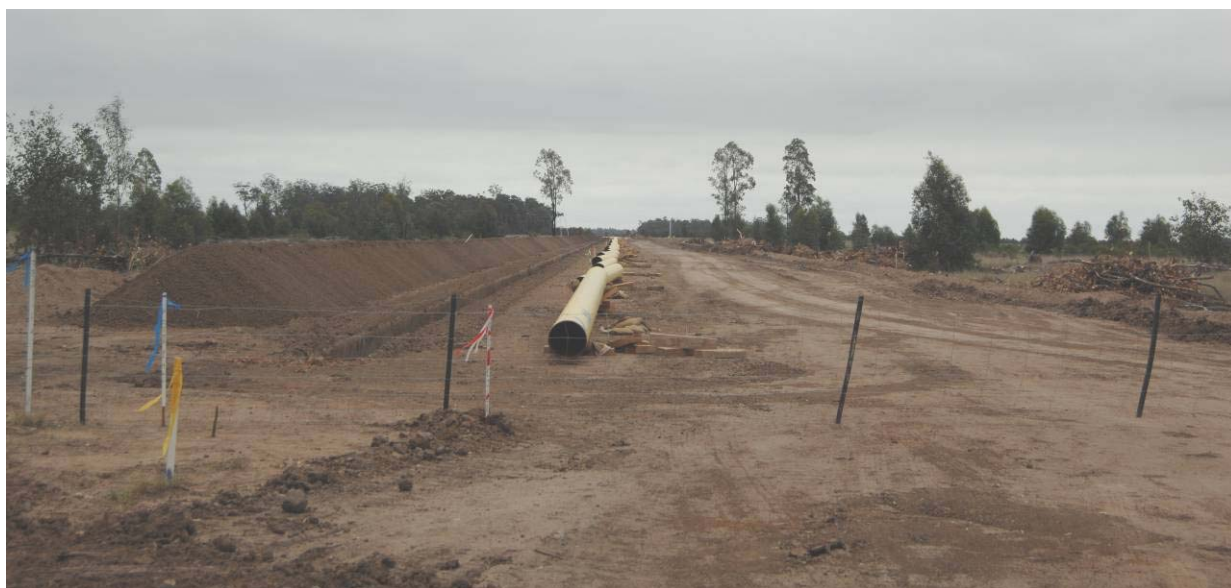
**Figure 6.12** *View looking west along pipeline easement under construction*

The landscape to the west of this location has been cleared, to enable the construction of the pipeline easement.

The view looking west shows an example of an underground pipeline being constructed in Landscape Unit 1 – Cleared Flat Farmland. This landscape unit has a low visual sensitivity. Even though the location of the pipeline easement during construction is noticeable, the construction activity is confined to a narrow corridor. Due to the low landscape sensitivity and few visitor numbers the visual impact through construction would be assessed as being low at worst.

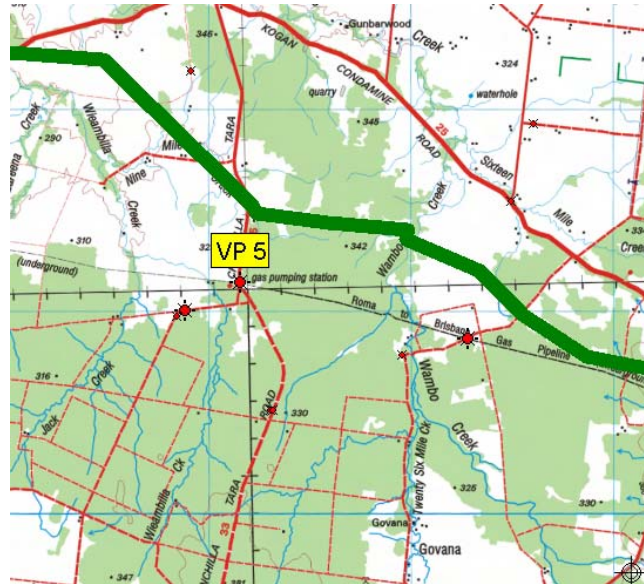
VP5 (GPS 56J 251506.5, 7011446.9)

The Roma to Brisbane Gas Pipeline crosses the Chinchilla-Tara Road at this location. There is also an existing gas pumping station.

The most visible landscape unit at this location is Landscape Unit 3 - Forest to the east and Landscape Unit 1- Flat Farmland to the north - west.

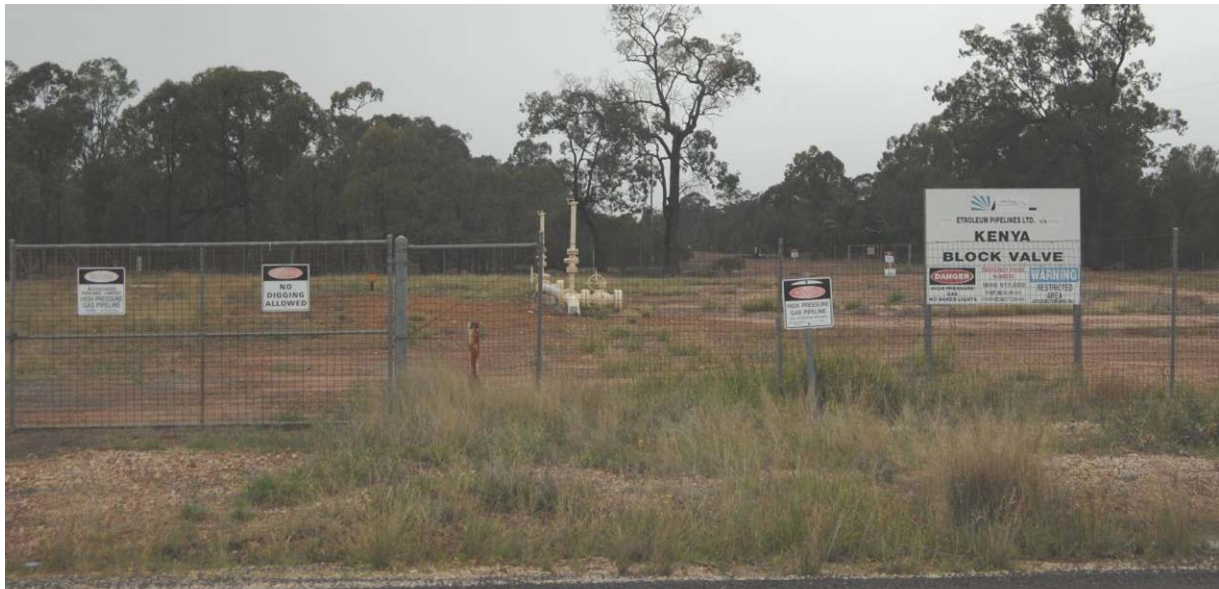
**Figure 6.13 View looking east to existing gas pumping station**

The existing gas pumping station is located approximately 15 – 20 m from the road. Figure 6.13 shows also shows that the most visible features associated with the gas pumping station is the warning signage posted on the fence and service gates.

The bare earth seen in Figure 6.13 suggests that there has been recent construction or maintenance activity along this section of the pipeline.

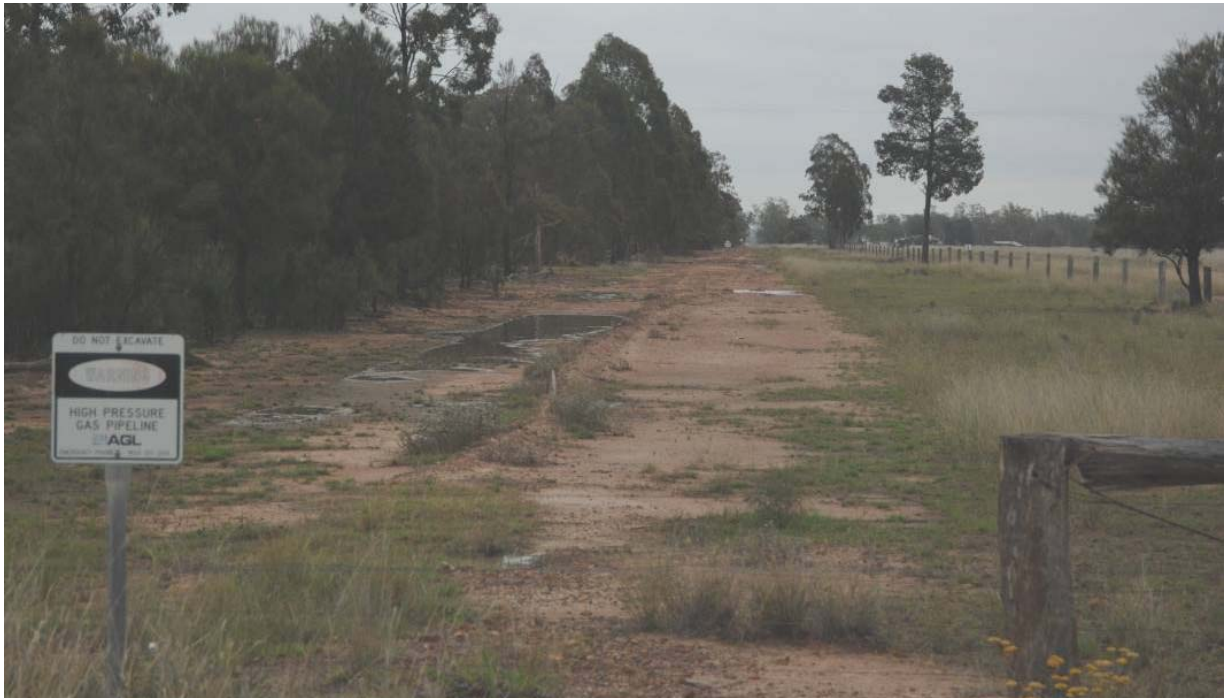
**Figure 6.14 View looking west along existing Roma - Brisbane gas pipeline**

From this location, the most distinguishable feature of the pipeline is the warning signage located on the fence and gates.

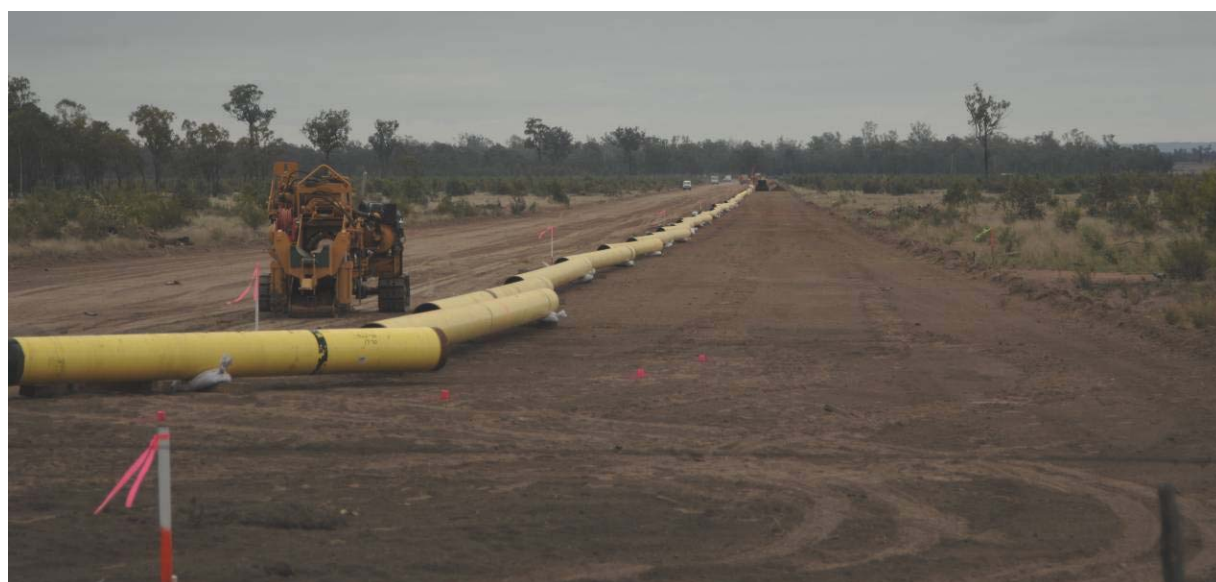
**Figure 6.15** *View looking north along the construction easement*

There is a new gas pipeline currently being constructed directly north of this location as seen in Figure 6.15.

The pipeline easement is noticeable during construction, due to the presence of the construction equipment and stockpile areas. However these are temporary features and will be removed once construction is completed.

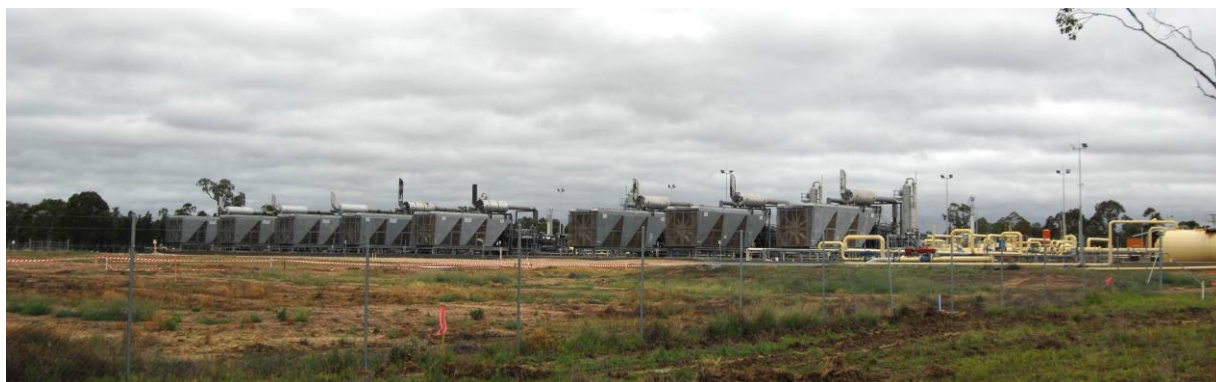
**Figure 6.16** *View looking west towards the existing gas compressor station.*

Figure 6.16 is taken from the fence line of the Central Processing Plant enclosure. This viewing location is approximately 100 m from the plant infrastructure.

Figure 6.16 shows that from a distance of approximately 100 m, the Central Processing Plant, which is the largest of the proposed structures, is a noticeable feature in the landscape. This is partly due to the muted colours and the overall height of the structures.

The Central Processing Plant seen in Figure 6.16 is located in Landscape Unit 1- Cleared Flat Farmland. From a distance of approximately 100 m the visual impact at this location is assessed as being low.

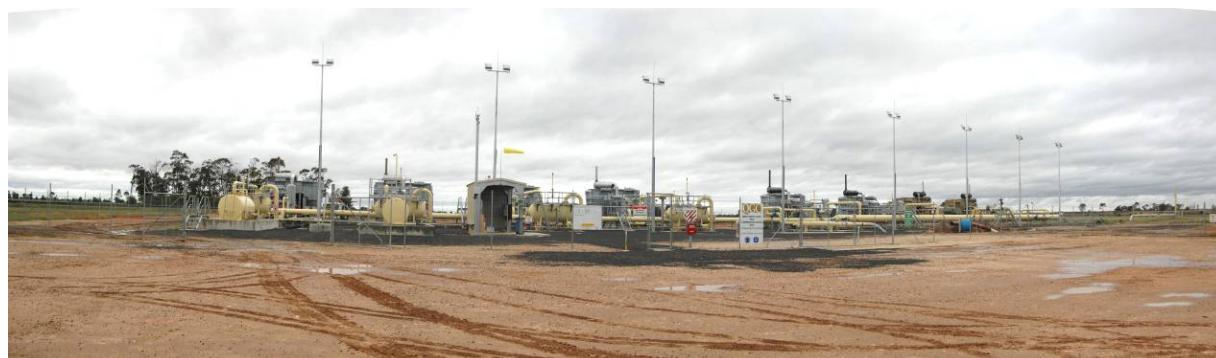
**Figure 6.17** *View looking east towards Field Compressor Station*

Figure 6.17 shows the view looking east towards an existing Field Compressor Station that has been recently constructed. This location is approximately 15 – 20m from the Field Compressor Station.

In this view, the Field Compressor Station has recently been constructed. NO landscape mitigation or rehabilitation works have been undertaken at this location.

Figure 6.17, shows that from a distance of less than 100 m; the Field Compressor stations have the potential to dominate views. However due to the low landscape sensitivity and low visitor numbers the visual impact at this location would be assessed as low. This would be further reduced once the site has been rehabilitated and with the incorporation of a landscape buffer to the perimeter of the site.

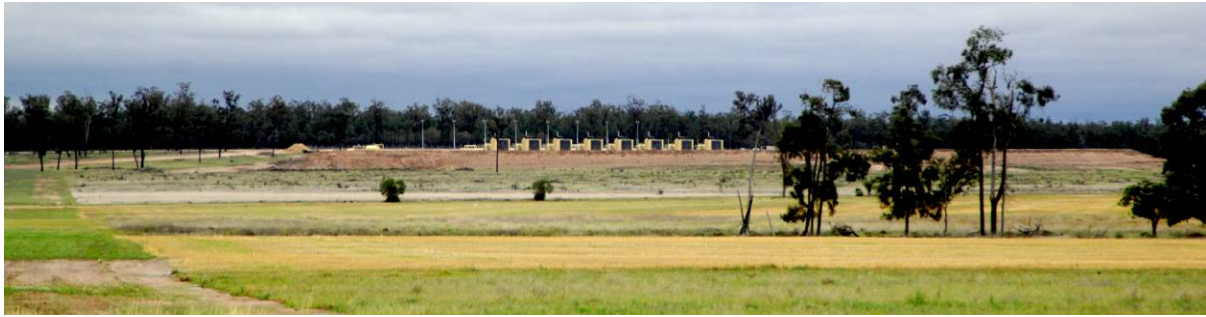
**Figure 6.18** *Existing Field Compressor approximately 1.0 away.*

Figure 6.18 shows the view looking north - west from the same location. This view is towards another Field Compressor Station located approximately 1.0km away and within the Windibrie Camp boundaries.

The Field Compressor Station is located on a cleared rise.

At a distance of approximately 1.0 km the existing Field Compressor Station is visible, however does not dominate the view.

Figure 6.18 shows that visibility of these structures diminishes over distance. Even though the structures are visible, they comprise a small component of the view. The Field Compressor station seen in Figure 6.18 is located within a landscape that has a low visual sensitive and low visitor numbers. Because of the distance and limited visibility, the visual impact of the existing Field Compressor Stations from approximately 1.0 km, would be assessed as low – negligible. This would be further reduced with the incorporation of a landscape buffer to the perimeter of the site.

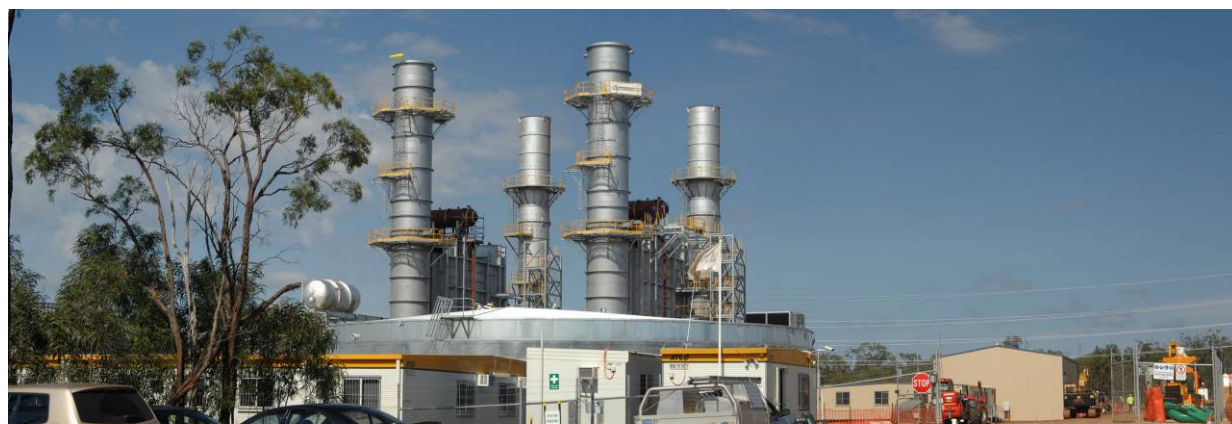
**Figure 6.19** *View looking west towards the Condamine Power Station*

The Condamine Power Station is a large structure located within the Pipeline project viewshed. This location also marks the beginning of the Export Pipeline.

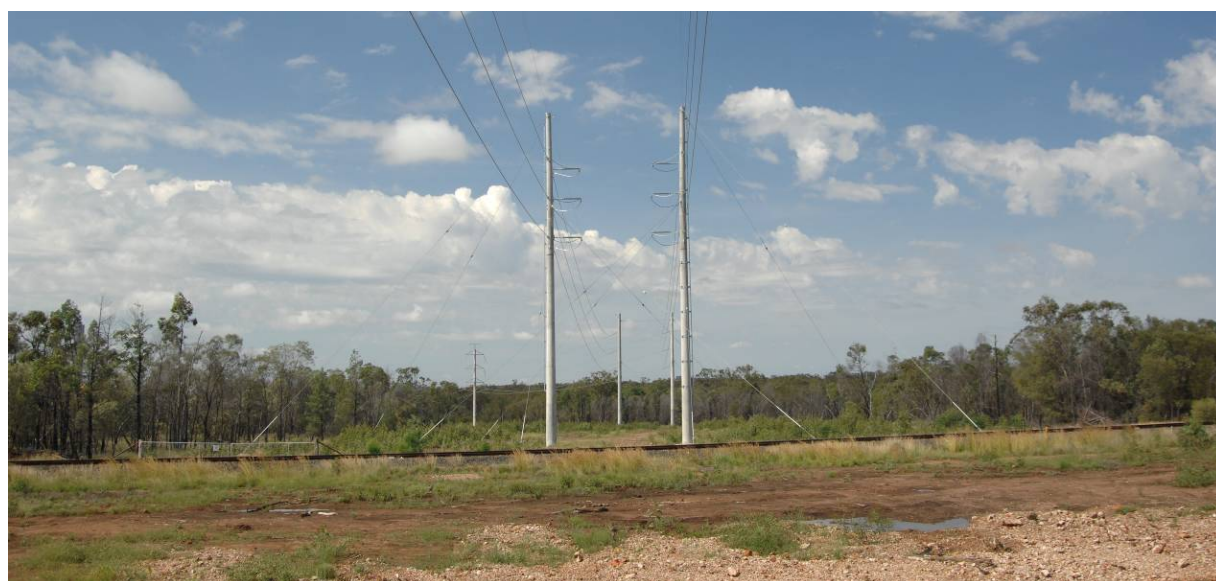
**Figure 6.20** View looking south from the Warrego Highway

Figure 6.20 shows the view looking south along the existing transmission line that connects the Condamine Power Station to the state electricity grid. The Western Railway line can also be seen in this figure.

The landscape to the south of the Warrego Highway is predominantly flat and contains large areas of vegetation.

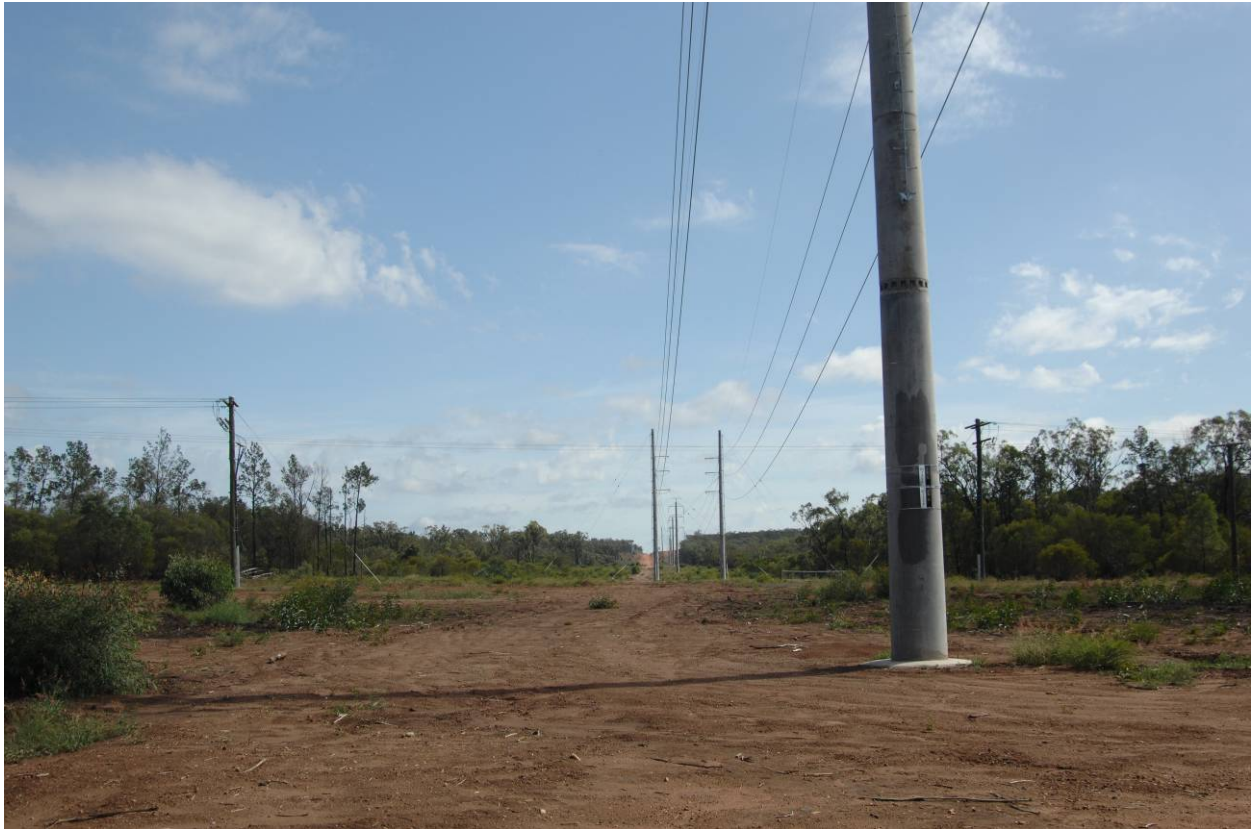
**Figure 6.21** *View looking north from the Warrego Highway*

Figure 6.21 shows the view looking north along the same transmission line from the Warrego Highway.

The landscape to the north is also flat and also contains large areas of tall vegetation. In this location, the vegetation has required removal for the construction and maintenance of the transmission line.

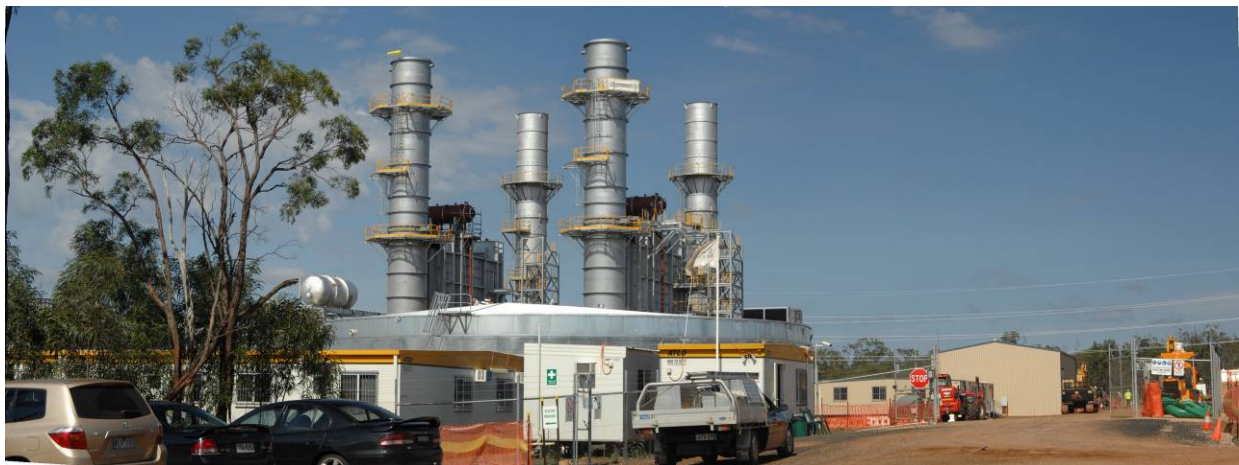
**Figure 6.22** *View looking West towards the Condamine Power Station*

This figure shows the height and bulk of infrastructure located within the Condamine Power Station.

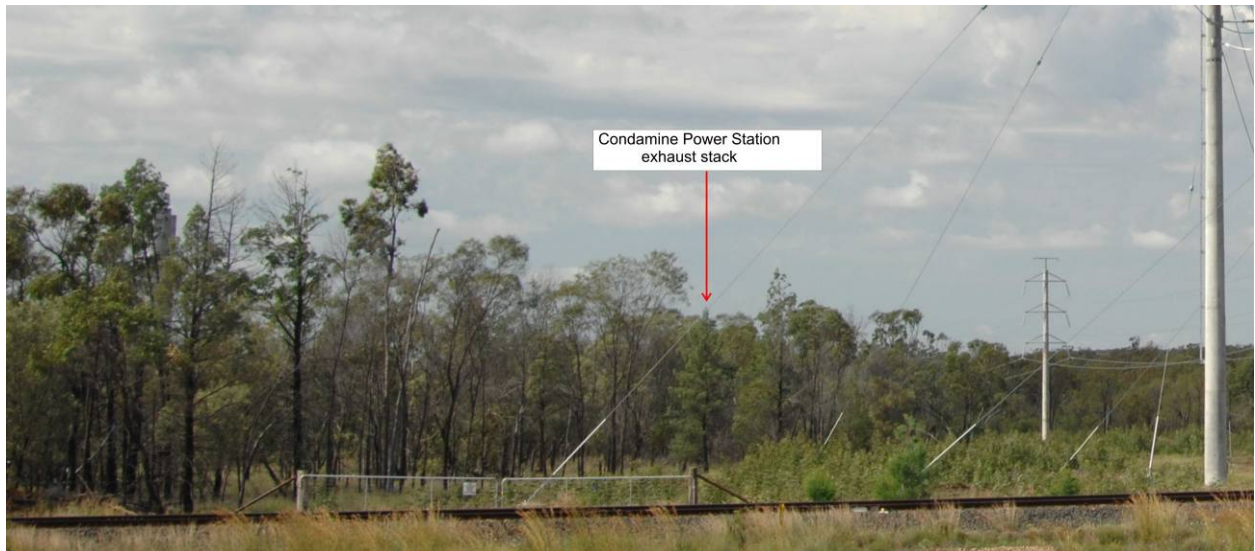
**Figure 6.23**    *Enlargement of Figure 6.20*

The Condamine Power Station is larger than any of the proposed structures associated with the Project. Even at a distance of approximately 200 m away (south), the Condamine Power Station is barely noticeable. This is due to the vegetation buffer that has been retained between the Condamine Power Station and the Warrego Highway.

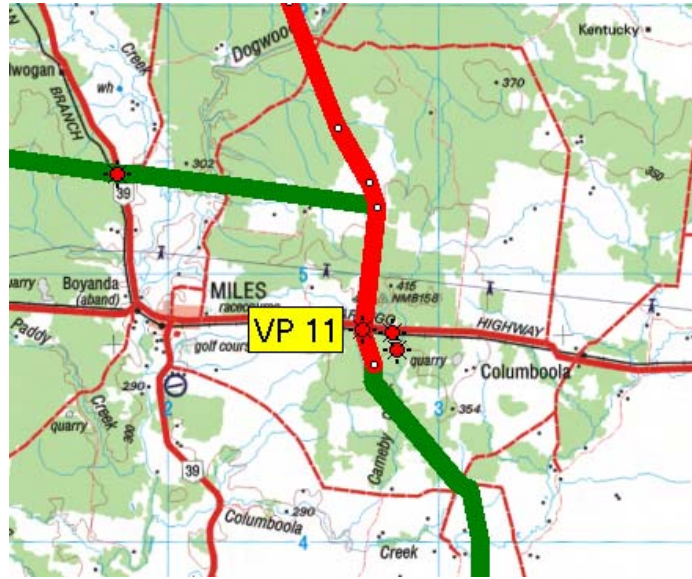
VP11 (GPS 56J 227123.1, 7047978.7)

The most visible landscape at this location is Landscape Unit 3 – Forest.

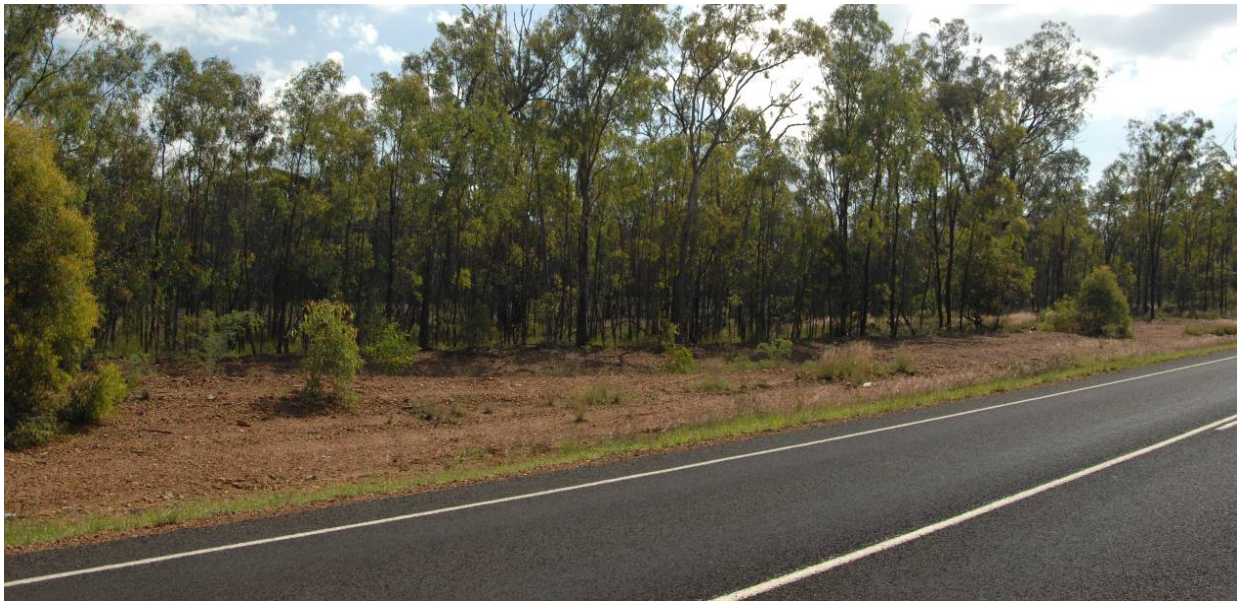
**Figure 6.24** View looking south-west from the Warrego Highway

Figure 6.24 shows that the landscape to the south of this location is predominantly flat. It also contains large areas of either remnant or regrowth vegetation.

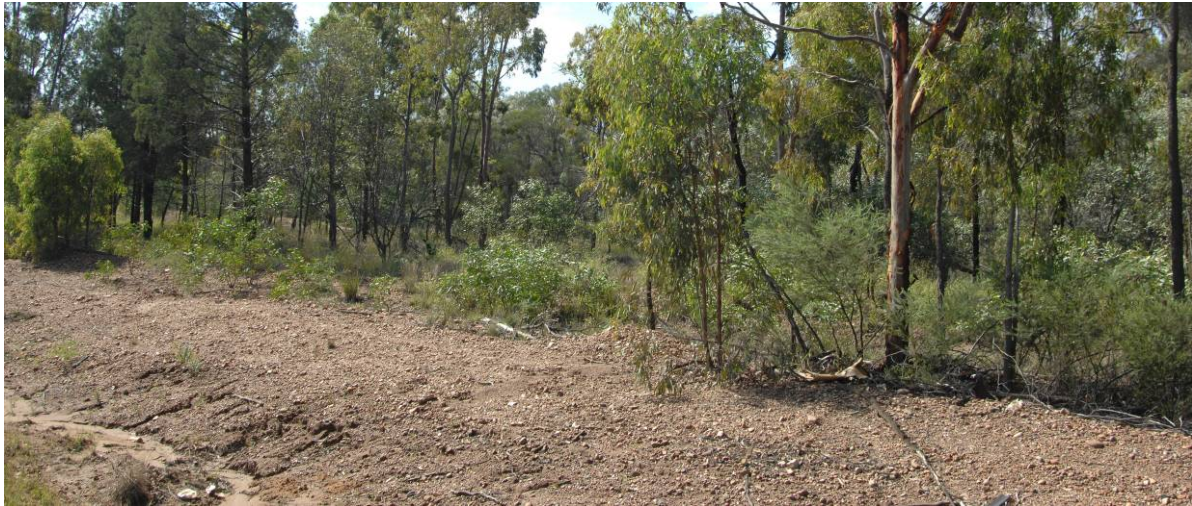
**Figure 6.25** *View looking north-west from the Warrego Highway*

The landscape to the north of this location is predominantly flat and contains large areas of vegetation. Vegetation removal required on the northern and southern sides of the Warrego Highway for the construction of the Collection Header and the Export pipelines at this location.
