### 3 **TOPOGRAPHY & GEOMORPHOLOGY**

This chapter provides a summary of the topography and geomorphology of the LNG Component of the Queensland Curtis LNG (QCLNG) Project, in particular the LNG Facility and surrounding area on Curtis Island. The chapter has been compiled using available data and published information, including aerial photographs, geological reports, topographic maps and database searches, supplemented by field investigations undertaken in October and November 2008<sup>1</sup>.

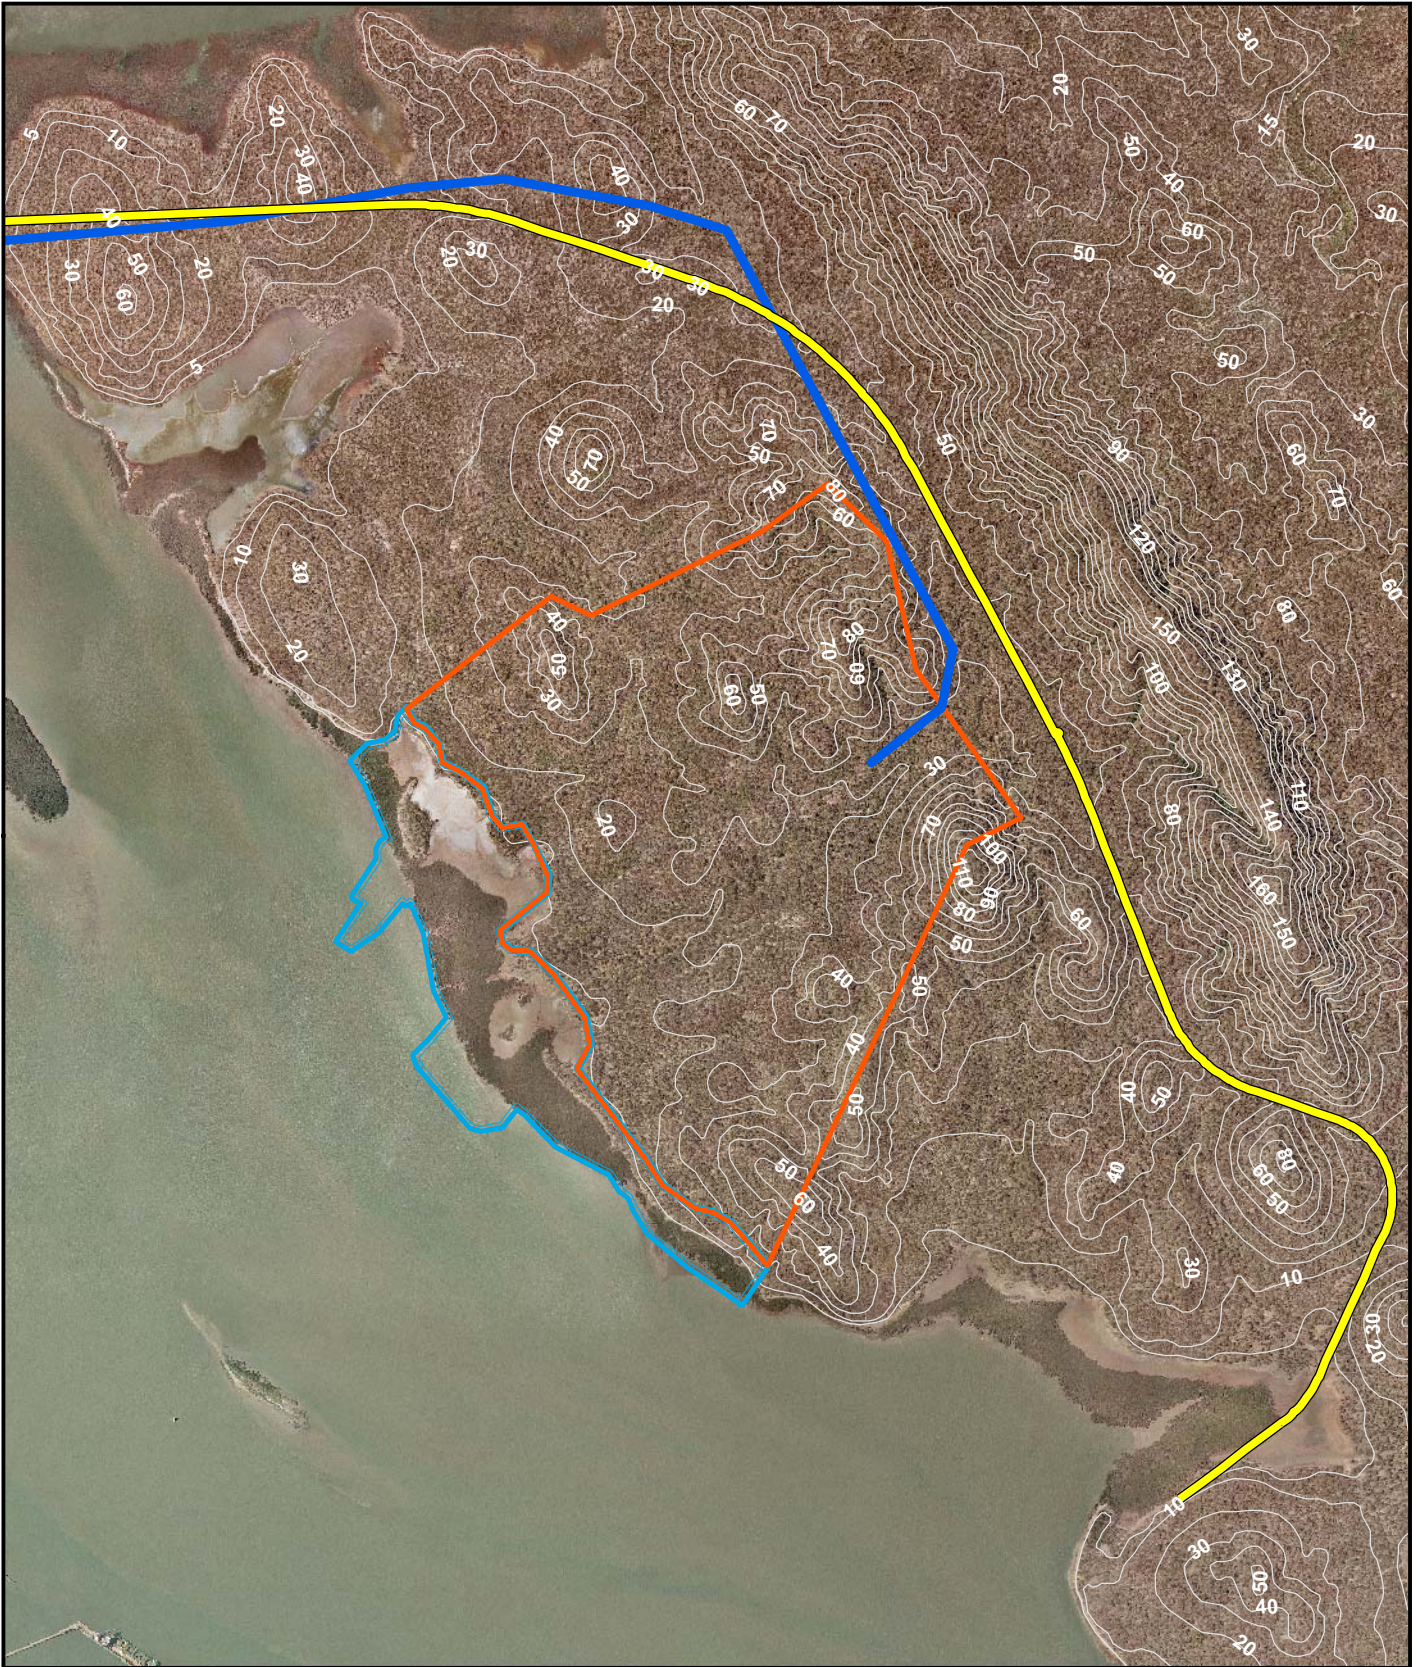
A BG Group business	Project <b>Queensland Curtis LNG Project</b>		Title <b>Topographic Map of QCLNG Site Area - Curtis Island</b>	
	Client <b>QGC - A BG Group business</b>

A topographic map showing the LNG Facility site and surrounds, including the proposed pipeline and road route, is provided in *Figure 5.3.1*.

The LNG Facility is located along the south-west coast of Curtis Island, in an area characterised by undulating hilly terrain. In general, the elevation across the site increases to the east (inland) from the coastal boundary of the LNG Facility, rising to an elevation of more than 80 m within the site near the eastern boundary. Immediately beyond the eastern site boundary a long valley runs south-east to north-west, with the proposed road and pipeline to be constructed roughly along the valley alignment.

Further to the east of the valley, and commencing approximately 350 m east of the eastern site boundary, a long ridgeline runs south-east to north-west extending almost from Graham Creek (northern end) to North China Bay. This ridgeline rises to approximately 145 m and forms a barrier separating the Curtis Island Industry Precinct of the Gladstone State Development Area

Both the proposed pipeline and road would make landfall on Curtis Island at Laird Point and head east for approximately 1.5 km through hilly terrain (up to approximately 40 m Australian Height Datum) before turning in a more southerly direction towards the back (eastern boundary) of the LNG Facility site.

From there, the road route runs south-east along the valley previously discussed, at the back of the LNG Facility, with the pipeline traversing the western side of the valley before climbing up to the eastern site boundary and entering the plant through a topographic saddle between two hills at the back of the LNG Facility site.

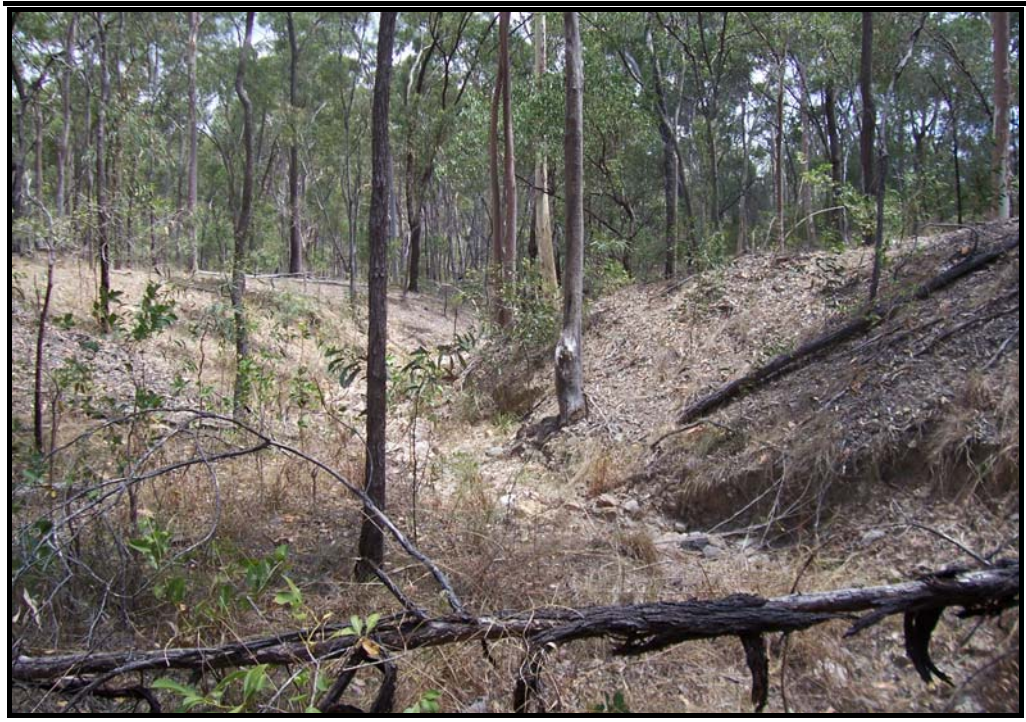
***Plate 5.3.1 Evidence of Erosion in the Upper Part of Watercourse (Flowing to the South)***

The creeks observed across the site generally range in width between 2 m and 5 m and typical depth of 0.5 m-1.5 m, but ranging up to more than 5 m in one watercourse in the upper slopes of the site towards the eastern site boundary. The watercourses exhibit variable degrees of erosion, with the upper reaches showing higher erosion than the lower reaches (*Plate 5.3.1*).

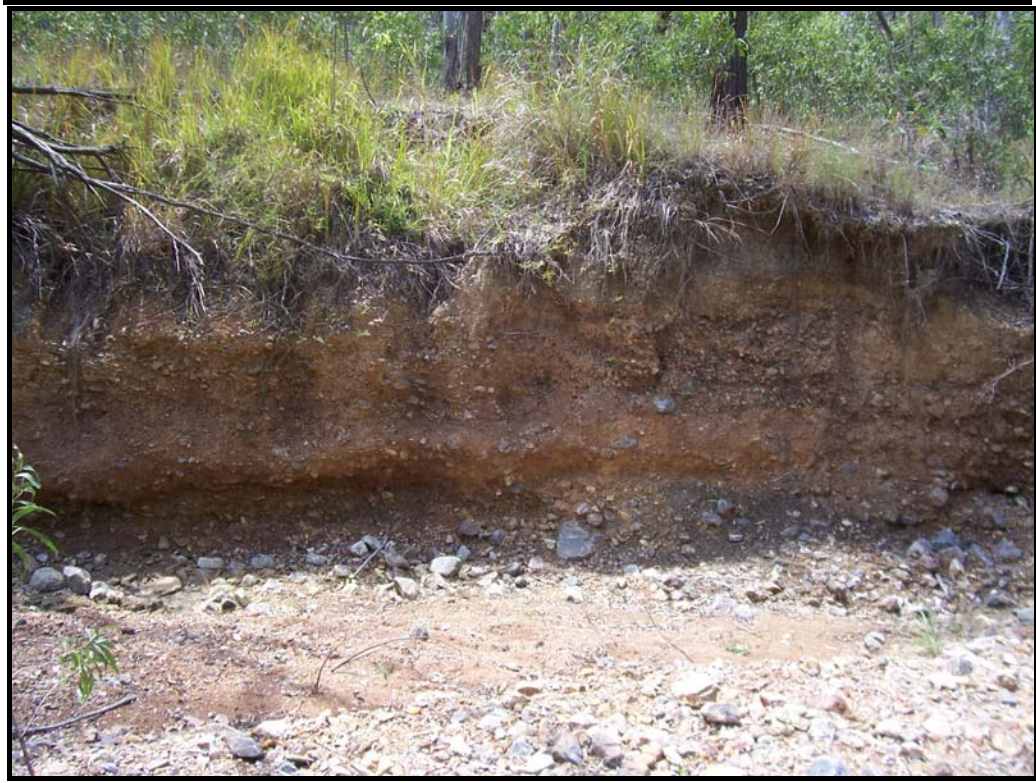
**Plate 5.3.2** *Erosion Along Creek Bank, Exposing Overlying Soil Profile Consisting of Overbank Alluvial Deposits*

Based on the evidence of erosion in several of the streams, it appears that erosion potential for the site exists, particularly during high rainfall events (*Plate 5.3.2*). Further detail on soil erosion potential is provided in *Volume 5, Chapter 4*.

The major factor influencing the development of landform characteristics across the site is water, with erosion of soils from runoff occurring as rills across the relatively flat sections of the site, and as water-driven erosion. The site contains a number of small watercourses, which occur between hills across the site and drain west to south-westwards towards the tidal flats on the western margin of the site. The watercourses are first and second order and exhibit variable degrees of bank erosion.

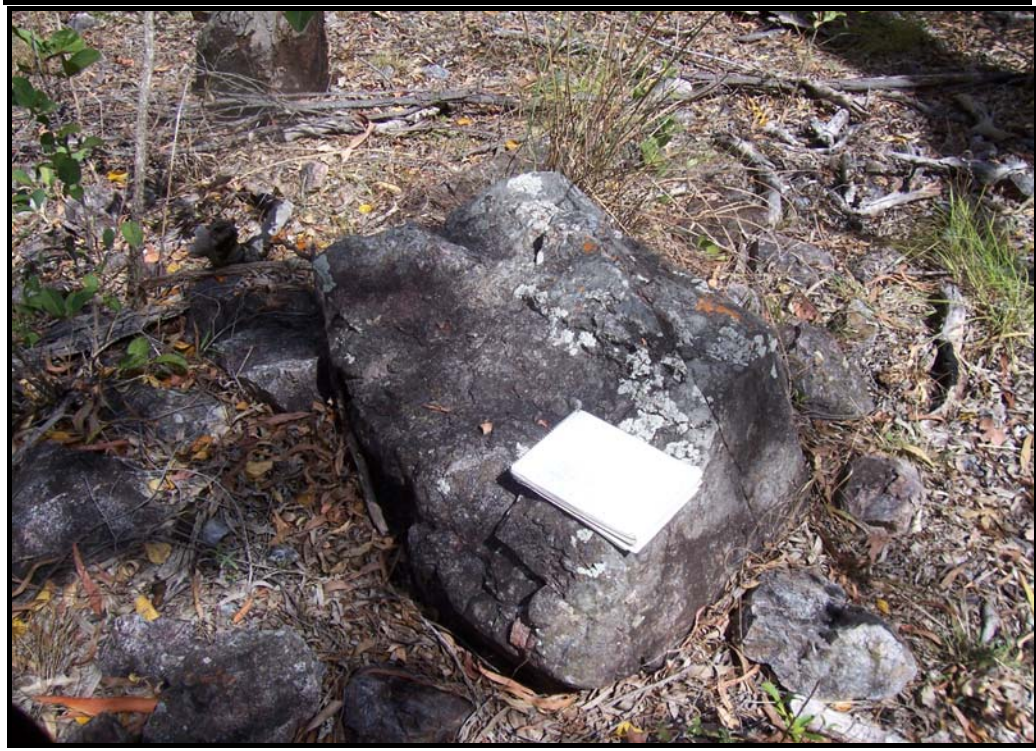
**Plate 5.3.3** *Outcrop of Dark Grey Blocky Indurated Mudstone of the Wandilla Formation, Curtis Island*

The exposed outcrop across the site was generally less than 5 per cent of the total area, with exposed bedrock limited to creeks and less commonly on higher ground on the top of hills. The majority of the site was covered with colluvium, which ranged in size from approximately 10 mm to 1 m. The distribution of clast sizes varied across the site, with most clasts ranging in size from 20 mm to 100 mm (refer *Plate 5.3.3*).
