**GOLD COAST QUARRY
ADDITIONAL INFORMATION TO THE ENVIRONMENTAL IMPACT STATEMENT**

Gold Coast Quarry

ROAD SAFETY REVIEW

Old Coach Road, Reedy Creek

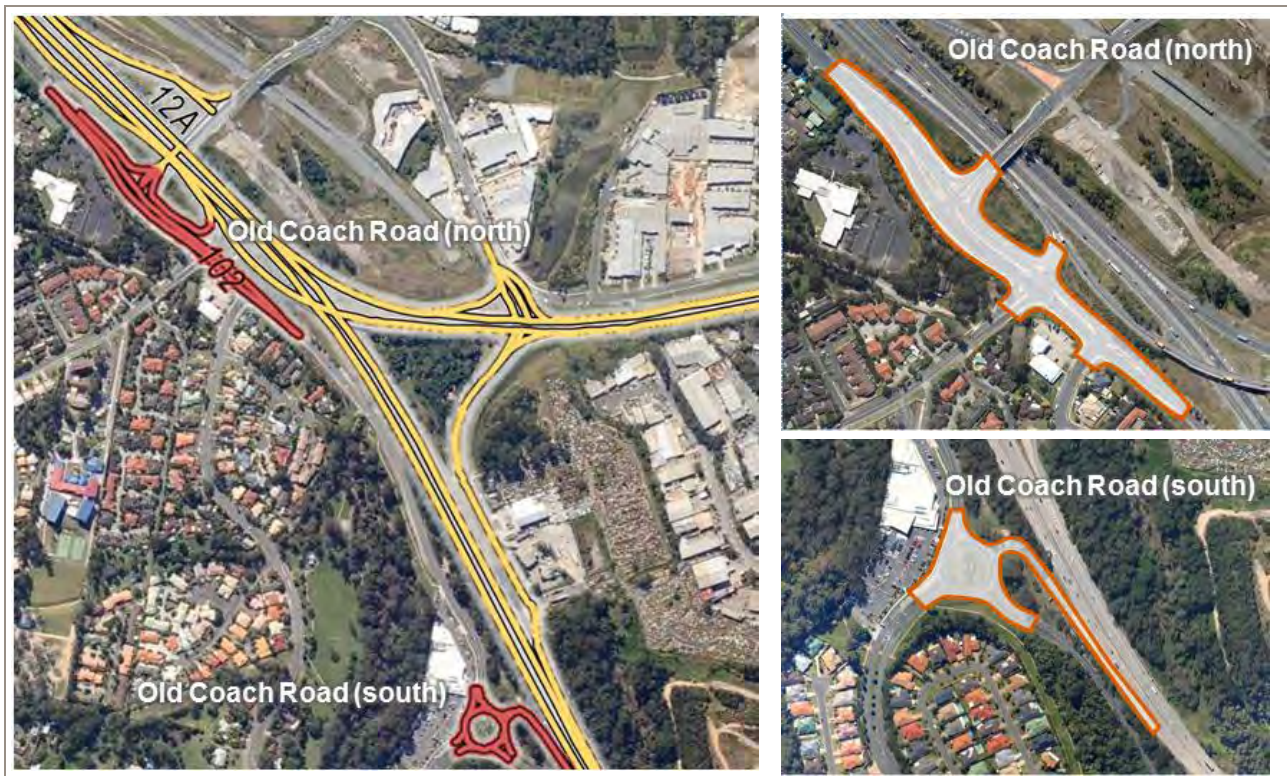
Figure 1-1 Scope of Road Safety Audit

Figure 1-1 indicates (in red) the geographical scope of the audit. The scope was limited to those sections and intersections on Old Coach Road that are State-controlled, including the northbound exit 85 off-ramp from the Pacific Motorway. For ease of reference, the audit references two sections: Old Coach Road (north) and Old Coach Road (south).

The area under review was inspected in daylight and darkness hours on 19 August 2013. The routes were driven a number of times in a light passenger vehicle and areas of concern were inspected on foot, where safe to do so.

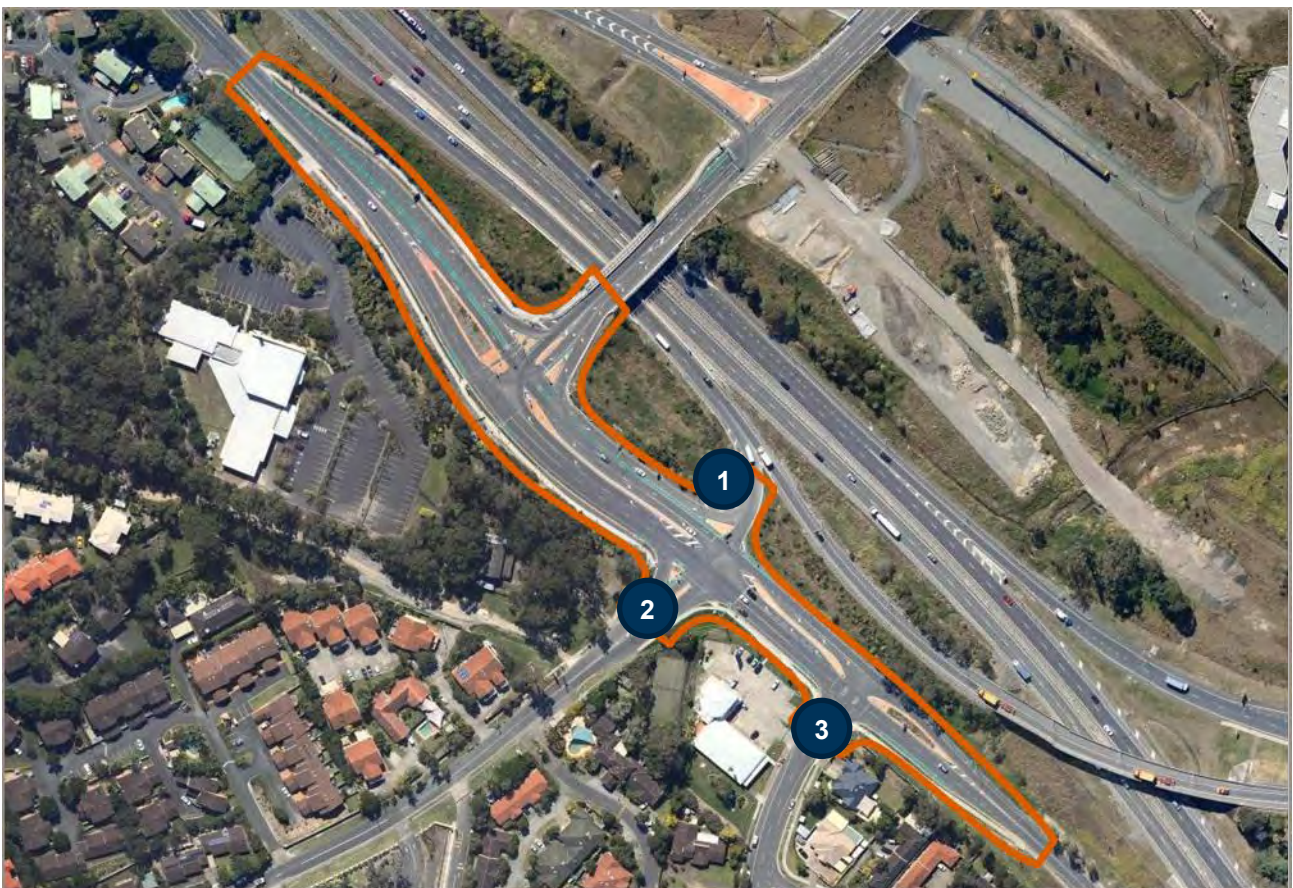
Figure 2-1 State-controlled Old Coach Road (north) Identified Issues

Location	Old Coach Road (northern approach) left turn slip lane to the northbound Pacific Motorway on-ramp, at the Old Coach Road/Bridgman Drive/On-ramp intersection		
Deficiency	Give Way line faded		
Risk	Vehicles may not perceive the need to give way at this location, with failure to give way potentially causing conflict with other vehicle movements.		
Recommendation	Repaint the Give Way line or consider using a thermoplastic material to reduce maintenance frequencies		
Priority	Low	Boral Presence	No

Location	Bridgman Drive approaching the Old Coach Road/Bridgman Drive/ On-ramp intersection		
Deficiency	Only three signal lanterns are provided for the through and right turn movements on the northbound approach		
Risk	May not provide a sufficient level of redundancy for the northbound movement		
Recommendation	Consider providing one additional lantern for the northbound approach signal group		
Priority	Low	Boral Presence	No

Location	Woodland Drive approaching the Old Coach Road/Woodland Drive intersection		
Deficiency	Stop sign rotated and Stop line faded		
Risk	Risk that vehicle may not detect the presence of the intersection or may not pay sufficient attention (as it may be considered as a Give Way controlled intersection)		
Recommendation	Re-orientate the Stop sign and repaint the Stop line (give consideration to using a thermoplastic material)		
Priority	Medium	Boral Presence	No

Location	Old Coach Road (northbound approach) to Old Coach Road/Kingsmore Boulevard/Off-ramp roundabout (approximately 150m in advance of the roundabout)		
Deficiency	Reduction in speed from 70km/h to 60km/h occurs on a curve and in close proximity to the reverse curves on the approach to roundabout		
Risk	Drivers may not have sufficient time to respond to the change in speed limit prior to negotiating the curves on approach to the roundabout		
Recommendation	Considering relocating the speed limit signage and pavement markings upstream to the straight section of Old Coach Road immediately prior to curve		
Priority	Low	Boral Presence	Yes

Location	Old Coach Road (northbound approach) to Old Coach Road/Kingsmore Boulevard/Off-ramp roundabout (approximately 150m in advance of the roundabout)		
Deficiency	Roundabout advisory sign is faded and offers a poor level of retro-reflectivity		
Risk	Drivers may not see the advisory sign at night or under adverse weather conditions and fail to anticipate the approach curves to the roundabout		
Recommendation	Replace sign		
Priority	Medium	Boral Presence	Yes

Location	Left hand side of Old Coach Road (northbound approach) to Old Coach Road/Kingsmore Boulevard/Off-ramp roundabout (approximately 20m prior to roundabout)		
Deficiency	Sharp drop off and unprotected culvert headwall located immediately outside the shoulder (within the clear zone)		
Risk	If an errant vehicle left the road at this location, there is a risk of loss of vehicle control		
Recommendation	Consider installing guardrail to shield the hazard		
Priority	Medium	Boral Presence	Yes

Location	Old Coach Road (northbound approach) to Old Coach Road/Kingsmore Boulevard/Off-ramp roundabout		
Deficiency	Median vegetation has grown to a height where it obscures the approach view of circulating traffic on the roundabout for approaching light/passenger vehicles		
Risk	Northbound vehicles may fail to observe/give way to circulating traffic on the roundabout, resulting in conflict/collision		
Recommendation	Trim the vegetation to a maximum height of 800mm above the road surface so that northbound drivers (in light vehicles) can observe circulating vehicles and their turn signals. Regularly maintain the vegetation to ensure that it does not grow high enough to obscure sight lights.		
Priority	Medium	Boral Presence	No

Location	Old Coach Road/Kingsmore Boulevard/Off-ramp roundabout		
Deficiency	Street lights in the middle of roundabout were not working		
Risk	Driver perception of the roundabout may be reduced at night time, increasing the potential for vehicles to fail to reduce approach speed or give way as required		
Recommendation	Repair street light		
Priority	Medium	Boral Presence	Yes

Location	Pacific Motorway northbound off-ramp (Exit 85)		
Deficiency	No guardrail present at the hairpin turn from the off-ramp (Exit 85)		
Risk	If an errant vehicle left the road on the hairpin, there is a risk of loss of control of vehicle or collision with the vegetation on the outside of the curve. It is likely that the existing vegetation will continue to grow and greater trunk diameters will pose an increased risk in the event of collision		
Recommendation	Consider installing guardrail along the outside of the hairpin curve		
Priority	Med	Boral Presence	Yes
