M0001 Waterway Locations and Assessments

M0001 – September 2020

Client: CuString 2.0
Reference: J0105

Title:	Waterway Locations and Assessment for M0001 – September 2020
Address:	
Job Number:	J0105
Client:	CuString 2.0

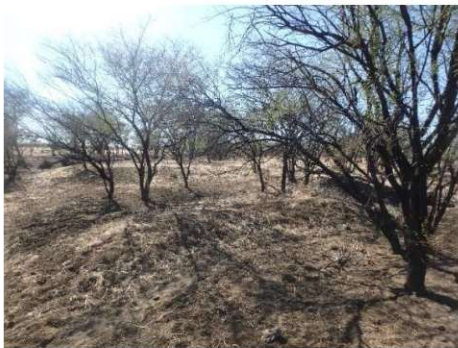
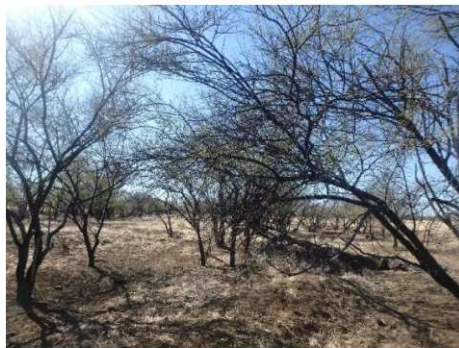
Left Bank	Right Bank

Desktop Mapping	Comment / Description
Vegetation Management Watercourse / Drainage (Vegetation Management Act, 1999)	
Stream Order	1
Waterway (Fisheries Act, 1994)	
Waterway	Absent
Watercourse Identification (Water Act, 2000)	
Watercourse / Drainage Feature / Unmapped	The watercourse location fits the definition of an unmapped Watercourse
Other Comments	
<p>Creek bed characteristics and vegetation characteristics: Area slightly undulating providing shallow depression for channelling water after rainfall. No riparian vegetation was observed in association with the watercourse. Severe erosion from cattle grazing was observed in the watercourse.</p> <p>Weed risk: <i>Vachellia nilotica</i>.*</p> <p>Current Aquatic Values: nil</p> <p>Vehicle / Construction access requirements: A crossing within the alignment is absent. Dry weather farm access track composed of clay is located to the south of the alignment. This track is accessed via Richmond Winton Road 15 km to the east. An extension of this track to the alignment could be completed largely without the removal of vegetation. Crossing of this watercourse would require minimal modification to the banks to be trafficable.</p>

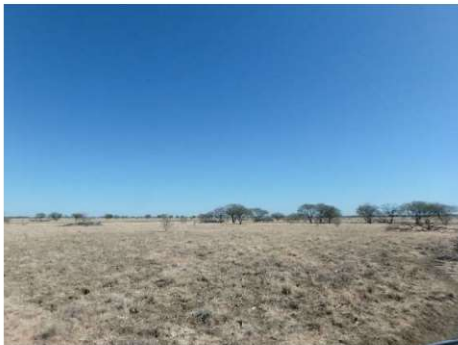
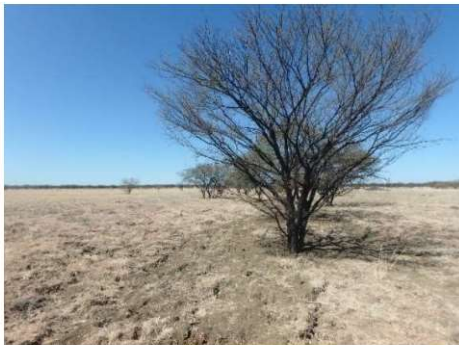
Upstream	Downstream

Desktop Mapping	Comment / Description
Vegetation Management Watercourse / Drainage (Vegetation Management Act, 1999)	
Stream Order	2
Waterway (Fisheries Act, 1994)	
Waterway	Absent
Watercourse Identification (Water Act, 2000)	
Watercourse / Drainage Feature / Unknown	The watercourse location fits the definition of an unmapped Watercourse
Other Comments	
<p>Creek bed characteristics and vegetation characteristics: Watercourse feature approximately 2m wide. Riparian vegetation absent. Watercourse feature infested with <i>Vachellia nilotica</i> and heavily grazed by cattle.</p> <p>Weed risk: <i>Vachellia nilotica</i>*</p> <p>Current Aquatic Values: nil</p> <p>Vehicle / Construction access requirements: A crossing within the alignment is absent. Dry weather farm access track composed of clay is located to the south of the alignment. This track is accessed via Richmond Winton Road 15 km to the east. An extension of this track to the alignment could be completed largely without the removal of vegetation. Crossing of this watercourse would require minimal modification to the banks to be trafficable.</p>

Left Bank	Right Bank
No watercourse bank present	No watercourse bank present

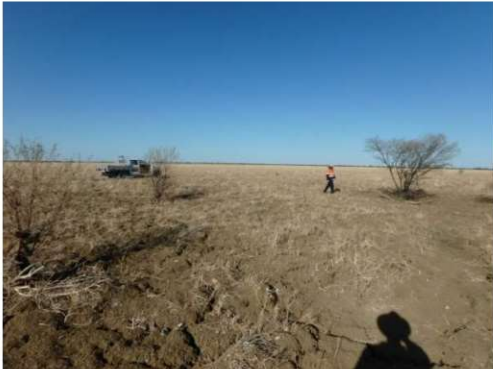
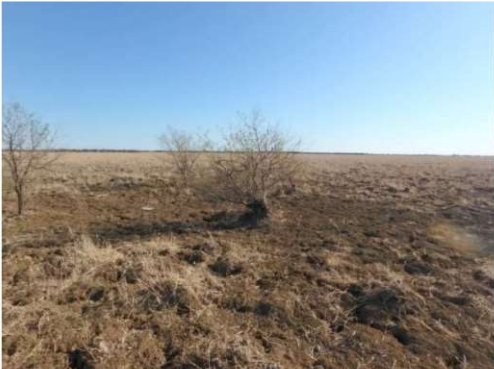
Left Bank	Right Bank

Desktop Mapping	Comment / Description
Vegetation Management Watercourse / Drainage (Vegetation Management Act, 1999)	
Stream Order	2
Waterway (Fisheries Act, 1994)	
Waterway	Low impact (green)
Watercourse Identification (Water Act, 2000)	
Watercourse / Drainage Feature / Unknown	The watercourse location fits the definition of an unmapped Watercourse
Other Comments	
<p>Creek bed characteristics and vegetation characteristics: Potential drainage feature. Area slightly undulating providing shallow depression for channelling water after rainfall. No riparian vegetation was observed in association with this feature.</p> <p>Weed risk: <i>Vachellia nilotica</i>.*</p> <p>Current Aquatic Values: nil</p> <p>Vehicle / Construction access requirements: A crossing within the alignment is absent. Dry weather farm access track composed of clay is located to the south of the alignment. This track is accessed via Richmond Winton Road 26.5 km to the east. An extension of this track to the alignment could be completed largely without the removal of vegetation. Crossing of this watercourse would require minimal modification to the banks to be trafficable.</p>

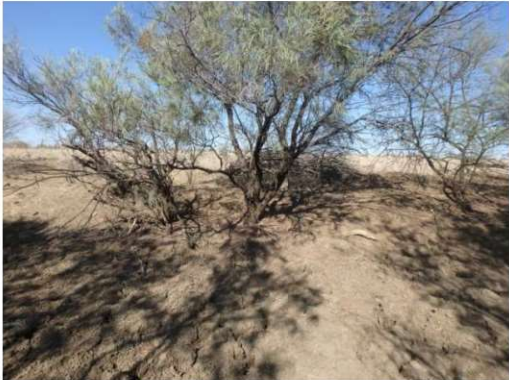
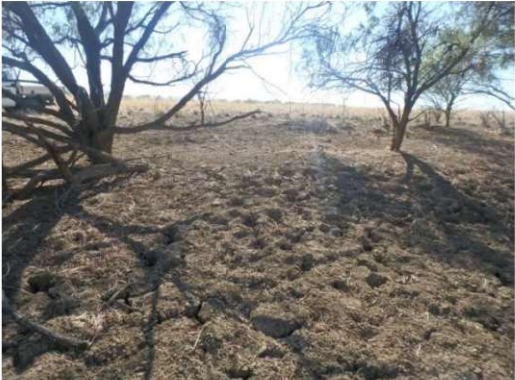
Left Bank	Right Bank

Desktop Mapping	Comment / Description
Vegetation Management Watercourse / Drainage (Vegetation Management Act, 1999)	
Stream Order	6
Waterway (Fisheries Act, 1994)	
Waterway	Major impact (purple)
Watercourse Identification (Water Act, 2000)	
Watercourse / Drainage Feature / Unknown	The watercourse location is defined as a mapped Watercourse
Other Comments	
<p>Creek bed characteristics and vegetation characteristics: Watercourse feature approximately 12m wide. Riparian vegetation includes <i>Alectryon oleifolius</i> and weed species. Watercourse feature heavily grazed by cattle and infested with <i>Vachellia nilotica</i> and <i>Parkinsonia aculeata</i>*</p> <p>Weed risk: <i>Vachellia nilotica</i>* and <i>Parkinsonia aculeata</i>*</p> <p>Current Aquatic Values: nil</p> <p>Vehicle / Construction access requirements: A crossing within the alignment is absent. Dry weather farm access track composed of clay is located to the southeast and southwest of the alignment. These tracks lead to the property boundaries. An extension of this track to the alignment could be completed largely without the removal of vegetation. Crossing of this watercourse would require minimal modification to the banks to be trafficable.</p>

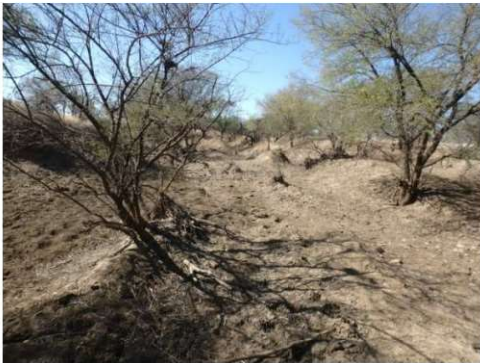
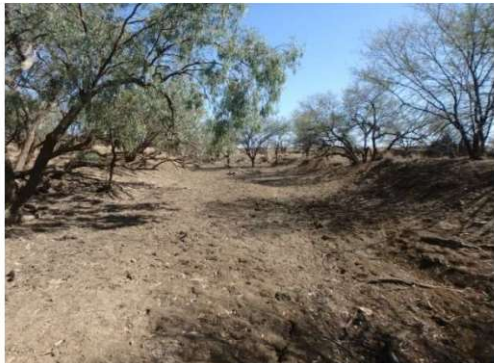
Upstream	Downstream

Desktop Mapping	Comment / Description
Vegetation Management Watercourse / Drainage (Vegetation Management Act, 1999)	
Stream Order	4
Waterway (Fisheries Act, 1994)	
Waterway	Major impact (purple)
Watercourse Identification (Water Act, 2000)	
Watercourse / Drainage Feature / Unknown	The watercourse location is defined as a mapped Watercourse
Other Comments	
<p>Creek bed characteristics and vegetation characteristics: Watercourse feature approximately 10-15m wide with some small overflow channels. Riparian vegetation includes <i>Eucalyptus coolabah</i>, <i>Apophyllum anomalum</i>, <i>Alectryon oleifolius</i>, <i>Ventilago viminalis</i> and weed species. Watercourse feature heavily grazed by cattle and infested with <i>Vachellia nilotica</i>.*</p> <p>Weed risk: <i>Vachellia nilotica</i>*</p> <p>Current Aquatic Values: nil</p> <p>Vehicle / Construction access requirements: A crossing within the alignment is absent. Dry weather farm access track composed of clay is located to the southeast and southwest of the alignment. These tracks lead to the property boundaries. An extension of this track to the alignment could be completed with minimal removal of vegetation. Crossing of this watercourse would require some modification to the banks to be trafficable, however some areas may require less modification than others.</p>

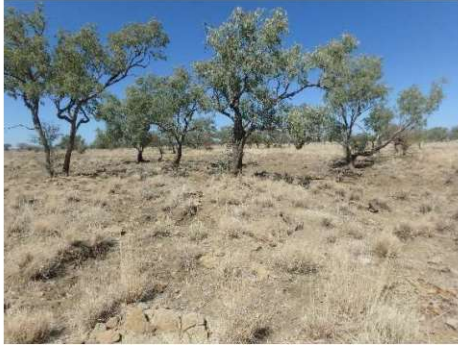
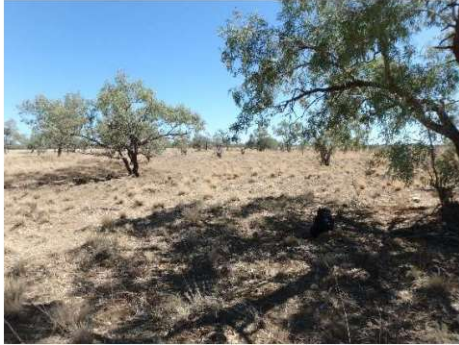
Left Bank	Right Bank

Desktop Mapping	Comment / Description
Vegetation Management Watercourse / Drainage (Vegetation Management Act, 1999)	
Stream Order	None
Waterway (Fisheries Act, 1994)	
Waterway	Absent
Watercourse Identification (Water Act, 2000)	
Watercourse / Drainage Feature / Unknown	The watercourse location is not defined.
Other Comments	
<p>Creek bed characteristics and vegetation characteristics: Potential drainage feature. Area slightly undulating providing shallow depression for channelling water after rainfall. No riparian vegetation was observed in association with this feature.</p> <p>Weed risk: nil</p> <p>Current Aquatic Values: nil</p> <p>Vehicle / Construction access requirements: Currently, a crossing within the alignment is absent. Dry weather farm access track composed of clay is located to the north of the alignment. This track is accessed via Mt Isa Road 12 km to the north. An extension of this track to the alignment could be completed largely without the removal of vegetation. Crossing of this watercourse would require minimal modification to the banks to be trafficable.</p>

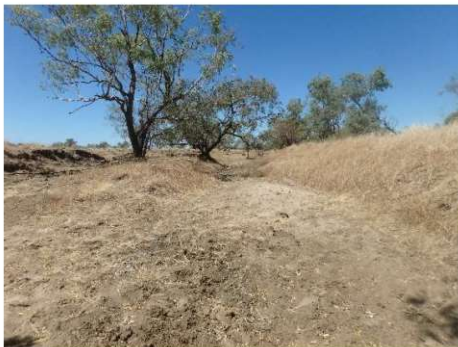
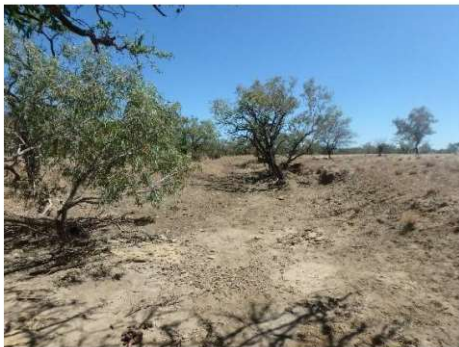
Upstream	Downstream

Desktop Mapping	Comment / Description
Vegetation Management Watercourse / Drainage (Vegetation Management Act, 1999)	
Stream Order	6
Waterway (Fisheries Act, 1994)	
Waterway	Major impact (purple)
Watercourse Identification (Water Act, 2000)	
Watercourse / Drainage Feature / Unknown	The watercourse location fits the definition of Watercourse
Other Comments	
<p>Creek bed characteristics and vegetation characteristics: Part of larger braided waterway. Shallow sided banks with a clay dominated bed with few rocks. <i>Eucalyptus coolabah</i> and <i>Lysiphyllum sp.</i> form a limited riparian strip of vegetation.</p> <p>Weed risk: nil</p> <p>Current Aquatic Values: nil</p> <p>Vehicle / Construction access requirements: A crossing within the alignment is absent. Dry weather farm access track composed of clay is located to the north of the alignment. This track is accessed via Mt Isa Road 12 km to the north. An extension of this track to the alignment could be completed minimal removal of vegetation. Crossing of this watercourse would require modification to the banks to be trafficable.</p>

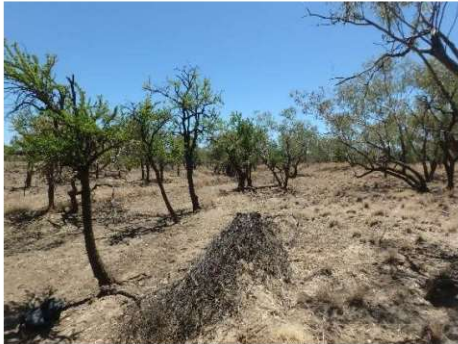
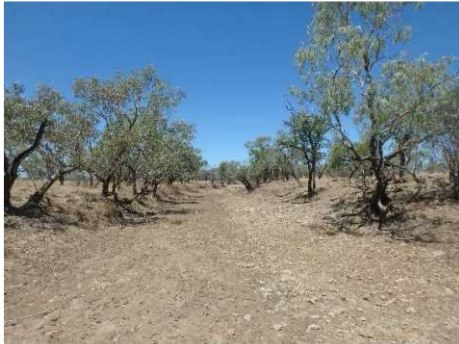
Upstream	Downstream

Desktop Mapping	Comment / Description
Vegetation Management Watercourse / Drainage (Vegetation Management Act, 1999)	
Stream Order	6
Waterway (Fisheries Act, 1994)	
Waterway	Major impact (purple)
Watercourse Identification (Water Act, 2000)	
Watercourse / Drainage Feature / Unknown	The watercourse location fits the definition of Watercourse
Other Comments	
<p>Creek bed characteristics and vegetation characteristics: Part of larger braided waterway. Shallow sided banks with a clay dominated bed with gravel and rocks. <i>Eucalyptus coolabah</i> and <i>Lysiphyllum sp.</i> form a limited riparian strip of vegetation.</p> <p>Weed risk: nil</p> <p>Current Aquatic Values: nil</p> <p>Vehicle / Construction access requirements: A crossing within the alignment is absent. Dry weather farm access track composed of clay is located to the north of the alignment. This track is accessed via Mt Isa Road 13 km to the north. An extension of this track to the alignment would require crossing other braided sections of this watercourse. Removal of riparian vegetation would be required. Crossing of this watercourse would require minor modification to the banks to be trafficable.</p>

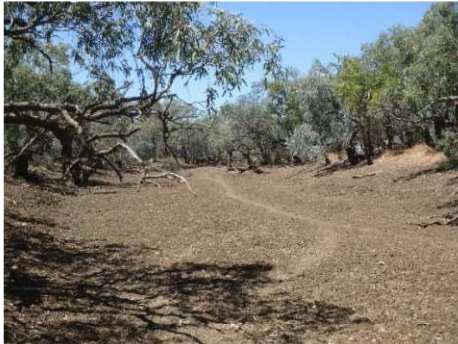
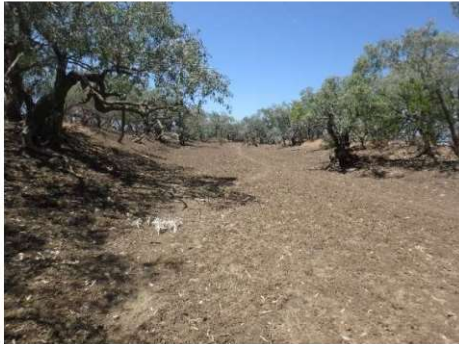
Upstream	Downstream

Desktop Mapping	Comment / Description
Vegetation Management Watercourse / Drainage (Vegetation Management Act, 1999)	
Stream Order	5
Waterway (Fisheries Act, 1994)	
Waterway	Major impact (purple)
Watercourse Identification (Water Act, 2000)	
Watercourse / Drainage Feature / Unknown	The watercourse location fits the definition of Watercourse
Other Comments	
<p>Creek bed characteristics and vegetation characteristics: Part of larger braided waterway. Shallow sided banks with a clay dominated bed with gravel and rocks. <i>Eucalyptus coolabah</i> and <i>Lysiphyllum sp.</i> form a riparian strip of vegetation. Heavily grazed banks.</p> <p>Weed risk: nil</p> <p>Current Aquatic Values: nil</p> <p>Vehicle / Construction access requirements: A crossing within the alignment is absent. Dry weather farm access track composed of clay is located to the north of the alignment. This track is accessed via Mt Isa Road 13.5 km to the north. An extension of this track to the alignment would require crossing other braided sections of this watercourse. Removal of riparian vegetation would be required. Crossing of this watercourse would require minor modification to the banks to be trafficable.</p>

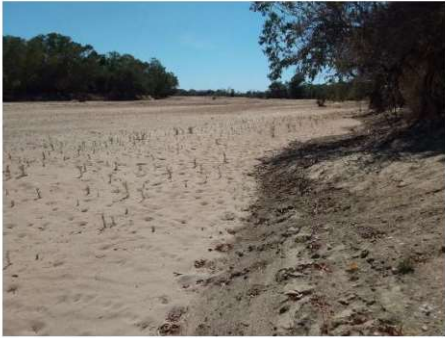
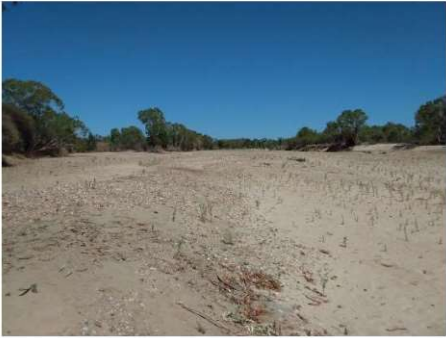
Upstream	Downstream

Desktop Mapping	Comment / Description
Vegetation Management Watercourse / Drainage (Vegetation Management Act, 1999)	
Stream Order	6
Waterway (Fisheries Act, 1994)	
Waterway	Major impact (purple)
Watercourse Identification (Water Act, 2000)	
Watercourse / Drainage Feature / Unknown	The watercourse location fits the definition of a Watercourse.
Other Comments	
<p>Creek bed characteristics and vegetation characteristics: Watercourse with coarse sandy 95m wide channel bed and eroded banks due to cattle ingress. Fringing riparian vegetation on banks and within central sand bars. Riparian canopy vegetation dominated by <i>Eucalyptus camaldulensis</i>, <i>Allocasuarina</i> sp., with dense coverage of exotic tall shrubs.</p> <p>Weed risk: Shrub layer a dense coverage of <i>Vachellia nilotica</i>* and <i>Prosopis</i> sp.*</p> <p>Current Aquatic Values: nil</p> <p>Vehicle / Construction assess requirements: The southern bank of the river is steep and eroded and would require modification for vehicles to traverse. An existing access track is located 800m to the east. Open paddocks to the south can be crossed in dry weather via Hughenden Riverside Road.</p>

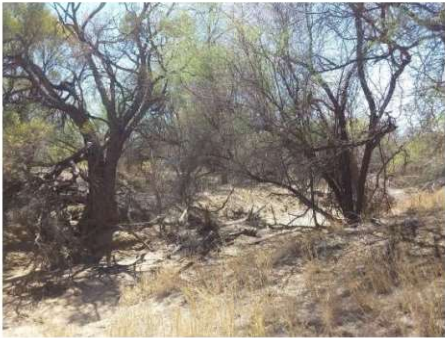
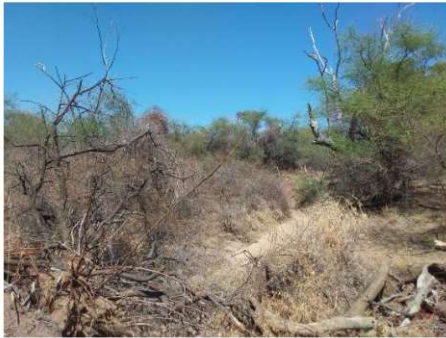
Upstream	Downstream

Desktop Mapping	Comment / Description
Vegetation Management Watercourse / Drainage (Vegetation Management Act, 1999)	
Stream Order	2
Waterway (Fisheries Act, 1994)	
Waterway	Low impact (green)
Watercourse Identification (Water Act, 2000)	
Watercourse / Drainage Feature / Unknown	The watercourse location fits the definition of an unmapped Watercourse.
Other Comments	
<p>Creek bed characteristics and vegetation characteristics: Watercourse with 3m wide clay channel bed containing modified banks due to cattle ingress, track and fence upgrades. Alignment co-insides with existing access track. Vegetation on banks with dense coverage of exotic tall shrubs. Scattered <i>Eucalyptus coolibah</i> also occur along the top of banks.</p> <p>Weed risk: <i>Prosopis sp.*</i> and <i>Vachellia nilotica*</i> at top of bank and within bed.</p> <p>Current Aquatic Values: nil</p> <p>Vehicle / Construction assess requirements – An existing access track is located within the alignment which has been upgraded recently. No modifications are required for access.</p>

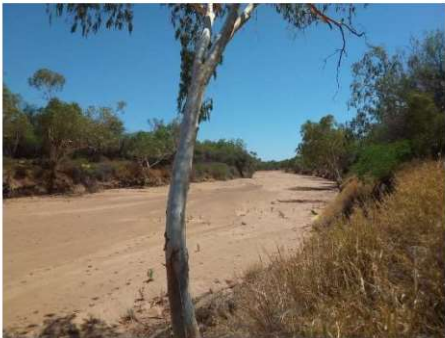
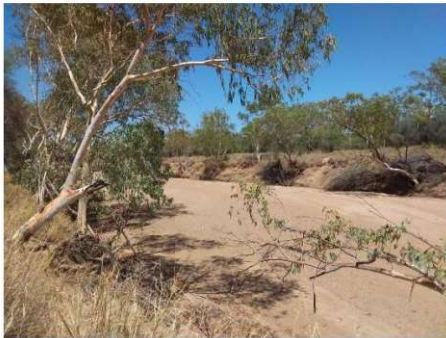
Upstream	Downstream

Desktop Mapping	Comment / Description
Vegetation Management Watercourse / Drainage (Vegetation Management Act, 1999)	
Stream Order	6
Waterway (Fisheries Act, 1994)	
Waterway	High impact (red)
Watercourse Identification (Water Act, 2000)	
Watercourse / Drainage Feature / Unknown	The watercourse location fits the definition of a Watercourse.
Other Comments	
<p>Creek bed characteristics and vegetation characteristics: Steep sided watercourse with 38m wide sandy gravel channel bed containing minimal modification by cattle grazing. Riparian canopy vegetation dominated by <i>Eucalyptus camaldulensis</i> with a dense coverage of exotic tall shrubs.</p> <p>Weed risk: <i>Prosopis sp.*</i> and <i>Vachellia nilotica*</i> at top of bank.</p> <p>Current Aquatic Values: nil</p> <p>Vehicle / Construction assess requirements – Major modifications would be required to span this waterway. Steep sided banks would require bank works to reduce gradient. No major access tracks cross this waterway within the vicinity of the alignment. Accessing the southern bank could be accomplished by utilising the access track associated with the previous waterway assessment (W3-2) which passes within 50m. The northern bank would be accessed via properties along Canterbury Plains Road.</p>

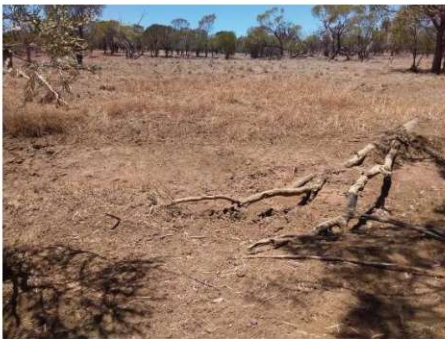
Cross section

Desktop Mapping	Comment / Description
Vegetation Management Watercourse / Drainage (Vegetation Management Act, 1999)	
Stream Order	3
Waterway (Fisheries Act, 1994)	
Waterway	Low impact (green)
Watercourse Identification (Water Act, 2000)	
Watercourse / Drainage Feature / Unknown	The watercourse location fits the definition of an unmapped Watercourse.
Other Comments	
<p>Creek bed characteristics and vegetation characteristics: Watercourse with 3m wide cracking clay channel bed. Seasonal pools up and downstream. Contains banks modified by cattle grazing. Adjacent vegetation dominated by <i>Acacia tephрина</i> and very scattered <i>Eucalyptus coolibah</i>.</p> <p>Weed risk: <i>Parkinsonia aculeata</i> observed nearby.</p> <p>Current Aquatic Values: nil</p> <p>Vehicle / Construction assess requirements: A crossing within the alignment is absent. This channel is on average 1m in depth. Minor modifications to bank gradients and approaches would enable small vehicular access in the dry season. Minimal removal of vegetation would be required. Nearest vehicular access is off Torver Valley Road.</p>

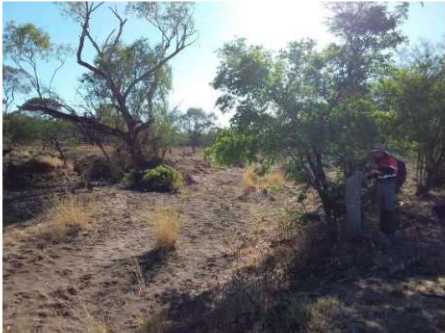
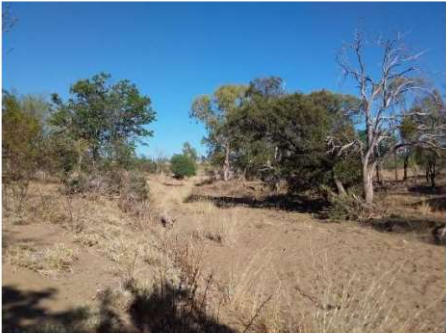
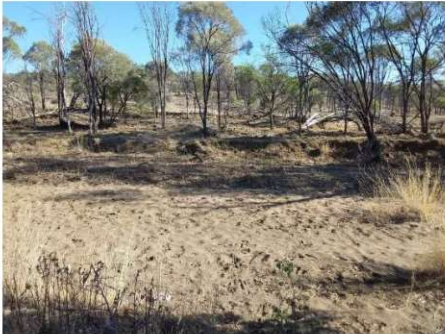
Desktop Mapping	Comment / Description
Vegetation Management Watercourse / Drainage (Vegetation Management Act, 1999)	
Stream Order	2
Waterway (Fisheries Act, 1994)	
Waterway	Low impact (green)
Watercourse Identification (Water Act, 2000)	
Watercourse / Drainage Feature / Unknown	The watercourse location fits the definition of an unmapped Watercourse.
Other Comments	
<p>Creek bed characteristics and vegetation characteristics: Watercourse with 11m wide sandy gravel channel bed and pools downstream. Contains banks modified by cattle grazing. Riparian vegetation composed of scattered <i>Eucalyptus camaldulensis</i>, <i>Eucalyptus coolibah</i> and <i>Lysiphyllum hookeri</i>.</p> <p>Weed risk: weed species not observed.</p> <p>Current Aquatic Values: nil</p> <p>Vehicle / Construction assess requirements: A crossing within the alignment is absent. A well-defined dry weather farm access track composed of clay is located 600m to the west of the alignment. This track is accessed via Torver Valley Road and crosses several other watercourses before it terminates at a stock watering point. A extension of this track to the alignment could be completed with some removal of vegetation.</p> <p>This channel is on average 0.5 to 1m in depth. Minor modifications to bank gradients and approaches would enable vehicular access in the dry season. Minimal removal of vegetation would be required.</p>

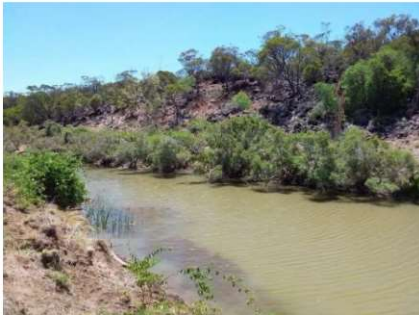
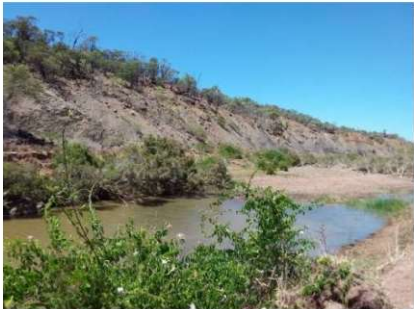
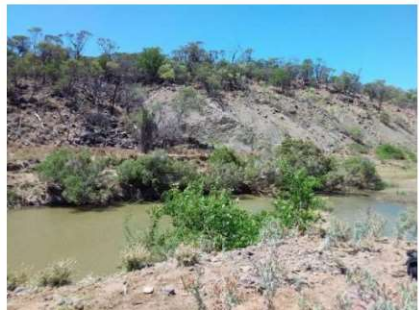
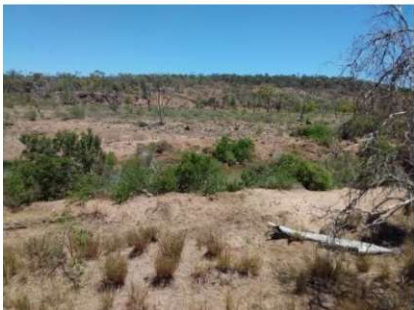
1.7 Betts Gorge Creek - Watercourse W3-7

Desktop Mapping	Comment / Description
Vegetation Management Watercourse / Drainage (Vegetation Management Act, 1999)	
Stream Order	4
Waterway (Fisheries Act, 1994)	
Waterway	Red - Present
Watercourse Identification (Water Act, 2000)	
Watercourse / Drainage Feature / Unknown	The watercourse location fits the definition of an unmapped Watercourse.
Other Comments	
<p>Creek bed characteristics and vegetation characteristics: Watercourse with 22m wide sandy gravel channel bed, regular bedrock exposed pools separated by sandy riffles. Elsewhere gravel and cobble banks modified by cattle grazing. Riparian vegetation composed of scattered <i>Melaleuca bracteata</i> with clumps of <i>Juncus</i> and other rushes.</p> <p>Weed risk: Rubber vine (<i>Cryptostegia grandiflora</i>) observed in riparian vegetation.</p> <p>Current Aquatic Values: macrophytes and bank reeds present. <i>Melaleuca</i> riparian species scattered along southern bank</p> <p>Vehicle / Construction assess requirements: A crossing within the alignment is absent. A very steep southern bank would require major modifications to provide a crossing point within the alignment. A potential crossing point may be possible 500m to the west. This would still require the establishment of access tracks across rocky basalt plateaus and modification of the stream bank downstream.</p> <p>Access tracks for this site are via the Kennedy Development Road to the east. The access track crosses the Flinders River within a kilometre of the main road (-20.658402, 144.384846). A second access track crossing (-20.624624, 144.276114) may also require upgrading to allow access.</p>

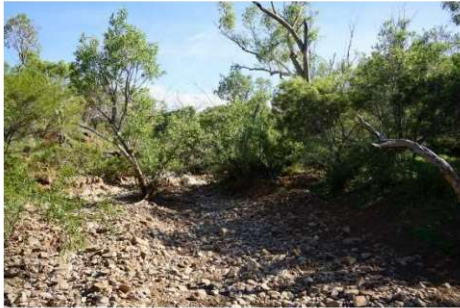
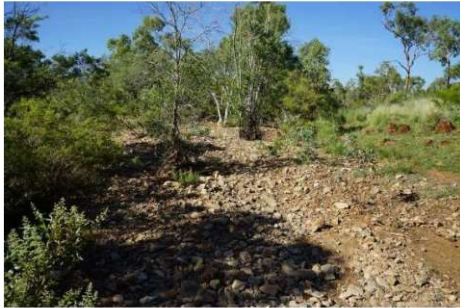
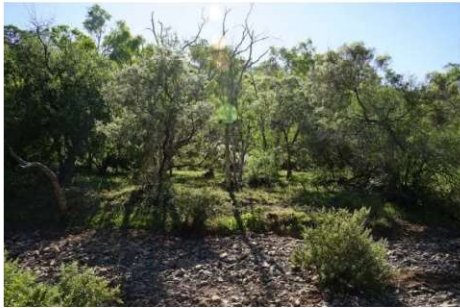
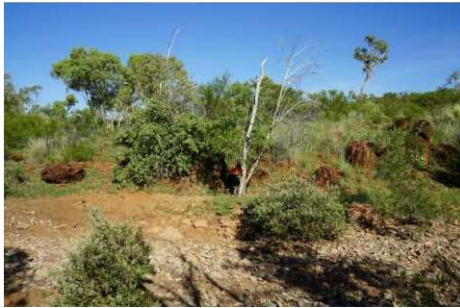
Desktop Mapping	Comment / Description
Vegetation Management Watercourse / Drainage (<i>Vegetation Management Act, 1999</i>)	
Stream Order	3
Waterway (<i>Fisheries Act, 1994</i>)	
Waterway	Low impact (green)
Watercourse Identification (<i>Water Act, 2000</i>)	
Watercourse / Drainage Feature / Unknown	The watercourse location fits the definition of an unmapped Watercourse.
Other Comments	
<p>Creek bed characteristics and vegetation characteristics: Ephemeral watercourse 50m wide with 12m wide low flow channel. Riparian vegetation on banks and within central sand bars.</p> <p>Weed risk: nil</p> <p>Current Aquatic Values: nil</p> <p>Vehicle / Construction access requirements: A crossing within the alignment is absent. This channel is on average less than 1m in depth. Minor modifications to bank gradients and approaches would enable vehicular access in the dry season. Removal of riparian vegetation would be required. Existing unsealed access track 680m to the west.</p>

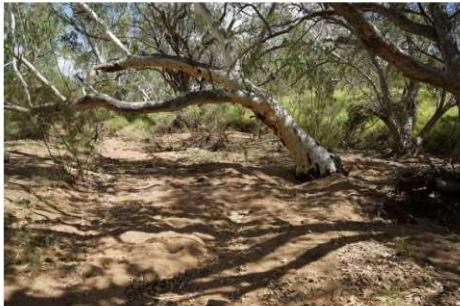
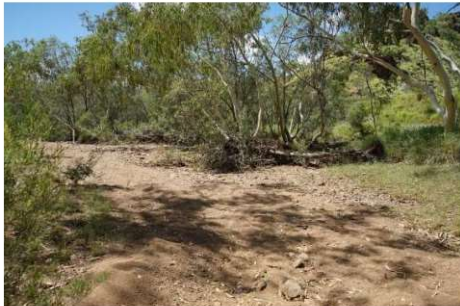
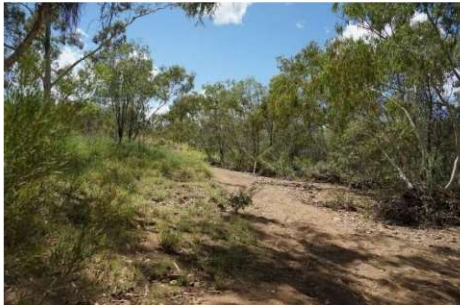
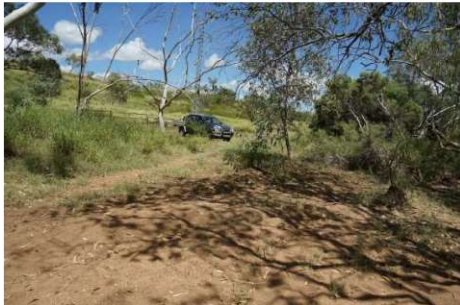
1.2 Watercourse W4-2

Desktop Mapping	Comment / Description
Vegetation Management Watercourse / Drainage (<i>Vegetation Management Act, 1999</i>)	
Stream Order	3
Waterway (<i>Fisheries Act, 1994</i>)	
Waterway	Moderate impact (amber)
Watercourse Identification (<i>Water Act, 2000</i>)	
Watercourse / Drainage Feature / Unknown	The watercourse location fits the definition of an unmapped Watercourse.
Other Comments	
<p>Creek bed characteristics and vegetation characteristics: Ephemeral watercourse 45m wide with narrow braided low flow channels. Riparian vegetation on sandy banks and within central sand bars. Trees to 15m in height.</p> <p>Weed risk: nil</p> <p>Current Aquatic Values: nil</p> <p>Vehicle / Construction access requirements: A crossing within the alignment is absent. A shallow channel with gradual bank slopes. Minor modifications to bank slopes and approaches would enable vehicular access during the dry season. Removal of riparian vegetation would be required. Existing unsealed access track 50m to the west and the Barkly Highway is 150m to the south.</p>

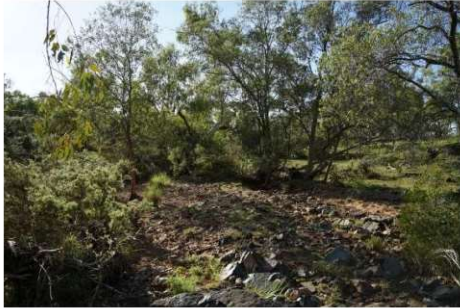
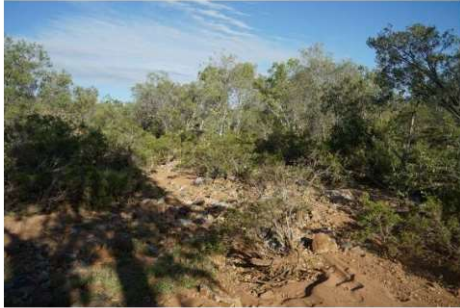
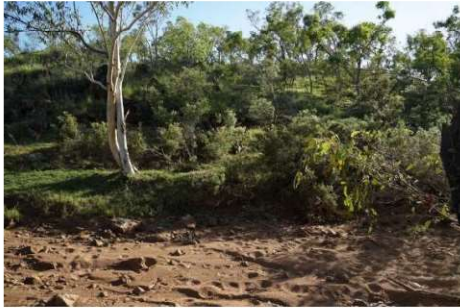
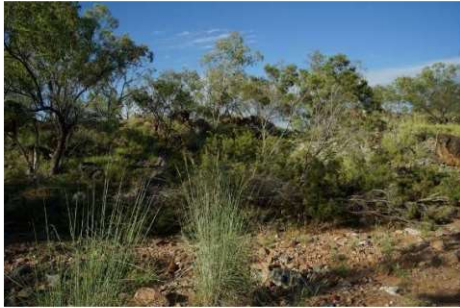
1.3 Watercourse W4-3

Desktop Mapping	Comment / Description
Vegetation Management Watercourse / Drainage (<i>Vegetation Management Act, 1999</i>)	
Stream Order	4
Waterway (<i>Fisheries Act, 1994</i>)	
Waterway	Moderate impact (amber)
Watercourse Identification (<i>Water Act, 2000</i>)	
Watercourse / Drainage Feature / Unknown	The watercourse location fits the definition of an unmapped Watercourse.
Other Comments	
<p>Creek bed characteristics and vegetation characteristics: Ephemeral watercourse 45m wide with narrow braided low flow channels. Riparian vegetation on sandy banks and within central sand bars. Trees to 16m in height. Numerous hollows observed.</p> <p>Weed risk: nil</p> <p>Current Aquatic Values: nil</p> <p>Vehicle / Construction access requirements: A crossing within the alignment is absent. A shallow channel with gradual bank slopes. Minor modifications to bank slopes and approaches would enable vehicular access during the dry season. Removal of riparian vegetation would be required. Existing unsealed access track 50m to the west and the Barkley Highway is 220m to the south.</p>

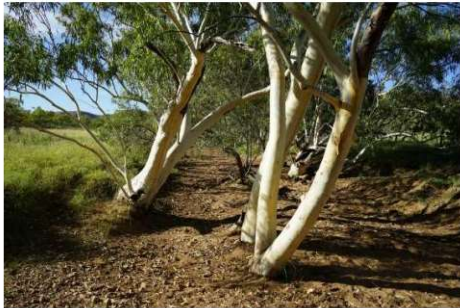
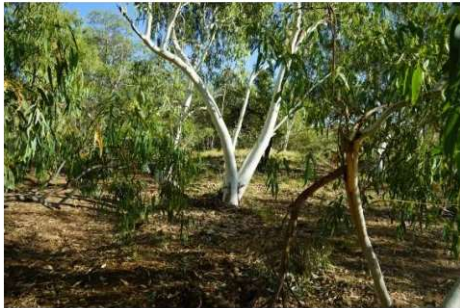
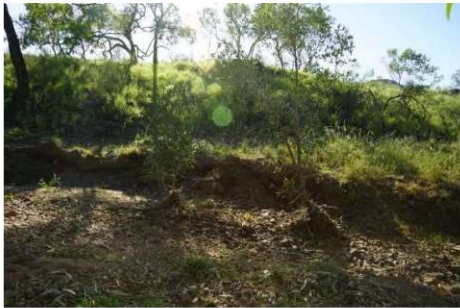
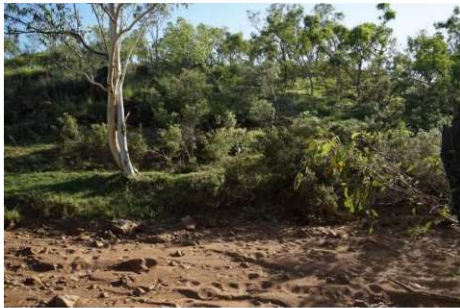
1.4 Watercourse W4-4

Desktop Mapping	Comment / Description
Vegetation Management Watercourse / Drainage (<i>Vegetation Management Act, 1999</i>)	
Stream Order	3
Waterway (<i>Fisheries Act, 1994</i>)	
Waterway	Low impact (green)
Watercourse Identification (<i>Water Act, 2000</i>)	
Watercourse / Drainage Feature / Unknown	The watercourse location fits the definition of an unmapped Watercourse.
Other Comments	
<p>Creek bed characteristics and vegetation characteristics: Ephemeral watercourse 20m wide with narrow braided low flow channels. Riparian vegetation on rock/sandy banks and within central sand bars. Trees to 16m in height. Numerous hollows in <i>Eucalyptus camaldulensis</i> observed.</p> <p>Weed risk: Minimal weed risk</p> <p>Current Aquatic Values: nil</p> <p>Vehicle / Construction access requirements: A crossing within the alignment is absent. A shallow channel over a small bench continuing to moderately inclined slopes. Minor modifications to bank slopes and approaches would enable vehicular access during the dry season. Removal of riparian vegetation would be required. The nearest recorded access track is 500m to the north with the Barkly Highway an additional 400m onwards from the access track.</p>

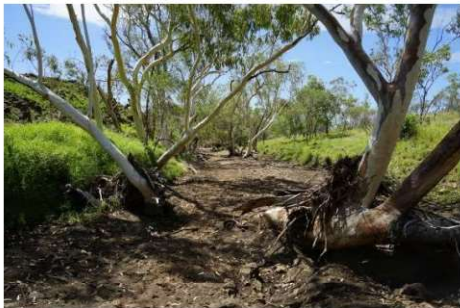
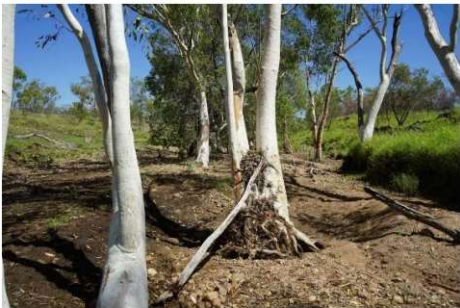
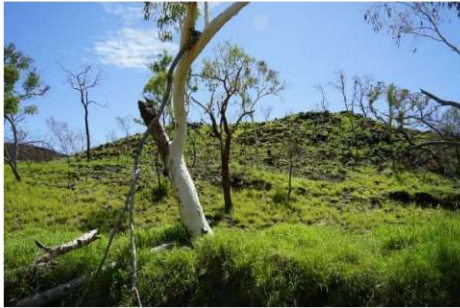
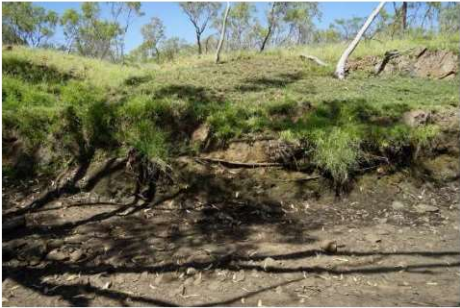
1.5 Watercourse W4-5

Desktop Mapping	Comment / Description
Vegetation Management Watercourse / Drainage (<i>Vegetation Management Act, 1999</i>)	
Stream Order	3
Waterway (<i>Fisheries Act, 1994</i>)	
Waterway	Low impact (green)
Watercourse Identification (<i>Water Act, 2000</i>)	
Watercourse / Drainage Feature / Unknown	The watercourse location fits the definition of an unmapped Watercourse.
Other Comments	
<p>Creek bed characteristics and vegetation characteristics: Ephemeral watercourse 33m wide with narrow braided low flow channels. Riparian vegetation on rock/sandy banks and within central sand bars. Trees to 12m in height. Numerous hollows in <i>Eucalyptus camaldulensis</i> observed.</p> <p>Weed risk: minimal weed risk</p> <p>Current Aquatic Values: nil</p> <p>Vehicle / Construction access requirements: A crossing within the alignment is absent. A shallow channel with shallow steep banks transitioning to gentle/moderate slopes. Minor modifications to bank slopes and approaches would enable vehicular access during the dry season. Removal of riparian vegetation would be required. The nearest recorded access track is 550m to the north with the Barkly Highway an additional 500m onwards from the access track. Access to the alignment may necessitate crossing this watercourse on several occasions.</p>

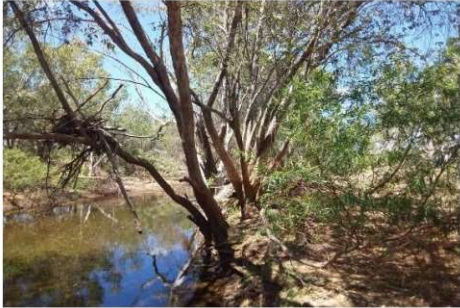
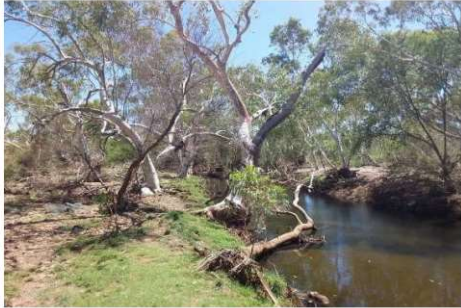
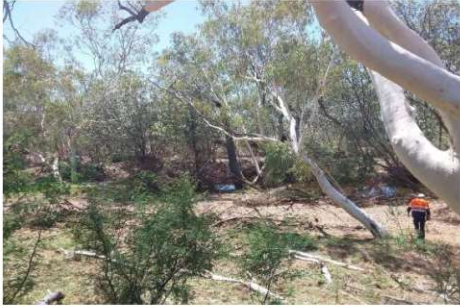
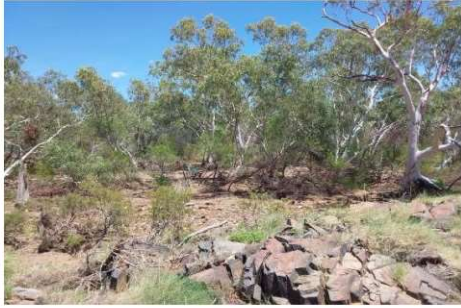
1.6 Leichhardt River (east branch) - Watercourse W4-6

Desktop Mapping	Comment / Description
Vegetation Management Watercourse / Drainage (<i>Vegetation Management Act, 1999</i>)	
Stream Order	5
Waterway (<i>Fisheries Act, 1994</i>)	
Waterway	High impact (red)
Watercourse Identification (<i>Water Act, 2000</i>)	
Watercourse / Drainage Feature / Unknown	The watercourse location fits the definition of a mapped Watercourse.
Other Comments	
<p>Creek bed characteristics and vegetation characteristics: Large flowing watercourse 85m wide containing large pool and flowing rocky runs up and downstream. Fringing riparian vegetation containing 18m high <i>Eucalyptus camaldulensis</i>. Major watercourse with scattered rocky bed sections.</p> <p>Weed risk: <i>Vachellia nilotica</i> observed.</p> <p>Current Aquatic Values: Aquatic flora, algae and macrophyte absent. Small fish observed.</p> <p>Vehicle / Construction access requirements: A crossing within the alignment is absent. Removal of a wide riparian corridor would be required if crossing at the alignment. However, an existing crossing is located 400m to the south allowing access to both sides of the watercourse within the alignment. Selective widening and minor tree clearing may be required to improve access using the existing access crossing.</p>

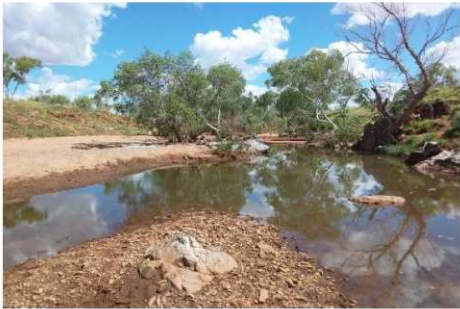
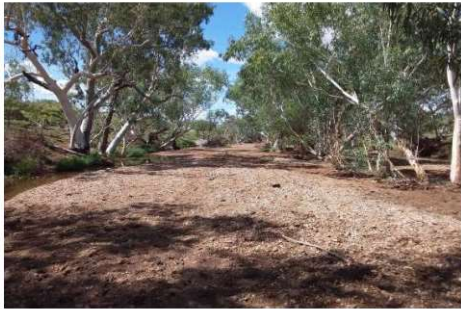
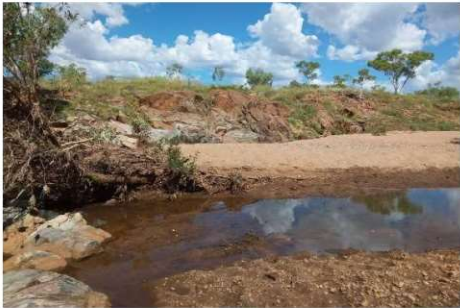
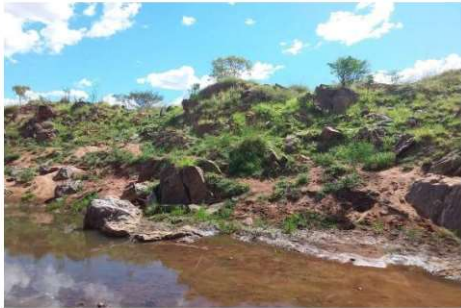
1.7 Gorge Creek -Watercourse W4-7

Desktop Mapping	Comment / Description
Vegetation Management Watercourse / Drainage (<i>Vegetation Management Act, 1999</i>)	
Stream Order	4
Waterway (<i>Fisheries Act, 1994</i>)	
Waterway	Moderate impact (amber)
Watercourse Identification (<i>Water Act, 2000</i>)	
Watercourse / Drainage Feature / Unknown	The watercourse location fits the definition of an unmapped Watercourse.
Other Comments	
<p>Creek bed characteristics and vegetation characteristics: Watercourse 35m wide containing large pool and rocky run downstream. Fringing riparian vegetation on banks and within central sand bars. Some sections of bed and bank with large, exposed rock.</p> <p>Weed risk: nil</p> <p>Current Aquatic Values: Aquatic flora, algae and macrophyte absent. Small fish observed.</p> <p>Vehicle / Construction access requirements: An existing crossing is located 400m to the north allowing access to both sides of the watercourse within the alignment. Selective widening and minor tree clearing may be required to improve access at the existing crossing.</p>

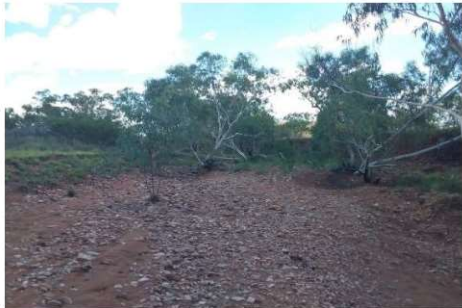
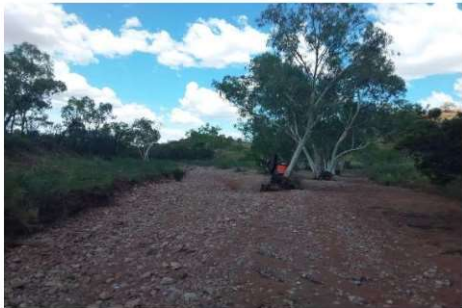
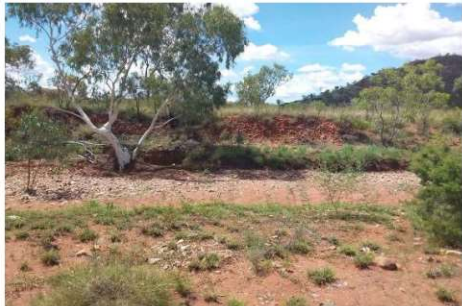
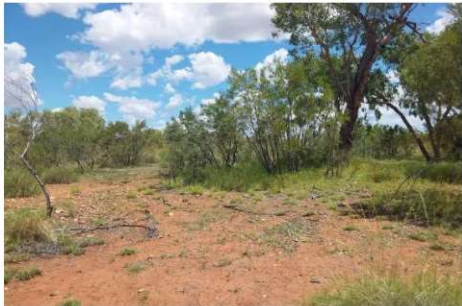
Upstream	Downstream

Desktop Mapping	Comment / Description
Vegetation Management Watercourse / Drainage (<i>Vegetation Management Act, 1999</i>)	
Stream Order	2
Waterway (<i>Fisheries Act, 1994</i>)	
Waterway	Low impact (green)
Watercourse Identification (<i>Water Act, 2000</i>)	
Watercourse / Drainage Feature / Unknown	The watercourse location fits the definition of an unmapped Watercourse.
Other Comments	
<p>Creek bed characteristics and vegetation characteristics: Ephemeral watercourse 30m wide with narrow low flow channel. Fringing riparian vegetation on banks and within central sand bars. Some hollows associated with <i>Eucalyptus camaldulensis</i>.</p> <p>Weed risk: minimal weed species presence.</p> <p>Current Aquatic Values: nil</p> <p>Vehicle / Construction access requirements: An existing crossing is located 30m north of the alignment. Selective tree removal and minor earthworks may be required to improve access at the existing crossing.</p>

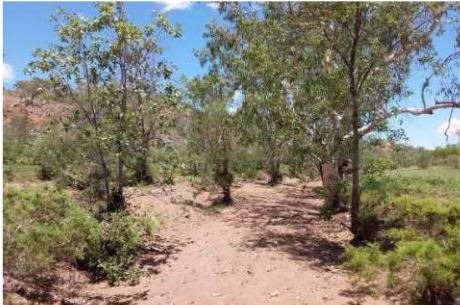
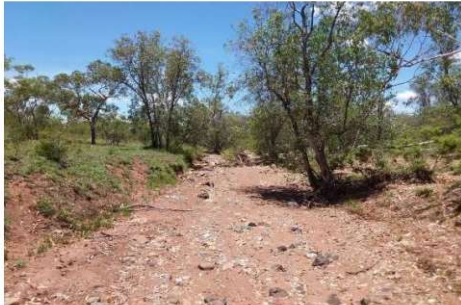
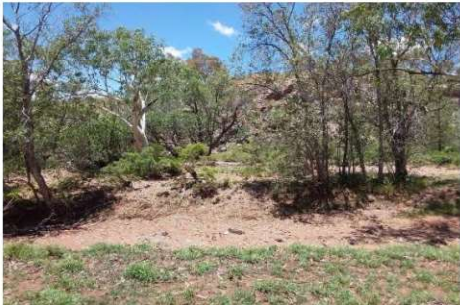
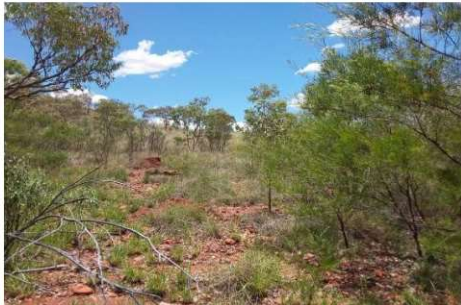
1.9 Watercourse W4-9

Desktop Mapping	Comment / Description
Vegetation Management Watercourse / Drainage (<i>Vegetation Management Act, 1999</i>)	
Stream Order	3
Waterway (<i>Fisheries Act, 1994</i>)	
Waterway	Low impact (green)
Watercourse Identification (<i>Water Act, 2000</i>)	
Watercourse / Drainage Feature / Unknown	The watercourse location fits the definition of an unmapped Watercourse.
Other Comments	
<p>Creek bed characteristics and vegetation characteristics: Ephemeral watercourse with wide low flow channel. A shallow channel over a small bench continuing to moderately inclined slopes with some exposed rock/boulders. Sparse riparian vegetation along watercourse banks and within sandy side bars.</p> <p>Weed risk: minimal weed species presence.</p> <p>Current Aquatic Values: nil</p> <p>Vehicle / Construction access requirements: A crossing within the alignment is absent. Modifications to the eastern bank and approaches would enable vehicular access during the dry season. Riparian vegetation on the banks and within the watercourse would require removal. The nearest recorded access track is 250m to the west.</p>

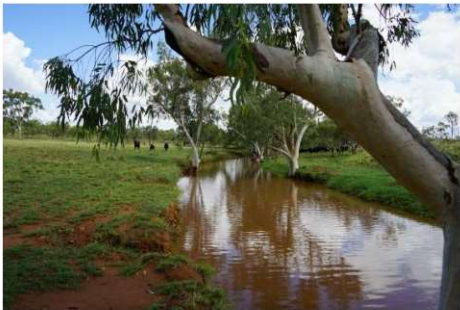
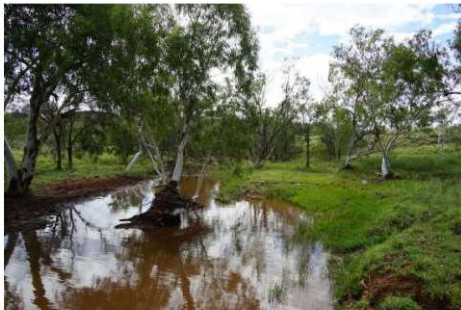
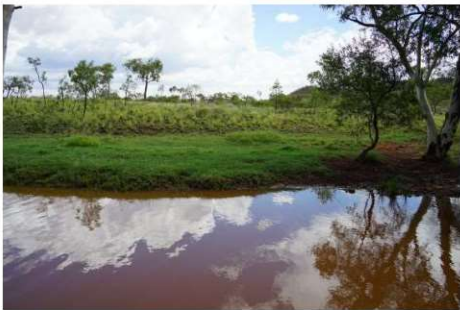
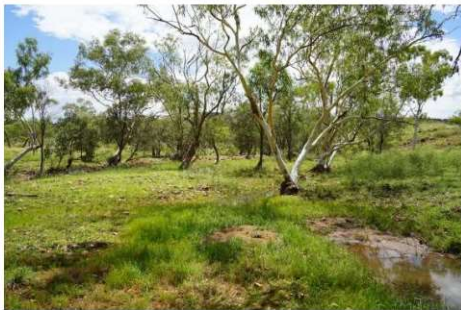
1.10 Lagoon Creek - Watercourse W4-10

Desktop Mapping	Comment / Description
Vegetation Management Watercourse / Drainage (<i>Vegetation Management Act, 1999</i>)	
Stream Order	3
Waterway (<i>Fisheries Act, 1994</i>)	
Waterway	Low impact (green)
Watercourse Identification (<i>Water Act, 2000</i>)	
Watercourse / Drainage Feature / Unknown	The watercourse location fits the definition of an unmapped Watercourse.
Other Comments	
<p>Creek bed characteristics and vegetation characteristics: Watercourse contains large pool fringed by <i>Eucalyptus camaldulensis</i>. Cattle were seen watering in the location resulting in turbid brown water. Trees where 12-16m in height.</p> <p>Weed risk: Minimal weed species presence.</p> <p>Current Aquatic Values: Aquatic flora, algae and macrophyte absent.</p> <p>Vehicle / Construction access requirements: A crossing within the alignment is absent and may not be required given the proximity to an existing access track 270m to the north. Minor earthworks are likely required to cross a tributary of this watercourse to the east with selective vegetation clearing also likely. Access to the western side of the watercourse can be gained from the existing access track by minor clearance of native vegetation.</p>

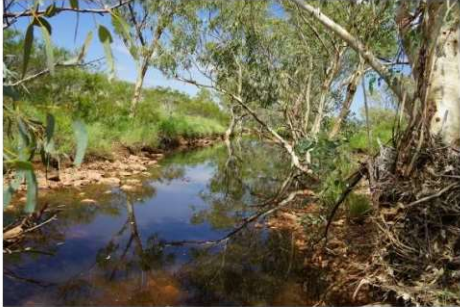
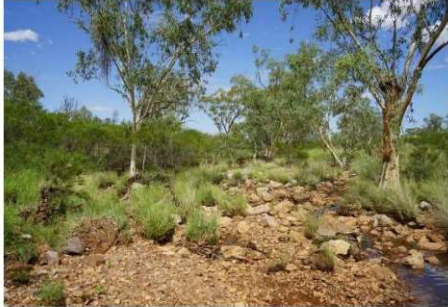
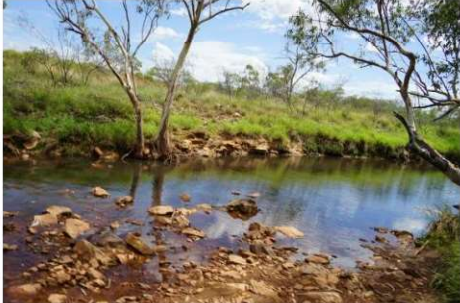
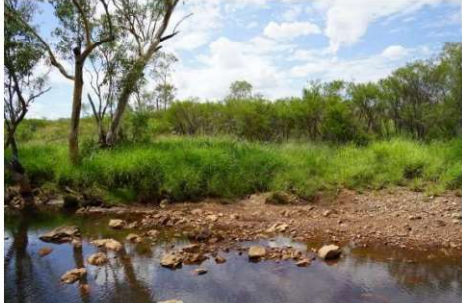
1.11 Watercourse W4-11 (Phosphate CU7 L072 Start)

Desktop Mapping	Comment / Description
Vegetation Management Watercourse / Drainage (<i>Vegetation Management Act, 1999</i>)	
Stream Order	2
Waterway (<i>Fisheries Act, 1994</i>)	
Waterway	Low impact (green)
Watercourse Identification (<i>Water Act, 2000</i>)	
Watercourse / Drainage Feature / Unknown	The watercourse location fits the definition of an unmapped Watercourse.
Other Comments	
<p>Creek bed characteristics and vegetation characteristics: 15m wide watercourse containing deep pool upstream flowing across rock and pebble riffle downstream. Riparian vegetation on banks containing <i>Eucalyptus camaldulensis</i> to 12m.</p> <p>Weed risk: Minimal weed species presence.</p> <p>Current Aquatic Values: Aquatic flora, algae and macrophyte absent.</p> <p>Vehicle / Construction access requirements: Existing crossing situated adjacent to the alignment. Minimal earthworks are required at this crossing. Selective vegetation clearing may be required to improve vehicular access.</p>

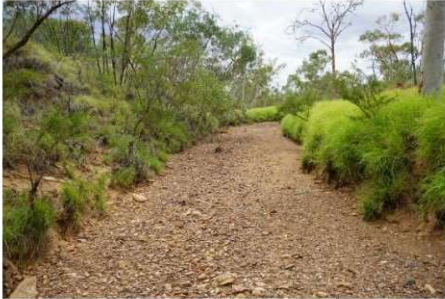
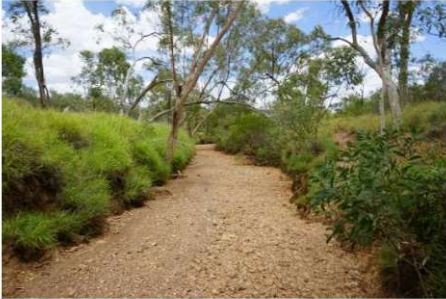
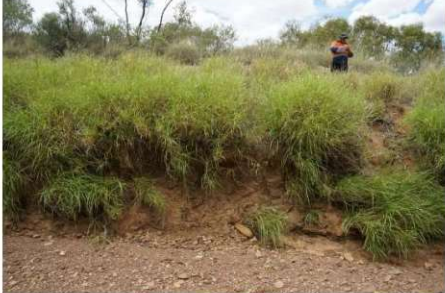
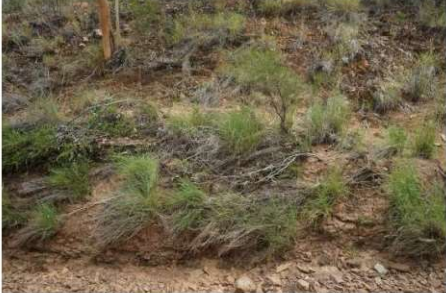
1.12 Watercourse W4-12

Desktop Mapping	Comment / Description
Vegetation Management Watercourse / Drainage (<i>Vegetation Management Act, 1999</i>)	
Stream Order	2
Waterway (<i>Fisheries Act, 1994</i>)	
Waterway	Low impact (green)
Watercourse Identification (<i>Water Act, 2000</i>)	
Watercourse / Drainage Feature / Unknown	The watercourse location fits the definition of an unmapped Watercourse.
Other Comments	
<p>Creek bed characteristics and vegetation characteristics: 18m wide watercourse, with bed width of 4m, flowing across rock and pebble riffle. Riparian vegetation on banks containing <i>Eucalyptus camaldulensis</i> to 10m.</p> <p>Weed risk: Minimal weed risks, banks dominated by buffel grass (<i>Cenchrus ciliaris</i>*)</p> <p>Current Aquatic Values: nil</p> <p>Vehicle / Construction access requirements: A crossing within the alignment is absent. Northern bank is steep and would require earthworks to reduce the gradient. Minor earthworks would be needed on the southern bank. Riparian vegetation removal also likely to be required. In addition, other minor watercourses may require crossings to enable to access this point. The nearest major access track/road is the Selwyn Chatsworth Road 2km to the south.</p>

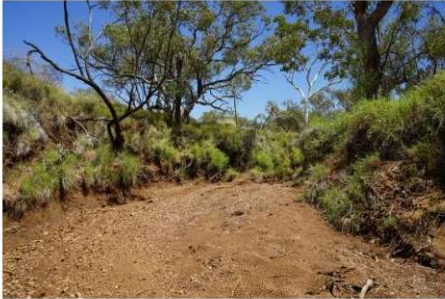
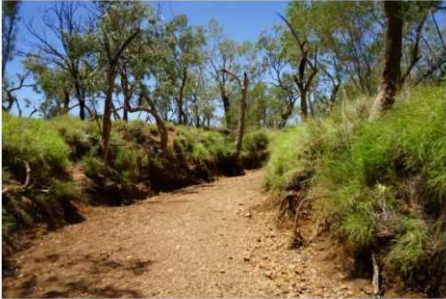
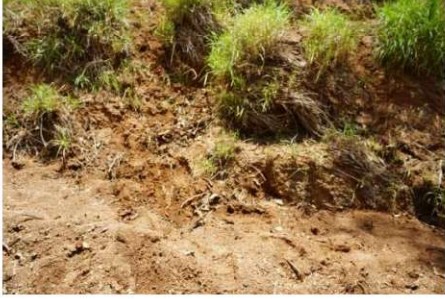
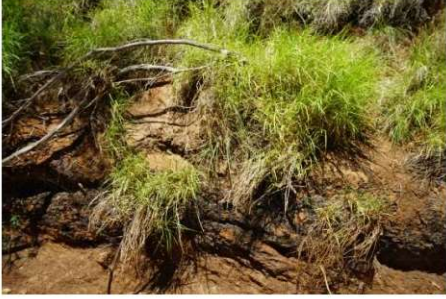
1.13 Watercourse W4-13

Desktop Mapping	Comment / Description
Vegetation Management Watercourse / Drainage (<i>Vegetation Management Act, 1999</i>)	
Stream Order	2
Waterway (<i>Fisheries Act, 1994</i>)	
Waterway	Low impact (green)
Watercourse Identification (<i>Water Act, 2000</i>)	
Watercourse / Drainage Feature / Unknown	The watercourse location fits the definition of an unmapped Watercourse.
Other Comments	
<p>Creek bed characteristics and vegetation characteristics: 12m wide watercourse flowing across pebble and sand riffle. Riparian vegetation on banks containing <i>Eucalyptus coolibah</i> to 9m.</p> <p>Weed risk: Minimal weed risks, banks dominated by buffel grass (<i>Cenchrus ciliaris</i>*)</p> <p>Current Aquatic Values: nil</p> <p>Vehicle / Construction access requirements: A crossing within the alignment is absent. Both banks are steep/incised and would require earthworks to reduce the gradient. Riparian vegetation removal also likely to be required. In addition, other minor watercourses may require crossings to enable to access this point. An access track is located 200m to the west. This access track is reached from the Selwyn Chatswood Road but crosses a separate waterway which may require earthworks and vegetation removal to allow improved access.</p>
