M0001 Waterway Locations and Assessments

M0001 – September 2020

Client: CuString 2.0
Reference: J0105

Title:	Waterway Locations and Assessment for M0001 – September 2020
Address:	
Job Number:	J0105
Client:	CuString 2.0

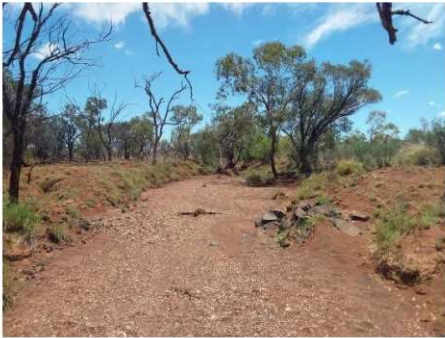
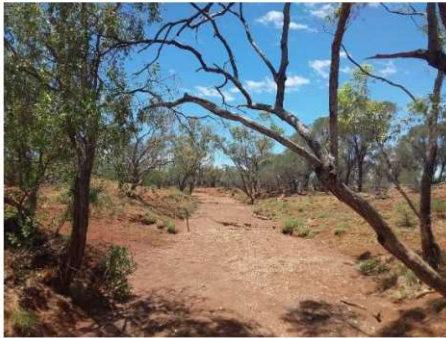
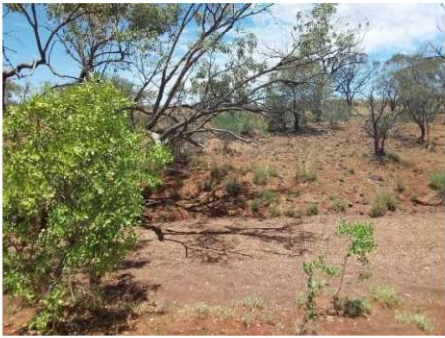
1.14 Watercourse W4-14

Desktop Mapping	Comment / Description
Vegetation Management Watercourse / Drainage (<i>Vegetation Management Act, 1999</i>)	
Stream Order	2
Waterway (<i>Fisheries Act, 1994</i>)	
Waterway	Low impact (green)
Watercourse Identification (<i>Water Act, 2000</i>)	
Watercourse / Drainage Feature / Unknown	The watercourse location fits the definition of an unmapped Watercourse.
Other Comments	
<p>Creek bed characteristics and vegetation characteristics: 11m wide watercourse with bed with of 5m flowing across gravel / pebble and sand riffle. Sparse riparian vegetation on banks containing <i>Eucalyptus leucophylla</i> and <i>Corymbia terminalis</i> to 6m.</p> <p>Weed risk: minimal weed invasion.</p> <p>Current Aquatic Values: nil</p> <p>Vehicle / Construction access requirements: A crossing within the alignment is absent. Minor earthworks required to improve the slopes of the banks. Vegetation clearing unlikely to be required. A minor access track located adjacent.</p>

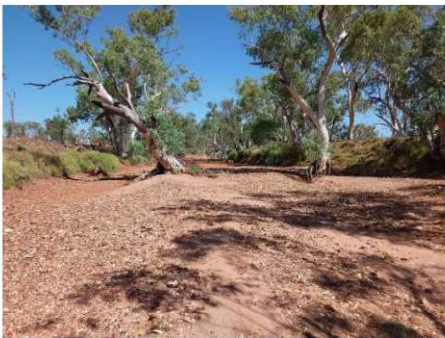
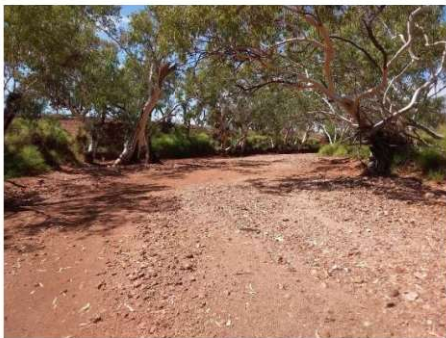
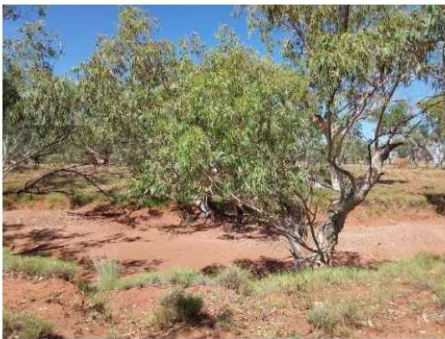
1.15 Watercourse W4-15

Desktop Mapping	Comment / Description
Vegetation Management Watercourse / Drainage (<i>Vegetation Management Act, 1999</i>)	
Stream Order	4
Waterway (<i>Fisheries Act, 1994</i>)	
Waterway	Moderate impact (amber)
Watercourse Identification (<i>Water Act, 2000</i>)	
Watercourse / Drainage Feature / Unknown	The watercourse location fits the definition of an unmapped Watercourse.
Other Comments	
<p>Creek bed characteristics and vegetation characteristics: 37m wide watercourse (top of bank) with bed with of 15m flowing across gravel / pebble and sand riffle with pools up and downstream. Riparian vegetation on banks containing <i>Eucalyptus camaldulensis</i> to 14m. Banks covered in native grasses.</p> <p>Weed risk: minimal weed invasion.</p> <p>Current Aquatic Values: nil</p> <p>Vehicle / Construction access requirements: A crossing within the alignment is absent. A potential crossing point is located 300m north and minor earthworks would be required to improve the slopes of the western and eastern banks at this point. In addition, only minimal riparian vegetation clearing is likely to be required. The nearest formed access track is 2km to the west.</p>

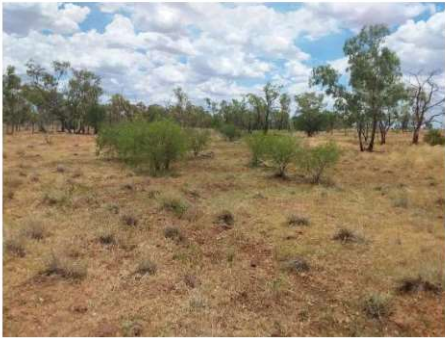
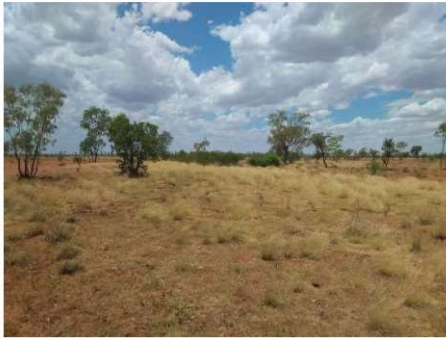
1.16 Watercourse W4-16

Desktop Mapping	Comment / Description
Vegetation Management Watercourse / Drainage (<i>Vegetation Management Act, 1999</i>)	
Stream Order	4
Waterway (<i>Fisheries Act, 1994</i>)	
Waterway	Moderate impact (amber)
Watercourse Identification (<i>Water Act, 2000</i>)	
Watercourse / Drainage Feature / Unknown	The watercourse location fits the definition of an unmapped Watercourse.
Other Comments	
<p>Creek bed characteristics and vegetation characteristics: 1m wide watercourse with a bed depth of 0.2m flowing across gravel / pebble and sand riffle with pools up and downstream. Scattered tree lined edges containing <i>Eucalyptus coolabah</i> to 8 m. Banks covered in native grasses.</p> <p>Weed risk: Minimal weed risk</p> <p>Current Aquatic Values: nil</p> <p>Vehicle / Construction access requirements: A crossing within the alignment is absent. Very limited modifications required for access. Dry weather only</p>

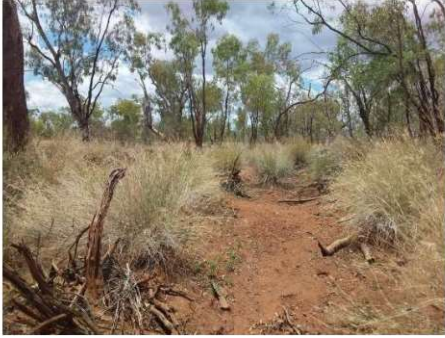
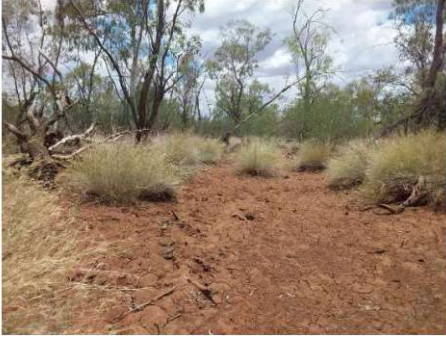
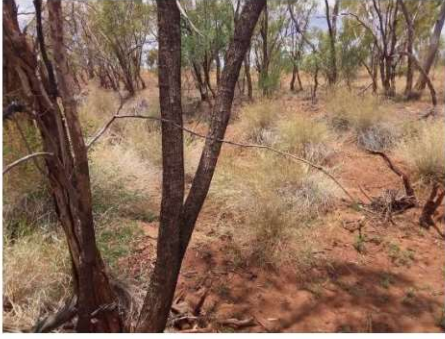
1.17 Watercourse W4-17

Desktop Mapping	Comment / Description
Vegetation Management Watercourse / Drainage (<i>Vegetation Management Act, 1999</i>)	
Stream Order	4
Waterway (<i>Fisheries Act, 1994</i>)	
Waterway	Moderate impact (amber)
Watercourse Identification (<i>Water Act, 2000</i>)	
Watercourse / Drainage Feature / Unknown	The watercourse location fits the definition of an unmapped Watercourse.
Other Comments	
<p>Creek bed characteristics and vegetation characteristics: 10m wide watercourse (top of bank) with a bed width (5m) and depth of 1.1 m. Flows across sandy clay riffle with pools downstream. Riparian vegetation on banks containing <i>Eucalyptus coolibah</i> to 11m. Banks covered in native grasses including <i>Leptochloa digitata</i>.</p> <p>Weed risk: Minimal weed risk</p> <p>Current Aquatic Values: nil</p> <p>Vehicle / Construction access requirements: A crossing within the alignment is absent. Minor earthworks required to improve the slopes of the banks. Minor vegetation clearing required. A minor access track located 400m to the east.</p>

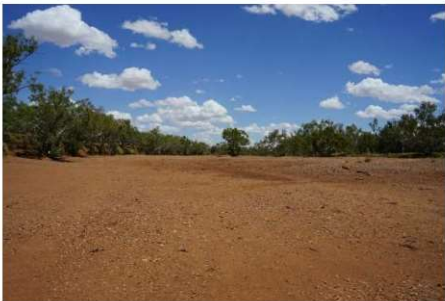
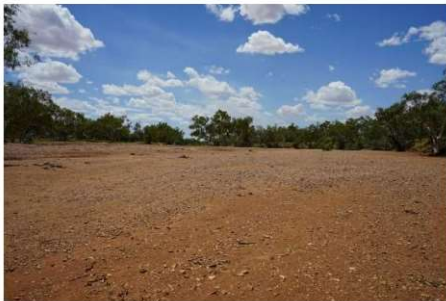
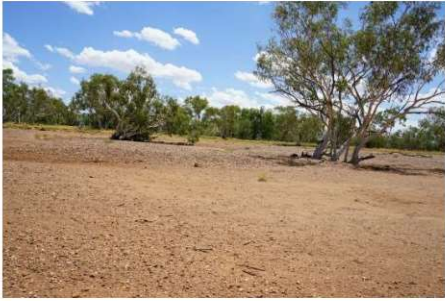
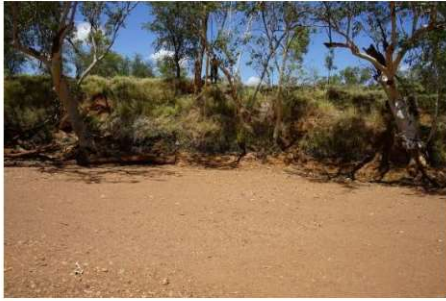
1.18 Burke River - Watercourse W4-18

Desktop Mapping	Comment / Description
Vegetation Management Watercourse / Drainage (<i>Vegetation Management Act, 1999</i>)	
Stream Order	6
Waterway (<i>Fisheries Act, 1994</i>)	
Waterway	Major impact (purple)
Watercourse Identification (<i>Water Act, 2000</i>)	
Watercourse / Drainage Feature / Unknown	The watercourse location fits the definition of a mapped Watercourse.
Other Comments	
<p>Creek bed characteristics and vegetation characteristics: 120m wide watercourse with bank heights up to 6m. Flows across sandy gravel riffle with pools downstream. Riparian vegetation on banks containing <i>Eucalyptus camaldulensis</i> and <i>Lophostemon grandiflorus</i> to 18m. Vegetated central and side bars often containing <i>Eucalyptus camaldulensis</i>.</p> <p>Weed risk: Minimal weed risk</p> <p>Current Aquatic Values: nil</p> <p>Vehicle / Construction access requirements: A crossing within the alignment is absent. Earthworks required to the western bank to reduce bank angle to allow vehicular access. Minor earthworks required to improve the slope of the eastern bank. Vegetation clearing required. A minor access track located 350m to the west.</p>

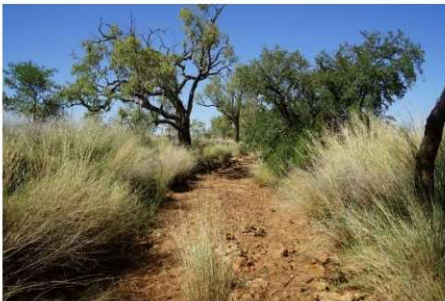
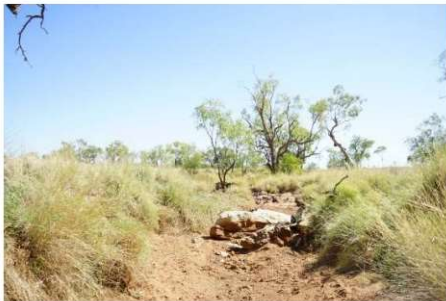
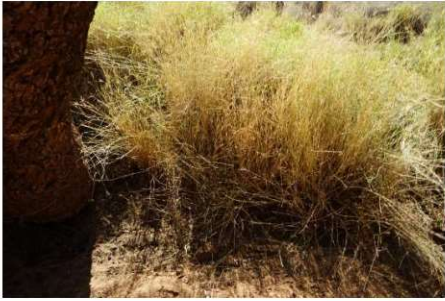
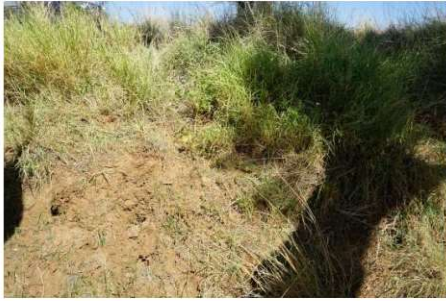
Desktop Mapping	Comment / Description
Vegetation Management Watercourse / Drainage (<i>Vegetation Management Act, 1999</i>)	
Stream Order	4
Waterway (<i>Fisheries Act, 1994</i>)	
Waterway	Moderate impact (amber)
Watercourse Identification (<i>Water Act, 2000</i>)	
Watercourse / Drainage Feature / Unknown	The watercourse location fits the definition of an unmapped Watercourse.
Other Comments	
<p>Creek bed characteristics and vegetation characteristics: 11m wide watercourse approximately 1.5m in depth. Flows across sandy cobble riffle with pools downstream. Riparian vegetation on banks containing <i>Eucalyptus coolibah</i> and <i>Lysiphyllum gilvum</i> to 9m. Banks covered in native grasses.</p> <p>Weed risk: Minimal weed risk</p> <p>Current Aquatic Values: nil</p> <p>Vehicle / Construction access requirements: A crossing within the alignment is absent. Earthworks required to reduce bank angle to allow vehicular access. Vegetation clearing unlikely to be required. A minor access track located 200m to the west. This access track links with the Chatsworth Phosphate Road 2km to the south and cross another watercourse which may require earthworks to improve access.</p>

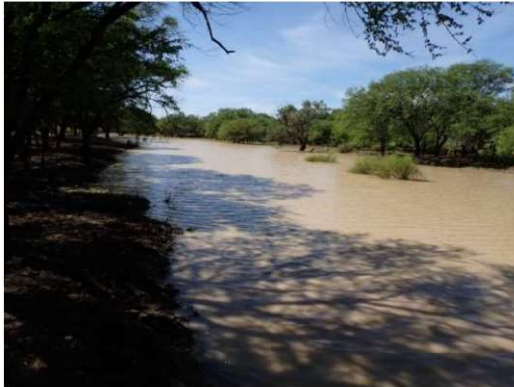
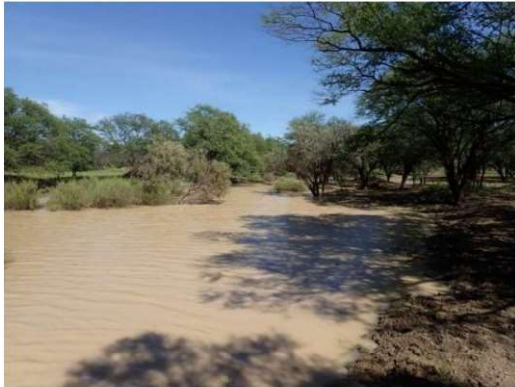
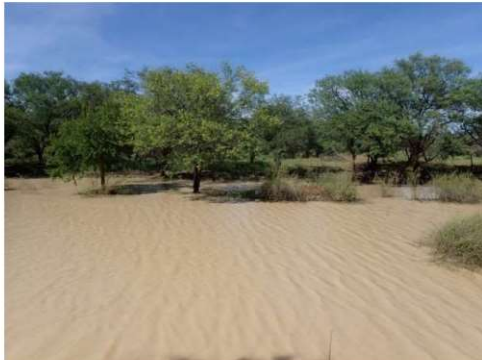
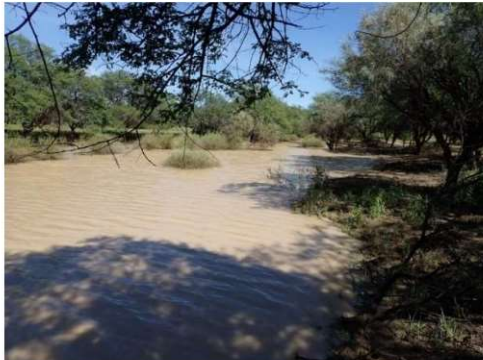
1.1 Alick Creek- Watercourse W6-1

Desktop Mapping	Comment / Description
Vegetation Management Watercourse / Drainage (<i>Vegetation Management Act, 1999</i>)	
Stream Order	7
Waterway (<i>Fisheries Act, 1994</i>)	
Waterway	Major impact (purple)
Watercourse Identification (<i>Water Act, 2000</i>)	
Watercourse / Drainage Feature / Unknown	The watercourse location fits the definition of a mapped Watercourse.
Other Comments	
<p>Creek bed characteristics and vegetation characteristics: 25m wide watercourse containing large pool and braided low flow channel. Riparian vegetation on banks. Clay banks and likely bed. <i>Grevillea parallela</i> dominated canopy layer to 5-7m in height.</p> <p>Weed risk: <i>Vachellia nilotica</i> observed.</p> <p>Current Aquatic Values: Aquatic flora, algae and macrophyte absent.</p> <p>Vehicle / Construction access requirements: A crossing within the alignment is absent. This channel is on average less than 2m in depth. Minor modifications to bank gradients and approaches would enable vehicular access in the dry season. Removal of riparian vegetation would be required. Existing unsealed access track 360m to the west.</p>

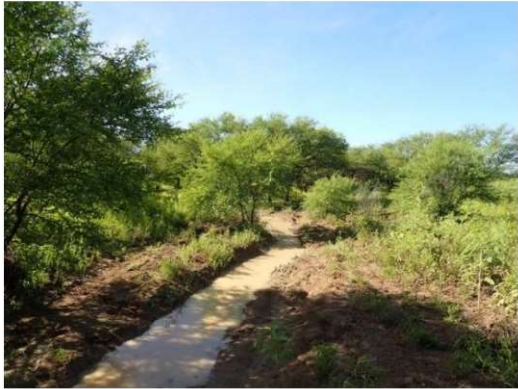
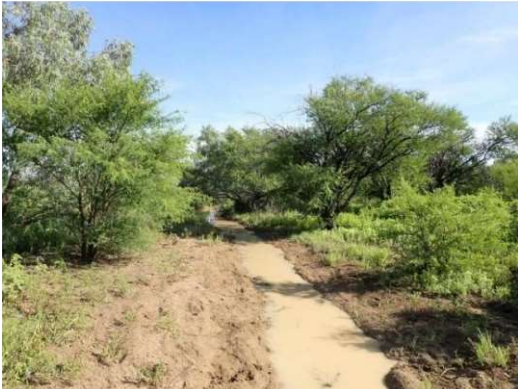
1.3 Alick Creek- Watercourse W6-3

Desktop Mapping	Comment / Description
Vegetation Management Watercourse / Drainage (<i>Vegetation Management Act, 1999</i>)	
Stream Order	6
Waterway (<i>Fisheries Act, 1994</i>)	
Waterway	Major impact (purple)
Watercourse Identification (<i>Water Act, 2000</i>)	
Watercourse / Drainage Feature / Unknown	The watercourse location fits the definition of a mapped Watercourse.
Other Comments	
<p>Creek bed characteristics and vegetation characteristics: Ephemeral watercourse 10.5m wide with 1.5m narrow low flow channel. Riparian vegetation on silt / clay banks. Scattered <i>Eucalyptus coolabah</i> dominates canopy layer to 5m in height, with <i>Cyperus spp.</i> ground cover.</p> <p>Weed risk: <i>Vachellia nilotica</i> observed.</p> <p>Current Aquatic Values: Aquatic flora, algae and macrophyte absent.</p> <p>Vehicle / Construction access requirements: A crossing within the alignment is absent. A shallow channel with shallow bank slopes. Minor modifications to bank slopes and approaches would enable vehicular access during the dry season. Removal of riparian vegetation would be required. Existing unsealed access track 700m to the west and 400m to the east.</p>

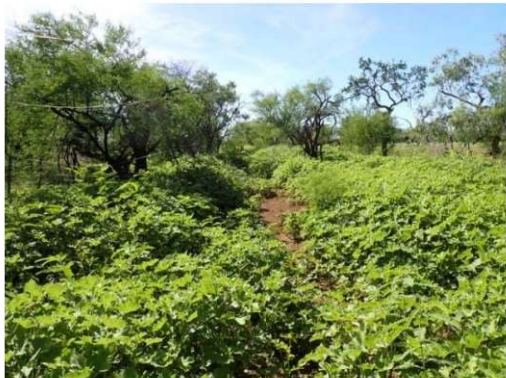
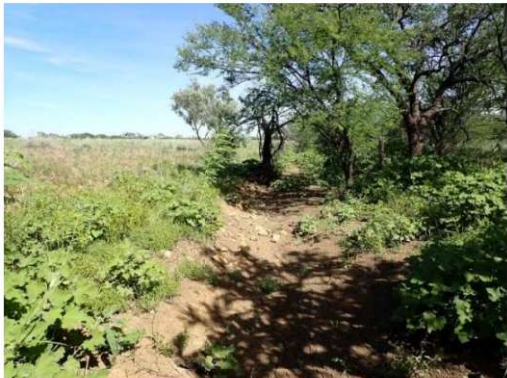
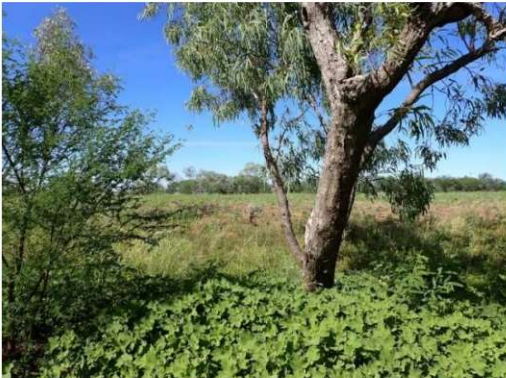
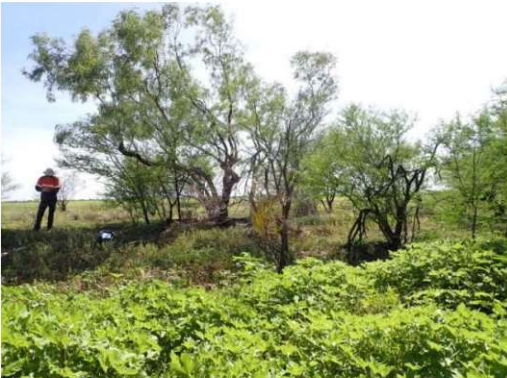
1.4 Alick Creek- Watercourse W6-4

Desktop Mapping	Comment / Description
Vegetation Management Watercourse / Drainage (<i>Vegetation Management Act, 1999</i>)	
Stream Order	4
Waterway (<i>Fisheries Act, 1994</i>)	
Waterway	Major impact (purple)
Watercourse Identification (<i>Water Act, 2000</i>)	
Watercourse / Drainage Feature / Unknown	The watercourse location fits the definition of a mapped Watercourse.
Other Comments	
<p>Creek bed characteristics and vegetation characteristics: Ephemeral watercourse 27m wide with 1.2m narrow dry channel. Riparian vegetation on silt / clay banks. Trees to 5m in height. Scattered <i>Eucalyptus coolabah</i> dominated canopy layer, with <i>Grevillea parallela</i>. Mixed layer of <i>Cyperus spp.</i>, <i>Sesbania spp.</i>, <i>Themeda spp.</i>, and other exotic and native grasses.</p> <p>Weed risk: <i>Vachellia nilotica</i> and <i>Xanthium pungens</i> observed.</p> <p>Current Aquatic Values: nil</p> <p>Vehicle / Construction access requirements: A crossing within the alignment is absent. A shallow channel with shallow slopes. Minor modifications to bank slopes and approaches would enable vehicular access during the dry season. Removal of riparian vegetation would be required. The nearest recorded access track is 140m to the west. Access to the alignment may necessitate crossing this watercourse on several occasions.</p>

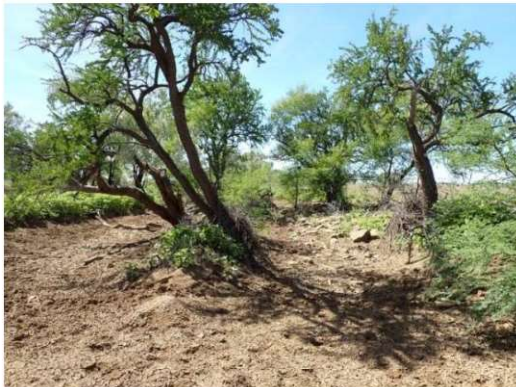
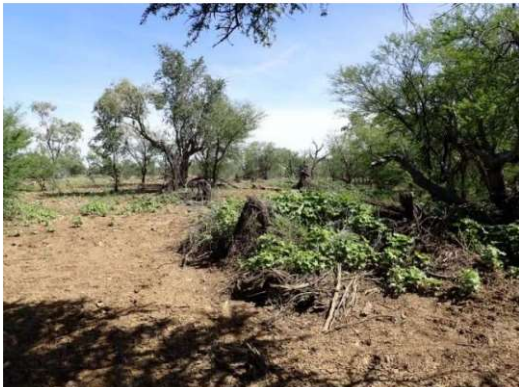
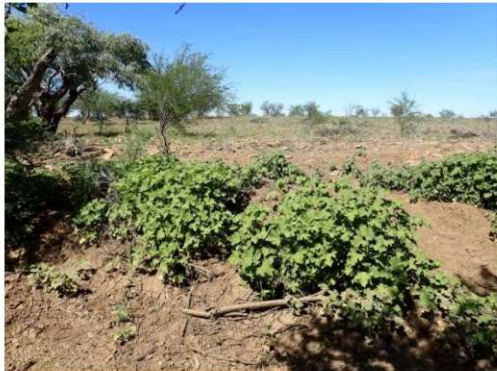
1.5 Alick Creek- Watercourse W6-5

Desktop Mapping	Comment / Description
Vegetation Management Watercourse / Drainage (<i>Vegetation Management Act, 1999</i>)	
Stream Order	5
Waterway (<i>Fisheries Act, 1994</i>)	
Waterway	Major impact (purple)
Watercourse Identification (<i>Water Act, 2000</i>)	
Watercourse / Drainage Feature / Unknown	The watercourse location fits the definition of a mapped Watercourse.
Other Comments	
<p>Creek bed characteristics and vegetation characteristics: Ephemeral watercourse 70m wide with narrow 5m braided dry channels. Riparian vegetation on silt / clay and rocky / pebbly banks and within central sandy / gravel bars. Trees to 4-6m in height. Scattered <i>Eucalyptus coolabah</i> dominates canopy layer. <i>Excoecaria parvifolia</i> up to 5m in height and <i>Lysiphyllum spp.</i> up to 6m in height were observed.</p> <p>Weed risk: <i>Vachellia nilotica</i> and <i>Xanthium pungens</i> observed.</p> <p>Current Aquatic Values: nil</p> <p>Vehicle / Construction access requirements: A crossing within the alignment is absent. A shallow channel with shallow sloped banks transitioning to gentle slopes. Minor modifications to bank slopes and approaches would enable vehicular access during the dry season. Removal of riparian vegetation would be required. The nearest recorded access track is 310m to the south west.</p>

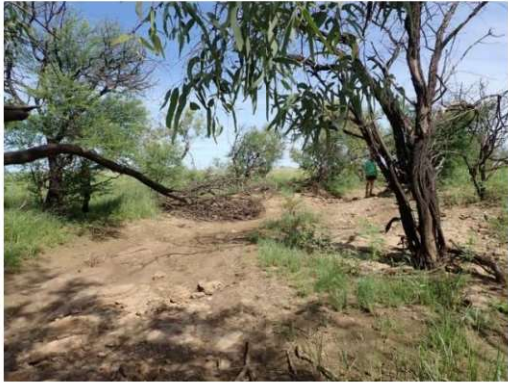
Desktop Mapping	Comment / Description
Vegetation Management Watercourse / Drainage (<i>Vegetation Management Act, 1999</i>)	
Stream Order	5
Waterway (<i>Fisheries Act, 1994</i>)	
Waterway	High impact (red)
Watercourse Identification (<i>Water Act, 2000</i>)	
Watercourse / Drainage Feature / Unknown	The watercourse location fits the definition of an unmapped Watercourse.
Other Comments	
<p>Creek bed characteristics and vegetation characteristics: Ephemeral watercourse 25m wide with narrow 4m isolated flow channel. Fringing riparian vegetation on banks. Scattered <i>Eucalyptus coolabah</i> up to 4-6m in height dominates canopy layer. <i>Cyperus spp.</i> covers ground layer. Regional ecosystem described as 4.3.4f.</p> <p>Weed risk: <i>Vachellia nilotica</i> observed.</p> <p>Current Aquatic Values: Aquatic flora, algae and macrophyte absent.</p> <p>Vehicle / Construction access requirements: A crossing within the alignment is absent. A shallow channel with moderate sloped banks. Minor modifications to bank slopes and approaches would enable vehicular access during the dry season. Removal of minor sections riparian vegetation would be required. The nearest recorded access track is 800 m to the west.</p>

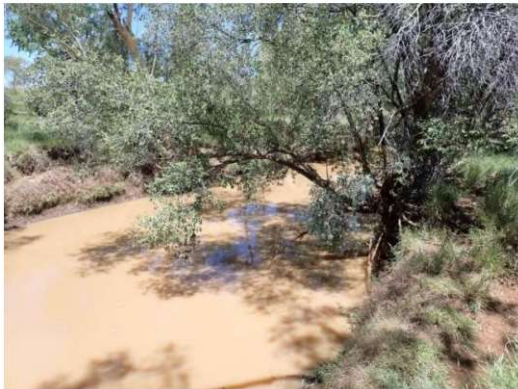
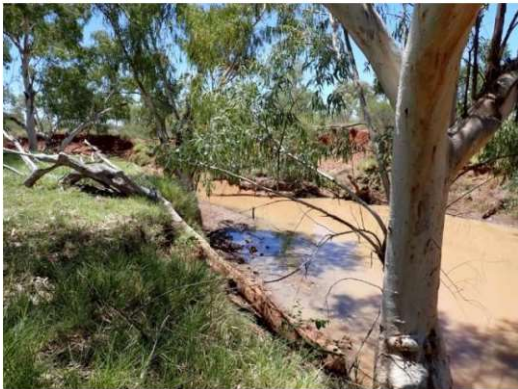
Desktop Mapping	Comment / Description
Vegetation Management Watercourse / Drainage (<i>Vegetation Management Act, 1999</i>)	
Stream Order	3
Waterway (<i>Fisheries Act, 1994</i>)	
Waterway	Low impact (green)
Watercourse Identification (<i>Water Act, 2000</i>)	
Watercourse / Drainage Feature / Unknown	The watercourse location fits the definition of an unmapped Watercourse.
Other Comments	
<p>Creek bed characteristics and vegetation characteristics: 90m wide watercourse containing large pool and 14.4m wide low flow channel. An unknown depth of channel with a steep bench (3m in height) to main channel water surface at time of survey. Main banks are moderately to steeply inclined slopes. Riparian vegetation 12-15m wide along watercourse silt / clay banks. <i>Eucalyptus camaldulensis</i> up to 15m in height dominate canopy layer with scattered <i>Lophostemon grandiflorus</i>.</p> <p>Weed risk: <i>Vachellia nilotica</i> and <i>Cenchrus ciliaris</i> observed.</p> <p>Current Aquatic Values: Aquatic flora, algae and macrophyte absent.</p> <p>Vehicle / Construction access requirements: A crossing within the alignment is absent. This channel is an unknown depth. Moderate modifications to bank gradients and approaches would enable vehicular access in the dry season. Removal of riparian vegetation would be required. Existing unsealed access track 385m to the west.</p>

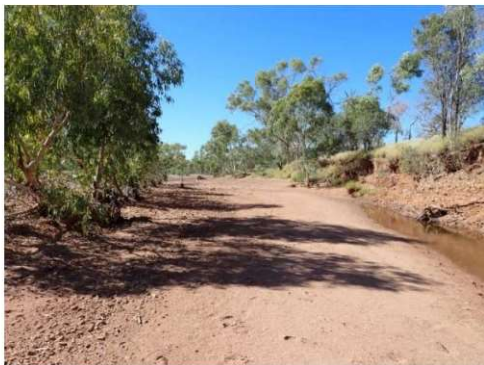
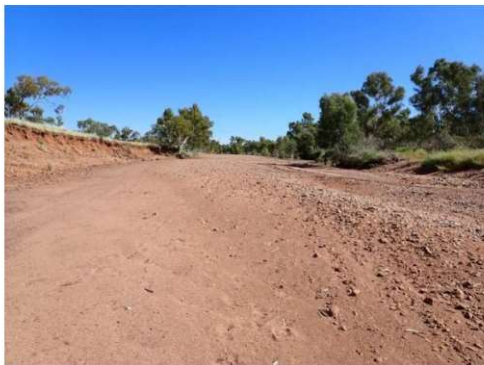
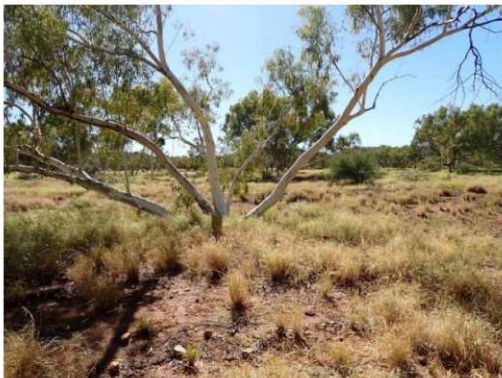
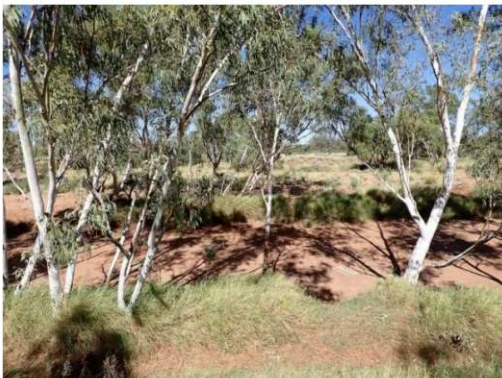
1.10 Leichhardt River- Watercourse W6-10

Desktop Mapping	Comment / Description
Vegetation Management Watercourse / Drainage (<i>Vegetation Management Act, 1999</i>)	
Stream Order	6
Waterway (<i>Fisheries Act, 1994</i>)	
Waterway	High impact (red)
Watercourse Identification (<i>Water Act, 2000</i>)	
Watercourse / Drainage Feature / Unknown	The watercourse location fits the definition of a mapped Watercourse.
Other Comments	
<p>Creek bed characteristics and vegetation characteristics: 230m wide watercourse with a steep bench watercourse channel 68m wide and a smaller steep 17m wide braided dry channels up to 2.6-4.6m deep with slight pooling. Sand / cobble and gravel banks common. Riparian vegetation along watercourse predominately <i>Eucalyptus camaldulensis</i> canopy layer up to 7-17m in height with scattered <i>Leptospermum grandifolium</i>, <i>Eucalyptus leucophylla</i> and <i>Acacia torulosa</i>.</p> <p>Weed risk: <i>Vachellia nilotica</i> and <i>Cenchrus ciliaris</i> observed.</p> <p>Current Aquatic Values: Aquatic flora, algae and macrophyte absent.</p> <p>Vehicle / Construction access requirements: A crossing within the alignment is absent. Channels are up to 2.6-4.6m in depth. Moderate modifications to bank gradients and approaches would enable vehicular access in the dry season. Removal of riparian vegetation would be required. Mt Isa – Duchess Road 300m to the east and an existing unsealed access track 50m to the west</p>

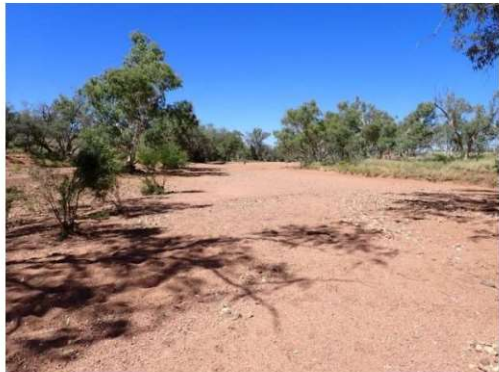
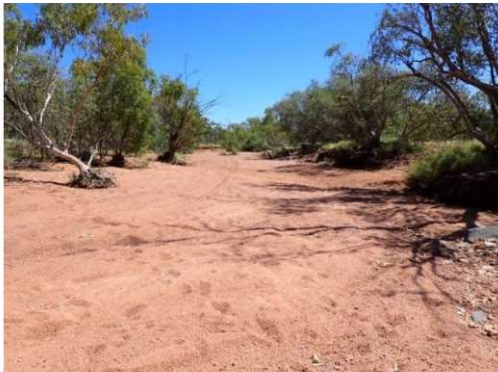
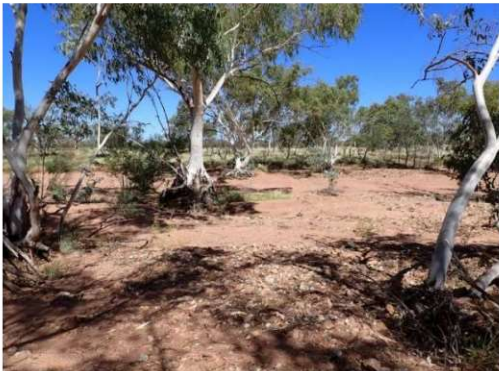
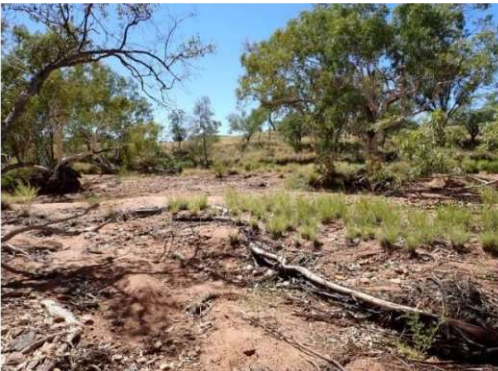
1.11 Mica Creek- Watercourse W6-11

Desktop Mapping	Comment / Description
Vegetation Management Watercourse / Drainage (<i>Vegetation Management Act, 1999</i>)	
Stream Order	5
Waterway (<i>Fisheries Act, 1994</i>)	
Waterway	Moderate impact (amber)
Watercourse Identification (<i>Water Act, 2000</i>)	
Watercourse / Drainage Feature / Unknown	The watercourse location fits the definition of an unmapped Watercourse.
Other Comments	
<p>Creek bed characteristics and vegetation characteristics: 89m wide watercourse with 3.4m deep dry channel. Left bank is a steep sloped bench and right bank is a gradual inclined sloped. Riparian vegetation occurs on sandy and cobble / pebble and gravelly banks and on central sand beds. <i>Eucalyptus camaldulensis</i> up to 9-12m in height dominates the canopy layer with scattered <i>Leptospermum grandifolium</i>. <i>Aristida spp.</i> dominated on high points of left bank with scattered exotic and native grasses.</p> <p>Weed risk: <i>Cenchrus ciliaris</i> observed.</p> <p>Current Aquatic Values: nil.</p> <p>Vehicle / Construction access requirements: A crossing within the alignment is absent. This channel is up to 3.4m in depth. Modifications to the eastern bank gradients and approaches would enable vehicular access in the dry season. Removal of riparian vegetation on banks and sand beds would be required. Existing unsealed access track 230m to the east and the Mt Isa – Boulia Road is 1.6 km to the west.</p>

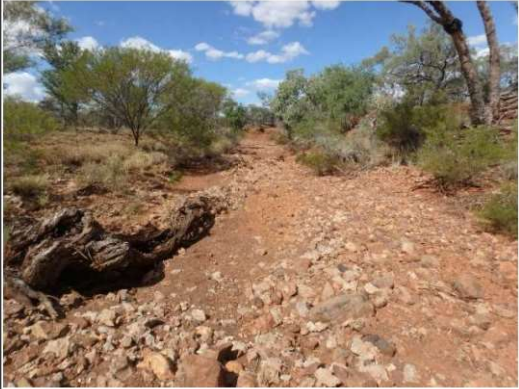
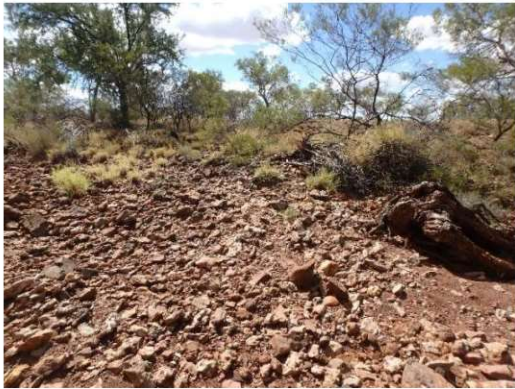
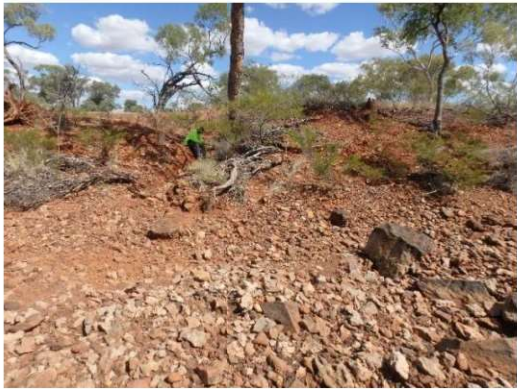
Desktop Mapping	Comment / Description
Vegetation Management Watercourse / Drainage (<i>Vegetation Management Act, 1999</i>)	
Stream Order	3
Waterway (<i>Fisheries Act, 1994</i>)	
Waterway	Low impact (green)
Watercourse Identification (<i>Water Act, 2000</i>)	
Watercourse / Drainage Feature / Unknown	The watercourse location fits the definition of an unmapped Watercourse.
Other Comments	
<p>Creek bed characteristics and vegetation characteristics: Ephemeral watercourse with banks and bed of laomy sand over clay, with surface rocks (pebbles, cobbles, and boulders). Banks lightly covered with a ground layer dominated by buffel grass (<i>Cenchrus ciliaris</i>). Riparian canopy extends to 12m high and is dominated by <i>Corymbia terminalis</i> and <i>Lysiphyllum carronii</i>.</p> <p>Weed risk: None recorded.</p> <p>Current Aquatic Values: None present.</p> <p>Vehicle / Construction access requirements: A crossing within the alignment is present as an access track parallel to the main road.</p>

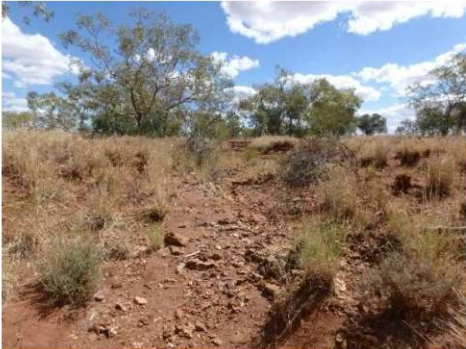
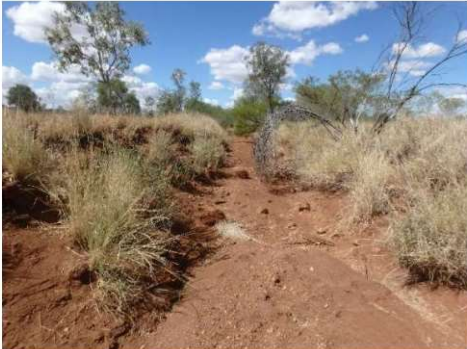
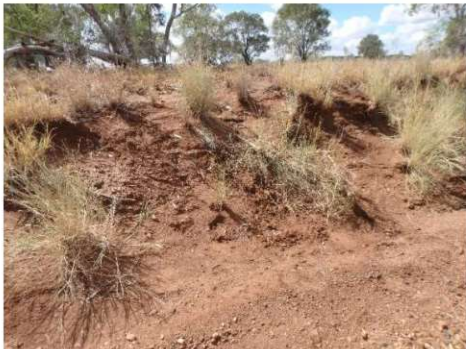
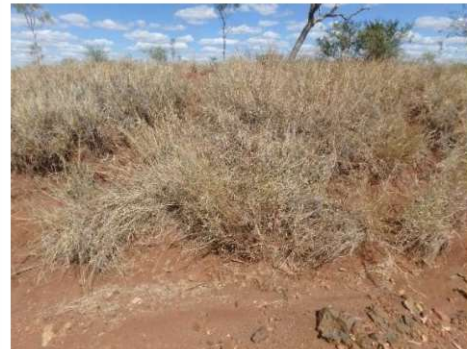
1.2 Watercourse W8-2

Desktop Mapping	Comment / Description
Vegetation Management Watercourse / Drainage (<i>Vegetation Management Act, 1999</i>)	
Stream Order	3
Waterway (<i>Fisheries Act, 1994</i>)	
Waterway	Low impact (green)
Watercourse Identification (<i>Water Act, 2000</i>)	
Watercourse / Drainage Feature / Unknown	The watercourse location fits the definition of a mapped Watercourse.
Other Comments	
<p>Creek bed characteristics and vegetation characteristics: Ephemeral watercourse 12m wide with 1-1.5m high banks. Bed and banks are clay based with loamy sand surface layer and occasional rocks (pebbles and cobbles). Riparian vegetation has trees to 10m in height; scattered <i>Eucalyptus coolabah</i> dominates canopy layer. <i>Lysiphyllum carronii</i> up to 6m in height were observed.</p> <p>Weed risk: <i>Vachellia</i> sp. Observed.</p> <p>Current Aquatic Values: None present.</p> <p>Vehicle / Construction access requirements: A crossing within the alignment is absent; however, due to the channel profile, minor modifications to bank slopes and approaches would enable vehicular access during the dry season. Removal of riparian vegetation may be required. The nearest recorded access track is 330m to the east alongside the main road.</p>

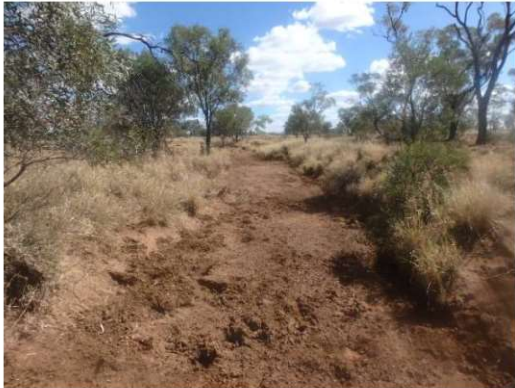
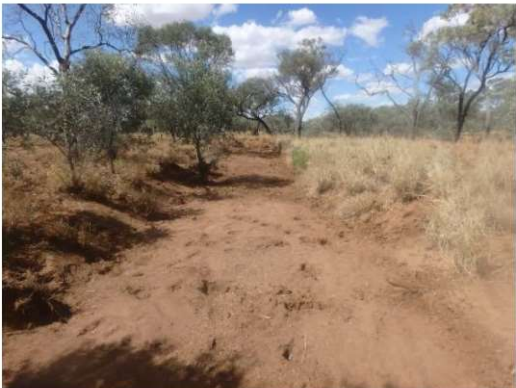
1.3 Watercourse W8-3

Desktop Mapping	Comment / Description
Vegetation Management Watercourse / Drainage (<i>Vegetation Management Act, 1999</i>)	
Stream Order	2
Waterway (<i>Fisheries Act, 1994</i>)	
Waterway	N/A
Watercourse Identification (<i>Water Act, 2000</i>)	
Watercourse / Drainage Feature / Unknown	The watercourse location fits the definition of a mapped Watercourse.
Other Comments	
<p>Creek bed characteristics and vegetation characteristics: Dry ephemeral watercourse 3.5m wide with 0.4m tall banks. Bed and banks of clay with loamy sand surface layer. Riparian trees to 3m in height, scattered <i>Acacia cambagei</i> dominated canopy layer. Ground layer dominated but <i>Cenchrus ciliaris</i>.</p> <p>Weed risk: None observed.</p> <p>Current Aquatic Values: None present.</p> <p>Vehicle / Construction access requirements: A crossing within the alignment is present 40m away as an access track parallel to main road.</p>

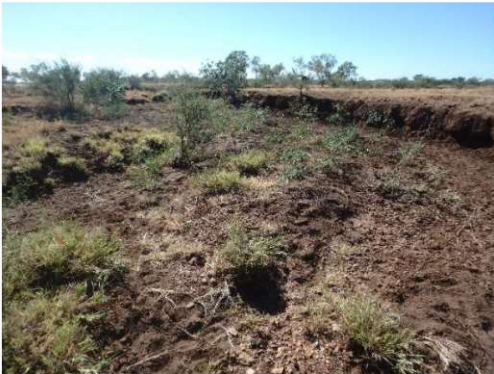
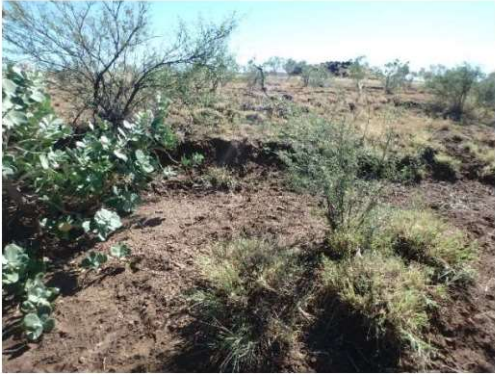
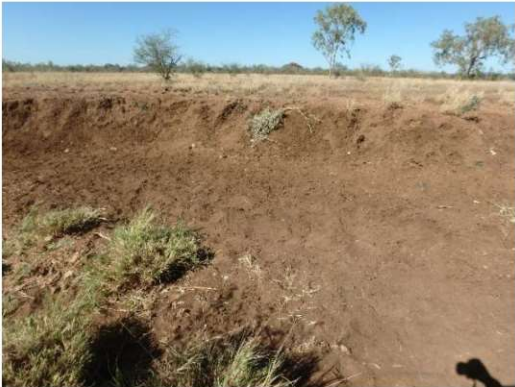
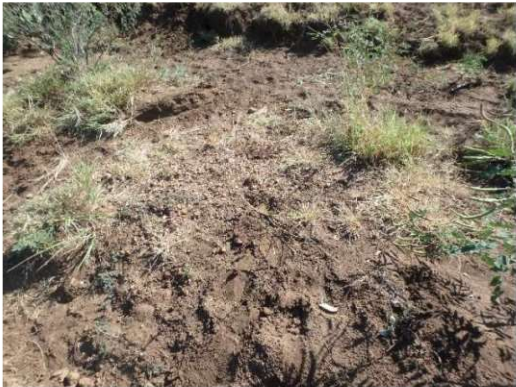
1.4 Watercourse W8-4

Desktop Mapping	Comment / Description
Vegetation Management Watercourse / Drainage (<i>Vegetation Management Act, 1999</i>)	
Stream Order	2
Waterway (<i>Fisheries Act, 1994</i>)	
Waterway	N/A
Watercourse Identification (<i>Water Act, 2000</i>)	
Watercourse / Drainage Feature / Unknown	The watercourse location fits the definition of a mapped Watercourse.
Other Comments	
<p>Creek bed characteristics and vegetation characteristics: Ephemeral watercourse with narrow low flow channel, yet wholly shallow. Riparian vegetation is dominated by weed species. Banks and bed are deep clays with loamy sand surface layer.</p> <p>Weed risk: <i>Vachellia</i> sp. observed.</p> <p>Current Aquatic Values: None present.</p> <p>Vehicle / Construction access requirements: A formed crossing within the alignment is absent; however, due to the shallow banks and bed it is currently possible to traverse via 4WD. Minor modifications to bank would enable easier vehicular access during the dry season.</p>

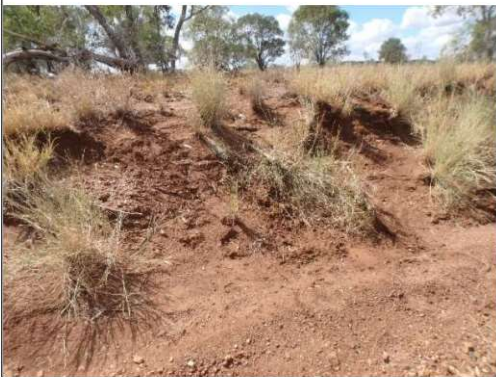
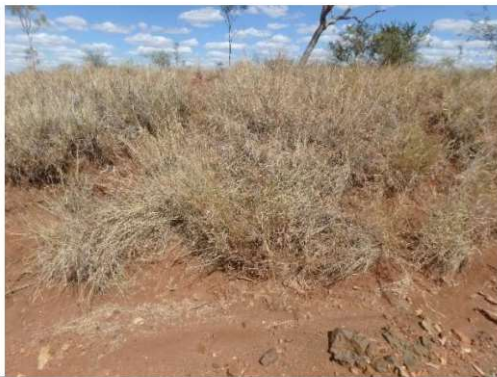
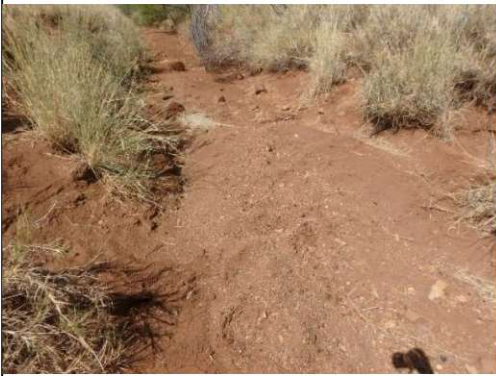
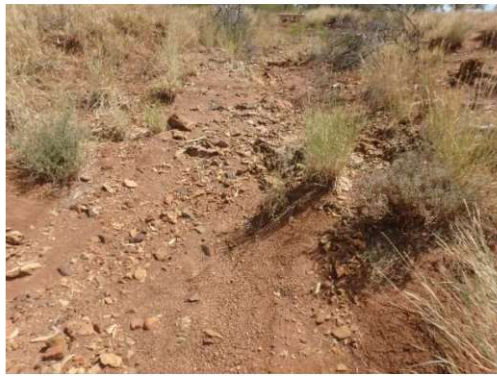
1.5 Watercourse W8-5

Desktop Mapping	Comment / Description
Vegetation Management Watercourse / Drainage (<i>Vegetation Management Act, 1999</i>)	
Stream Order	1
Waterway (<i>Fisheries Act, 1994</i>)	
Waterway	N/A
Watercourse Identification (<i>Water Act, 2000</i>)	
Watercourse / Drainage Feature / Unknown	The watercourse location fits the definition of a mapped Watercourse.
Other Comments	
<p>Creek bed characteristics and vegetation characteristics: Ephemeral watercourse 4m wide with a 2m sand/clay dry channel and occasional areas of surface rock (pebbles and cobbles). Wetland species absent. Bank vegetation dominated by <i>Cenchrus ciliaris</i> and <i>Acacia chisholmii</i>. Sparse canopy of <i>Corymbia terminalis</i> up to 6m.</p> <p>Weed risk: None observed.</p> <p>Current Aquatic Values: None present.</p> <p>Vehicle / Construction access requirements: A crossing within the alignment is present along roadside access track. Little to no modifications required for access.</p>

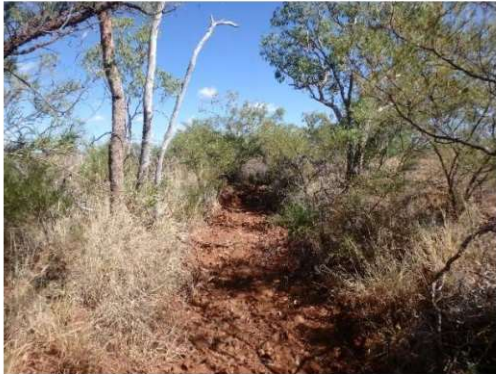
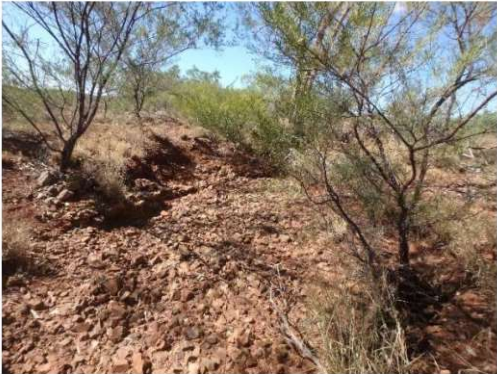
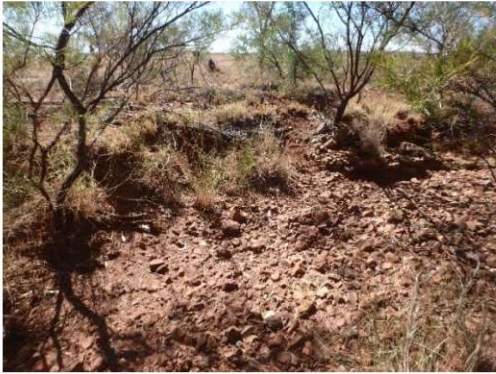
1.6 Watercourse W8-6

Desktop Mapping	Comment / Description
Vegetation Management Watercourse / Drainage (<i>Vegetation Management Act, 1999</i>)	
Stream Order	1
Waterway (<i>Fisheries Act, 1994</i>)	
Waterway	N/A
Watercourse Identification (<i>Water Act, 2000</i>)	
Watercourse / Drainage Feature / Unknown	The watercourse location fits the definition of a mapped Watercourse.
Other Comments	
<p>Creek bed characteristics and vegetation characteristics: 3m wide watercourse with sparse riparian vegetation on banks. Clay base with sandy top layer and rocks (pebbles and cobbles) on banks. <i>Corymbia termialis</i> dominated canopy layer to 5m in height, while <i>Acacia chisholmii</i> dominated the shrub layer.</p> <p>Weed risk: None observed.</p> <p>Current Aquatic Values: None present.</p> <p>Vehicle / Construction access requirements: A crossing within the alignment is absent, however would be possible to traverse. Minor modifications to bank vegetation, i.e. removal of some <i>A. chisholmii</i>, would enable vehicular access in the dry season.</p>

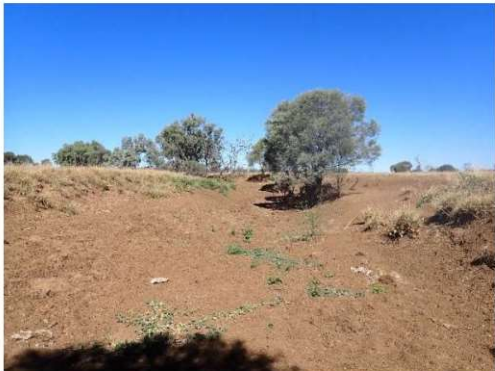
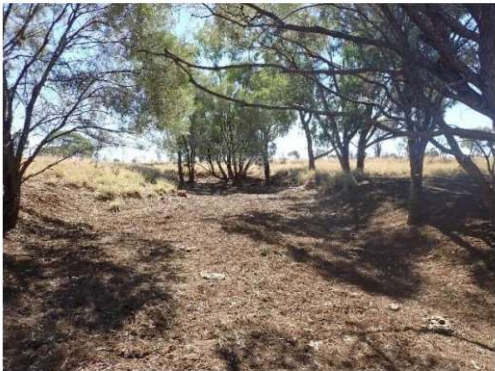
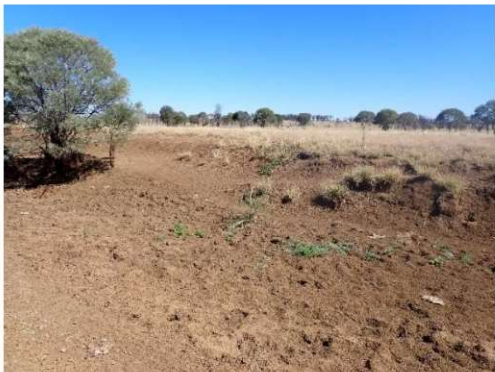
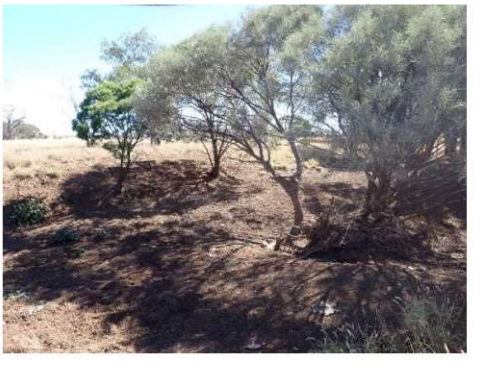
1.1 Scrubby Creek W10-1

Desktop Mapping	Comment / Description
Vegetation Management Watercourse / Drainage (<i>Vegetation Management Act, 1999</i>)	
Stream Order	4
Waterway (<i>Fisheries Act, 1994</i>)	
Waterway	Low impact (green)
Watercourse Identification (<i>Water Act, 2000</i>)	
Watercourse / Drainage Feature / Unknown	The watercourse location fits the definition of a mapped Watercourse.
Other Comments	
<p>Creek bed characteristics and vegetation characteristics: Ephemeral watercourse 17m wide with 0.9m narrow low flow main clay-based dry channel. Riparian vegetation on silt / clay banks. Remnant grassland vegetation with small riparian corridor retained. Scattered <i>Acacia cambagei</i> dominates canopy layer with very scattered <i>Eucalyptus coolabah</i> to 5-12m in height. <i>Cenchrus ciliaris</i>* dominant ground cover.</p> <p>Weed risk: <i>Cenchrus ciliaris</i>* observed.</p> <p>Current Aquatic Values: nil</p> <p>Vehicle / Construction access requirements: A crossing within the alignment is absent. A shallow 0.6m deep channel with a slight 0.3m rise on the right bank. Minor modifications to bank slopes and approaches would enable vehicular access during the dry season. Removal of riparian vegetation would be required. A rarely used farm track follows the fenceline 100m to the south. The Hughenden Muttaborra Road within 1500m to the west and 2000m to the east.</p>

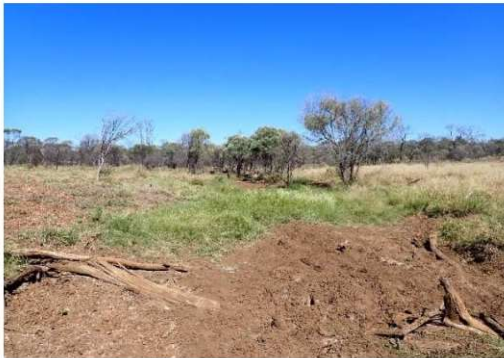
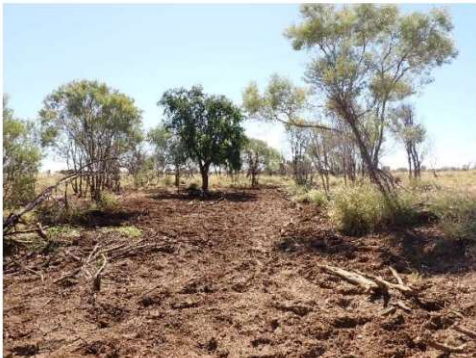
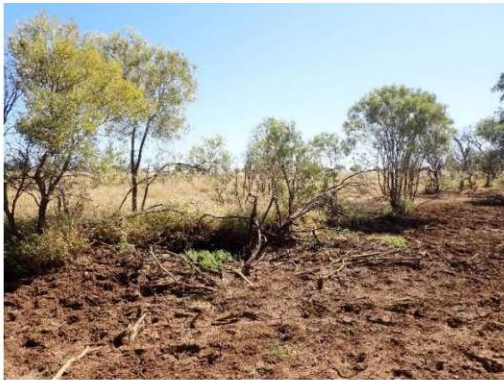
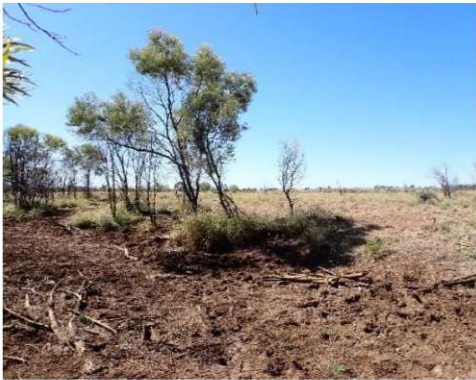
1.2 Watercourse W10-2

Desktop Mapping	Comment / Description
Vegetation Management Watercourse / Drainage (<i>Vegetation Management Act, 1999</i>)	
Stream Order	3
Waterway (<i>Fisheries Act, 1994</i>)	
Waterway	Low impact (green)
Watercourse Identification (<i>Water Act, 2000</i>)	
Watercourse / Drainage Feature / Unknown	The watercourse location fits the definition of a mapped Drainage Feature.
Other Comments	
<p>Creek bed characteristics and vegetation characteristics: Ephemeral watercourse 7m wide with 0.4m narrow low flow clay-based dry channel. Riparian vegetation on silt / clay banks. Non remnant area. Scattered <i>Acacia cambagei</i> dominates canopy layer with sparse <i>Lysiphyllum</i> sp. to 6m in height, with <i>Cenchrus ciliaris</i> dominant ground cover.</p> <p>Weed risk: <i>Cenchrus ciliaris</i> observed.</p> <p>Current Aquatic Values: nil</p> <p>Vehicle / Construction access requirements: A crossing within the alignment is absent. A shallow channel with shallow banks. Minor modifications to bank slopes and approaches would enable vehicular access during the dry season. Removal of riparian vegetation would be required. The nearest recorded access track within 100m to the south and main road within 1500m to the east. Access to the alignment may necessitate crossing this watercourse on several occasions.</p>

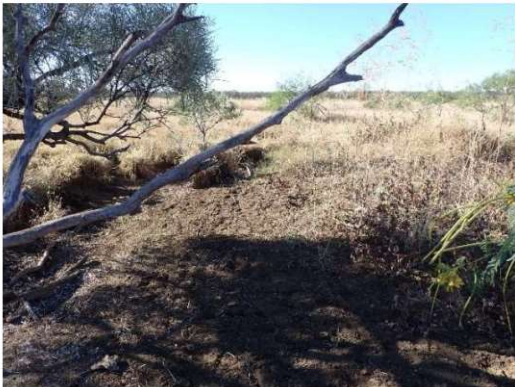
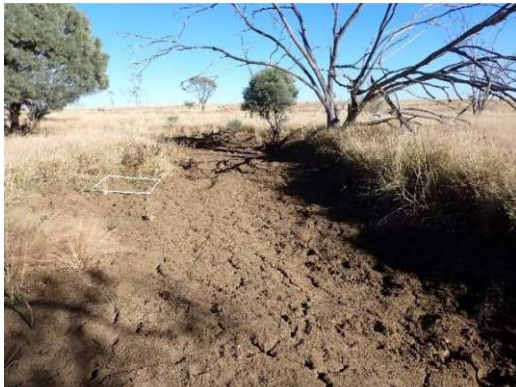
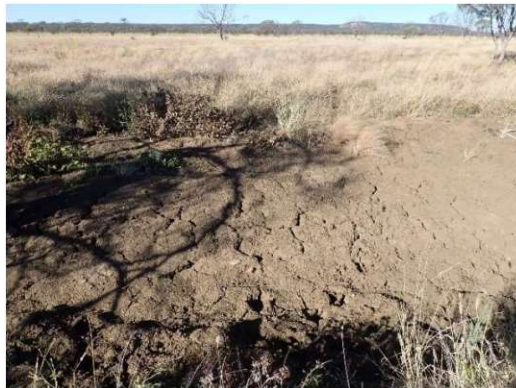
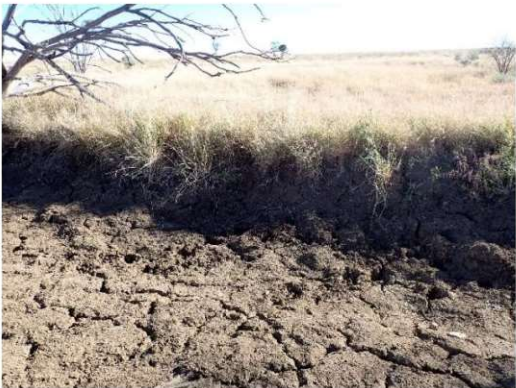
Desktop Mapping	Comment / Description
Vegetation Management Watercourse / Drainage (<i>Vegetation Management Act, 1999</i>)	
Stream Order	2
Waterway (<i>Fisheries Act, 1994</i>)	
Waterway	Low impact (green)
Watercourse Identification (<i>Water Act, 2000</i>)	
Watercourse / Drainage Feature / Unknown	The watercourse location fits the definition of a mapped Drainage Feature.
Other Comments	
<p>Creek bed characteristics and vegetation characteristics: Ephemeral watercourse 7m wide with 1m narrow low flow clay-based dry channel. Riparian vegetation on silt / clay banks. Scattered <i>Acacia cambagei</i> dominates canopy layer to 6m in height, with <i>Cenchrus ciliaris</i> dominant and scattered <i>Cyperus sp.</i> ground cover.</p> <p>Weed risk: <i>Cenchrus ciliaris</i> and <i>Xanthium pungens</i> observed.</p> <p>Current Aquatic Values: nil</p> <p>Vehicle / Construction access requirements: A crossing within the alignment is absent. A shallow 1m deep channel with shallow bank slopes. Minor modifications to bank slopes and approaches would enable vehicular access during the dry season. Removal of riparian vegetation would be required. Existing unsealed access track within 100m to the south and the main road 700m to the west. Access to the alignment may necessitate crossing this watercourse on several occasions.</p>

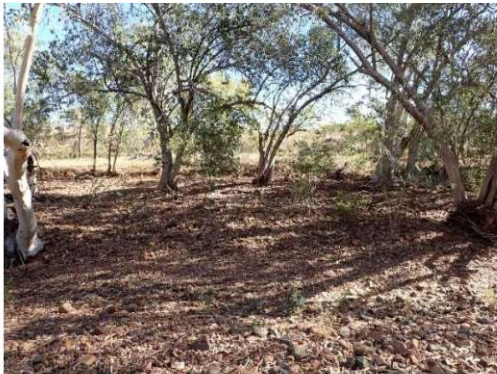
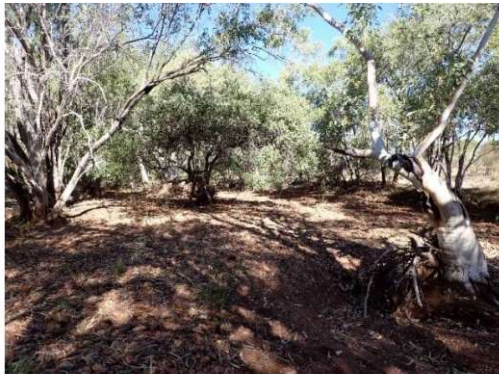
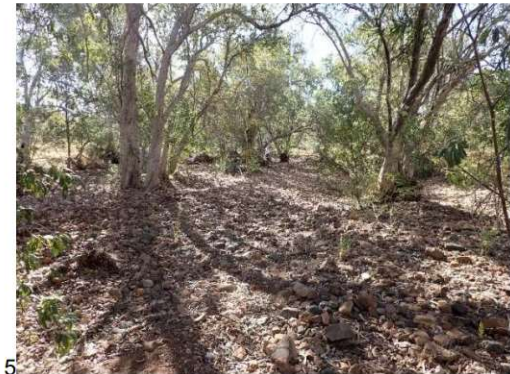
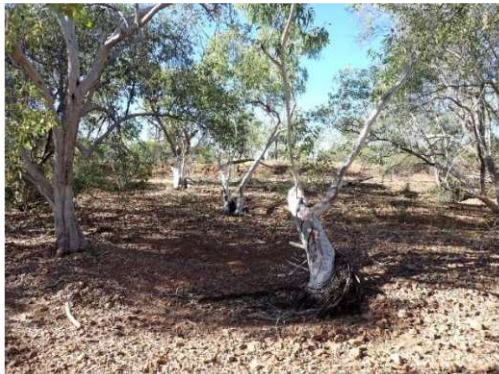
1.5 Watercourse W10-5

Desktop Mapping	Comment / Description
Vegetation Management Watercourse / Drainage (<i>Vegetation Management Act, 1999</i>)	
Stream Order	3
Waterway (<i>Fisheries Act, 1994</i>)	
Waterway	Low impact (green)
Watercourse Identification (<i>Water Act, 2000</i>)	
Watercourse / Drainage Feature / Unknown	The watercourse location fits the definition of an unmapped Watercourse.
Other Comments	
<p>Creek bed characteristics and vegetation characteristics: Ephemeral watercourse 86m wide with 1.2m narrow braided low flow dry rock / gravel channels and 2-4m deep outer banks. Riparian vegetation on rock / gravel banks. <i>Lophostemon grandifolium</i> dominates canopy layer with <i>Eucalyptus cameldulensis</i> to 16m in height. <i>Acacia torulosa</i> observed in tree canopy and shrub layers. <i>Cenchrus ciliaris</i> dominates edges of banks with scattered <i>Cyperus sp.</i> <i>Aristida sp.</i> in the ground layer.</p> <p>Weed risk: <i>Cenchrus ciliaris</i> and <i>Vachellia farnesiana</i> observed.</p> <p>Current Aquatic Values: nil</p> <p>Vehicle / Construction access requirements: A crossing within the alignment is absent. This channel is on average less than 1.2m in depth with 2-4m deep outer banks. Moderate modifications to bank gradients and approaches would enable vehicular access in the dry season. Removal of riparian vegetation would be required. Existing unsealed access track and waterway crossing within 100m to the north west.</p>
