M0001 Waterway Locations and Assessments

M0001 – September 2020

Client: CuString 2.0
Reference: J0105

Title:	Waterway Locations and Assessment for M0001 – September 2020
Address:	
Job Number:	J0105
Client:	CuString 2.0

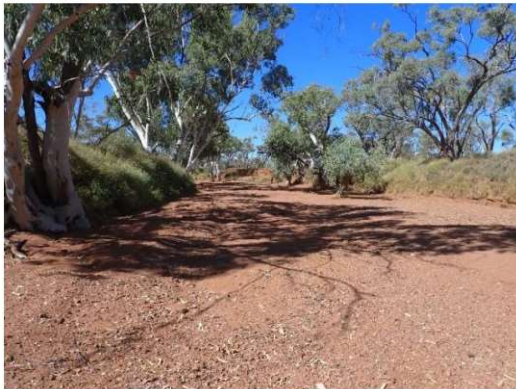
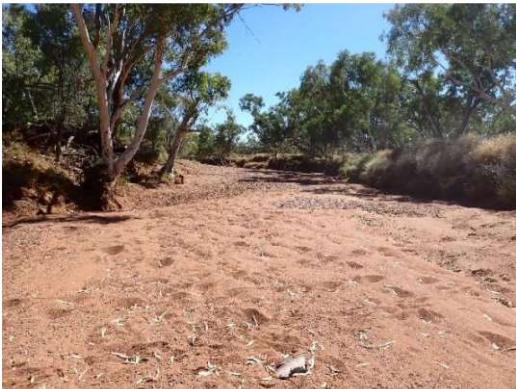
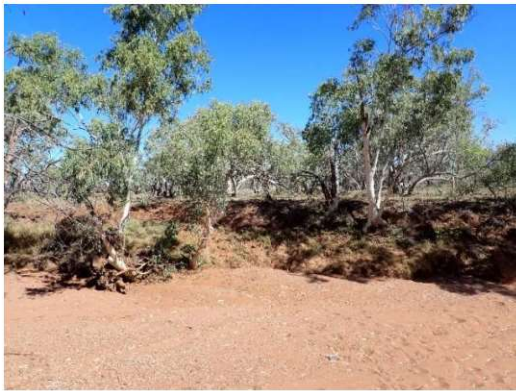
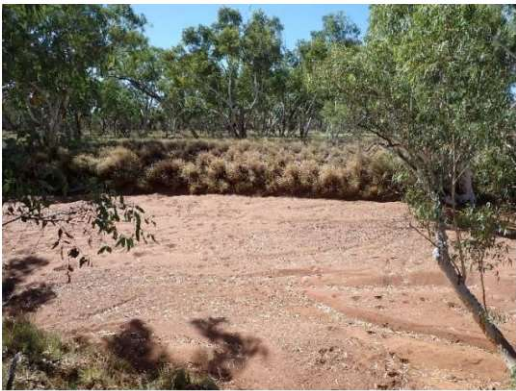
1.6 Gorge Creek W10-6

Desktop Mapping	Comment / Description
Vegetation Management Watercourse / Drainage (<i>Vegetation Management Act, 1999</i>)	
Stream Order	5
Waterway (<i>Fisheries Act, 1994</i>)	
Waterway	Moderate impact (amber)
Watercourse Identification (<i>Water Act, 2000</i>)	
Watercourse / Drainage Feature / Unknown	The watercourse location fits the definition of an unmapped Watercourse.
Other Comments	
<p>Creek bed characteristics and vegetation characteristics: Ephemeral watercourse 24m wide with a 4m deep sand / gravel dry channel with steep banks. <i>Eucalyptus cameldulensis</i> dominates canopy layer with scattered <i>Eucalyptus coolabah</i> to 15m in height. Banks covered in <i>Cenchrus ciliaris</i>.</p> <p>Weed risk: <i>Cenchrus ciliaris</i> observed.</p> <p>Current Aquatic Values: nil</p> <p>Vehicle / Construction access requirements: A crossing within the alignment is absent. This channel is on average 4m deep. Moderate modifications to bank gradients and approaches would enable vehicular access in the dry season. Removal of riparian vegetation would be required. Existing unsealed access track 250m to the south east. Access to the alignment may necessitate crossing this watercourse on several occasions.</p>
