Waterway Barrier Works Technical Report

Waterway investigation and fish community survey in relation to the Scenic Rim Agricultural Industrial Precinct project.

Technical Report – April 2020

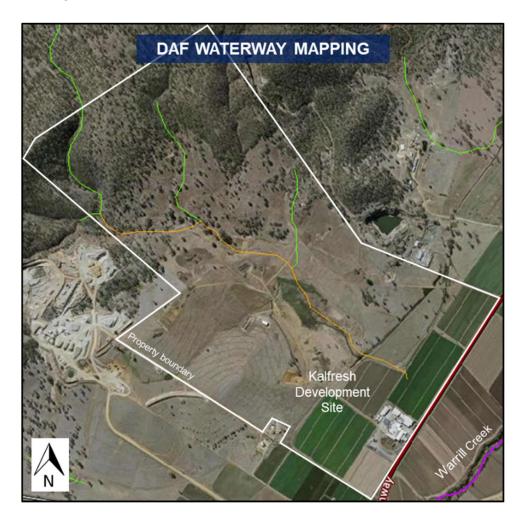
Figure 1. Study area showing DAF waterway mapping layer, including amber, green waterways and downstream purple waterway (Warrill Creek).

The Impact Assessment Report (RPS, 2020) describes the existing on-site hydrology. Within the elevated land in the northern portion of the site, ephemeral gullies exist that flow after seasonal rainfall. There are several existing farm dams on site for watering livestock. Department of Agriculture and Fisheries (DAF) waterway mapping indicates that there are three green 'low-risk' waterways and a single amber 'moderate-risk' waterway within the site (Figure 1). The mapping indicates that there is no waterway connectivity through the cropping area to Warrill Creek.

A DAF mapped amber waterway runs through the middle of the proposed development site (Figure 1). To adequately assess the characteristics of this waterway a total of six sites were visited from the top to the bottom of the site (Figure 2).

It is likely that the classification as an amber 'moderate risk' waterway is a result of the low gradient of the land in combination with the waterway mapping capturing the gullies as green waterways. Based on the findings above, this investigation recommends reclassifying the amber waterway as green 'low risk' waterway (Table 1). The characteristics of this waterway indicate it has a lower risk to fish passage consistent with a green 'low risk' waterway classification. This study also confirms that upper waterway limit is the upper extent of the mapped amber waterway (Figure 3).

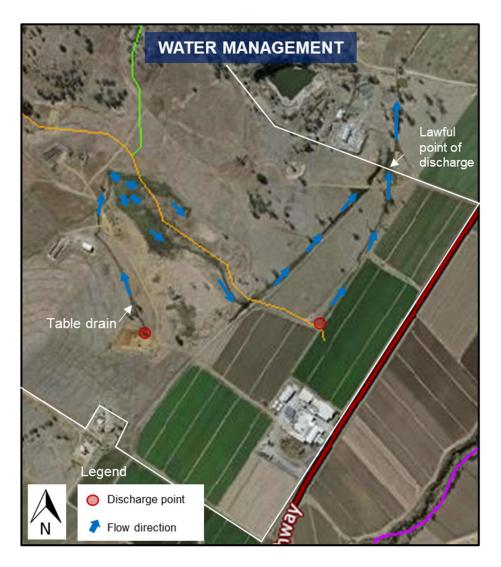
Figure 2. Processing water discharge points.

The existing vegetable processing and packing facilities utilise bore water that is pumped from the facility to two discharge points. The first is a high point west of the processing facility where water is discharged to a perched table drain. The water then runs north down this table drain to the centre of the site, where it is treated via overland flow through a very broad and flat basin. The overland flow is captured at the bottom of the basin by a channel adjacent to the existing levee bank and directed to the lawful point of discharge (Figure 2).

The second point of discharge is a constructed drain northeast of the processing facilities. The water flows northwards within the drain to the lawful point of discharge.

West of site four, water from the Kalfresh vegetable washing operation exits the perched table drain where it disperses and spreads down into the valley floor, before being captured by the drainage channel (Figure 2). Fish were found in this lower section of the amber waterway (diversion channel), including sites 2 and 4. The constant release of water into the lower section of the site would act to waterlog this area and enhance any natural flows experienced within the site. It is highly likely that this artificially increases opportunities for fish passage into the site from downstream habitats of Warrill Creek.

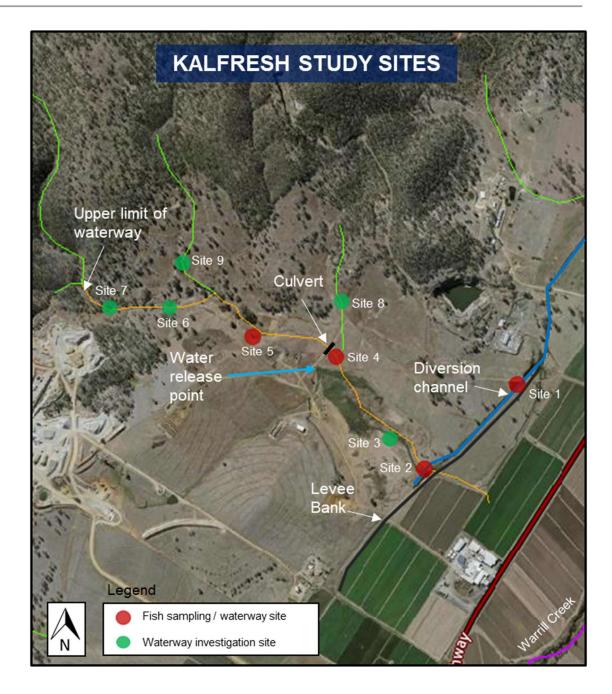
Figure 3. Waterway and fish sampling investigation sites within the Kalfresh site. DAF mapped green and amber waterways are shown as well as historical levee bank (black line), and location of diversion channel (blue line).

There are three mapped green waterways located within the site, one above the upper section of the amber waterway and two green waterways that join the amber waterway mid-way down the site (Figure 1 and 3).

The green waterways within the site were found to be drainage lines, contained no defined bed or banks, other waterway features or fish habitats (Table 1; Appendix A). Further, the sites did not contain adequate water or flow despite recent and substantial rainfall in the month prior and the day before the site investigation. Therefore, it was determined that these were not waterways for the purpose of the *Fisheries Act 1994*.

The upper section of this waterway (between 4 and 7) were found to have waterway features that included defined bed and banks and some pool formations (Table 1). Generally, in the upper section (sites 6 and 7) small pools were present due to underlying bedrock and where bedrock was not present large sections of stream were dry (Table 1; Appendix A). The pools in this upper section were very shallow (mean depth of 20cm) and would easily evaporate during seasonal periods of dry weather. It is unlikely that this upper section of the waterway would retain permanent flow such that waterway connectivity would continue to occur following rain events. No fish were observed or caught in the upper section of the waterway.

This investigation confirmed that the DAF waterway mapping layer has accurately mapped a discontinuation of the waterway through downstream cropping areas (Figure 3). As within the cropping area below the levee bank and constructed drainage channel no waterway features currently exist.
