8. Groundwater Resources

With the expansion of Hinze Dam to the Stage 3 height, there is a need to assess existing groundwater resources within the area of inundation and investigate whether the project has the potential to result in groundwater-related environmental or social impacts. As part of the project the height of the main dam embankment crest will be raised from 93.5 m to 108.5 m AHD. The FSL will be raised 12.3m from 82.2 m to 94.5 m AHD increasing the area of inundation within the Hinze Dam catchment.

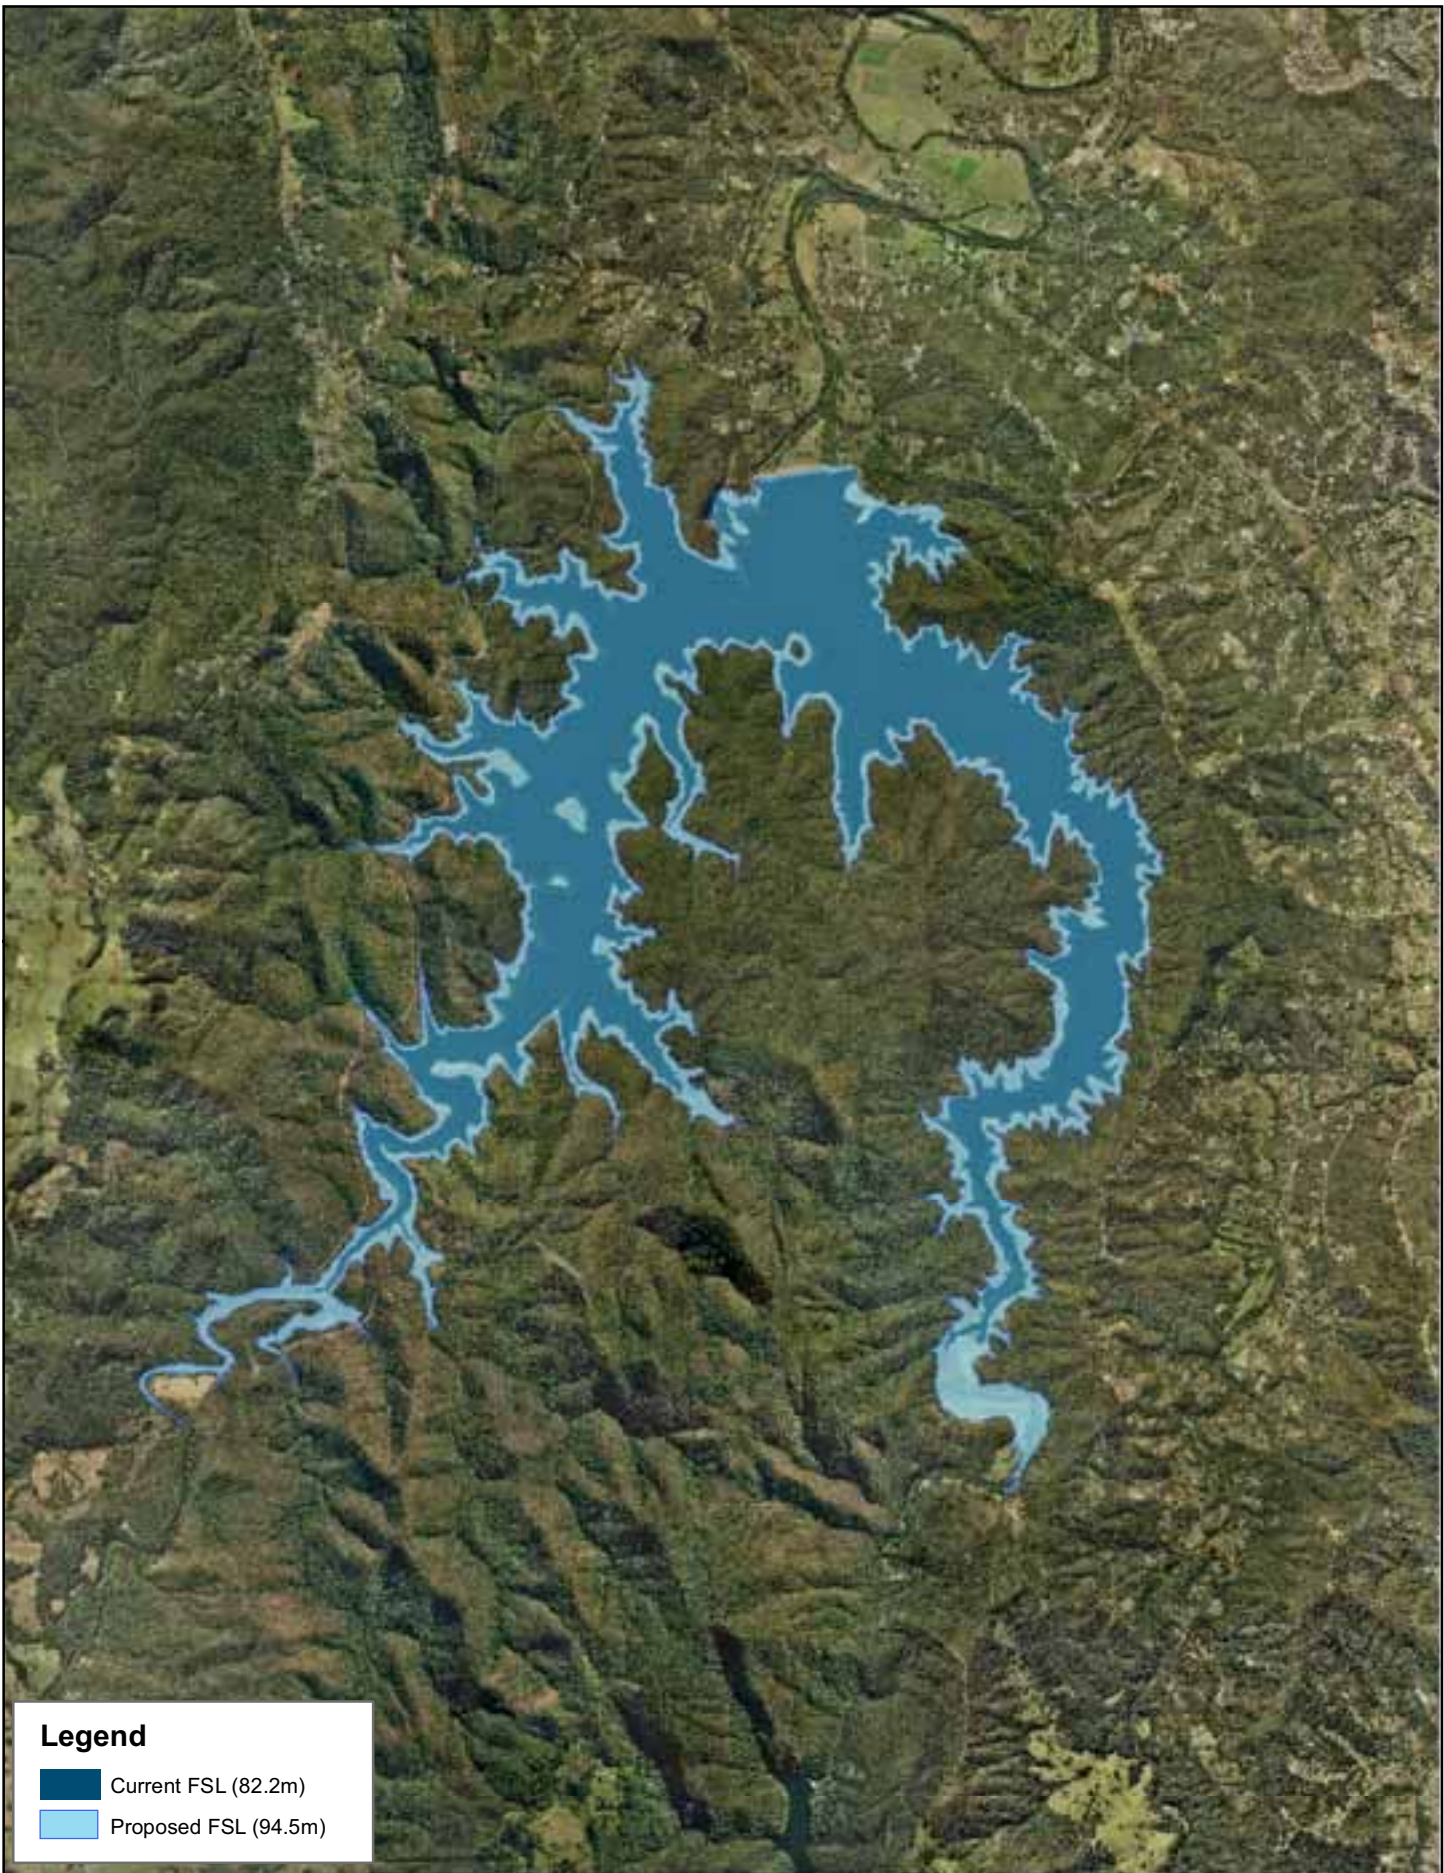
Figure 8-1
Footprint of Proposed
Inundation Area
Hinze Dam Stage 3 EIS

Current FSL (82.2m)
-

Proposed FSL (94.5m)

An overview of the hydrogeological setting within the vicinity of Hinze dam is presented in this section. This assessment is based on the area subject to inundation as a result of the project. The existing extent of inundation together with the area of inundation following Stage 3 development is shown in **Figure 8-1** Hinze Dam Area of Inundation .
