Flooding

## Chapter 19 - Table of Contents

## 19 Flooding

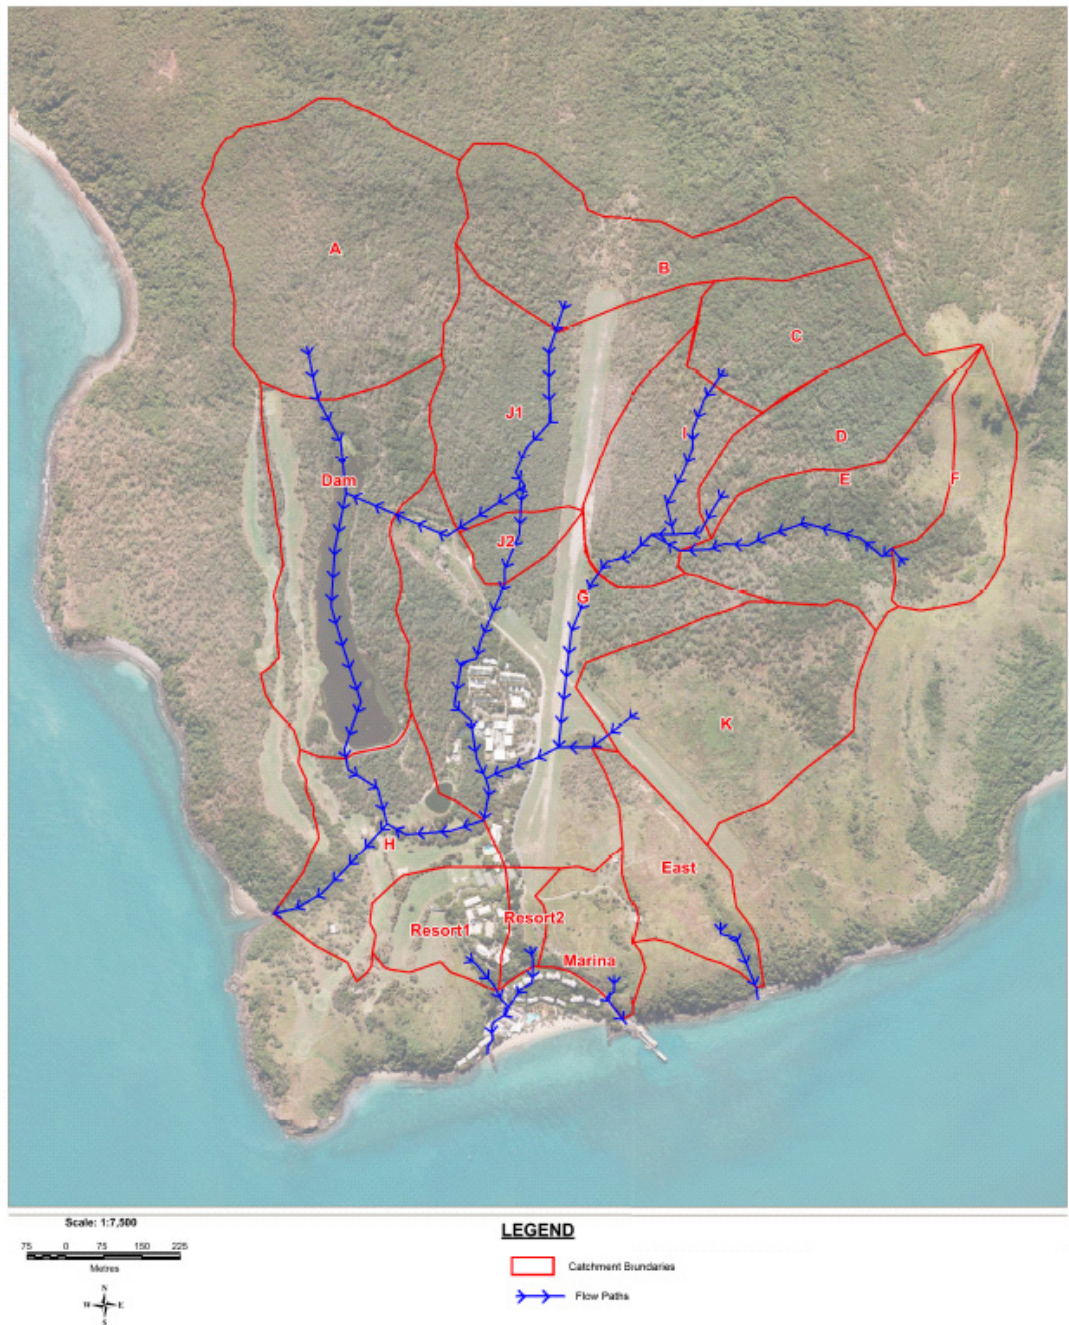
**Figure 19-2. Proposed Catchment Plan.**

The proposed extension to the dam will increase the catchment area contributing to the dam (refer to **Table 19-1**, **Figure 19-2** and **Figure 19-4**). However, all of the runoff from the additional catchment area will not be able to be diverted into the dam due to environmental restrictions on works in this area. During small rainfall events, a new waterway will direct flow contained in the main channel of the creek to the extension of the dam. During medium to large rainfall events, some of the runoff from the additional catchment will be directed to the dam, but the remainder will continue in a southerly direction along the existing floodplain.

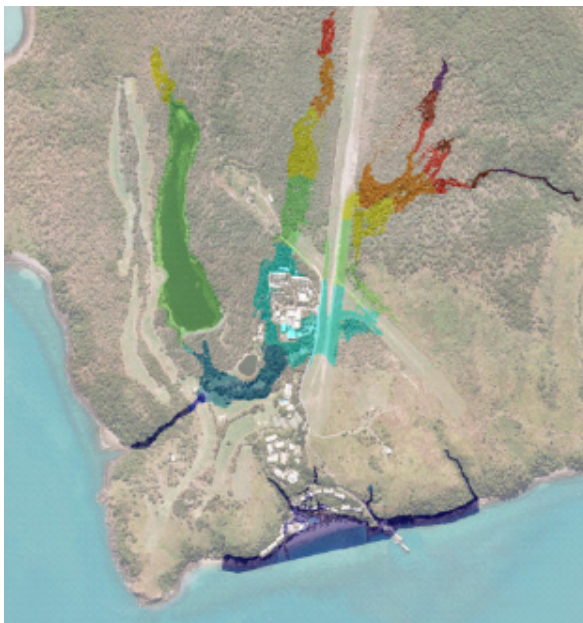
**Figure 19-5. Existing 1% AEP Water Level.**

The existing case 1% AEP flood levels and depths are presented in **Figure 19-5** and **Figure 19-6** respectively. The results show that the flood flow is conveyed in the steep valley which discharges towards the existing resort. At the downstream end of this valley, the flow is diverted to an underground pipe drainage network. However, some overflow occurs during the 1% AEP event, causing flooding to some existing buildings. Thus, the detailed design of the future stormwater drainage system in this area will need to take this into account so that all future buildings are immune to flooding in the 1% AEP event.

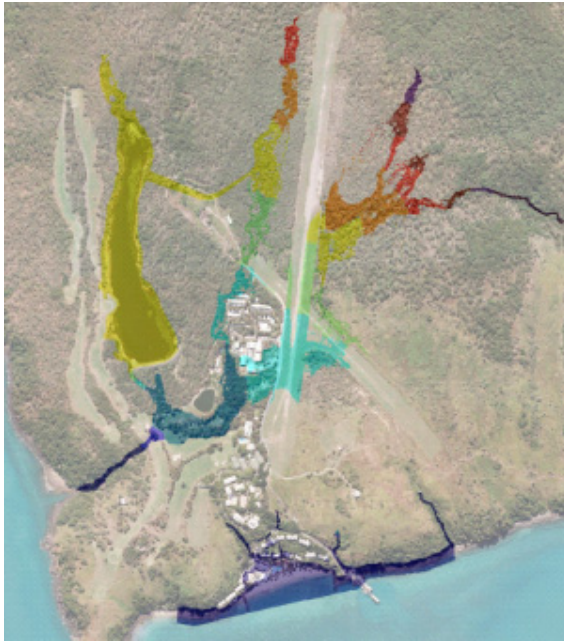
**Figure 19-7. Proposed 1% AEP Water Level.**

The developed case 1% AEP flood levels and depths are presented in **Figure 19-7** and **Figure 19-8** respectively. The results are similar to those discussed above. There is also flooding in the vicinity of some of the proposed buildings. The buildings that could be affected are the aircraft hangers, and a small part of the tourist villa district located east of the runway. These issues will need to be addressed during the detailed design of the site. In summary, the results of the flood model indicate that some stormwater drainage upgrades will be required as part of the proposed redevelopment of the Lindeman Island Resort.

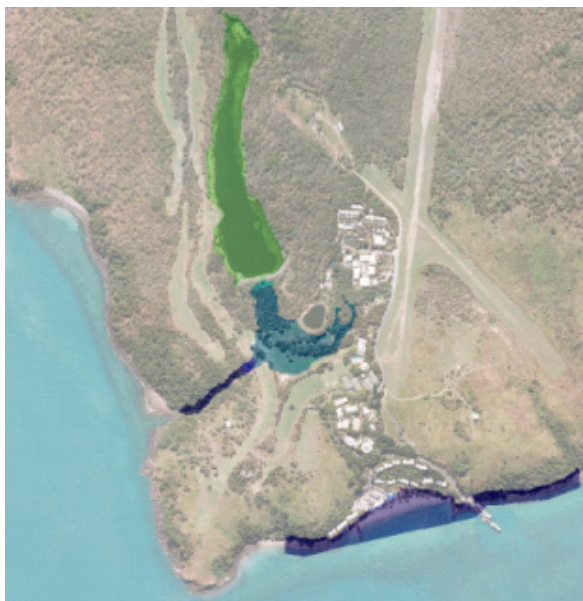
**Figure 19-9. Existing Case Sunny Day Failure Water Level.**

The existing case sunny day failure is a failure of the dam in its existing condition, starting with the dam at its full supply level. The peak flood levels and depths due to the existing case sunny day failure case are presented in **Figure 19-9** and **Figure 19-10** respectively. The flood extent does not break out of the Gap Creek valley into the resort area. Hence, there are no persons at risk from a sunny day dam failure under existing conditions.

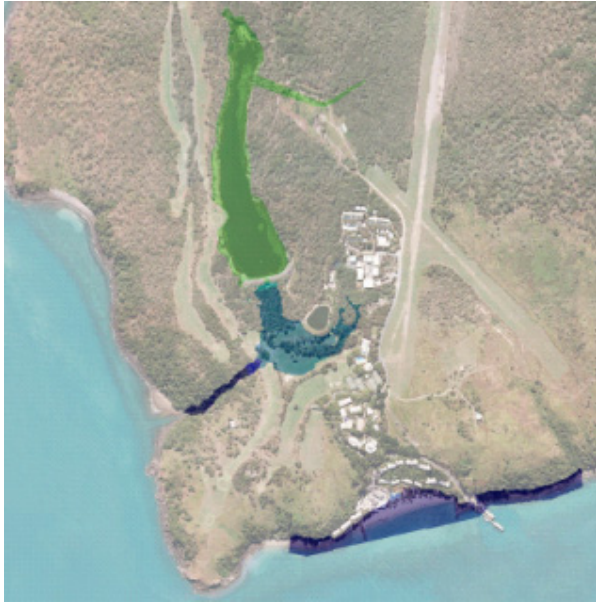
**Figure 19-11. Proposed Case Sunny Day Failure Water level.**

The peak flood levels and depths due to the sunny day failure with the proposed dam arrangement are presented in **Figure 19-11** and **Figure 19-12** respectively. Similar to existing conditions, the flood extent does not break out of the Gap Creek valley into the resort area. Hence, there are no persons at risk from a sunny day dam failure under developed conditions.

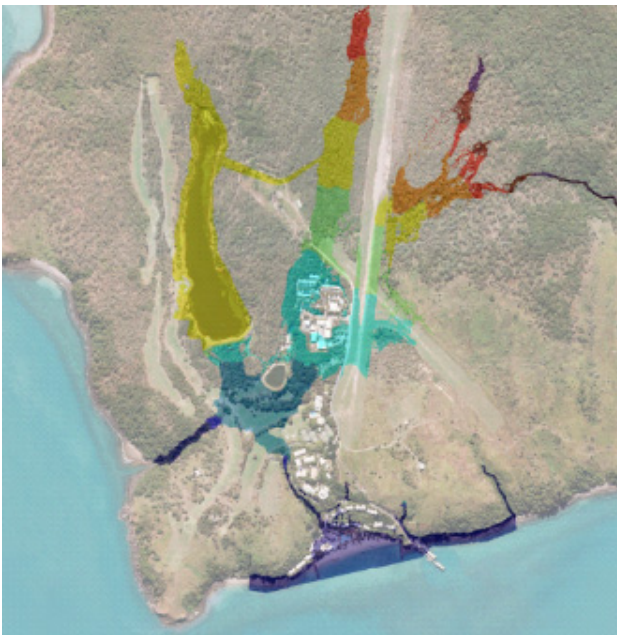
**Figure 19-15. Proposed Dam Failure during a Flood Water Level.**

The peak flood levels and depths due to the developed scenario dam crest failure case are presented in **Figure 19-15** and **Figure 19-16** respectively. The results are similar to the existing case results, and show that the flow breaches the existing ridge and discharges towards the resort area.
