**Potential impacts of downstream passage
of fauna over a labyrinth spillway at
Lake Macdonald
Six Mile Creek**

A. P. Berghuis

December 2017

Aquatic Biopassage Services
for Seqwater

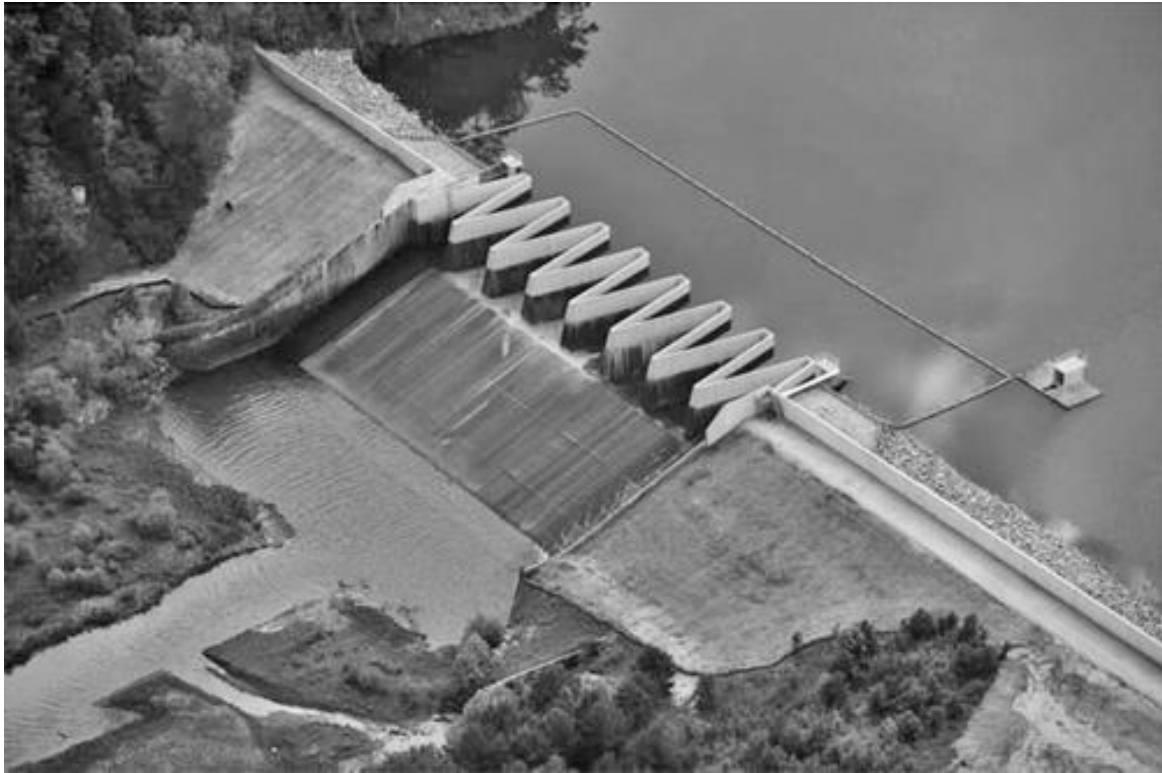
Figure 2. Example of a labyrinth type spillway with no stilling basin or plunge pool, image from Crookston and Tullis (2013).

Some of the dams and weirs overseas with labyrinth spillways have incorporated fishways for upstream passage, however no mention of downstream fish passage was found for any labyrinth spillway. Many of the retrofitted dams appeared to incorporate a low height labyrinth spillway on top of a previously conventional crest. Very few of the labyrinth spillway designs viewed online incorporate a stilling basin or any type of plunge pool that may protect downstream migrating fauna below the labyrinth spillway, refer Figure 2.

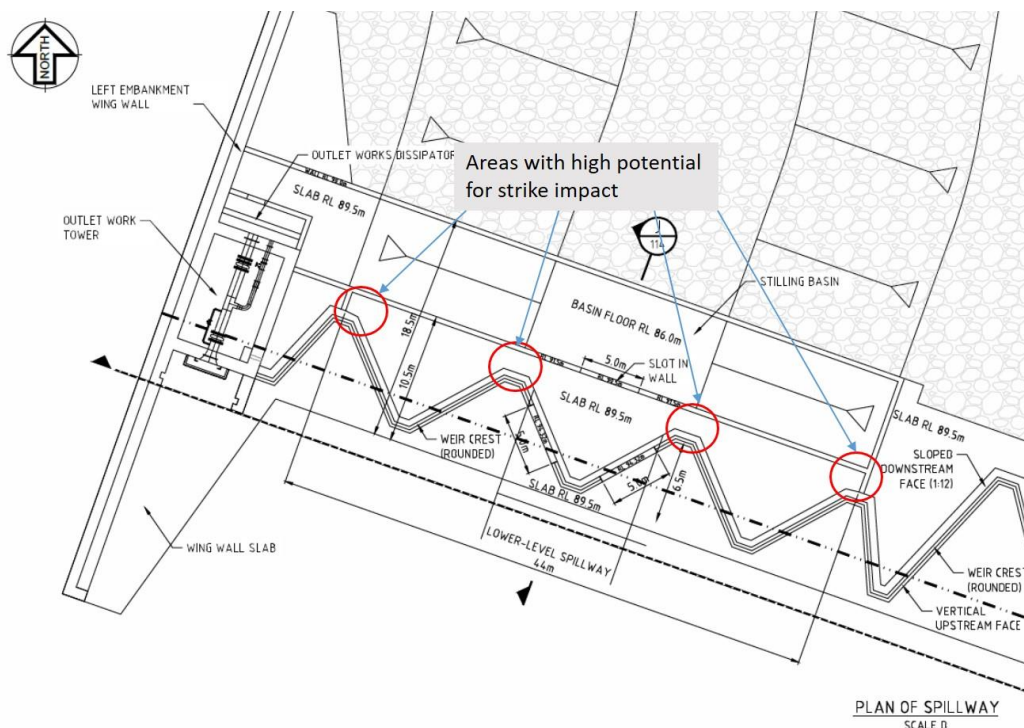
Figure 4. Low flow section of labyrinth spillway showing areas with high potential for strike (from AECOM Drawing 60451967 - 113).

The stilling basin nib walls have the potential to cause injury to fish that strike them during overtopping flows; particularly at locations where the spillway is close to the nib wall as shown in Figure 4. Modelling of the flow patterns in both of the stilling basins using a technique such as 3D Computational Fluid Dynamics (3D CFD) will provide details to inform an improved wall arrangement.

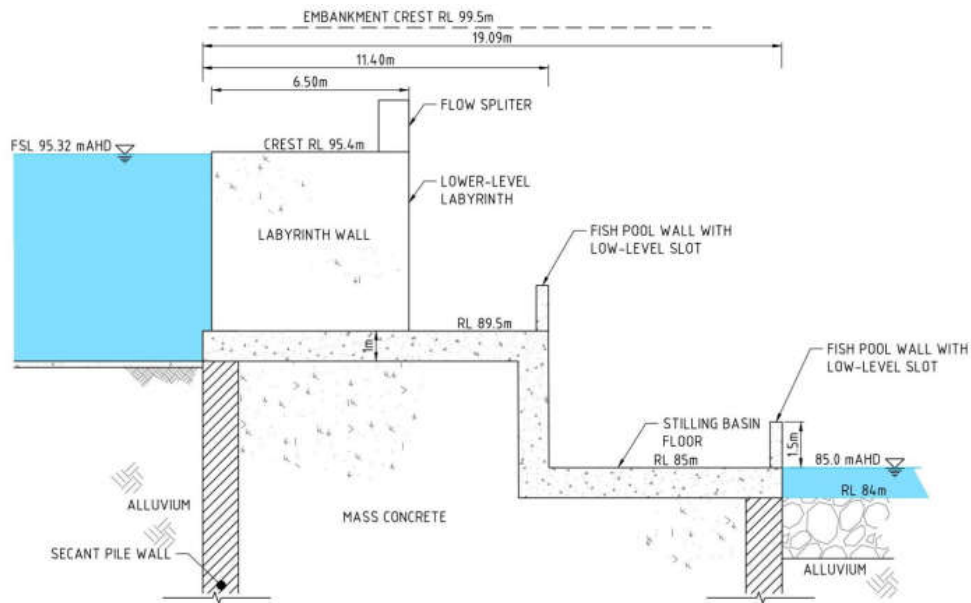
Figure 1. Six Mile Creek Dam –Concept design of the original layout of the labyrinth spillway. (Provided by AECOM)

Seqwater has been working with AECOM and Aquatic Biopassage Services to develop solutions to minimise fauna injury in the spillway and stilling basin design. The initial concept design for the labyrinth spillway is shown in Figure 1.

The design for downstream plunge pool walls is for rounded upstream crests to minimise sharp upstream edges, this is not shown in the early concept designs in Figure 1 and 2.

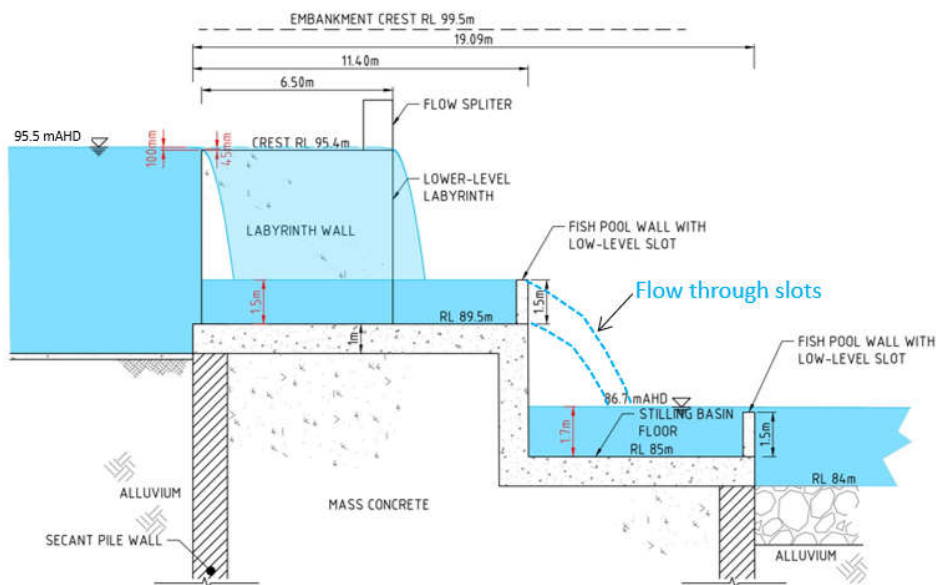
Figure 2. Conceptual water profiles for the original layout of the labyrinth spillway crest and plunge pools. (Provided by AECOM)

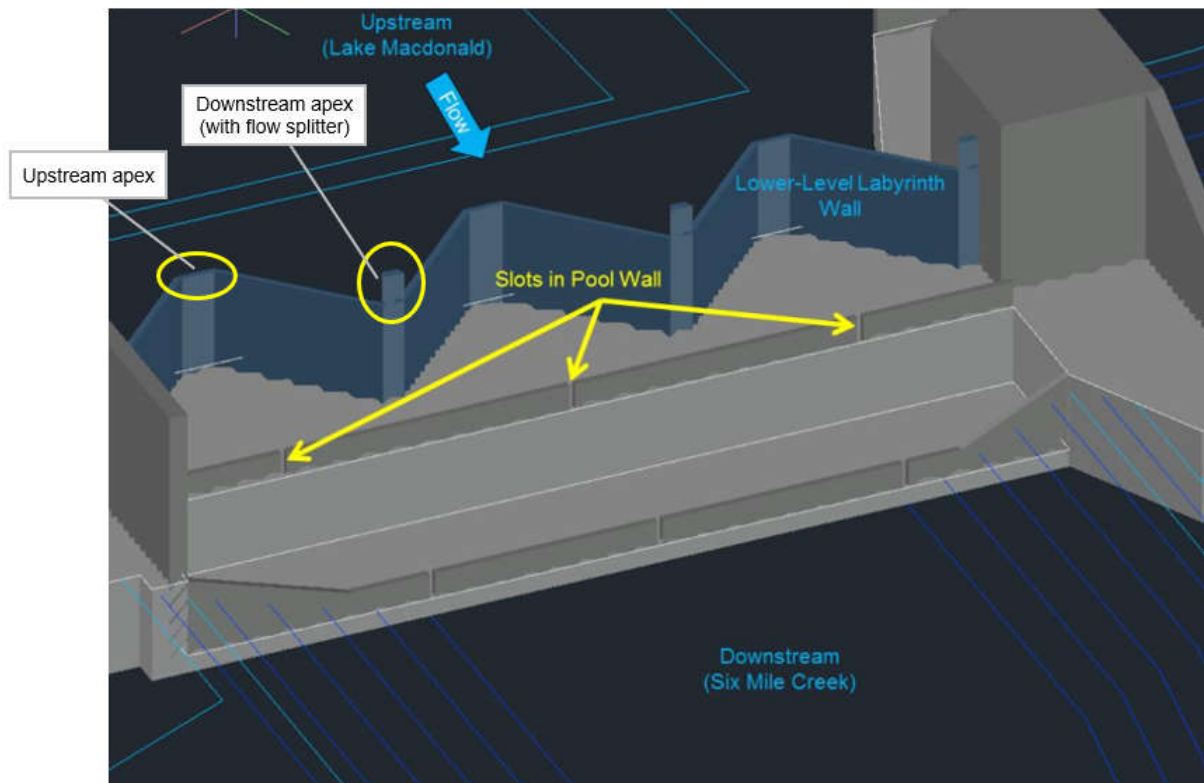
Figure 3. 3D sketch of concept design labyrinth spillway and plunge pools (Configuration 1)
(Provided by AECOM)

For reference, Figure 3 shows a 3D sketch of the concept design labyrinth spillway used as a starting point for spillway modelling.

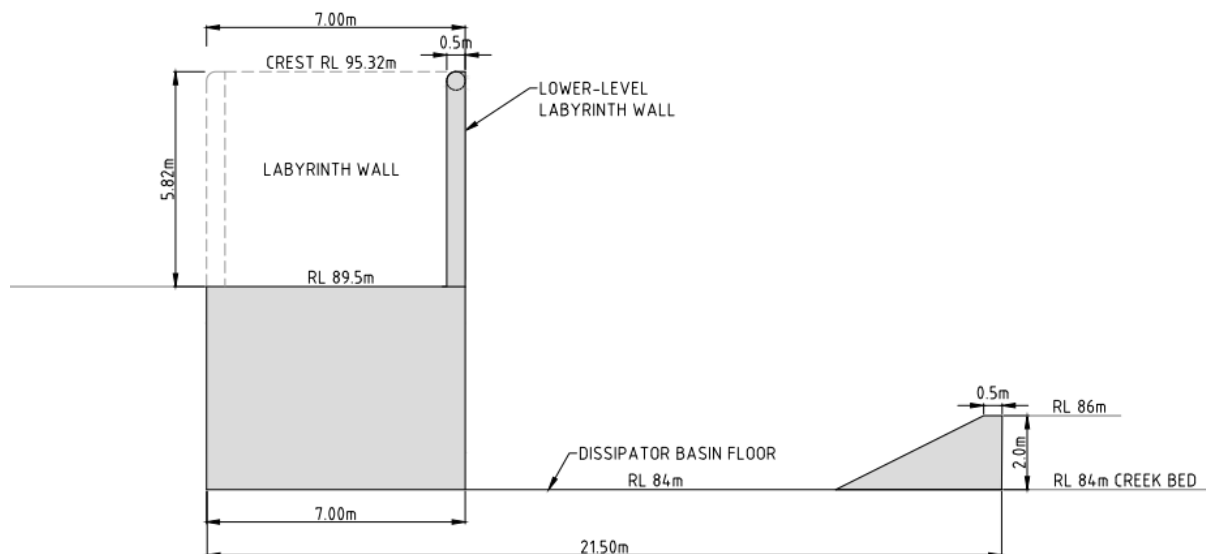
Figure 4. Cross-section of single pool labyrinth arrangement (Configuration 5)

Configuration 5, with a single pool arrangement, has been selected as the final plunge pool design to move forward to detailed design. A cross section of this configuration is provided in Figure 4. The CFD modelling produced by AECOM for the latest iteration of the Configuration 5 plunge pool design indicates favourable conditions for flow over the acute angle sections of the spillway. Issues with high velocity and potential for abrasion are eliminated for the lower range of flows and reduced to

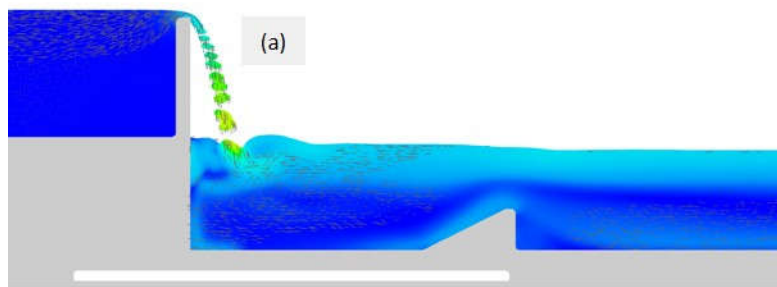
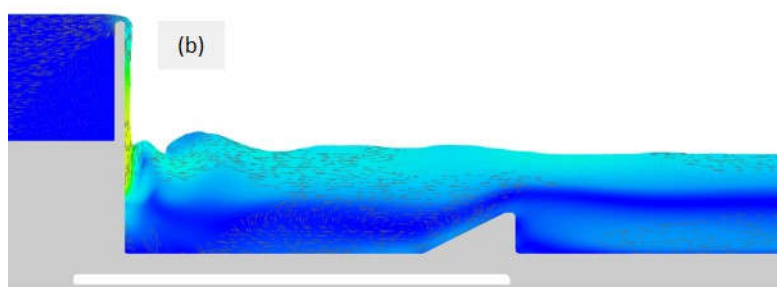
Figure 1. 300mm overtopping CFD model run slices through spillway section at an acute angle (a) and upstream apex section (b).

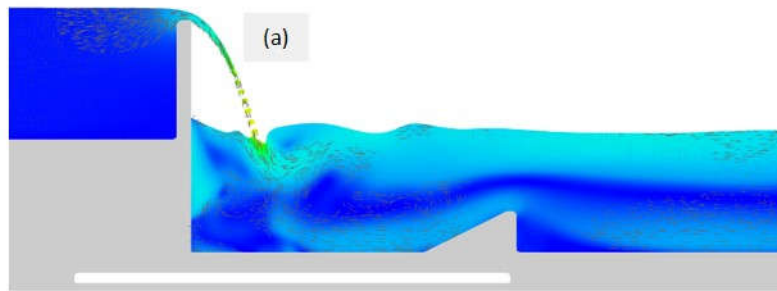
Figure 2. 600mm overtopping CFD model run slices through spillway section at an acute angle (a) and upstream apex section (b).

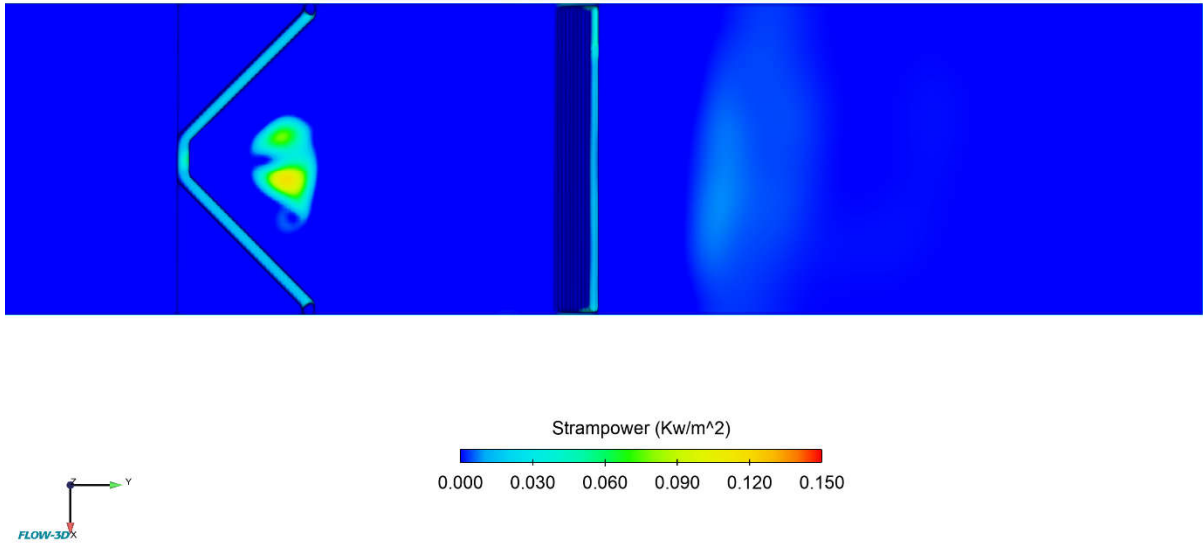
Figure 5. Plan view of CFD model run at 600 mm overtopping flow; showing impact on stilling basin floor caused by flows over the upstream apex section of spillway.
