Gateway Upgrade Project

Soils Section Supporting Information

Land Survey Summary

Appendix G1 Detailed Land Survey Summary

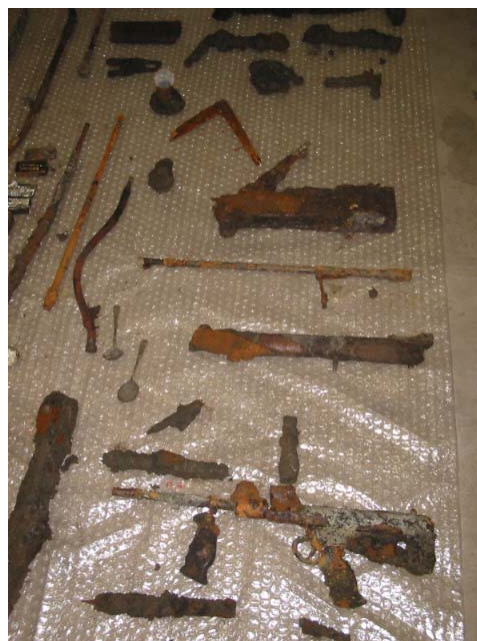
Photograph 3. Weapon parts recovered by G-tek during the investigation of Meeandah dams.

An assessment of the dams was conducted by G-tek for Parsons Brinckerhoff during February 2003 and the nature of contamination within the dams was confirmed as general ordnance stores, primarily weapon parts and surgical instruments.

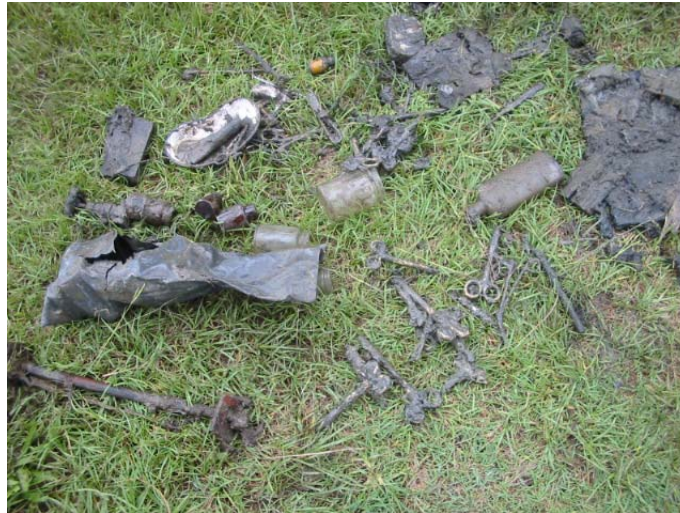
Photograph 4. Surgical equipment recovered by G-tek during the investigation of Meeandah dams.
