4. Topography, Geomorphology, Geology and Soils

Hinze Dam Stage 3 EIS

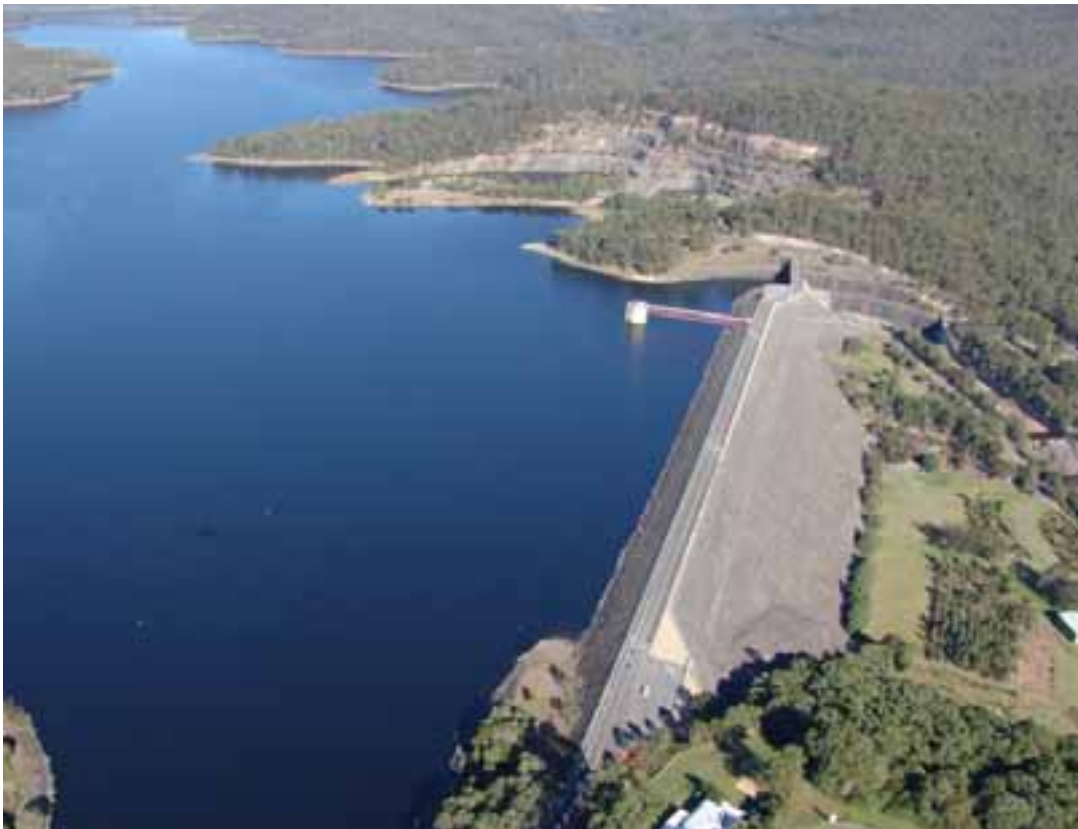
■ **Figure 4-1 View Across the Dam Wall to the Existing Quarry**

The Hinze Dam is located downstream of the confluence of the Nerang River and Little Nerang Creek. The height of the dam from toe to crest is approximately 63.5m. The existing dam crest level is at 93.5m AHD and the current full supply level of the dam is 82.2m AHD (refer to **Figure 4-1**).

A quarry is located immediately west of the existing dam wall. The current void is located above the current full supply line and is approximately 300m in length and 70m in height above the current FSL. Photographs of the quarry are shown in **Figure 4-1** and **Figure 4-3** . The quarry will be the source of approximately 2.1million m³ rock for the construction of the dam. The extraction of this volume of rock will result in the final landform at the quarry site being significantly different to the existing situation.

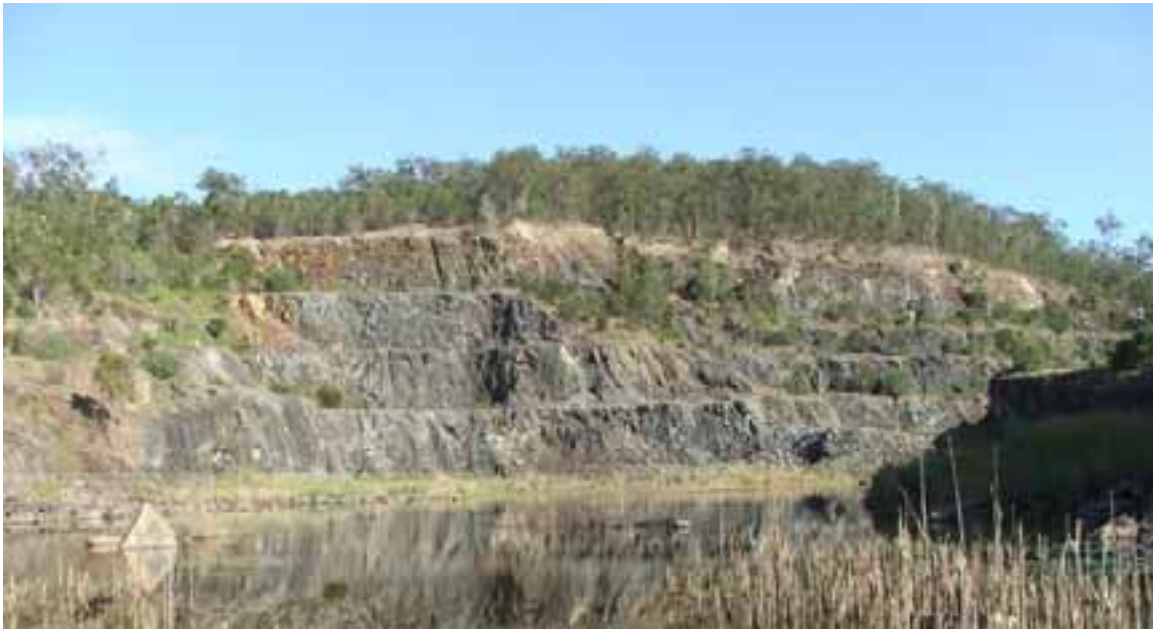
■ **Figure 4-3 View from the Lake of the Existing Quarry**

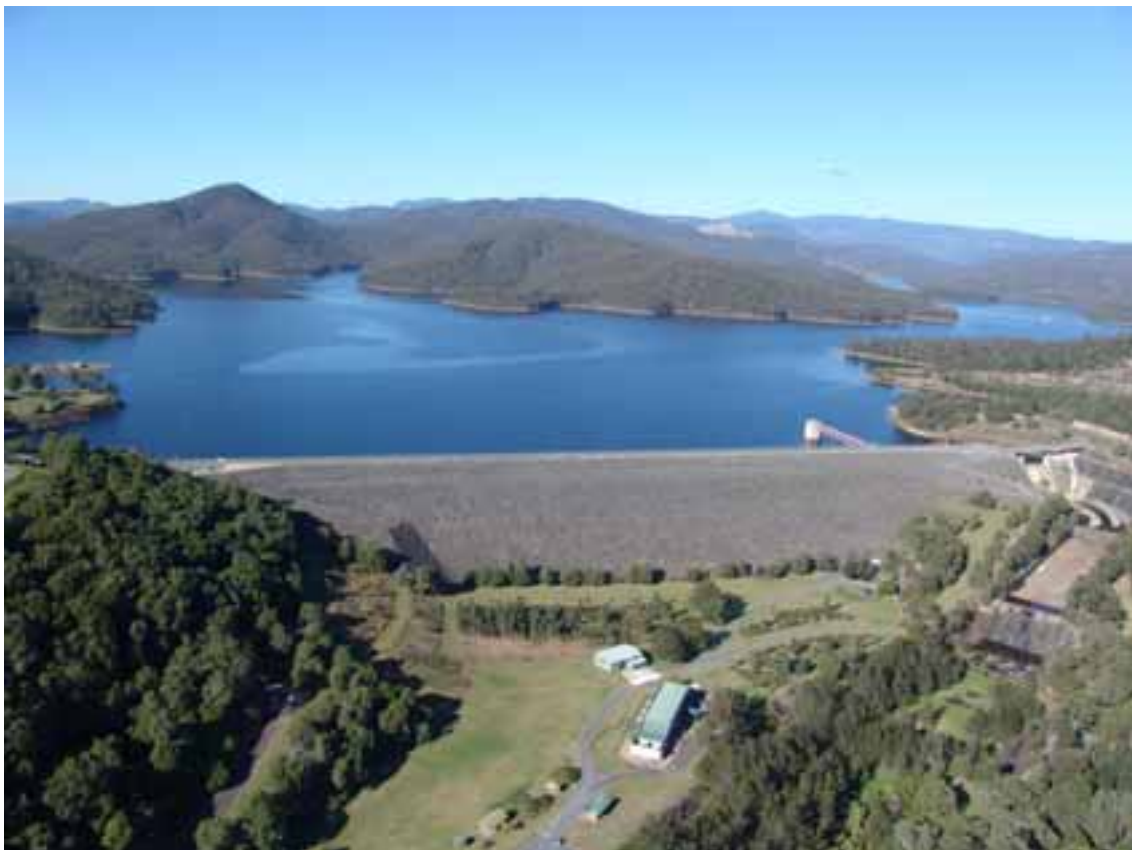
■ **Figure 4-4 View Looking up the Two River Valleys to Pages Pinnacle**

The most dominant topographical feature within the vicinity of the dam and impoundment area is Pages Pinnacle, which is located near the southern boundary of Lot 4 SP 164198. Pages Pinnacle is an exposed igneous rock, with an elevation of 398m AHD and dominates the landscape in this area (**Figure 4-4**). The Tallai Range to the east of the lake drains to Little Nerang Creek via typically short steep gullies. Spot heights for the top of the peaks in the Tallai Range vary between 108m and 369.5m AHD.

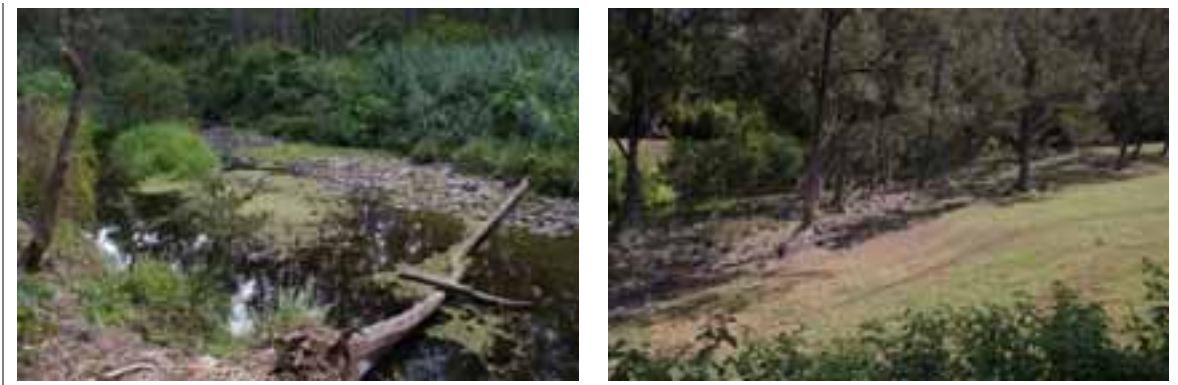
■ **Figure 4-6 ‘Good’ and ‘Poor’ Sites on Nerang River Upstream of Advancetown Lake**

Impacted sites were also noted (e.g. near Priems Crossing) where cattle access and water extraction methods had affected bank stability and low flow conveyance (refer **Figure 4-6**).

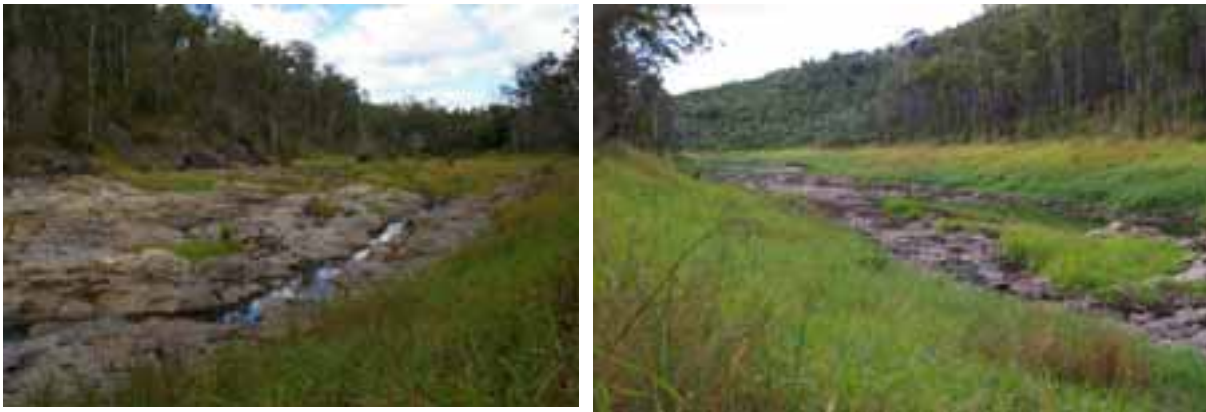
■ **Figure 4-7 Upstream and Downstream Views at Stage 3 Inundation Area**

This site exhibited a variety of habitat types including cascades, riffles, glides and pools (**Figure 4-7**). The channel was incised to bedrock and, therefore, stable, and set between vegetated benches of predominantly bedrock and coarse alluvial material. The bank stability was rated as good. Both channel alternation, in-stream habitat and conveyance were all rated as excellent, while flow and sediment transport processes appeared near-natural. Overall geomorphic values were rated as good.

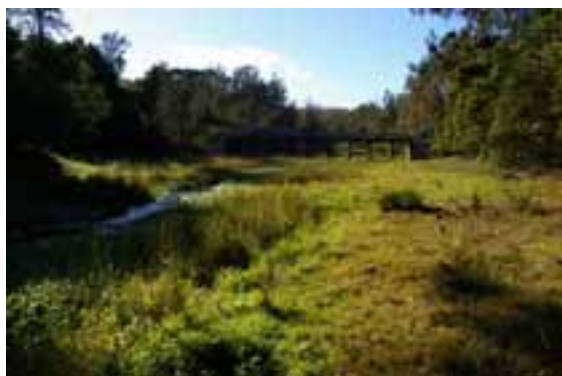
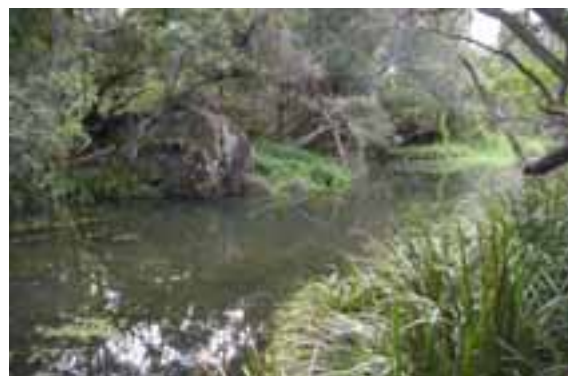
■ **Figure 4-8 Stable Alluvial Bars and Bank Outcropping**

Higher geomorphic values are largely restricted to the low flow channel with a range of habitat features present including pools, riffles and glides. Extensive bars, including floodrunners, were observed along the reach (e.g. upstream from R. A Stevens Bridge). Elevated debris marks indicated that higher flows still occur through this reach and these would be important for pool scouring, mobilisation of bar material and transport of large woody debris. However, the extent of vegetation across the bars suggest that these higher “resetting” flows capable of reworking the outer bars and transporting organic matter is much less frequent compared as a result of the existing dam, as would be expected. Although a range of geomorphic values are present, the overall geomorphic condition is rated as ‘moderate’ to ‘poor’ and largely modified. Brizga (2006) rated the deviation from reference condition for a range of environmental values as ‘minor’ to ‘moderate’ in the reach downstream from the dam.

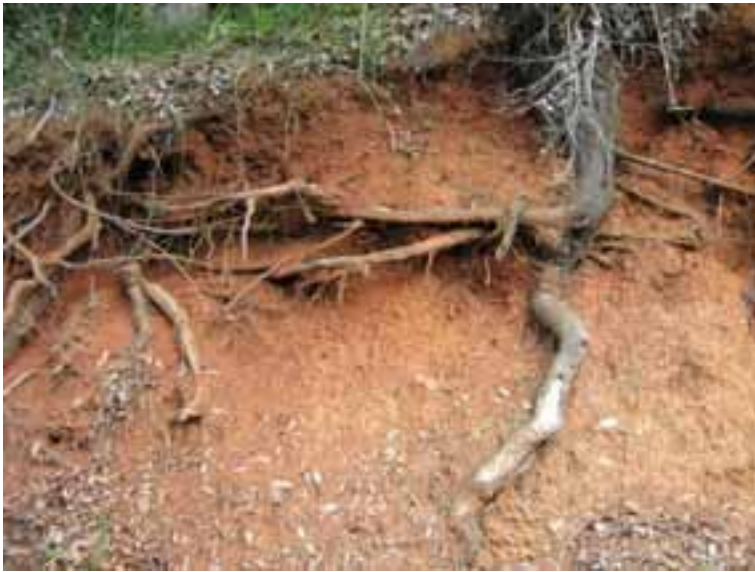
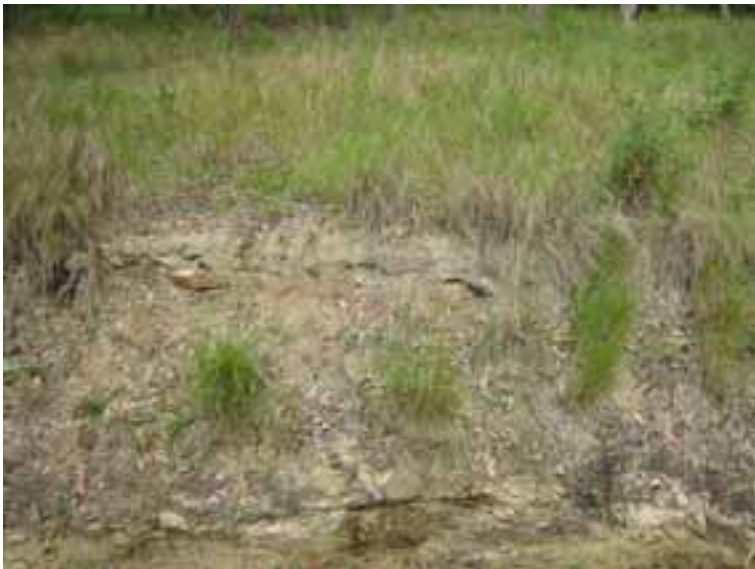
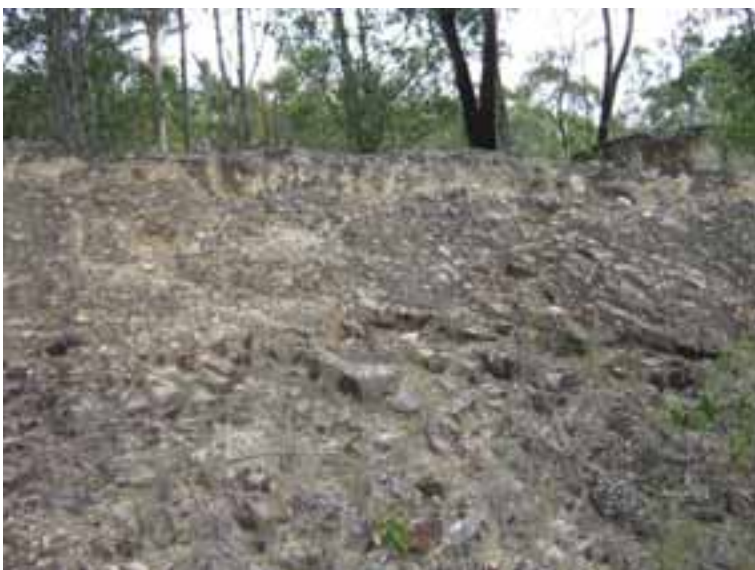
■ **Figure 4-14 Examples of the Dominant Soil Types in Road Side Cuttings**

The field sites generally confirmed the relationship between rock type and the soils formed. Soil depths and soils types can vary quite markedly over short distances, in some areas, as evident in road cuttings (as shown in Error! Reference source not found. where variable depth of weathering, nature of materials and soils found within a couple of hundred meters) due to the steeply dipping strata within some of the Neranleigh-Fernvale beds.

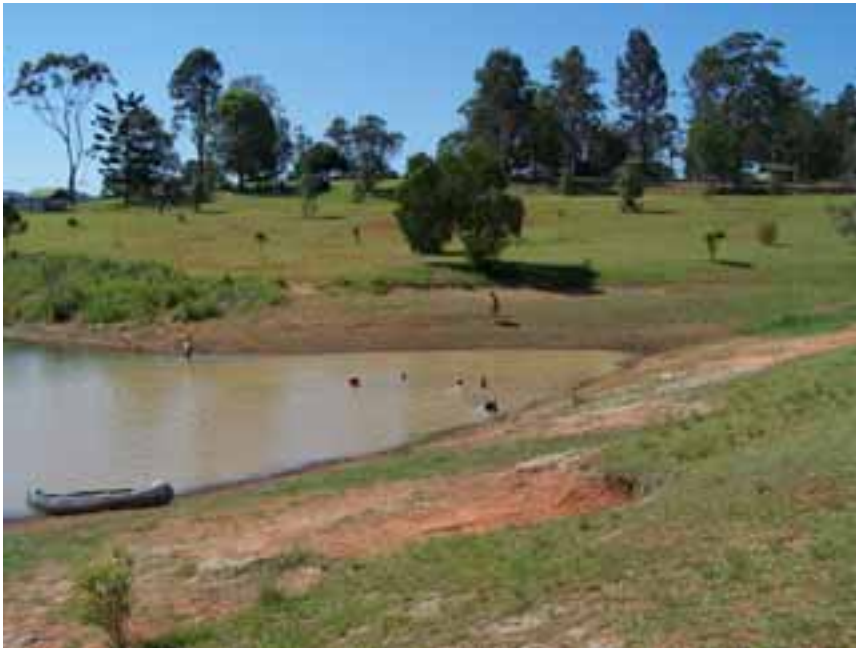
■ **Figure 4-15 Evidence of Erosion in the Recreation Area**

Given the steep slopes around the impoundment there is a high potential for soil erosion, however there was minor erosion observed around the current impoundment area or within gullies draining into the dam, as these slopes are currently heavily vegetated. Minor erosion has been caused by wavelets around the impoundment and an example of this is shown in **Figure 4-15**.

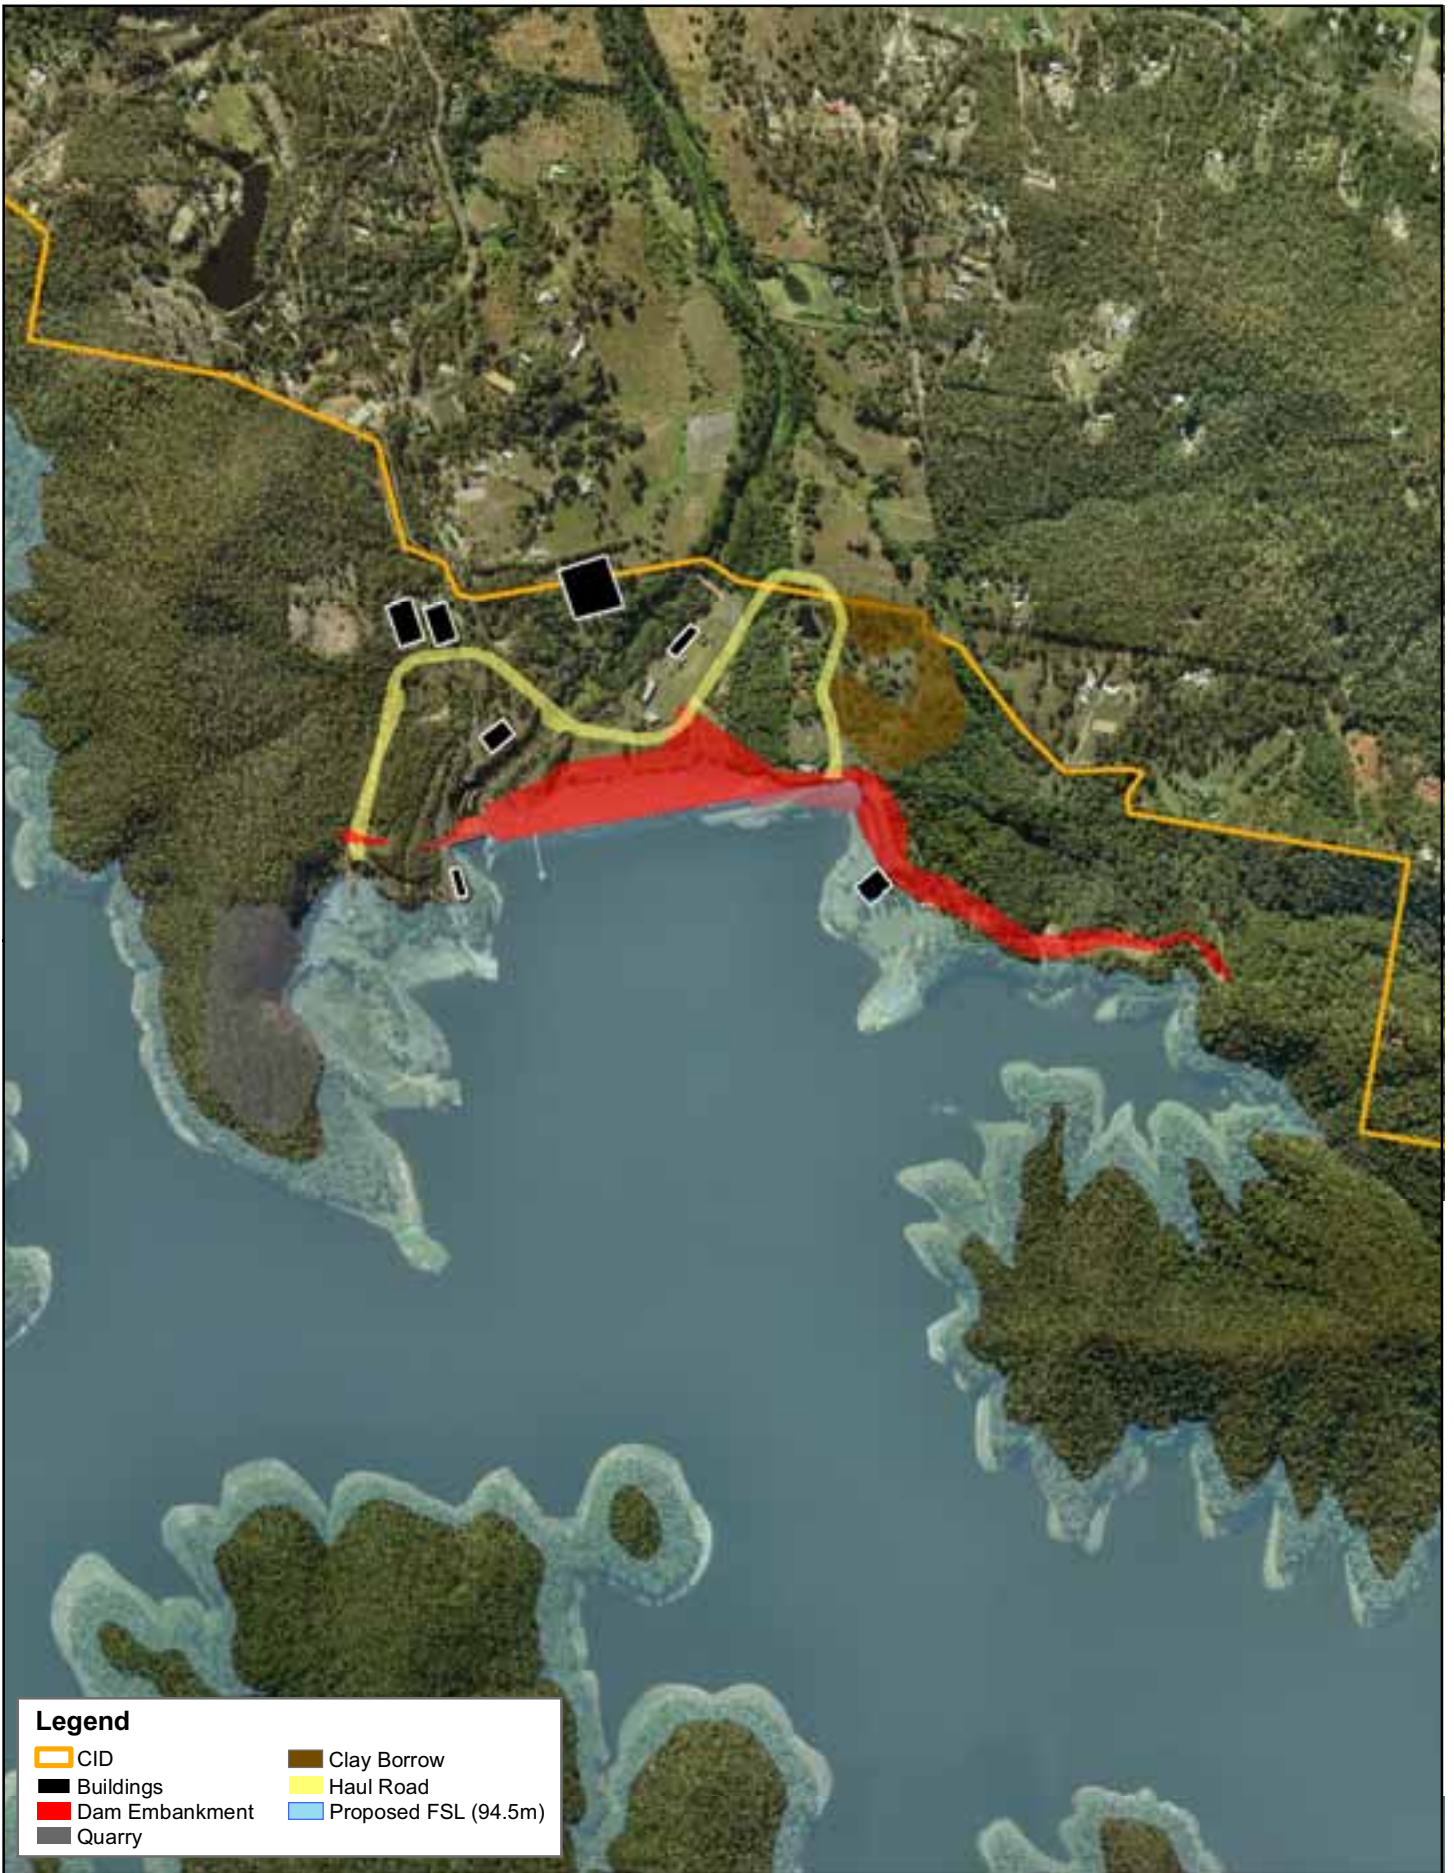
Figure 4-16
Location of major
Construction Activity
Hinze Dam Stage 3 EIS

The location of the major construction activities is shown in **Figure 4-16** .

Quarrying activities will permanently remove rock from hillsides on Pelican Point and back towards the dam wall. A total of 2.1M m³ of ‘fresh’ rock will be removed as well as approximately 780 000m³ of overburden material which will be used as general fill, predominately for the new recreation area. The final cut will extend back from Pelican Point, west of the ridge, to be level with the dam wall. The base of the quarry site will be excavated to 85m AHD which will be below the final full supply line of 94.5m AHD. This will result in benching of slopes and exposed rock faces to a maximum height of approximately 90m AHD. Part of the quarry site will be rehabilitated and landscaped for the construction of the new recreation area and facilities. The concept plan for this area is shown in **Figure 4-16** .

The borrow area, as shown on **Figure 4-16**, will have approximately 250 000m³ of material removed for the construction of the dam clay core. Following construction the borrow area will be re-profiled and rehabilitated so the site is safe and stable.
