# APPENDIX D

*Water Quality Management Plan and additional survey and assessments for Marcoola Drain*

### **WATER QUALITY (SALINITY) MANAGEMENT PLAN**

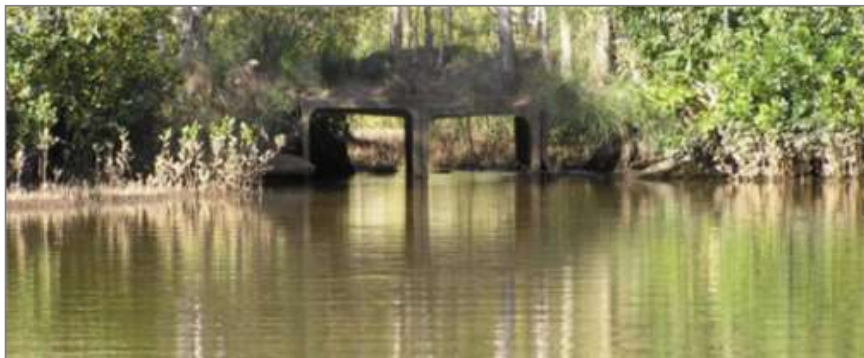
**Figure 1 Marcoola Drain Culvert under Finland Road**

The tailwater will mix with any fresh or brackish water that is present in the Northern Perimeter drain before leaving the site via the Marcoola Drain. The Marcoola Drain was originally a cane drain that has been converted into an artificial waterway to drain the golf course and associated development at Marcoola. The open cut drain is tidal with flows partially constricted by a culvert under Finland Road (Figure 1). Upstream of the culvert is the northern section of the Mount Coolum National Park.

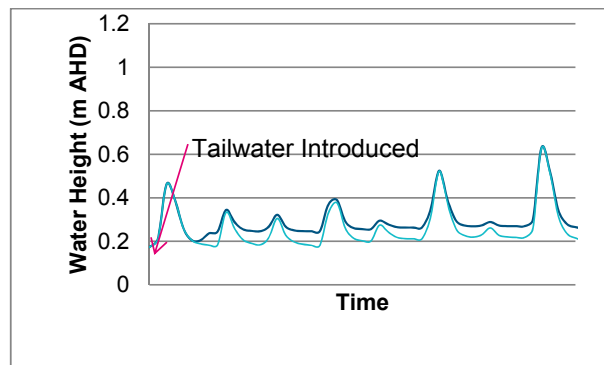
A zoomed in figure of several tidal cycles is shown below. Dark and light blue lines are modeled baseline and tailwater scenarios, respectively.

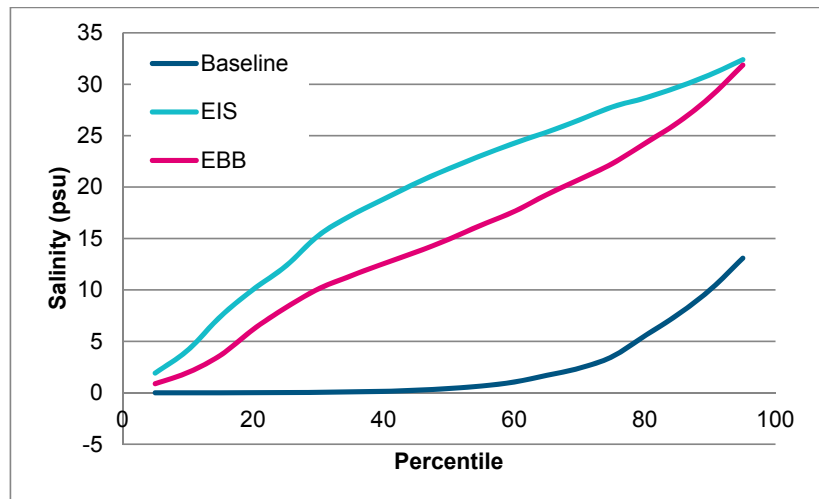
Point 1

Note: Scales for salinity are not the same for each of the three points, for clarity of presentation.
