# WINCHESTER SOUTH PROJECT

Environmental Impact Statement  
**Additional Information**

# **Winchester South Project EIS**

## **Aquatic Ecology and Stygofauna, Additional Information**

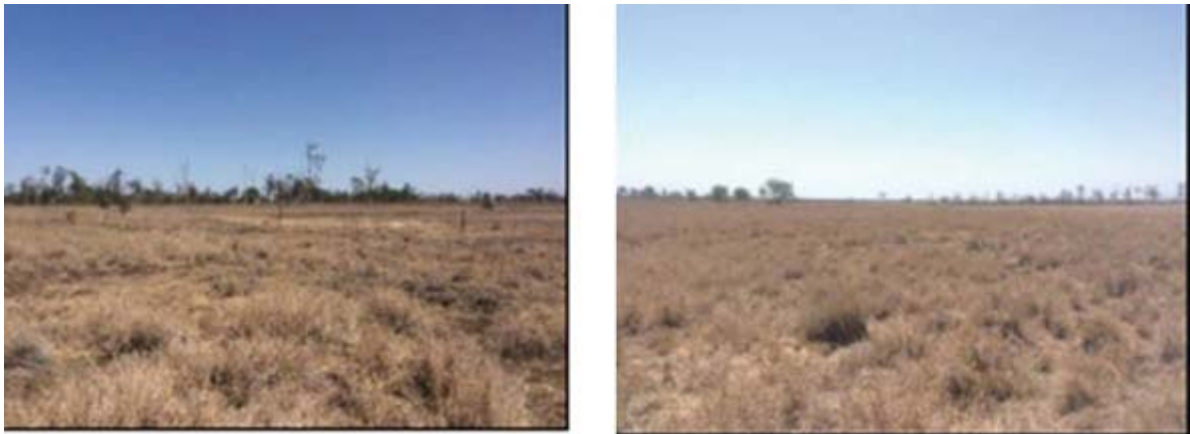
Site U3a is a drainage depression (Figure 6.1). There are no defined bed or banks, or any other waterway features. There is no visible standing water. The depression appears to be a drainage feature that funnels immediate localised rainfall and would not likely provide flow beyond the duration of a rain event.

The lack of defined bed and banks, in combination with insufficient water availability to sustain basic ecological processes and habitats, and the lack of riparian vegetation, suggest this reach of the mapped feature is not a waterway providing for fish passage.

Figure 6.1 Site U3a (Photos from EIS; ESP 2021)

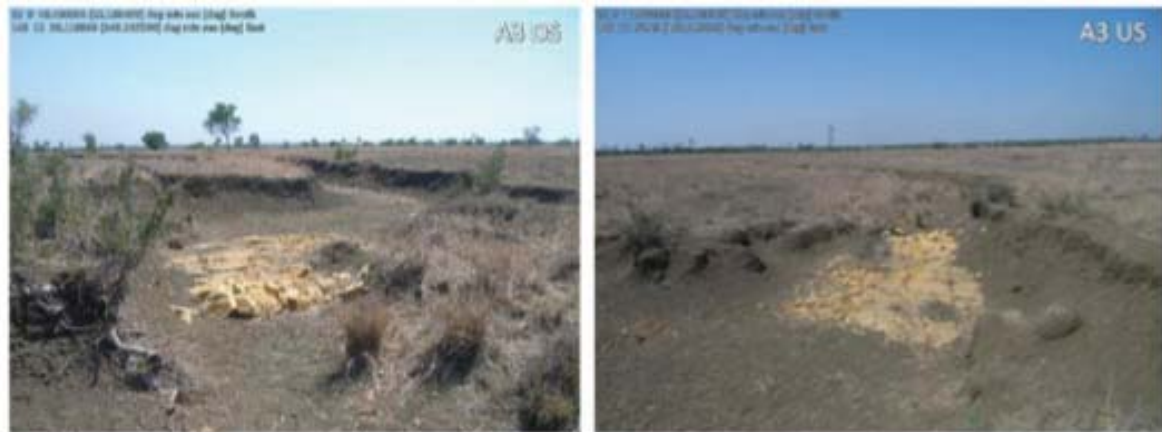
Site A3 appears to be an eroded drainage feature (Figure 6.4). There is no evidence of previous standing water and no aquatic plants visible. The feature appears to funnel immediate localised rainfall and would not likely provide adequate flow beyond the duration of a rain event. This section of the waterway does not appear to provide fish habitat or for fish passage.

Figure 6.4 Site A3 (from Geomorphology Assessment; Fluvial Systems 2020)

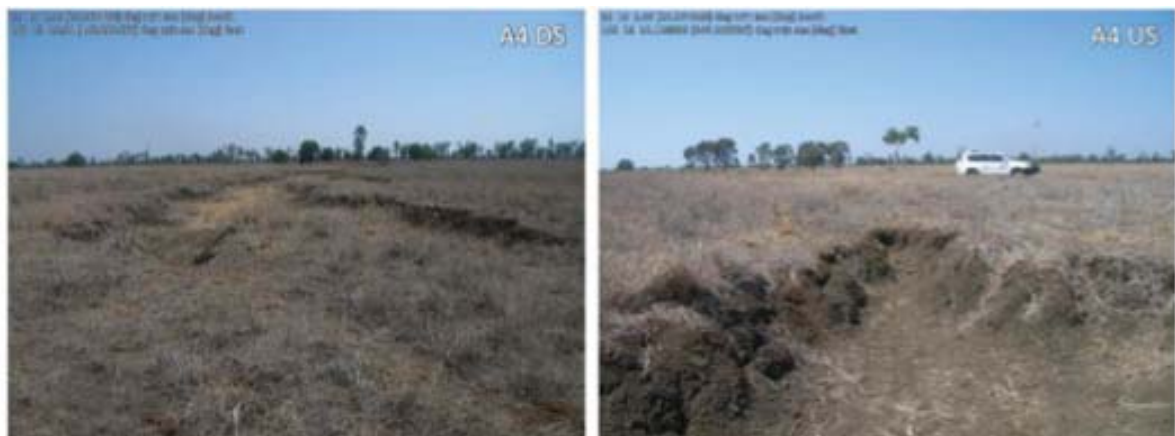
Site A4 appears to consist of broken sections of a depression that funnel water from localised rainfall events (Figure 6.5). It does not appear that the depression holds water for any length of time, and any available water would be temporary; that is, it is likely to dry up within days without further rainfall.

The depression does not appear that it would provide adequate flow to provide for fish passage, or habitat opportunities.

Figure 6.5 Site A4 (from Geomorphology Assessment; Fluvial Systems 2020)

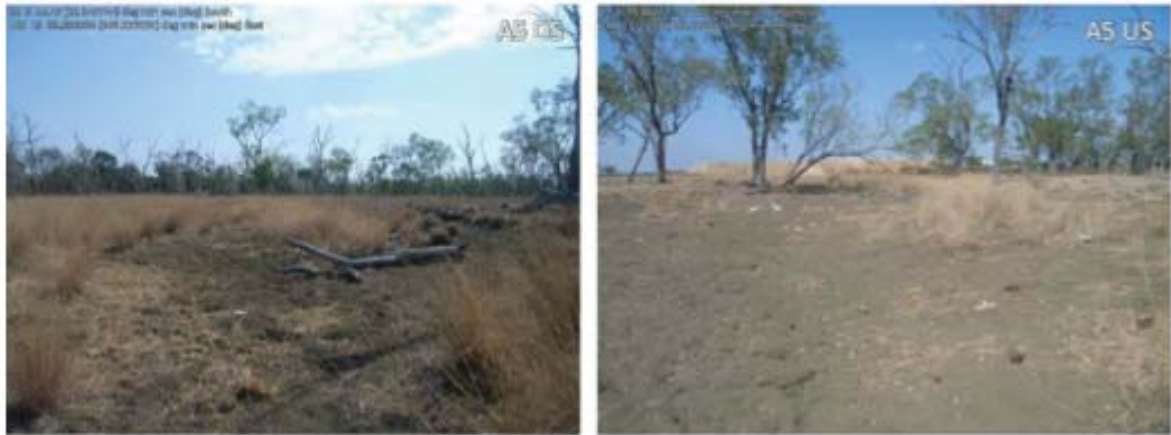
at Site A5 and immediately upstream at Site A3, suggesting this section of the waterway does not provide for fish passage.

Due to the lack of a channel with defined bed and banks, no riparian vegetation, lack of fish habitat or passage opportunities, Site A5 is not considered a waterway providing for fish passage.

Figure 6.6 Site A5 (from Geomorphology Assessment; Fluvial Systems 2020)

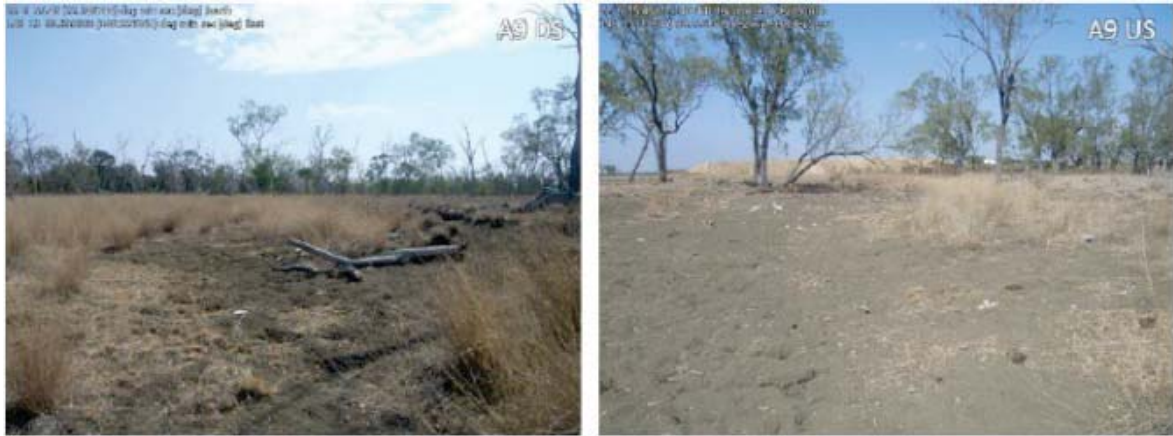
Site A9 appears to be a drainage feature lacking the features of a waterway providing for fish passage (Figure 6.8). The drainage feature is flat, with no defined bed and banks. Terrestrial vegetation can be seen growing across the feature. This section of the mapped waterway would not provide adequate flow beyond an immediate rainfall event. There are no fish habitat or fish passage opportunities at this site, or at sites further upstream.

Due to the lack of a channel with defined bed and banks, no riparian vegetation, and a lack of fish habitat and connectivity for fish passage, Site A9 is not considered a waterway providing for fish passage.

Figure 6.8 Site A9 (from Geomorphology Assessment; Fluvial Systems 2020)

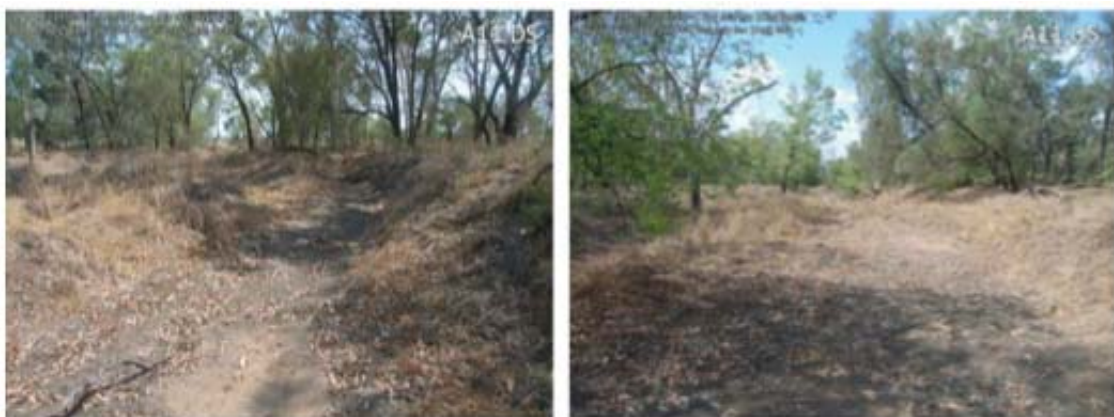
This section of the waterway appears as a wide, deep channel that may provide fish passage opportunities during periods of flow from upstream catchments (Figure 6.12). There appears to be a defined bed and banks at both sites. It is a waterway providing for fish passage.

Figure 6.12 Site A11 (from Geomorphology Assessment; Fluvial Systems 2020)

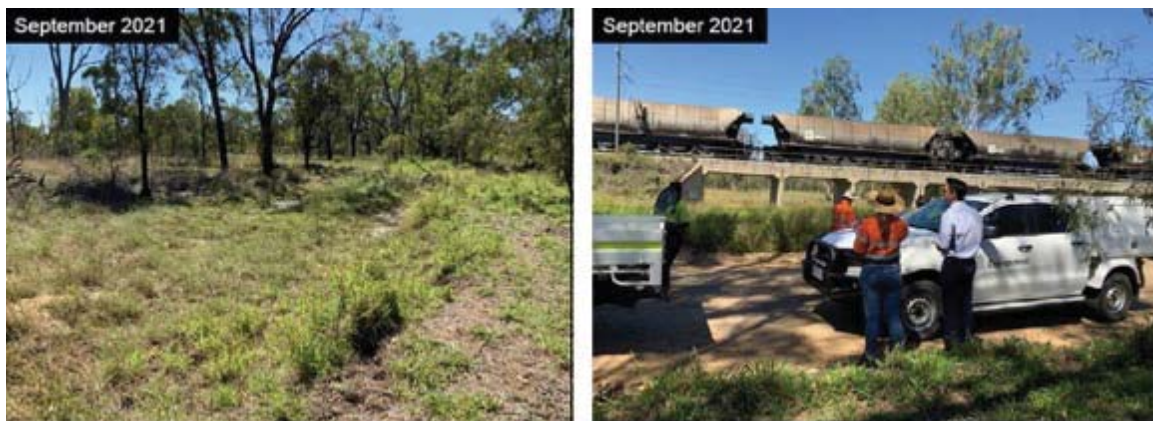
Our assessment of Sites 2 and 3 found the sites appear to be located in the vicinity of a rail bridge crossing, immediately downstream from Site A11 (Figure 6.13). The feature at Site 2 appears to be a wide flat channel, with a low bank. Terrestrial vegetation is growing across the feature.

The images of these sites do not allow for an adequate assessment to determine if these sites are a waterway providing for fish passage. However, our assessments of sites upstream and downstream of Site 2 and 3 in February 2022 found this section of the mapped waterway met the DAF requirements to be classified as a waterway providing for fish passage (see Appendix B).

Figure 6.13 Site 2 and Site 3 (from site inspections; Whitehaven Coal 2021)

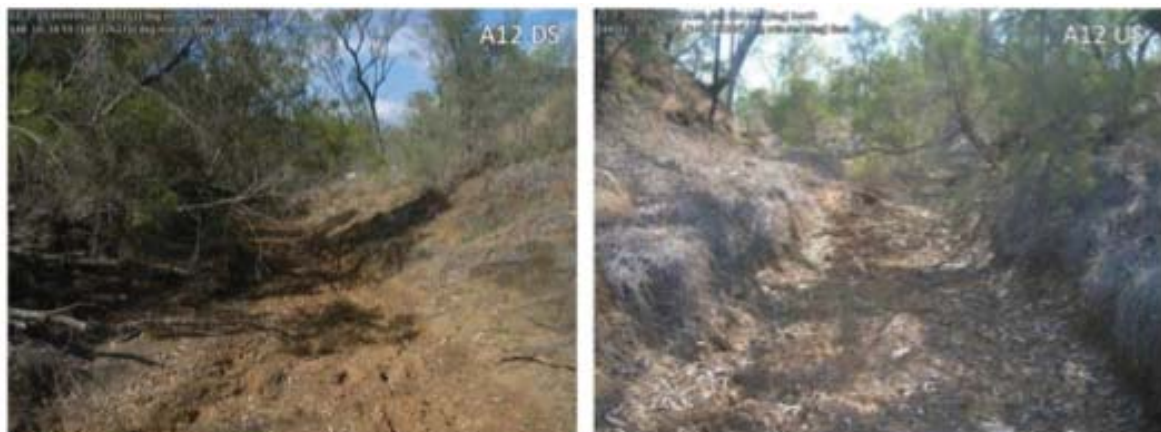
This section of the waterway appears as a deep channel that may provide fish passage opportunities during periods of flow from upstream catchments (Figure 6.14). There appears to be a defined bed and banks with overhanging vegetation, offering habitat opportunities during periods of flow. It is therefore a waterway providing for fish passage.

Figure 6.14 Site A12 (from Geomorphology Assessment; Fluvial Systems 2020)

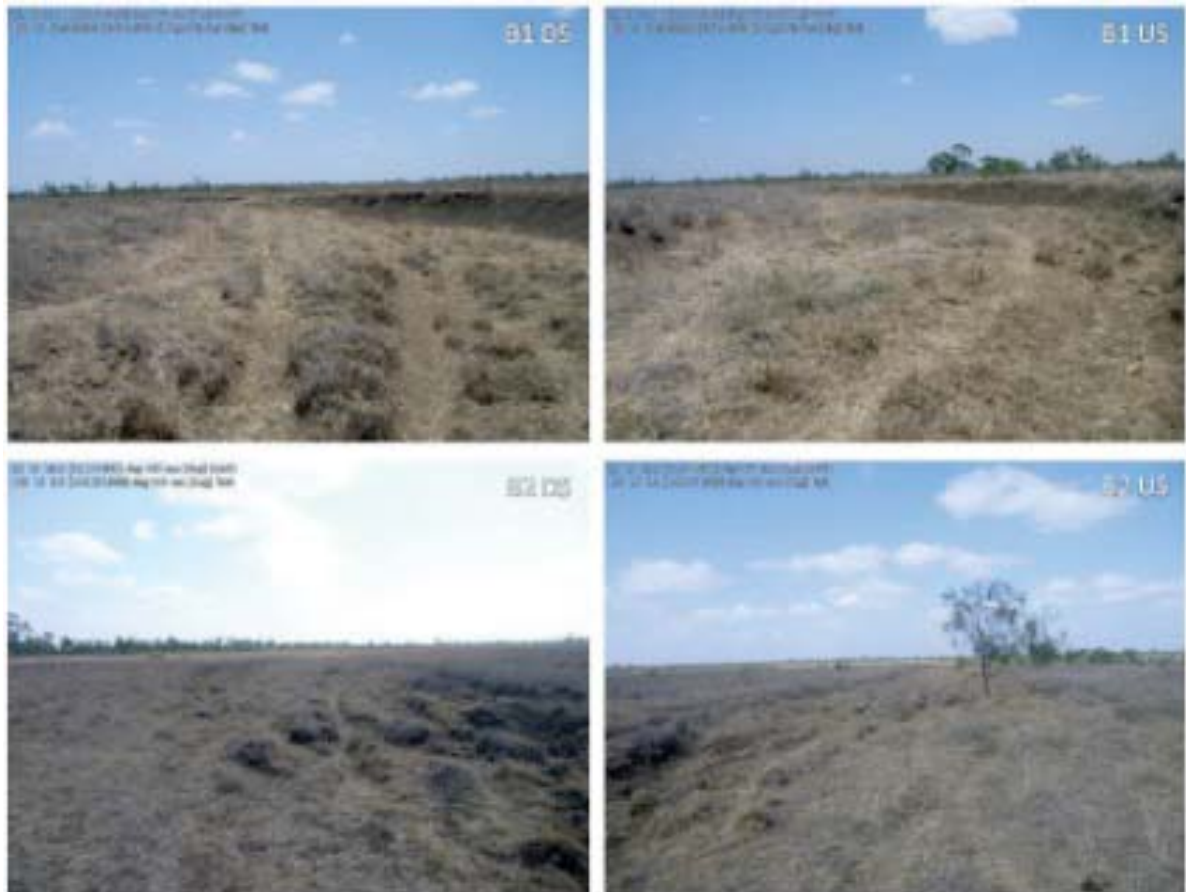
A return visit to Site B2 during the February 2022 site surveys also found Site B2 was a wide flat drainage gully with no standing water and no indications that the site held water for an extended period (see Site 72 in Appendix B for a full description).

Due to the lack of a channel with defined bed and banks, no riparian vegetation, and a lack of fish habitat and connectivity for fish passage, Sites B1 and B2 are not considered a waterway providing for fish passage.

Figure 6.20 Sites B1 and B2 (from Geomorphology Assessment; Fluvial Systems 2020)

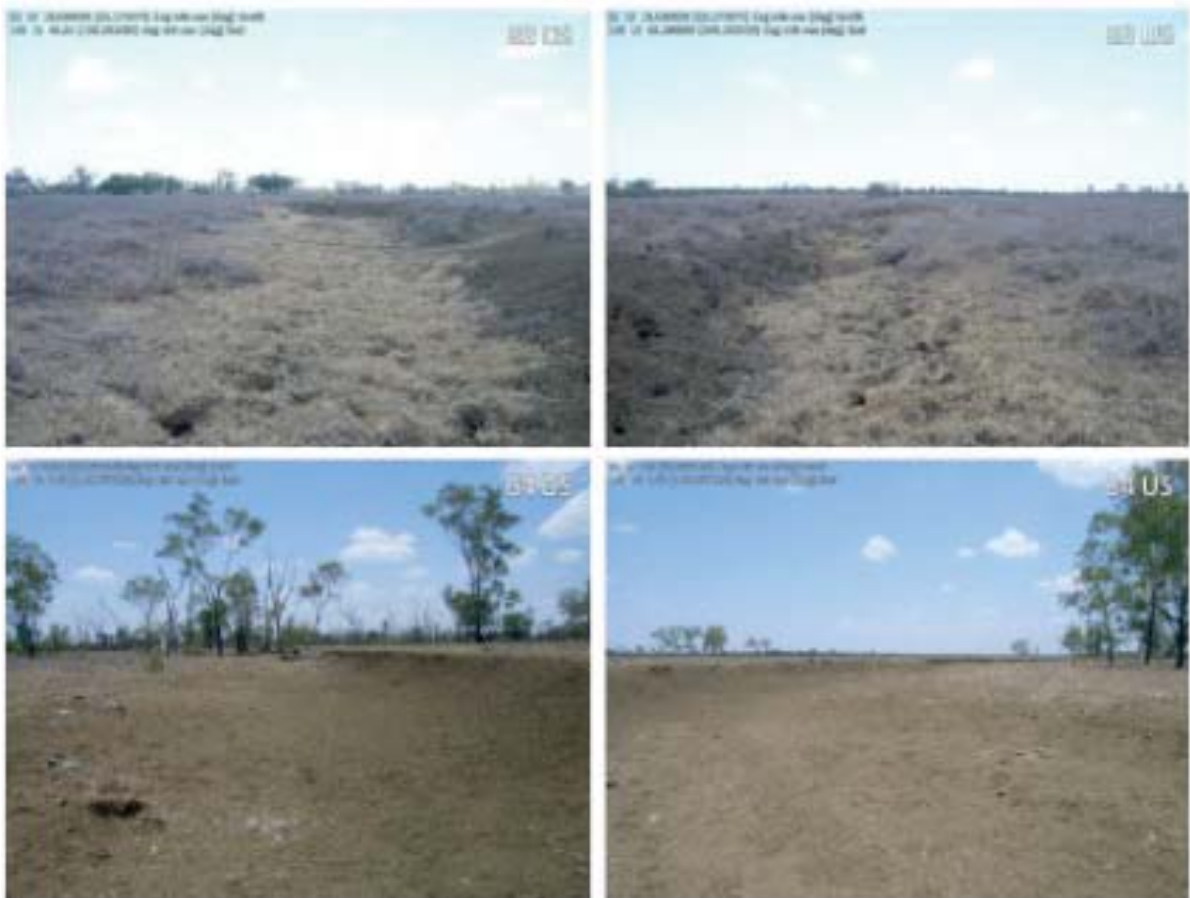
Sites B3 and B4 are drainage depressions or gullies and lack features of a waterway providing for fish passage (Figure 6.24). These sites do not have a defined bed and banks, and do not appear that they would provide adequate flow other than in times of localised rainfall. There appears to be some erosion along the edges of some drainage channels; however, this is likely from short high velocity flows during periods of high localised rainfall.

The mapped feature at Sites B3 and B4 did not exhibit any of the qualities of a waterway as defined by DAF, and as such, is not considered a waterway providing for fish passage.

Figure 6.24 Sites B3 and B4 (Photos from Geomorphology Assessment; Fluvial Systems 2020)

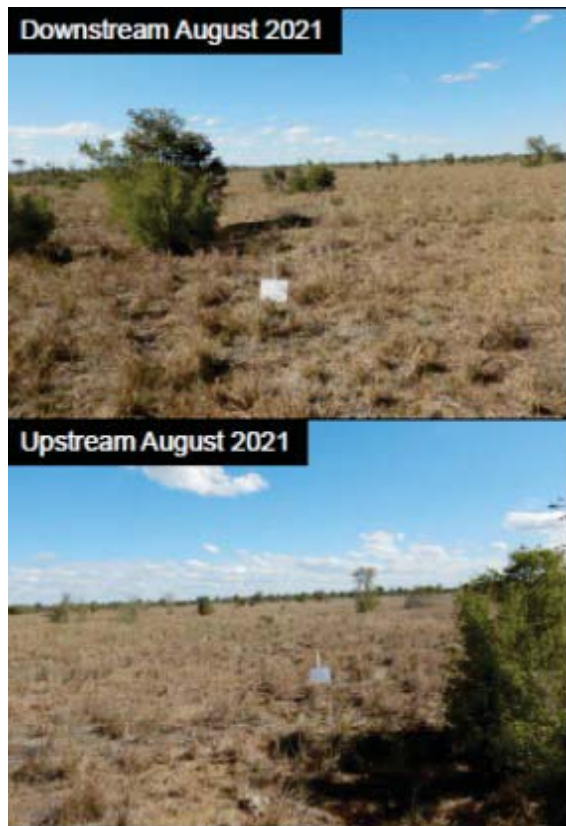
Figure 6.29 Site D2 (Photos from site inspections; Whitehaven Coal 2021)

Site D2 is a drainage feature / overland flow path (Figure 6.29). The drainage feature does not provide fish passage or habitat opportunities and does not appear to have defined bed and banks. This section of the mapped feature would not provide adequate flow beyond an immediate rainfall event. Terrestrial vegetation can be seen growing across the feature.

Due to the lack of a channel with defined bed and banks, no riparian vegetation, and a lack of fish habitat and connectivity for fish passage, Site D2 is not considered a waterway providing for fish passage.

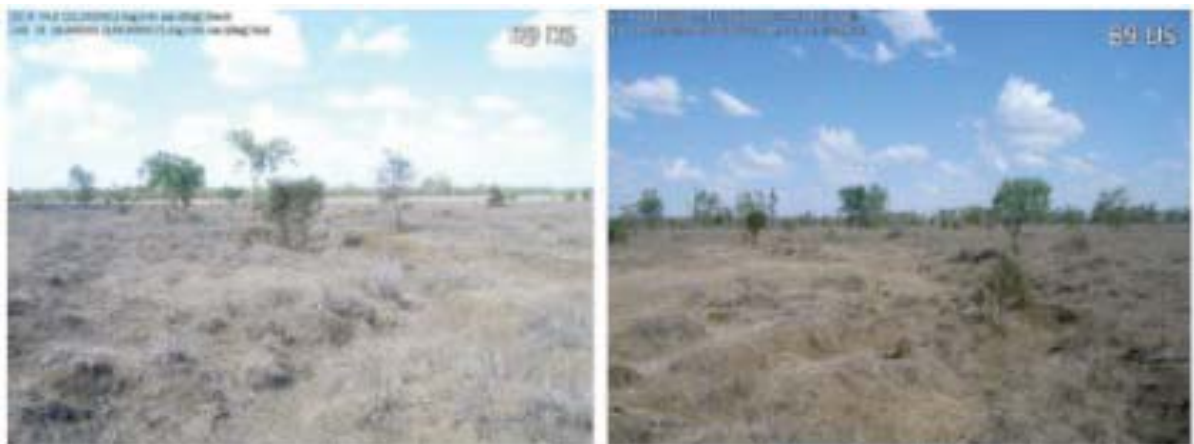
Figure 6.31 Site B9, showing upstream and downstream of the assessment site (Photos from Geomorphology Assessment; Fluvial Systems 2020)

Site B9 is a drainage depression (Figure 6.31). The depression does not have a continuously defined bed and banks, and would not provide adequate flow beyond an immediate rainfall event. The drainage feature does not provide fish passage or habitat opportunities, and lacks the features of a waterway providing for fish passage. Terrestrial vegetation, particularly grasses, can be seen growing across the depression.

The mapped feature at Site B9 does not exhibit any of the qualities of a waterway as defined by DAF, and as such, is not considered a waterway providing for fish passage.

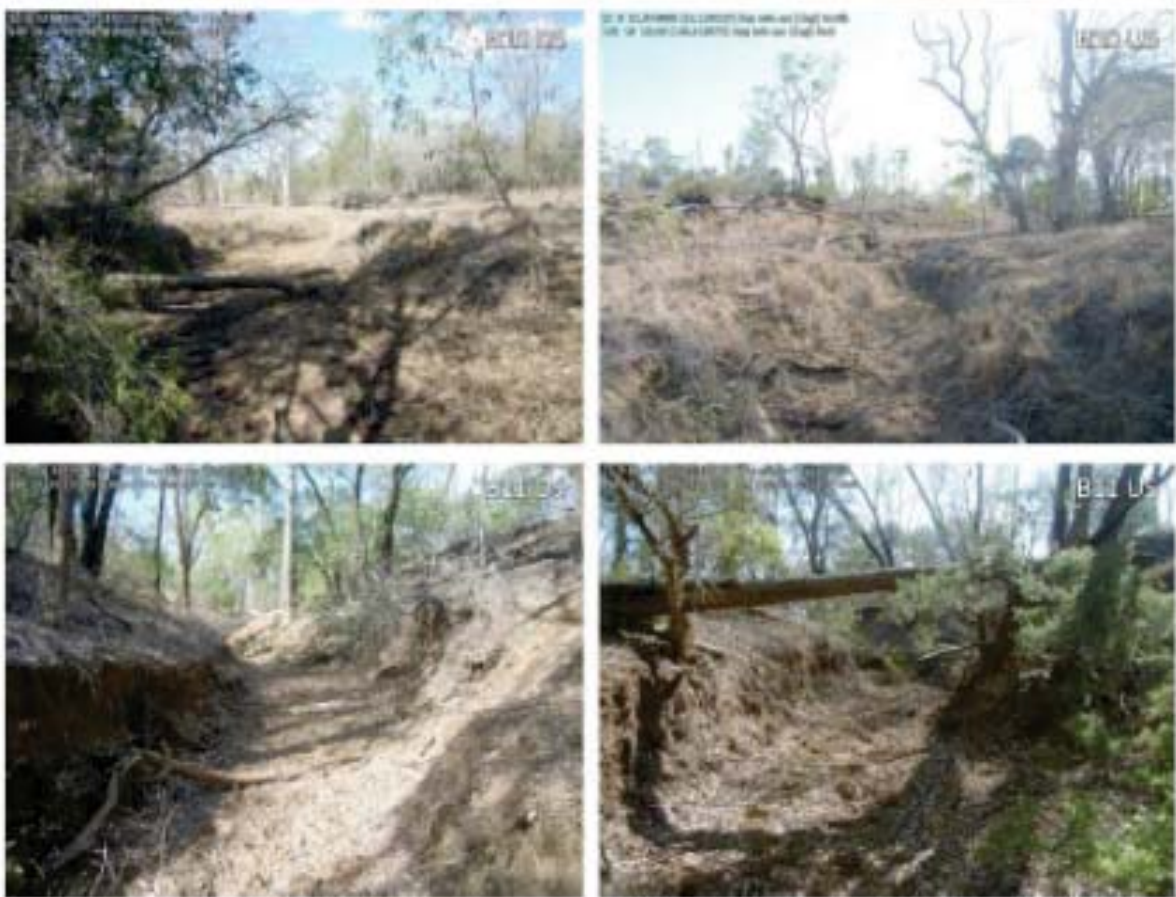
Figure 6.32 Sites B10 and B11 (Photos from Geomorphology Assessment; Fluvial Systems 2020)

This section of the waterway appears as a wide, deep channel that may provide fish passage opportunities during periods of flow from upstream catchments (Figure 6.32). There appears to be a defined bed and banks at both sites. However, the channel is narrow with high banks,

suggesting flow velocity may be high and may not provide adequate flow beyond an immediate rainfall event.

The mapped feature at Sites B10 and B11 exhibits some qualities of a waterway as defined by DAF, and may be considered a waterway providing for fish passage.

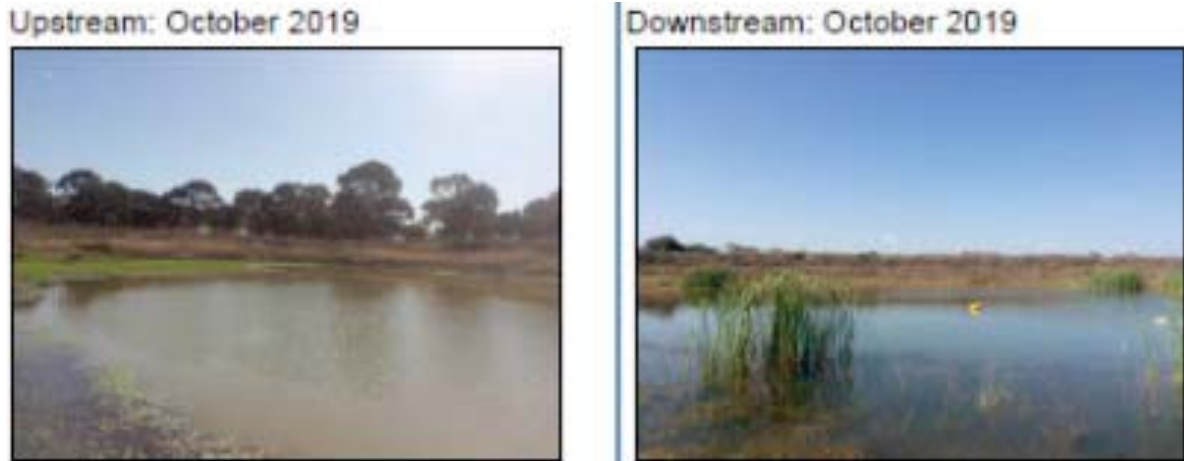
Figure 6.33 Site FD4, constructed dam (Photos from EIS; ESP 2021)

Site FD4 is a large, constructed dam (Figure 6.33). Dam walls are approximately 5 m in height. Aquatic vegetation is growing within the dam, providing fish habitat opportunities. Fish have been captured during previous fish surveys at this site (see Section 3.2.1 for details). However, the steep, high dam walls act as a barrier to fish passage and prevent connectivity to upstream and downstream reaches.

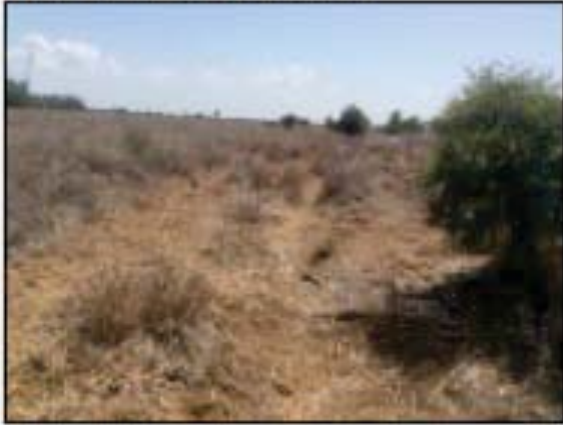
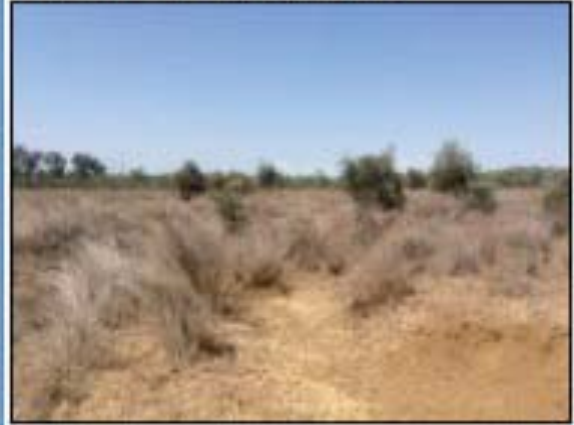
Figure 6.36 Site U5, showing upstream and downstream in October 2019 (Photos from EIS; ESP 2021)

Site U5 is a drainage depression, immediately downstream from Site C6. The drainage depression does not have defined bed or banks and appears that the mapped feature would not provide adequate flow beyond an immediate rainfall event (Figure 6.36). The drainage depression at Site U5 is not a waterway providing habitat or fish passage opportunities.

Due to the lack of a channel with defined bed and banks, no riparian vegetation, and a lack of fish habitat and connectivity for fish passage, Site U5 is not considered a waterway providing for fish passage.

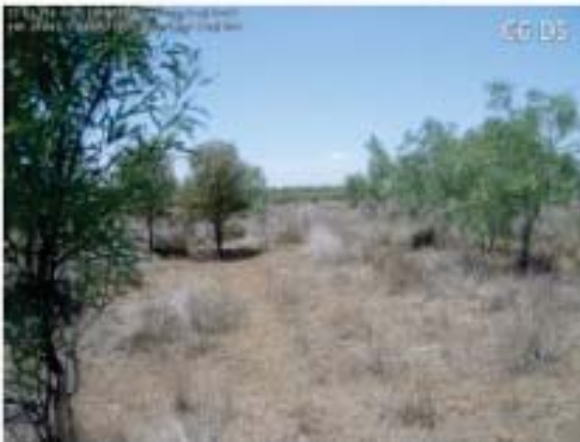
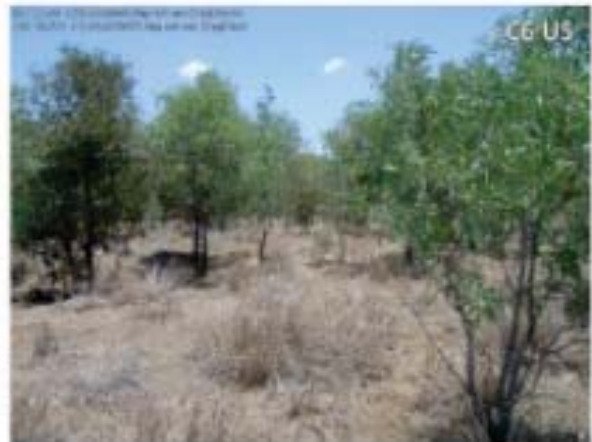
Figure 6.37 Site C6 (Photos from Geomorphology Assessment; Fluvial Systems 2020)

Site C6 (R18 in Olive Downs EIS) is a drainage depression that lacks the features of a waterway providing for fish passage. There are no defined bed and banks or suitable habitat features (Figure 6.37 and Figure 6.38).

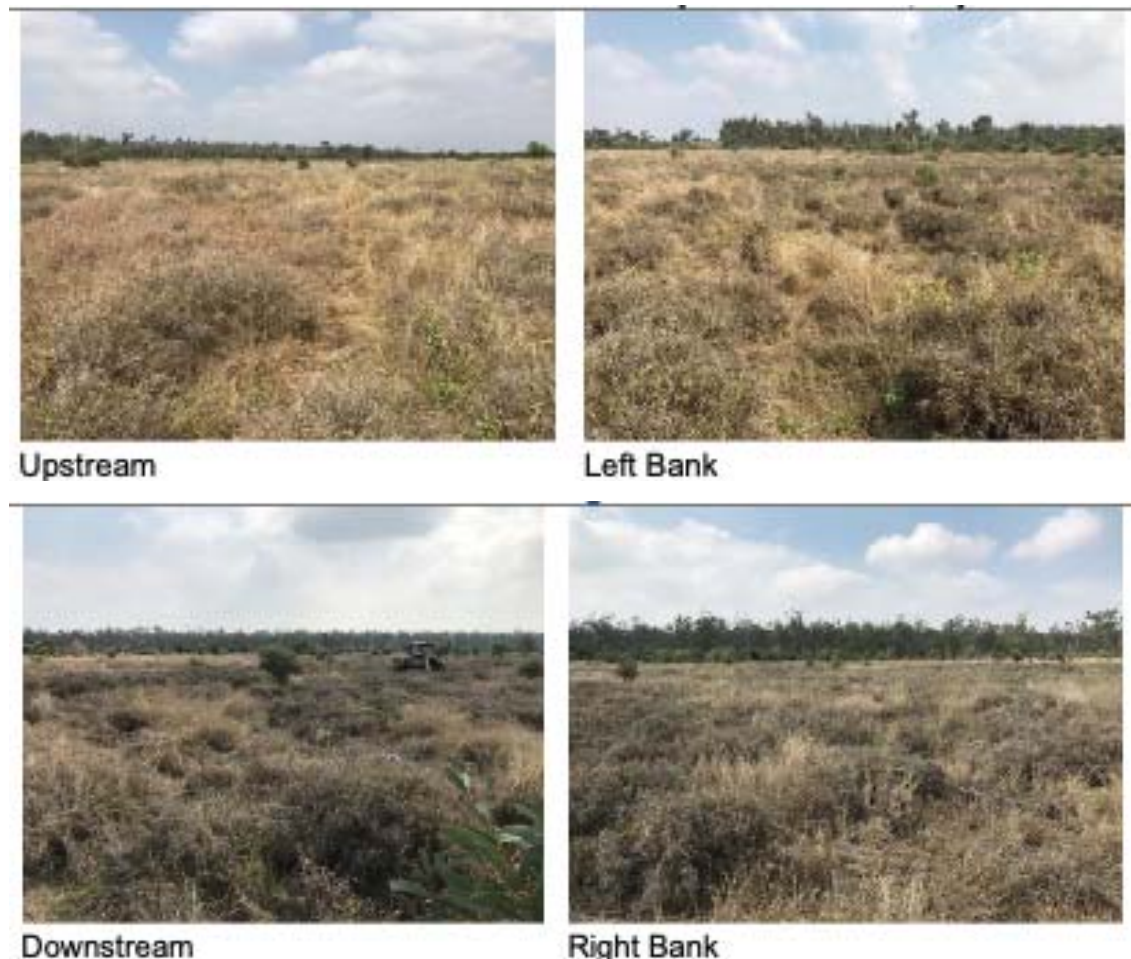
Figure 6.40 Site R22 (Photos from Olive Downs EIS, DPM Envirosiences 2018)

Site R22 is an ephemeral drainage depression that lacks the features of a waterway providing for fish passage. There are no defined bed and banks or suitable habitat features (Figure 6.40).

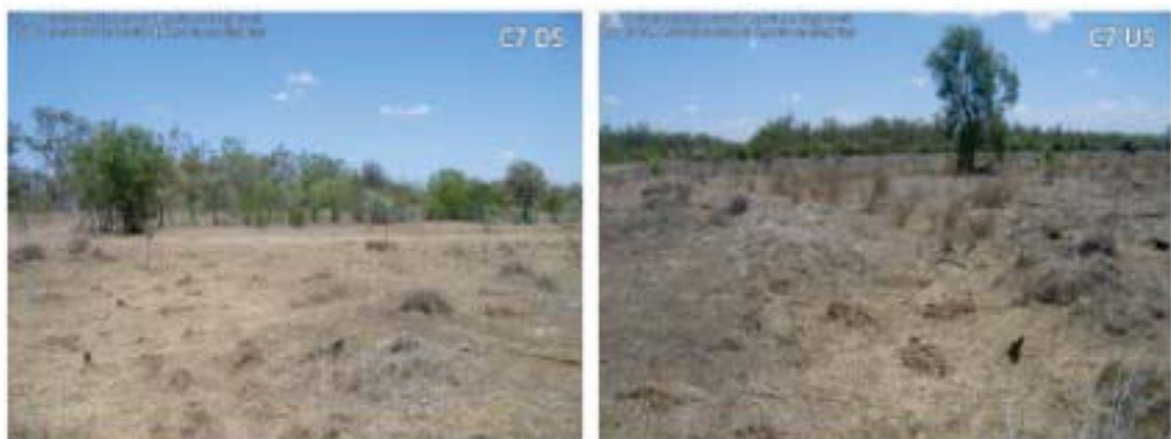
Figure 6.41 Site C7 (Photos from Geomorphology Assessment; Fluvial Systems 2020)

Site C7 is a drainage depression that lacks the features of a waterway providing for fish passage. There are no defined bed and banks or suitable habitat features (Figure 6.41).

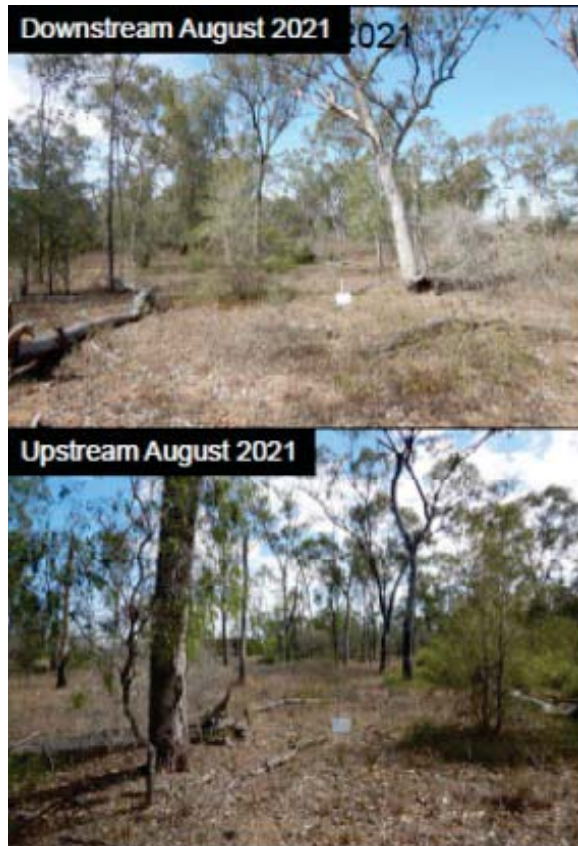
Figure 6.42 Site D6 (Photos from site inspections; Whitehaven Coal 2021)

Our assessment found Site D6 is a drainage corridor that lacks the features of a waterway providing for fish passage (Figure 6.42). There are no defined bed and banks or suitable habitat features.

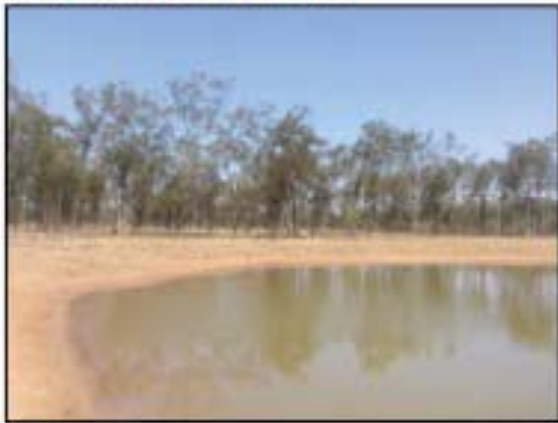
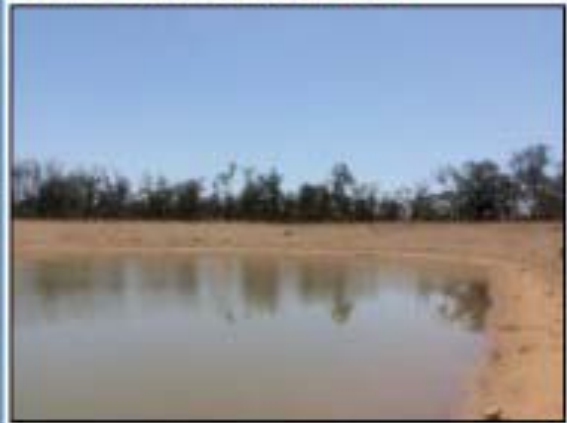
Figure 6.43 Site FD7, constructed dam, showing upstream and downstream in October 2019  
(Photos from EIS; ESP 2021)

Site FD7 is a large, constructed dam (Figure 6.43). The downstream side of the dam appears to have a moderately steep bank of approximately 3 m in height above the water level in the dam. Vegetation surrounding the dam appears to be terrestrial grasses with some shrubs and trees set further back from the dam edge.

While the dam may provide fish habitat opportunities, there is a lack of connectivity to suitable habitat upstream and particularly downstream due to the high dam wall.

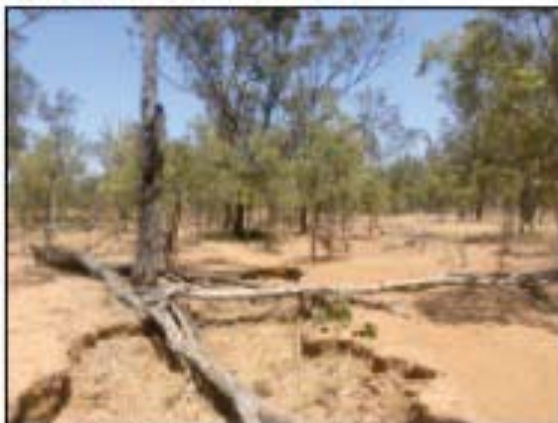
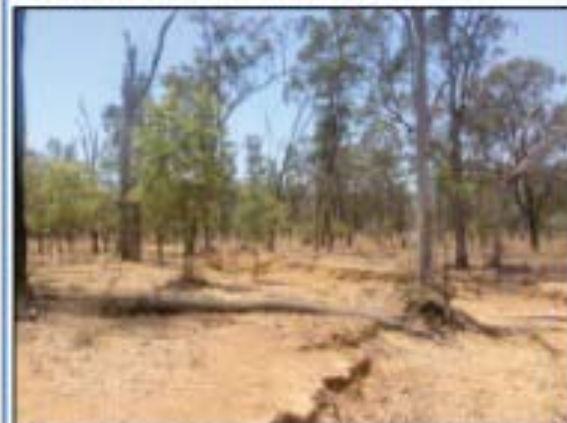
Figure 6.44 Site U6 (Photos from EIS; ESP 2021)

Site U6 is a drainage depression or gully that lacks the features of a waterway providing for fish passage (Figure 6.44). While there is some erosion along the edges of a broken gully, there is no continuous bed and banks, or suitable habitat features.

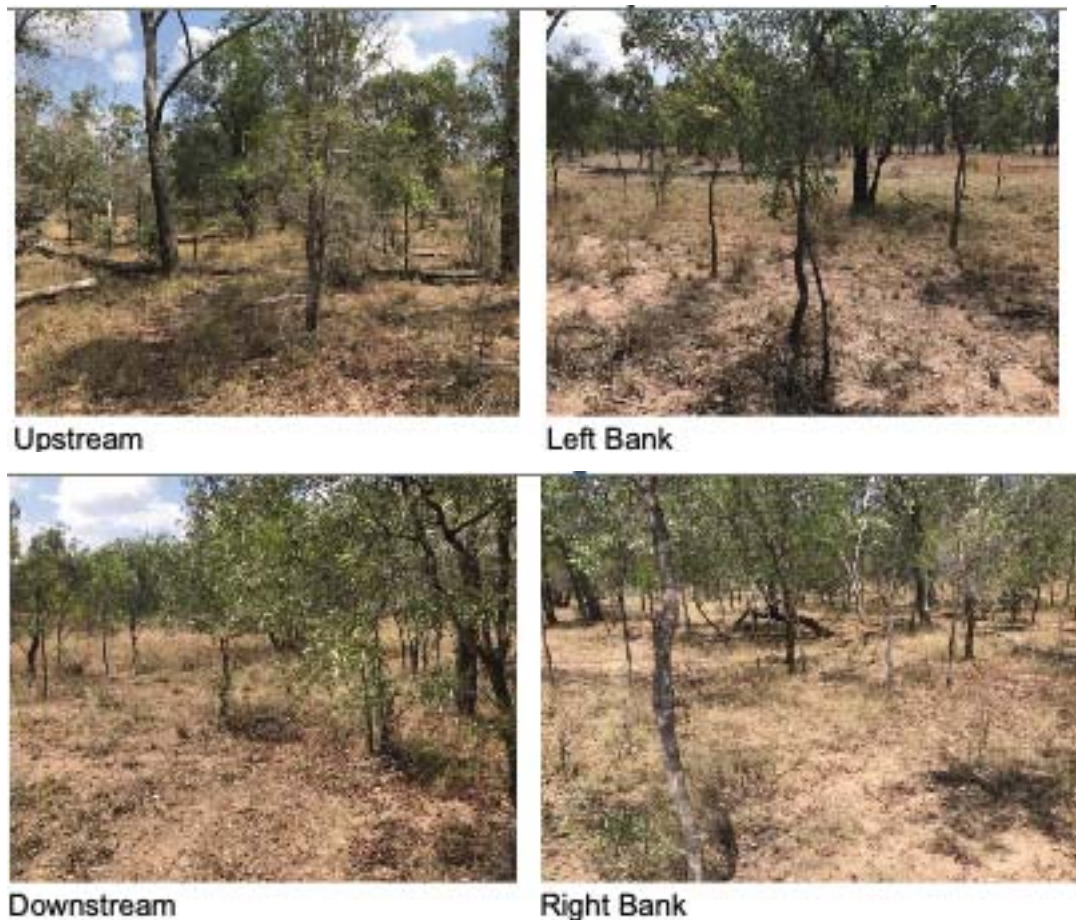
Figure 6.46 Site R21 (Photos from Olive Downs EIS, DPM Envirosiences 2018)

Site R21 is an ephemeral drainage line that lacks the features of a waterway providing for fish passage. There are no defined bed and banks or suitable habitat features (Figure 6.46).

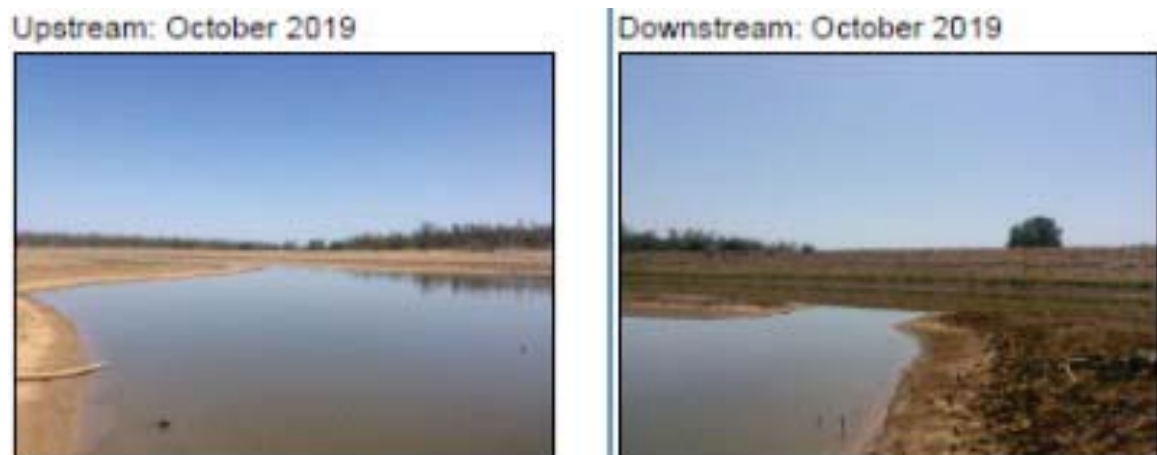
Figure 6.47 Site LW5, constructed dam, showing upstream and downstream in October 2019 (Photos from EIS; ESP 2021)

Site LW5 is a large, constructed dam (Figure 6.47). The dam walls are approximately 3 m in height, and act to restrict connectivity to upstream and downstream reaches. Aquatic plants are present in the dam. There is no riparian vegetation or shading, and a lack of habitat features. There appears to be no connectivity to upstream and downstream reaches.

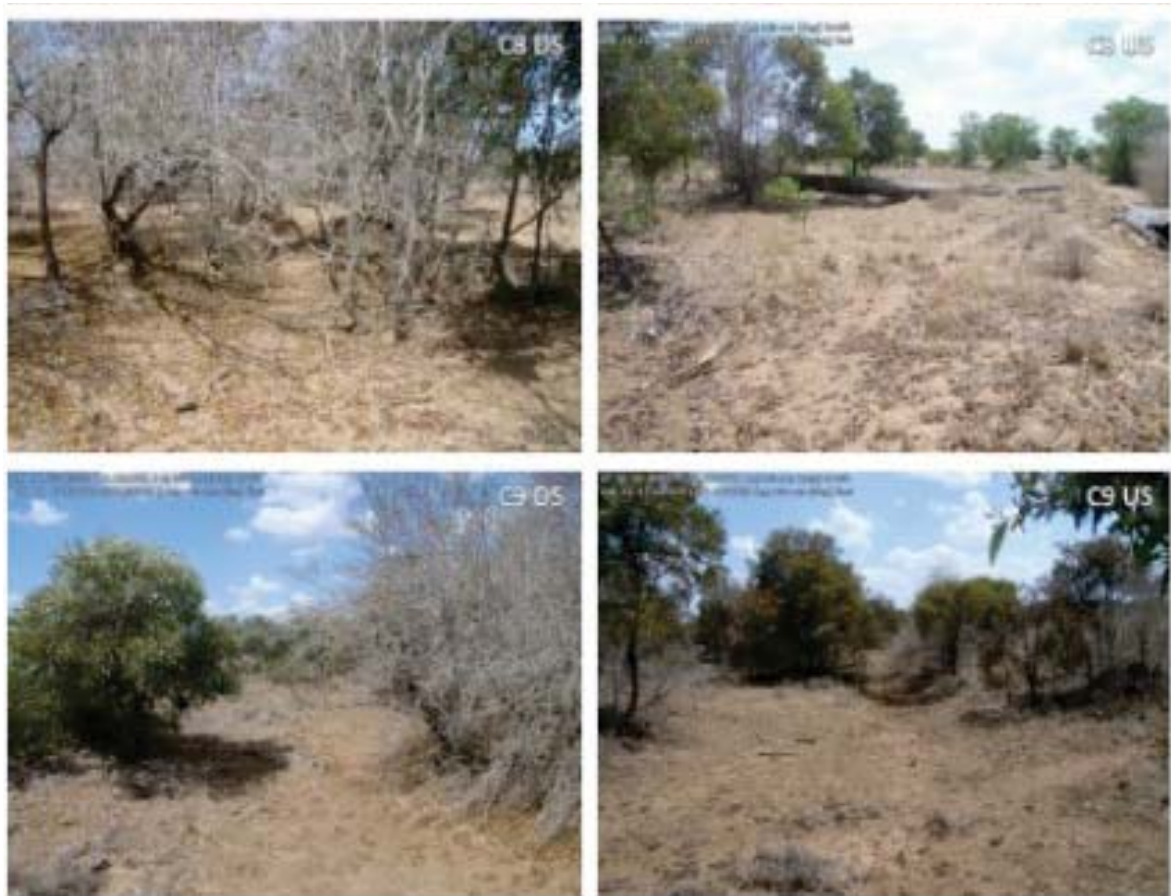
Figure 6.48 Sites C8 and C9 (Photos from Geomorphology Assessment; Fluvial Systems 2020)

Sites C8 through to C13 appear to be a drainage gully that lack the features of a waterway providing for fish passage (Figure 6.48, Figure 6.49 and Figure 6.50). These sites do not appear that they would provide adequate flow beyond an immediate rainfall event. There are no fish habitat or fish passage opportunities. The gully at Site C13 appears to narrow, deepen and become steeper, suggesting high velocity flow as it travels down a steep gradient toward the Isaac River.

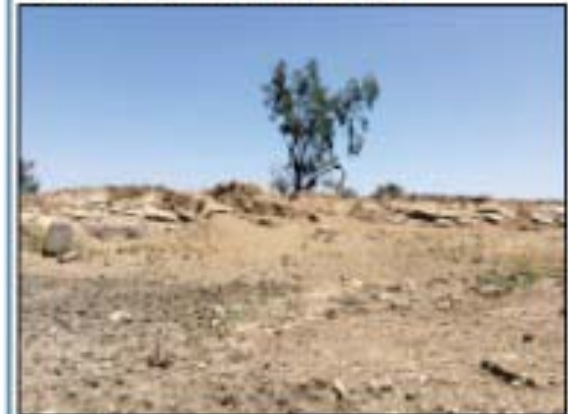
Figure 6.56 Site LW2 (Photos from EIS; ESP 2021)

Site LW2 is a dry constructed dam (Figure 6.56). There is no riparian vegetation and no shading. There does not appear to be any fish habitat.

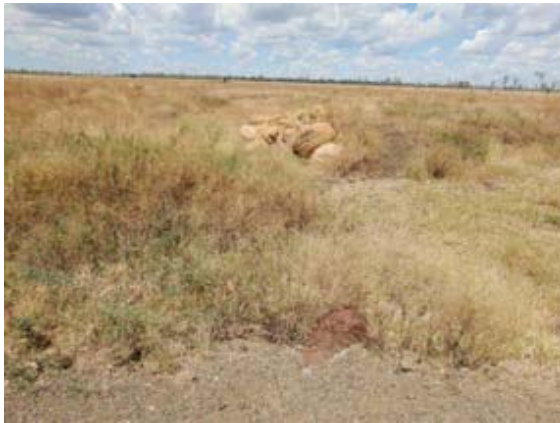
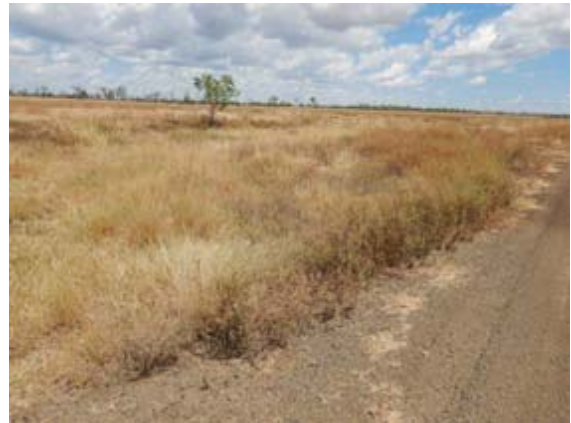
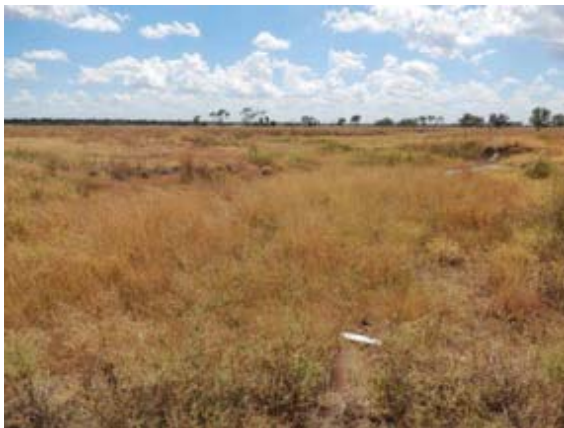
Site 79 (U3 in previous assessments; see Appendix A) is a drainage gully passing through a dirt road. A pipe culvert (~40 cm diameter) passes under the road but does not start within or discharge to a channel with defined bed and banks. The upstream gully banks are broken and undulating with several flow paths converging at the culvert entrance. Rocks have been placed on the outside of the bed as an erosion control. Downstream of the culvert, eroding banks are on the outside of a bend from high velocity flows, likely during periods of localised heavy rainfall.

Due to the lack of a channel with defined bed and banks, no riparian vegetation, and a lack of fish habitat and connectivity for fish passage, Site 79 is not considered a waterway providing for fish passage.

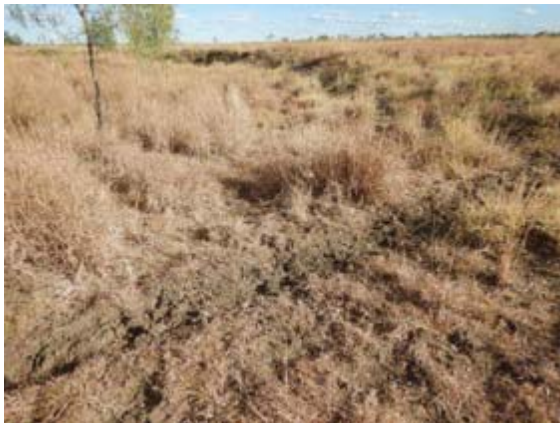
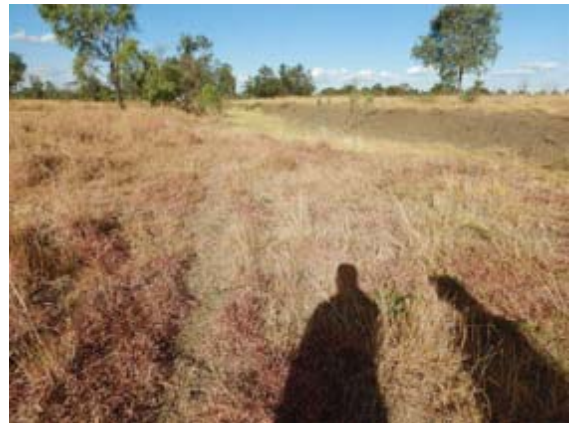
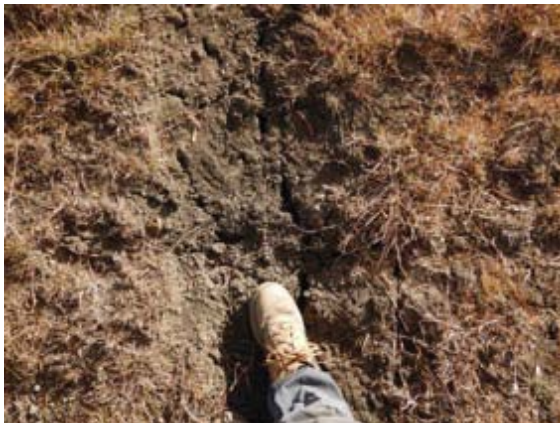
Figure 6.59 Site 166 showing a) upstream, b) left bank, c) downstream, d) right bank, and e) unconsolidated/cracking soils with no evidence of aquatic flora or fauna

Our assessment found Sites 166 and 165 are drainage depressions or gullies that lack features of a waterway providing for fish passage (Figure 6.59 and Figure 6.60). There appears to be some erosion along the edges of some of the depressions. However, these sections do not have a continuous defined bed and banks, and instead consist of broken sections of a drainage gully, particularly along straight sections of the channel. The drainage

depression at these sites would not flow other than in times of localised rainfall. Flow is not sufficient to maintain aquatic ecological processes. There was no evidence of aquatic flora or fauna presence at these sites, including a lack of dead sedges or evidence of aquatic fauna such as mollusc shells. Due to the lack of a channel with continuously defined bed and banks, no riparian vegetation, and a lack of fish habitat and connectivity for fish passage, Sites 166 and 165 are not considered waterways providing for fish passage.

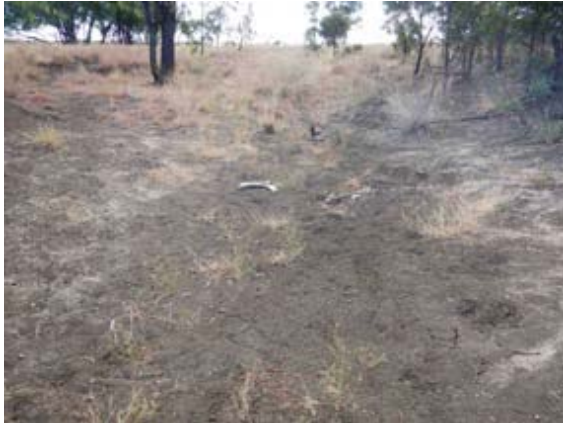
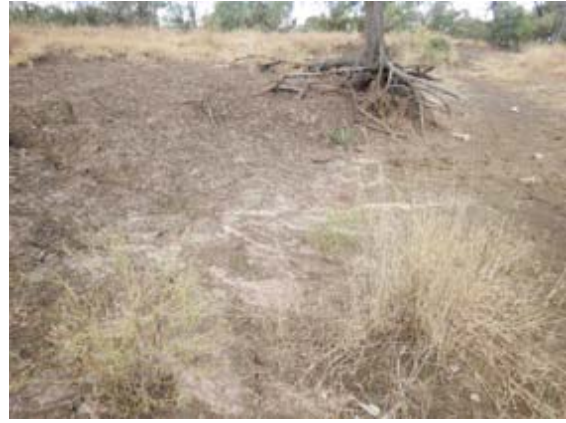
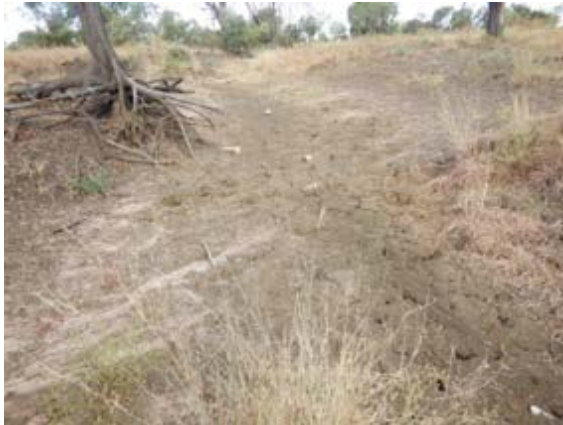
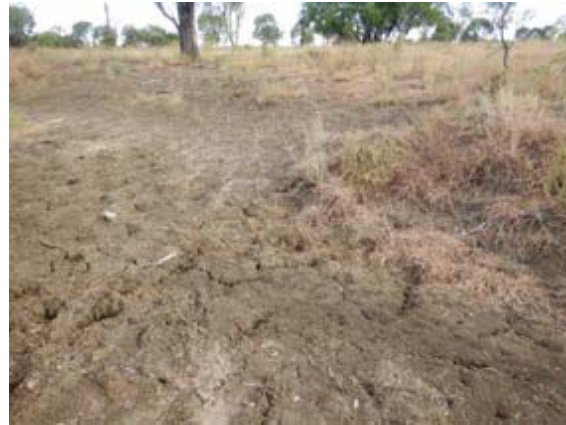
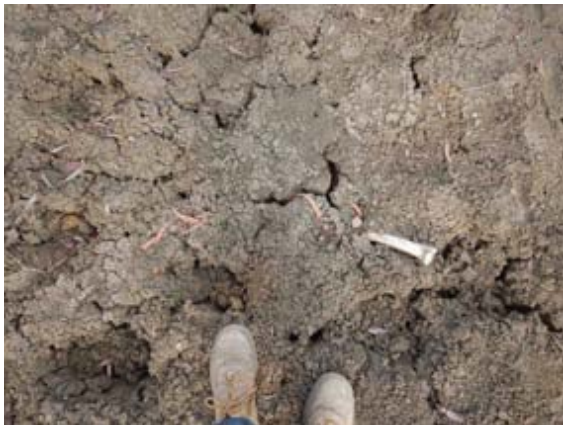
Figure 6.60 Site 165 showing a) upstream, b) left bank, c) downstream, d) right bank, and e) unconsolidated/cracking soils with no evidence of aquatic flora and fauna
