# WINCHESTER SOUTH PROJECT

Environmental Impact Statement  
**Additional Information**

# **Winchester South Project EIS**

## **Aquatic Ecology and Stygofauna, Additional Information**

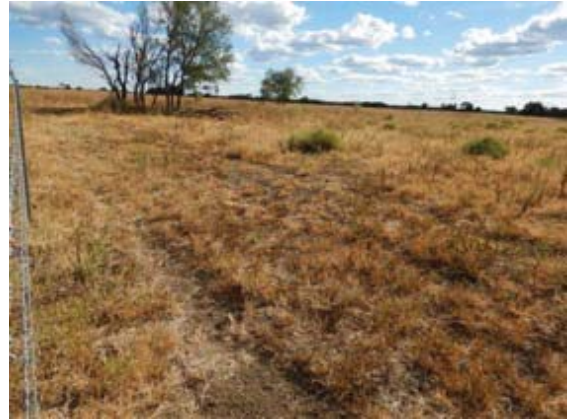
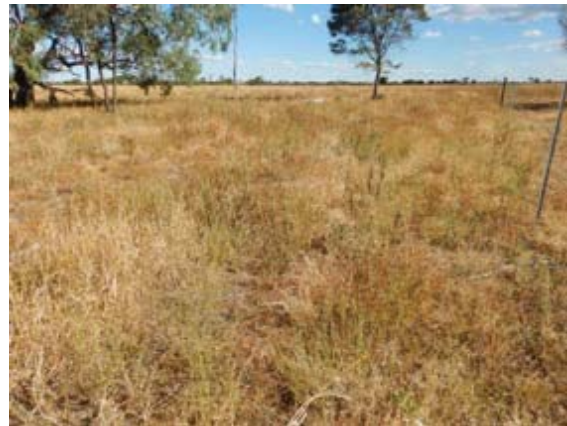
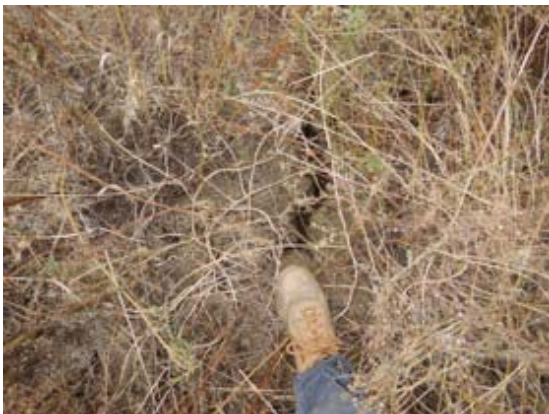
Site 161 is a drainage depression, immediately upstream of a 'turkey's nest' dam (Site 160). The drainage depression does not have continuously defined bed or banks, and there was no evidence that it would provide adequate flow beyond an immediate rainfall event (Figure 6.61). There was no riparian vegetation or fish habitat present. The drainage depression at Site 161 is not a waterway providing for fish passage.

Figure 6.61 Site 161 showing a) upstream, b) left bank, c) downstream, d) right bank, and e) unconsolidated/cracking soils with no evidence of aquatic flora or fauna

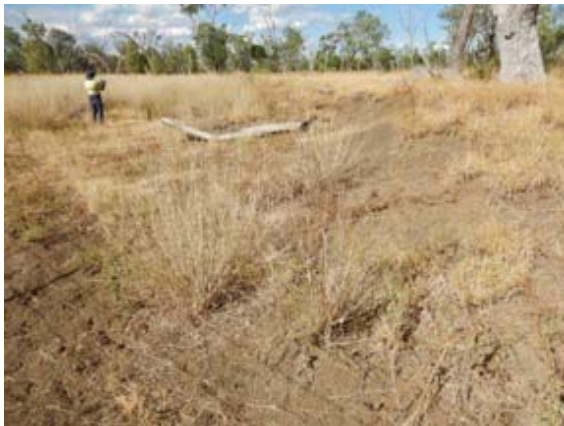
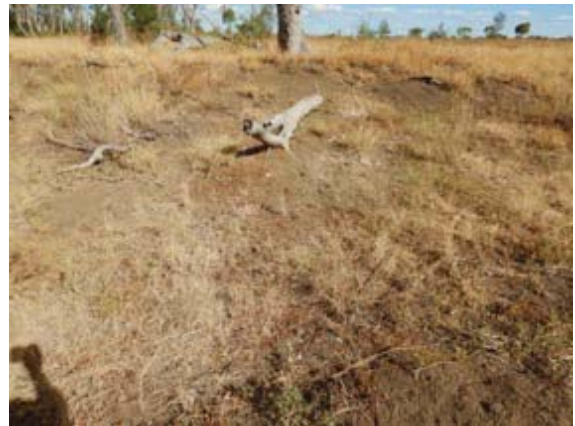
(Figure 6.63). The bed and banks are not well defined, are highly eroded, and consist of loose silty soil. Due to the high dam wall immediately upstream, Site 159 is unlikely to provide adequate flow beyond the duration of a rainfall event. Due to the lack of a channel with continuously defined bed and banks, no riparian vegetation, lack of fish habitat or passage opportunities, Site 159 is not considered a waterway providing for fish passage.

Figure 6.63 Site 159 showing a) upstream, b) left bank, c) downstream, d) right bank, e) unconsolidated/cracking soils, and f) a wider view of the feature, looking downstream

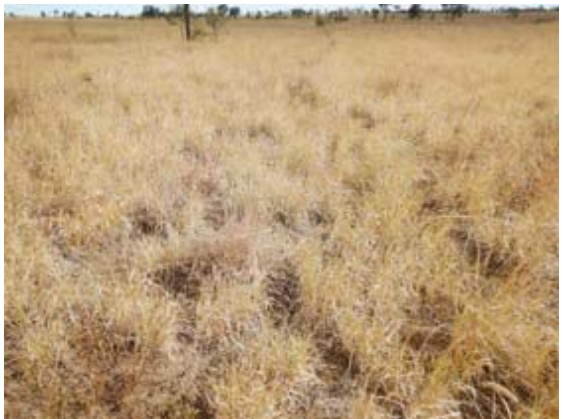
Figure 6.67 Site 156 showing a) upstream, b) left bank, c) downstream, and d) unconsolidated/cracked soils

Site 156 is a flat drainage feature with no defined bed and banks (Figure 6.67). Terrestrial vegetation can be seen growing across the feature. This section of the mapped feature would not provide adequate flow beyond an immediate rainfall event. There are no fish habitat or fish passage opportunities at this site.

The lack of defined bed and banks, in combination with insufficient water availability to sustain basic aquatic ecological processes and habitats, and the lack of riparian vegetation, means this reach is not a waterway providing for fish passage.

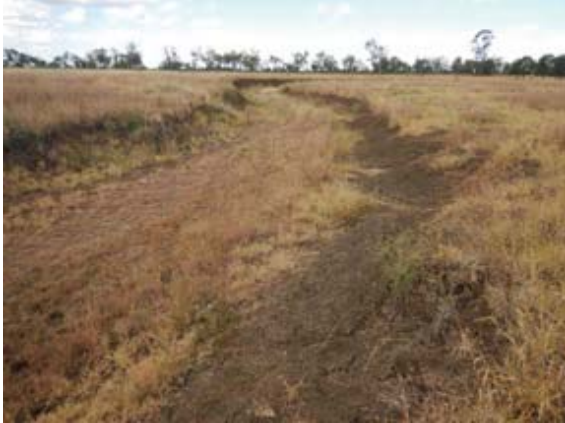
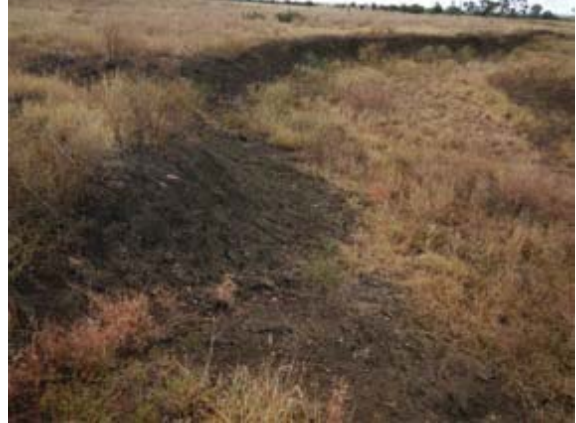
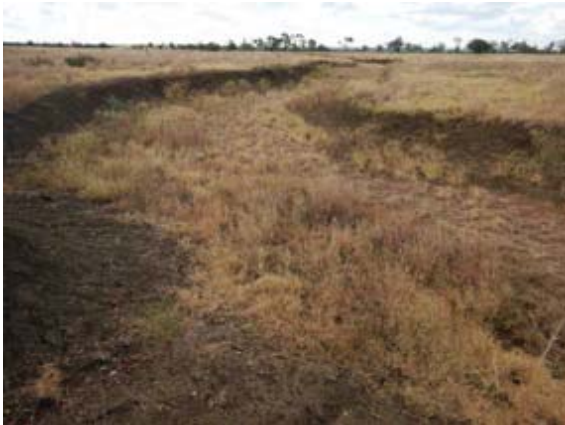
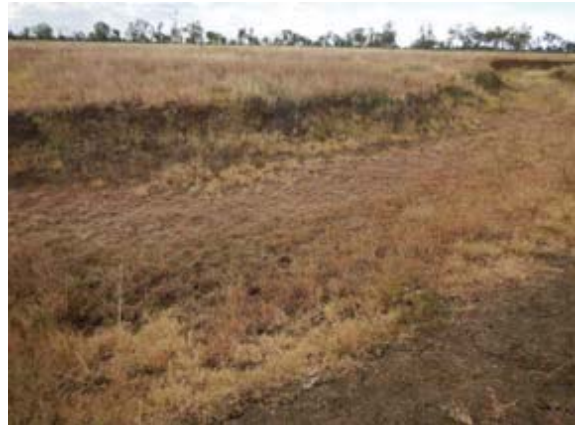
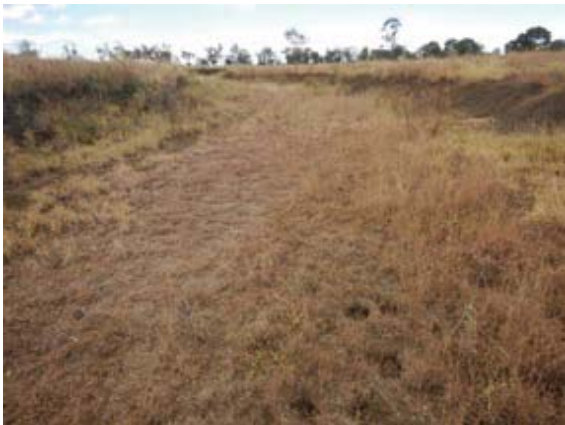
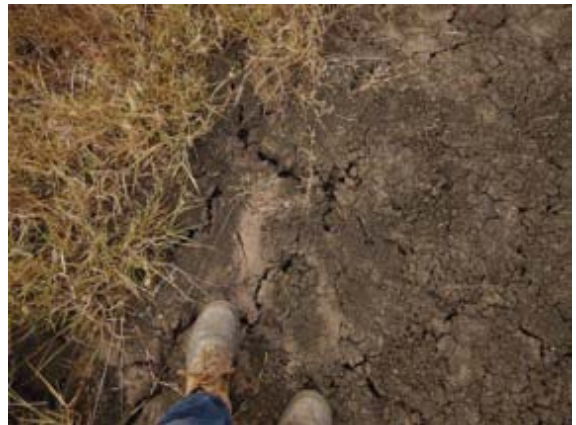
Figure 6.69 Site 157 showing a) upstream, b) left bank, c) downstream, d) right bank, e) main channel gully indicated by long grasses, and f) unconsolidated/cracks soils

Site 157 is a wide drainage channel with highly eroded areas, particularly on the outside bends (Figure 6.69). The soil is silty and unconsolidated. A shallow depression within the gully would carry flows during rainfall events, but it is unlikely to provide adequate flow beyond the duration of a rainfall event. There is a complete lack of fish habitat, suggesting this section of the waterway does not provide fish passage opportunities.

Due to the lack of a main channel with continuously defined bed and banks, and lack of fish habitat or passage opportunities, Site 157 is not considered a waterway providing for fish passage.

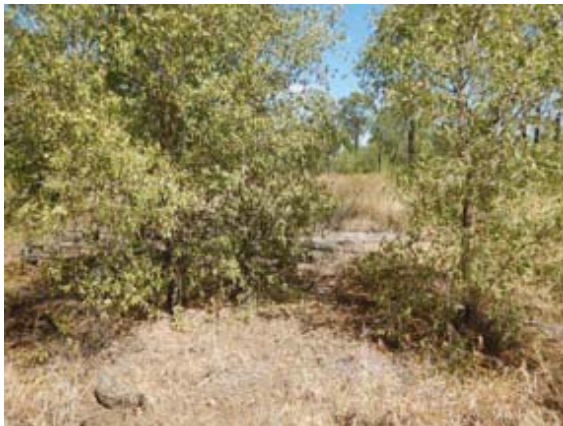
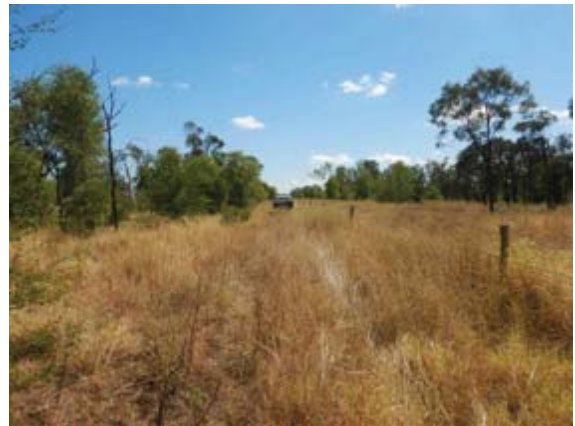
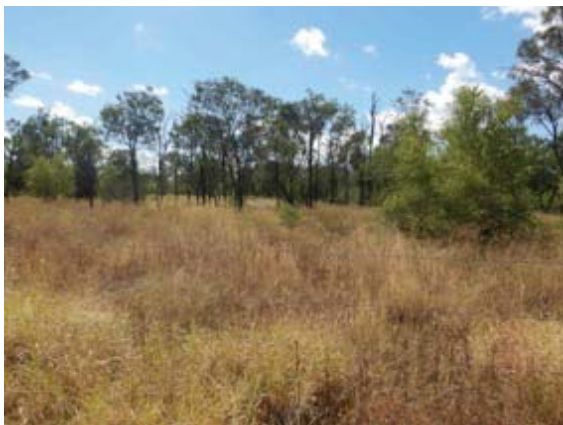
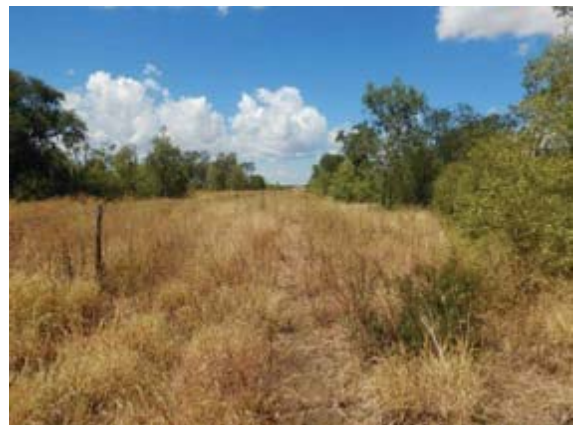
Figure 6.70 Site 75 (A6) showing a) upstream, b) left bank, c) downstream, and d) right bank

Sites 75 and 76 (Sites A6 and A7, respectively, in previous assessments; see Appendix A) are homogenous with surrounding terrain, with no drainage feature present at either site. A search of the area failed to find a drainage feature present within 250 m of each site.

Due to the lack of a waterway with any waterway features, Sites 75 and 76 are not considered a waterway providing for fish passage (Figure 6.70 and Figure 6.71). This further suggests that there is no opportunity for fish passage from the downstream reaches of the mapped amber feature to the upstream mapped green tributaries.

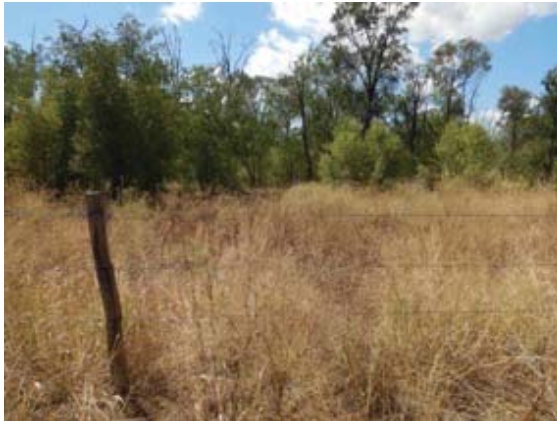
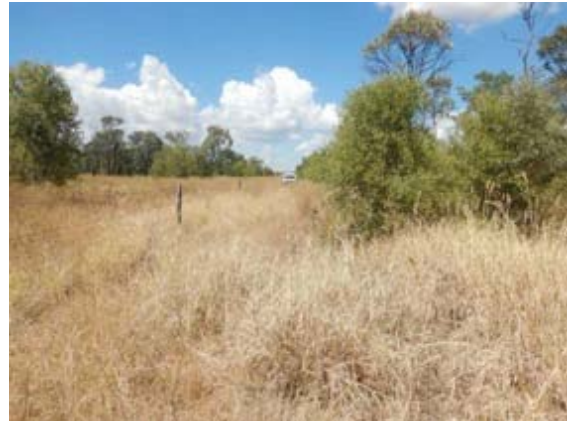
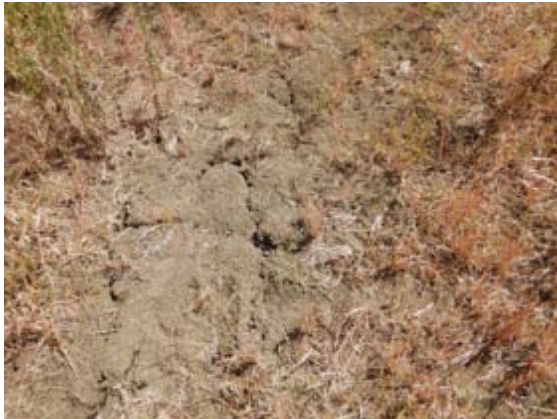
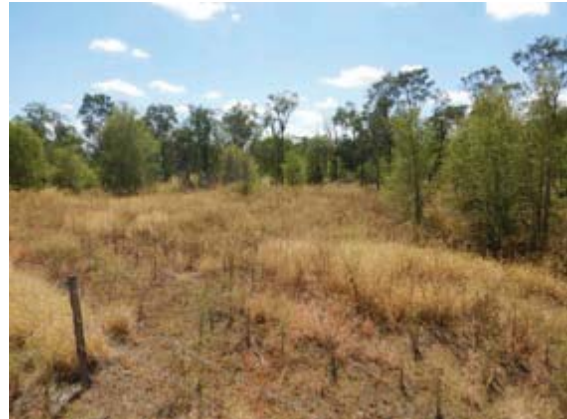
Figure 6.71 Site 76 (A7) showing a) upstream, b) left bank, c) downstream, d) right bank, e) unconsolidated/cracks soils, and f) wider view of downstream terrain

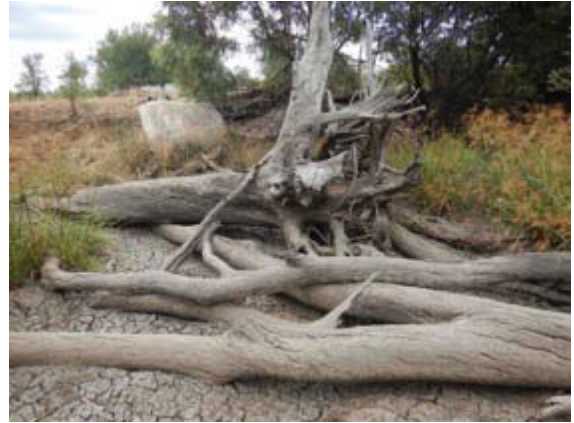
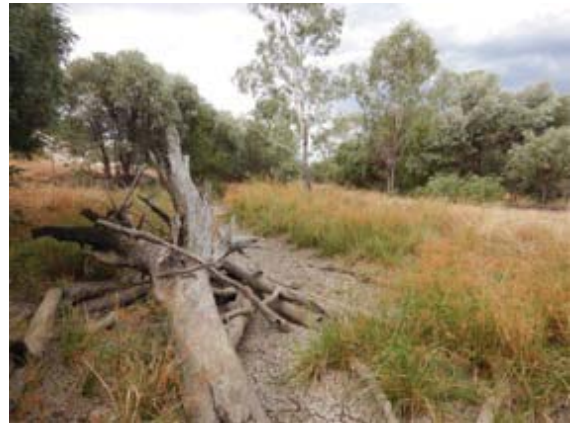
Figure 6.75 Site 96 showing a) upstream, b) left bank, c) downstream, and d) right bank

Site 96 is a wide, shallow gully with low banks (Figure 6.75). The bed was cracked and dry in February 2022, but the nature of the cracked soils was indicative of previous water ponding. Further, aquatic plants (sedges (*Cyperus* spp.)) were abundant at this site, suggesting water may occur at Site 96 for an extended period following rainfall. These sedges and large woody debris provides fish habitat.

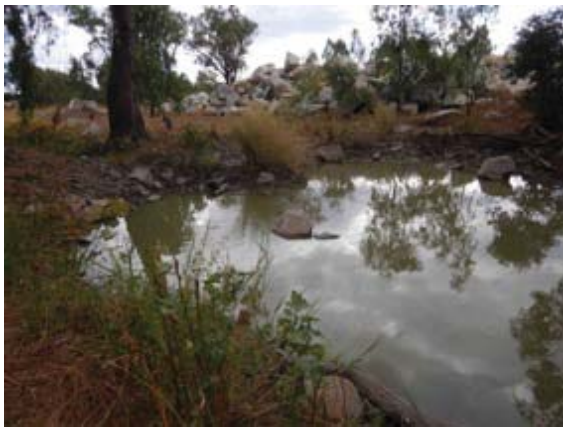
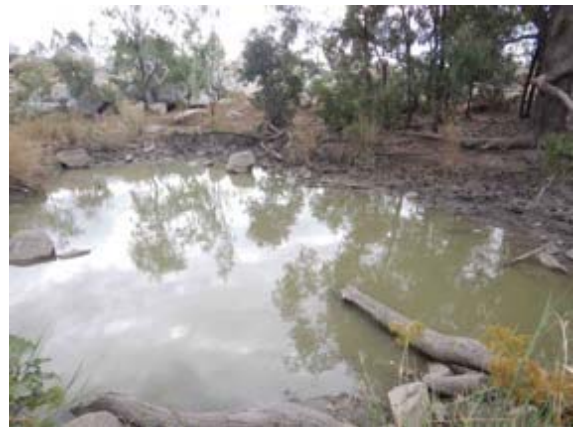
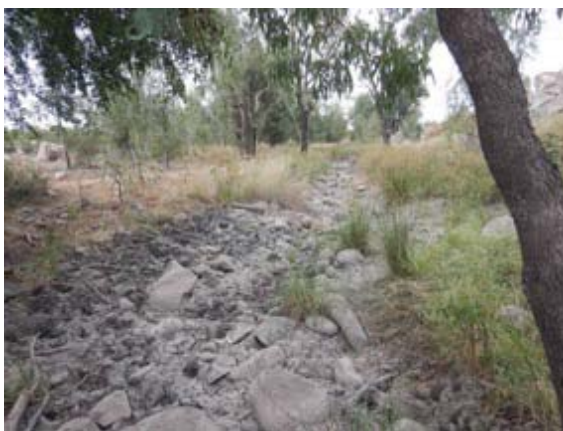
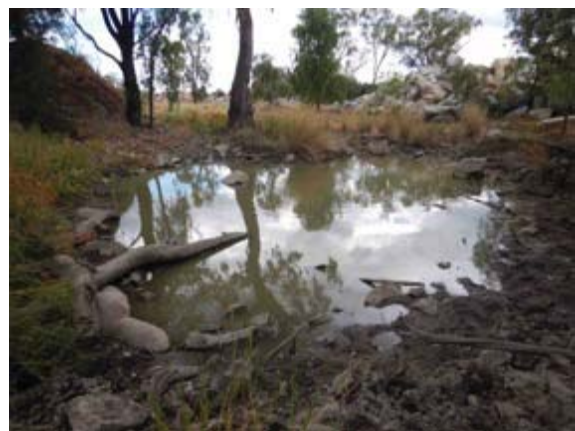
Figure 6.77 Site 94 showing a) upstream side of pond, b) left bank of pond, c) downstream channel, and d) wider view of pond looking upstream

Site 94 is a small, 12 m wide, shallow pool of water (Figure 6.77). The pool has low banks and connectivity to upstream and downstream reaches. The channel flowing into the pool is not well defined and appears to be directing overland flows from the dirt road described at

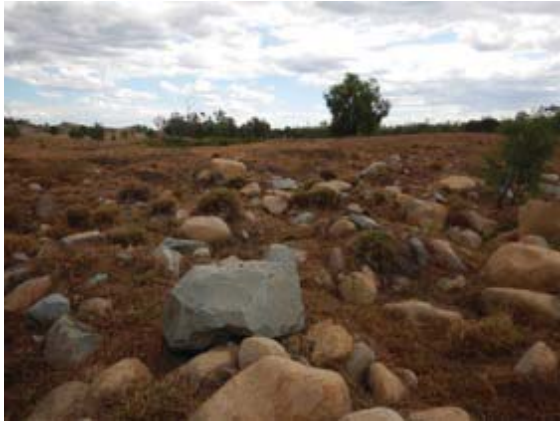
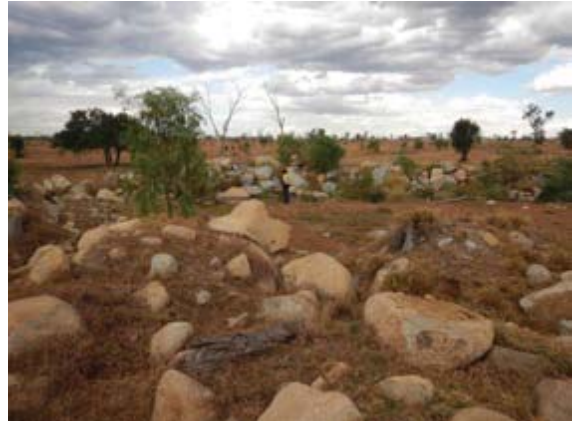
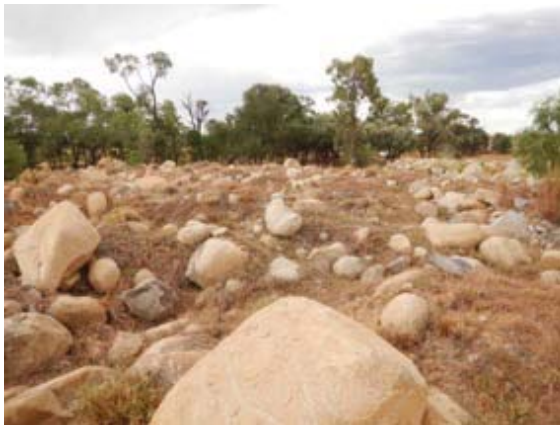
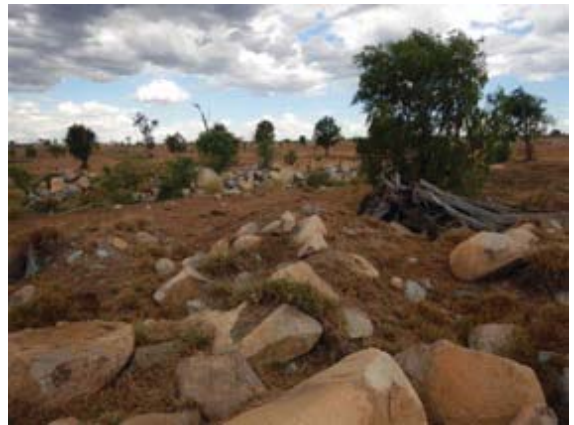
Figure 6.80 Site 90 showing a) across constructed barrier toward upstream dam, b) looking west, c) toward downstream, and d) looking east

Site 90 is a wide rocky constructed barrier located between Sites 93 and 89 (Figure 6.80). The barrier is approximately 2 m above the natural ground level and does not provide any fish habitat or fish passage opportunities. The constructed channel at Site 91 appears to have been created to allow flows around Site 90.

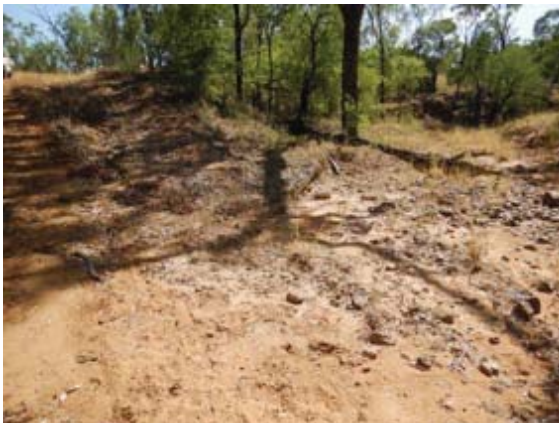
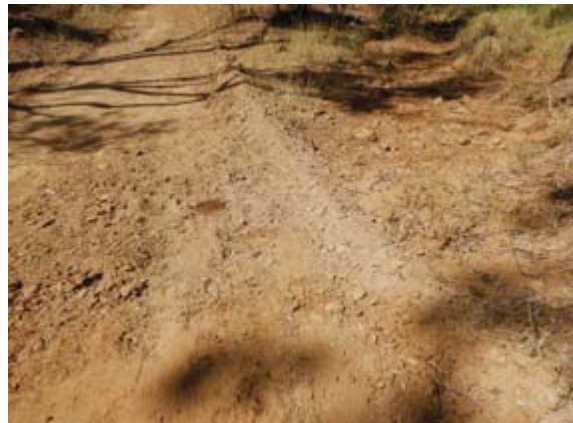
Figure 6.85 Site 98 showing a) upstream, b) left bank with road crossing, c) downstream, d) right bank with road crossing, e) left bank downstream of road, and f) unconsolidated soils with indications of recent grading across channel bed

Site 98 (A12 in previous assessments; see Appendix B) is approximately 400 m upstream of the confluence with the Isaac River. A dirt road crosses the channel. The dirt road is at the same level as the channel bed, with no culvert passing under the road. Recent grading of the road has produced shallow banks of dirt across the channel creating possible barriers to fish passage (Figure 6.85).

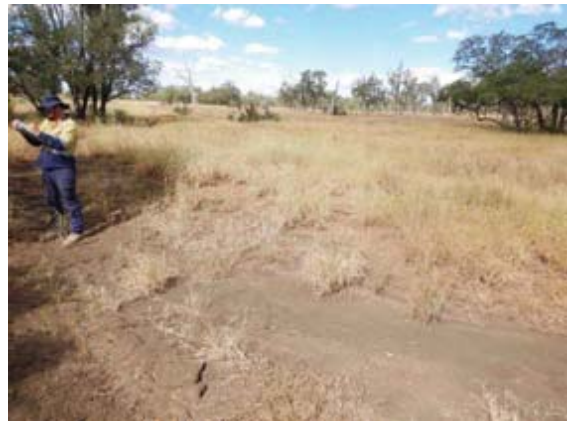
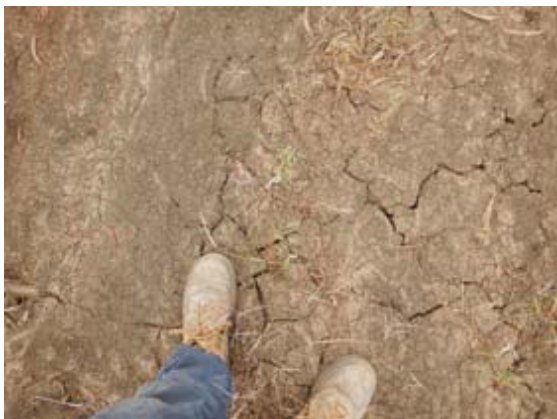
Figure 6.87 Site 154 showing a) upstream, b) left bank, c) downstream, d) right bank, and e) unconsolidated/cracks soils

Sites 155 and 154 lack defined bed and banks and are indicative of overland flow paths that funnel immediate localised rainfall, and would not provide flow beyond the duration of a rain event (Figure 6.86 and Figure 6.87). Erosion is minimal suggesting flow velocities are low. Vegetation appears to be terrestrial grasses, with no aquatic plants. The soils are not indicative of previous water ponding.

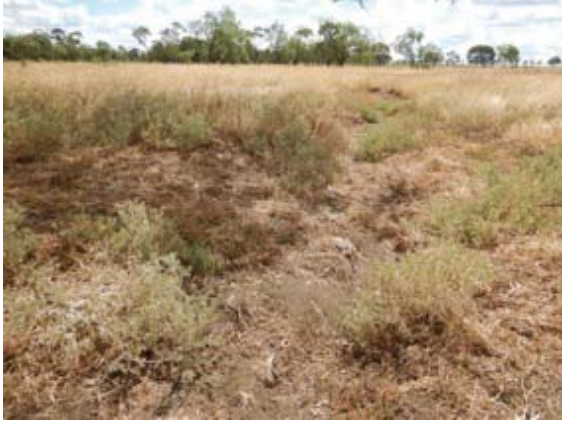
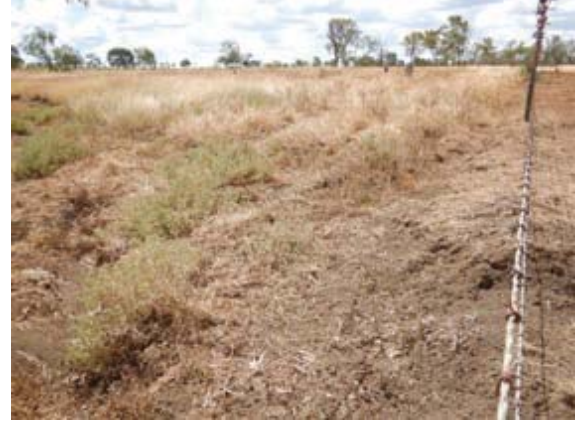
Figure 6.88 Site 137 showing a) upstream, b) left bank, c) downstream, and d) right bank

Site 137 is a narrow drainage gully directing flows toward a large, constructed dam and would not provide flow beyond the duration of a rain event (Figure 6.88). There is no riparian vegetation, aquatic plants or any other evidence of standing water.

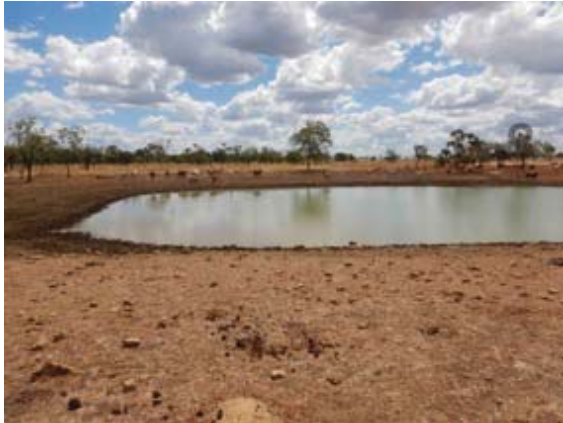
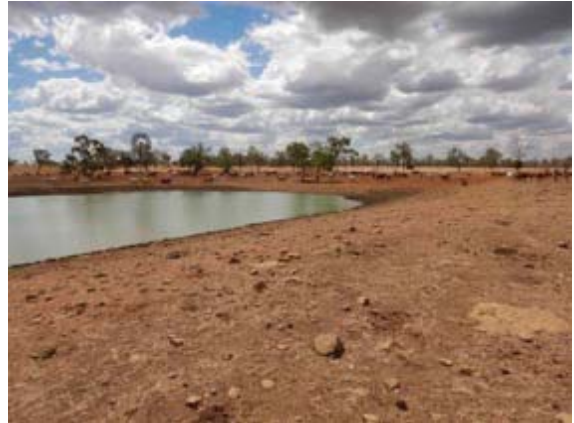
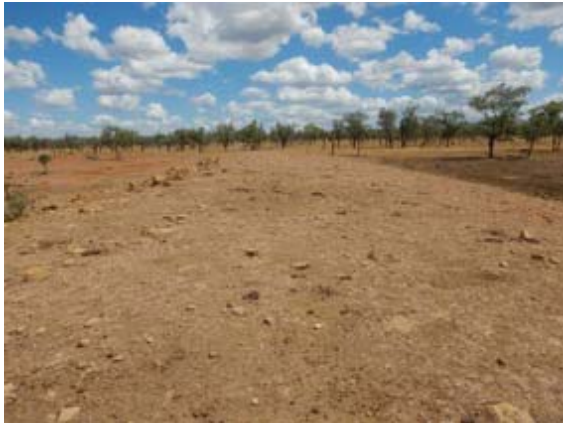
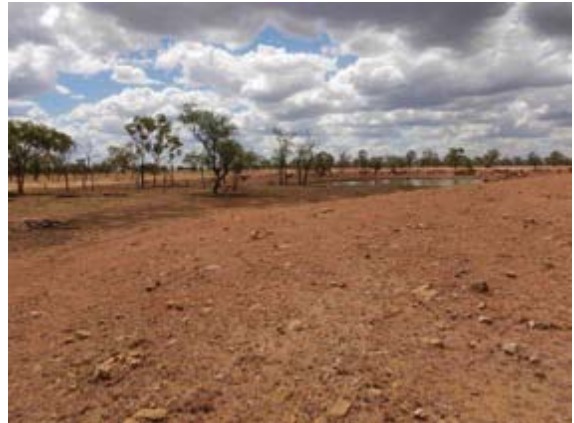
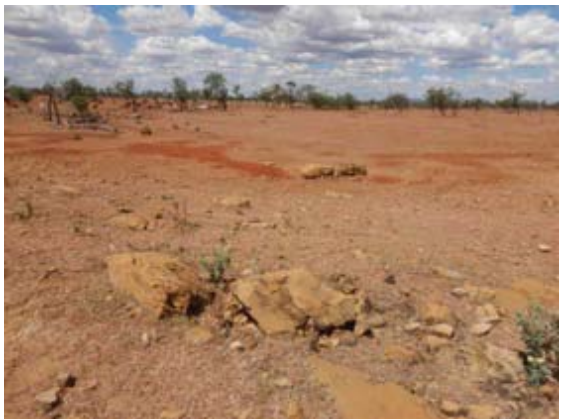
Figure 6.89 Site 135 showing a) upstream across dam, b) left bank of dam, c) downstream, toward dam overflow, d) toward dam from dam overflow, and e) looking downstream from dam overflow

Site 135 (FD1 in previous assessments; see Appendix A) is a large, constructed dam (Figure 6.89). The dam walls are approximately 7 m high and act to restrict connectivity to downstream reaches. The dam wall along the downstream extent of the dam extends away from the dam to the south, which appears designed to direct dam overflows.

The dam at Site 135 acts as a barrier to fish passage and there is no waterway providing for fish passage upstream (see Site 137 described above) or downstream (Figure 6.89e).

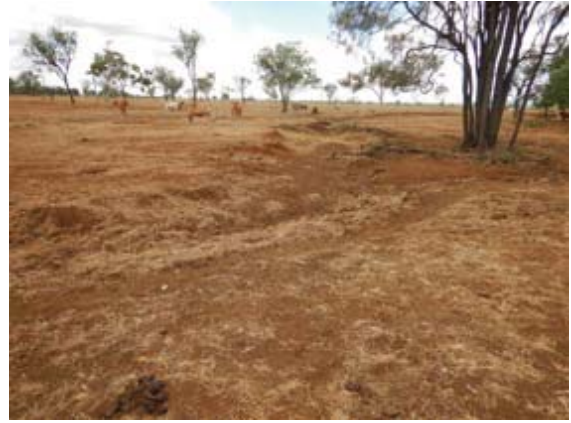
Figure 6.91 Site 134 showing a) upstream toward dam with several drainage lines visible, and b) downstream

Sites 133 (Site 6 in previous assessments; see Appendix A) and 134 are small drainage depressions, downstream of the large constructed dam, that lack features of a waterway providing for fish passage (Figure 6.90 and Figure 6.91).

There are several small drainage lines running through Site 133, converging downstream at Site 134. There is some erosion along the edges of the drainage lines, particularly on the outside of bends. Sections of the depressions do not have a continuous defined bed and banks, and instead consist of broken sections of a drainage gully, particularly along straight sections of the channel. The drainage depression at these sites would not likely provide adequate flow other than in times of localised rainfall.

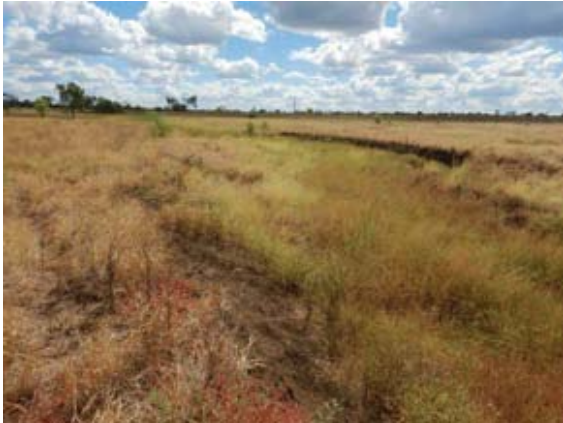
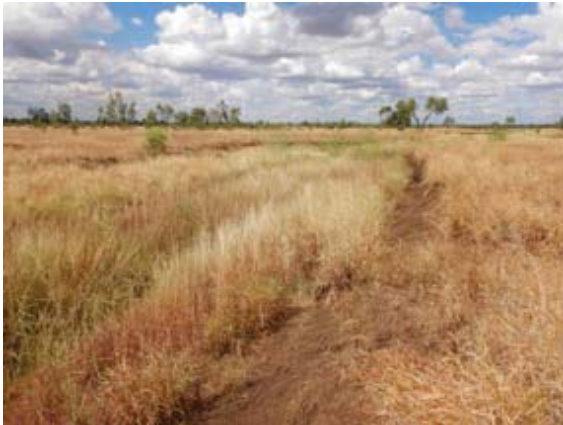
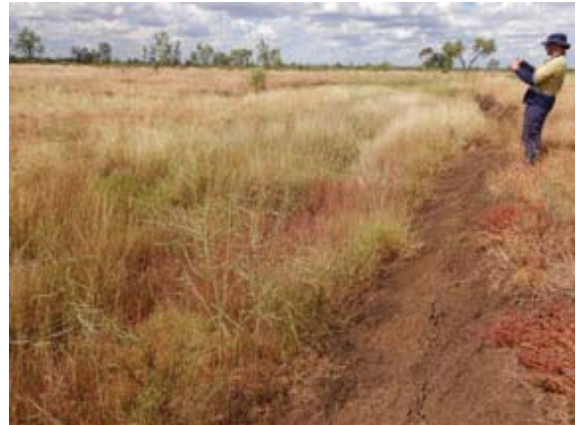
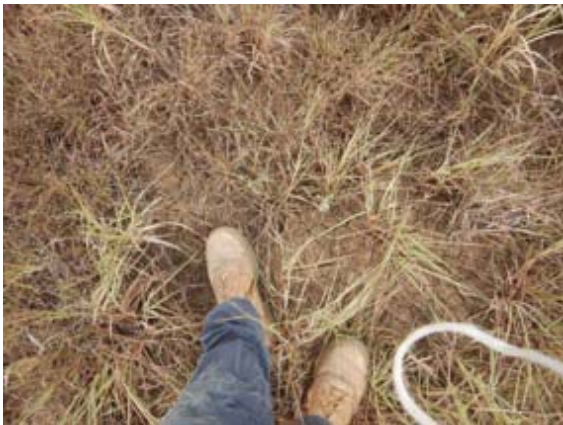
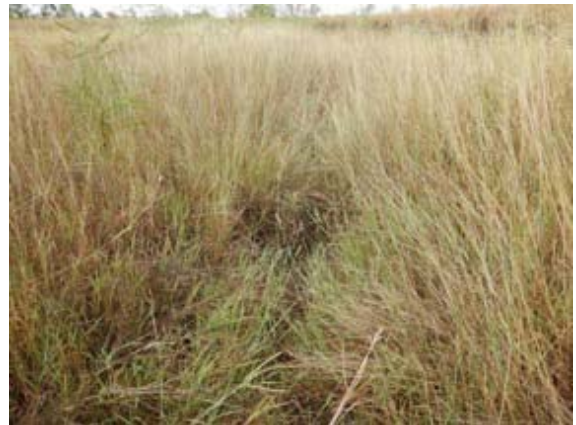
Figure 6.92 Site 138 showing a) upstream, b) left bank, c) downstream, d) right bank, e) unconsolidated/cracks soils, and f) vegetated gully floor

Site 138 is a wide flat drainage gully, with no standing water or evidence of previous standing water (Figure 6.92). There is significant erosion along the edges of some of the gullies, particularly on the outside of bends.

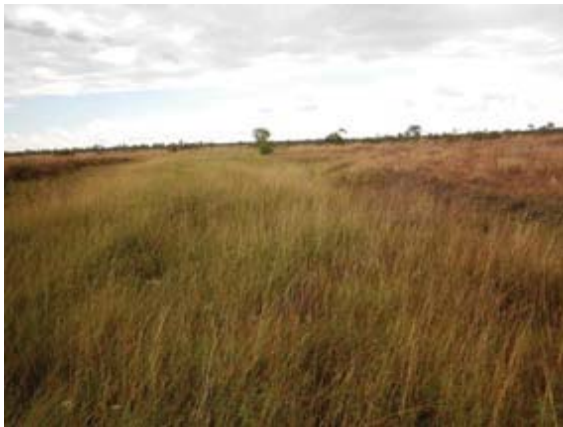
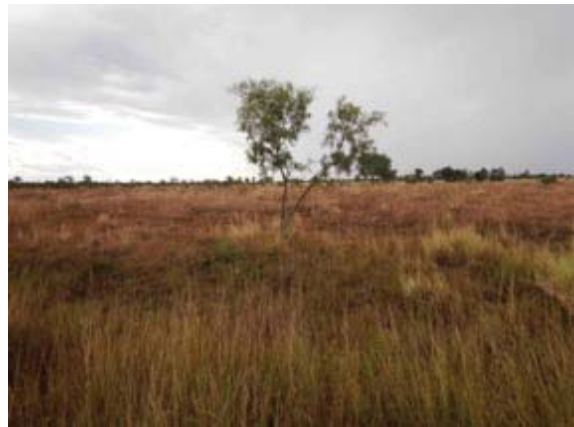
Figure 6.97 Site 73 showing a) upstream, b) left bank, c) downstream, and d) right bank

Sites 73 and 72 (B2 in previous assessments; see Appendix A) are wide flat drainage gullies, with no standing water in February 2022 (Figure 6.97 and Figure 6.98). There is significant erosion along the edges of some of the gullies, particularly on the outside of bends. There is a shallow vegetated depression within the gully with terrestrial vegetation, indicating that it is unlikely to provide adequate flow beyond the duration of a rainfall event. There are no aquatic plants or fish habitat.

Due to the lack of a main channel with continuously defined bed and banks, no riparian vegetation, lack of fish habitat or passage opportunities, Sites 73 and 72 are not considered a waterway providing for fish passage.

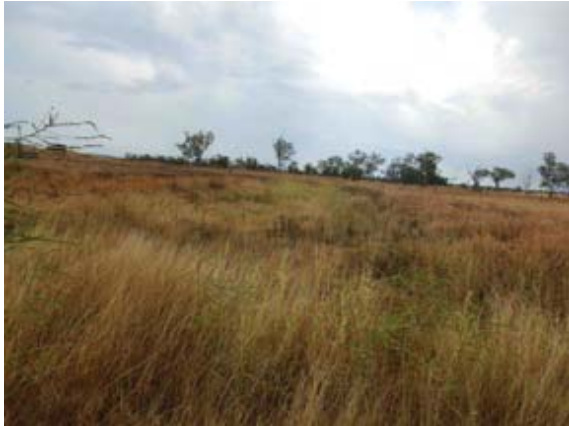
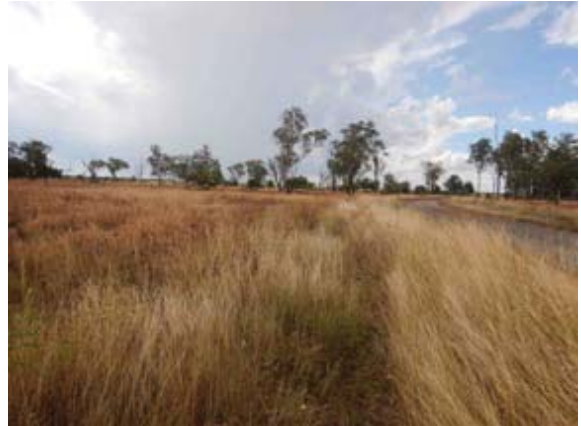
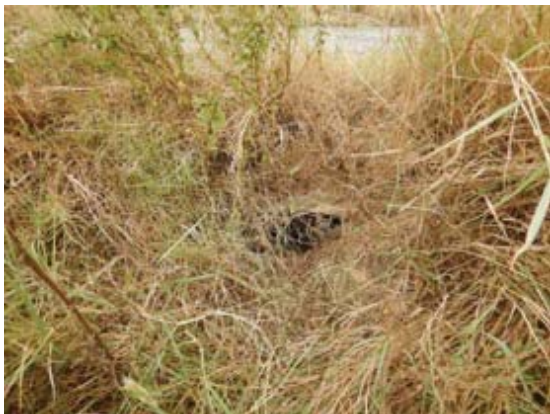
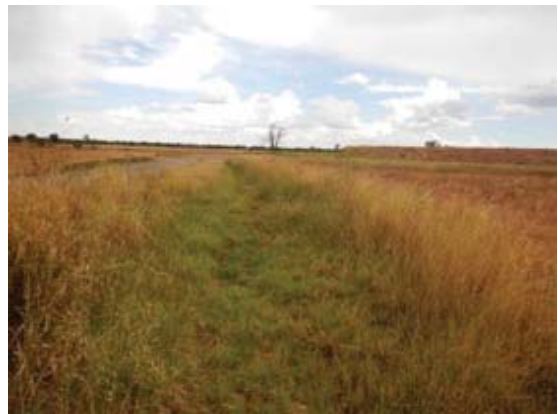
Figure 6.101 Site 71 showing a) upstream, b) left bank with road crossing, c) downstream, road pipe culvert, and d) right bank with road crossing

Sites 71 and 70 are drainage gullies, with ill-defined bed and banks, and instead, consist of broken sections of a drainage channel (Figure 6.101 and Figure 6.102).

This section of the mapped feature is not a waterway providing for fish passage.

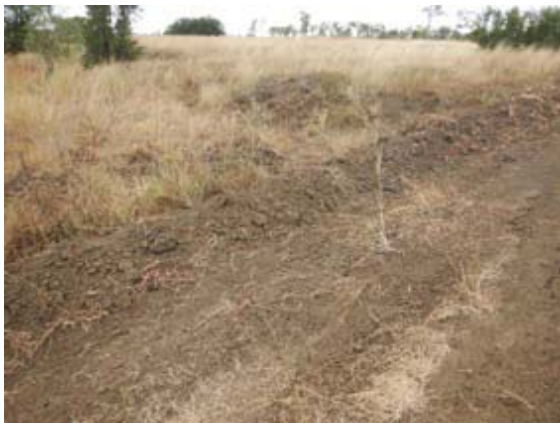
Figure 6.103 Site 69 showing a) upstream, b) left bank, c) downstream, d) right bank and e) recent grading across channel

Site 69 is a drainage depression crossed by a dirt track, with no culvert passing under the track (Figure 6.103).

There appears to be some erosion along the edges of the depression, particularly on the outside of bends. However, straight sections of the depression do not have a continuous defined bed and banks, and instead consist of broken sections of a drainage gully. The drainage depression would only flow in times of localised rainfall.

Due to the lack of a channel with continuously defined bed and banks, no riparian vegetation, and a lack of fish habitat and connectivity for fish passage, Site 69 is not a waterway providing for fish passage.

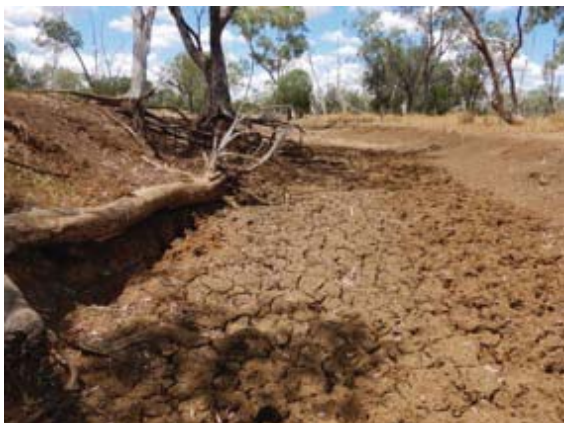
Figure 6.104 Site 129 showing a) upstream, b) left bank, c) downstream, d) right bank, and e) dried, cracked bed in depression

Site 129 is a wide drainage gully, with no visible standing water in February 2022 (Figure 6.104). A small depression within the gully contained cracked soils that were indicative of some pooling of water after periods of flow. However, the depression appears to be a gully that funnels immediate localised rainfall that would not likely provide flow beyond the duration of a rain event. There was no evidence of aquatic flora or fauna (such as dead aquatic plants

This section of the waterway is not a waterway providing for fish passage.

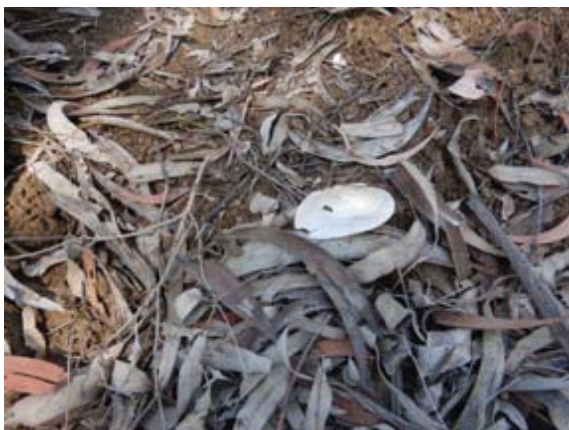
Figure 6.115 Site 122 showing a) upstream, b) left bank, c) downstream, d) right bank, and e) mussel shell observed within a gully

This long section of the mapped feature (includes B5 and B6 from previous assessments; see Appendix A) is described as broken sections of a drainage gully, consisting of a wide flat gully with shallow sloping sides (Figure 6.107 to Figure 6.115). In some sections, the gully splits into several smaller gullies/drainage lines. There is some erosion present, particularly on the outside of bends.

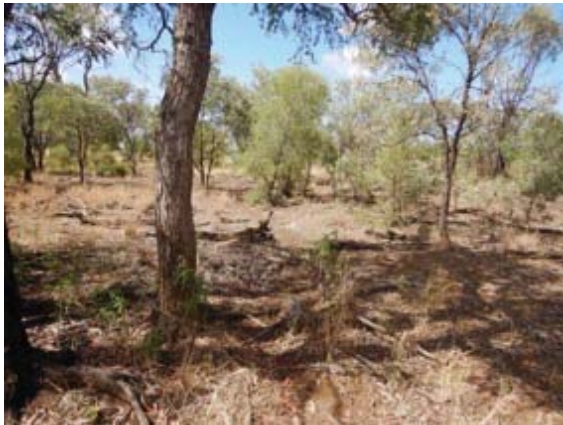
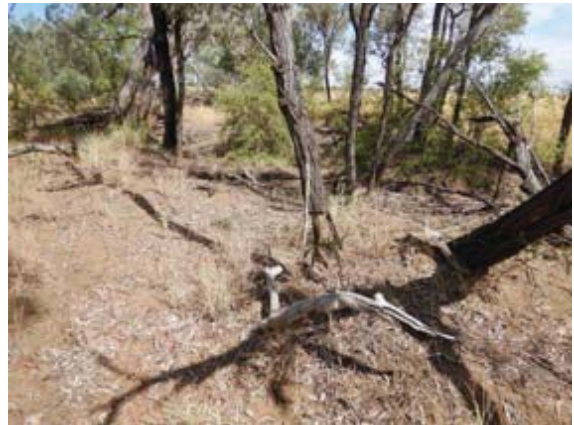
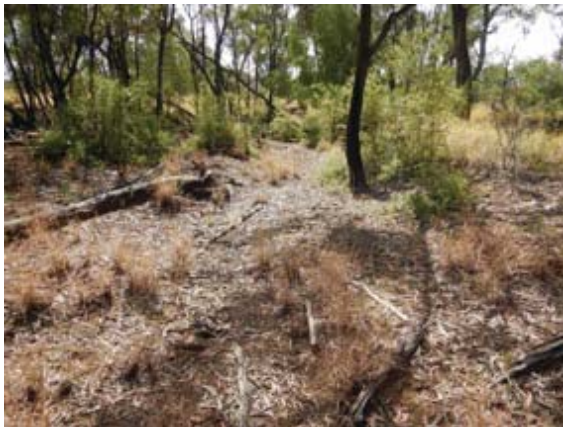
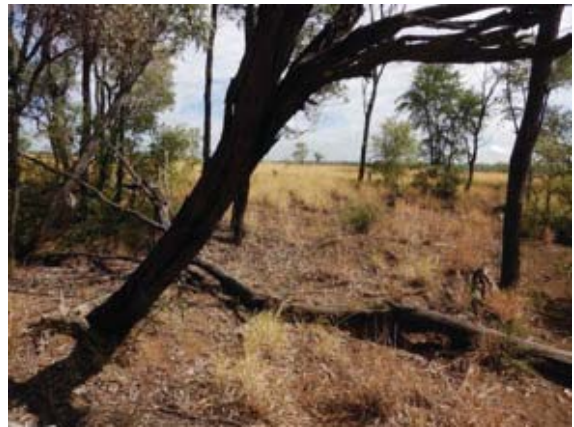
Site 62 consists of multiple drainage lines (Figure 6.120).

There are no continuous defined bed or banks, or any other waterway features. There is no evidence of previous standing water. Broken sections of a drainage channels funnel immediate localised rainfall and would not likely provide flow beyond the duration of a rain event.

There are waterway features downstream of this point. As such, Site 62 is the upstream limit of the waterway providing for fish passage along the central mapped feature.

Figure 6.120 Site 62 showing a) upstream, b) left bank, c) downstream, and d) right bank

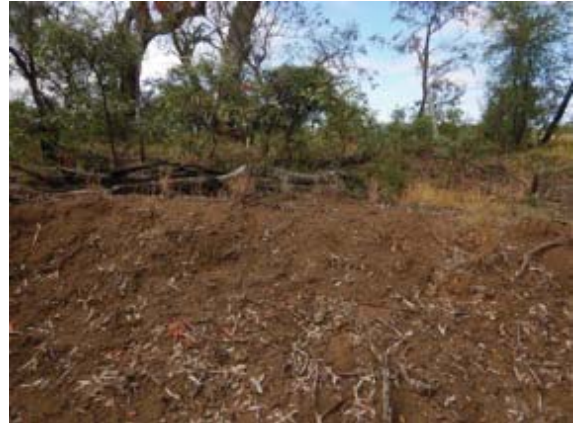
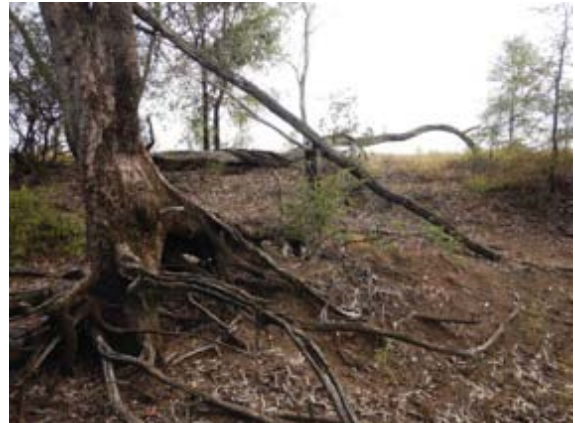
Sites 60 through to 58 are representative of a waterway providing for fish passage. The channel along this section of the mapped feature contains a defined bed and banks (Figure 6.121 to Figure 6.124). Large *Eucalypts* and other native trees line the sides of the banks. Multiple habitat opportunities, including woody debris and rocky structures, were observed throughout.

While no standing water was found in the channel, several depressions were identified that likely provided standing water during and after periods of flow.

Figure 6.121 Site 60 showing a) upstream, b) left bank, c) downstream, d) right bank, and e) unconsolidated soils with sections of exposed rocky bed

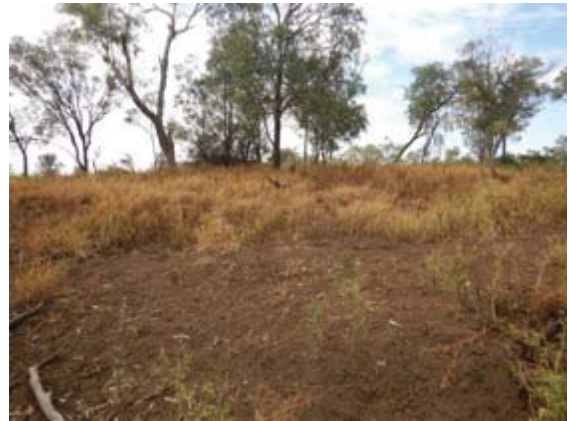
Figure 6.124 Site 58 showing a) upstream, b) left bank, c) downstream, and d) right bank

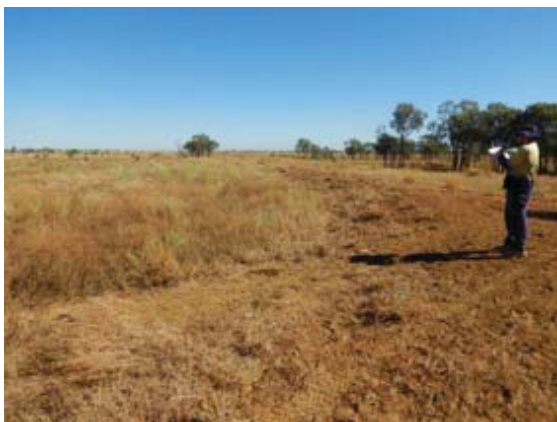
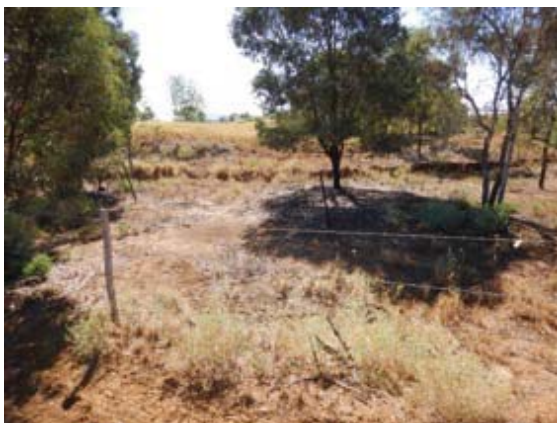
Figure 6.127 Site 111 showing a) upstream along diversion wall, b) left bank with road crossing, c) downstream toward dam, d) right bank with road crossing, e) diversion wall, and f) additional view of downstream flow toward dam

Site 111 is a drainage depression directing overland flows along a diversion wall toward a large, constructed dam (Figure 6.127). There are no continuously defined bed or banks, or any other waterway features. There is no evidence of standing water or of flow beyond the duration of a rain event.

The lack of defined bed and banks, in combination with insufficient water availability to sustain basic aquatic ecological processes and habitats, and the lack of aquatic vegetation, means this reach of the mapped feature is not a waterway providing for fish passage.

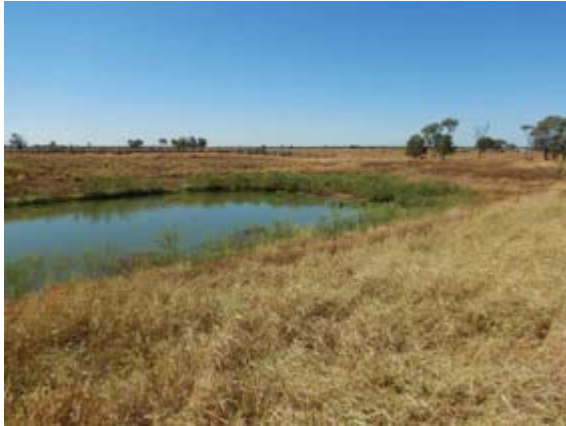
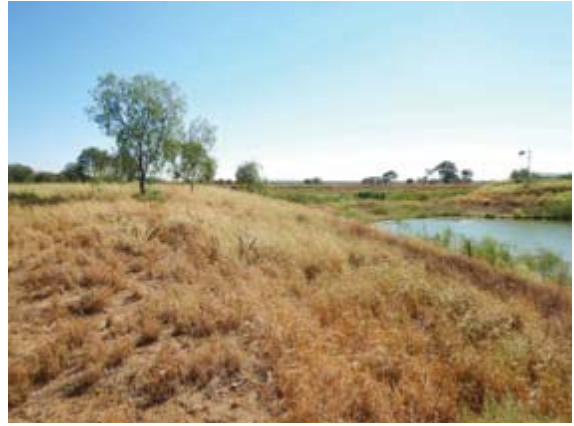
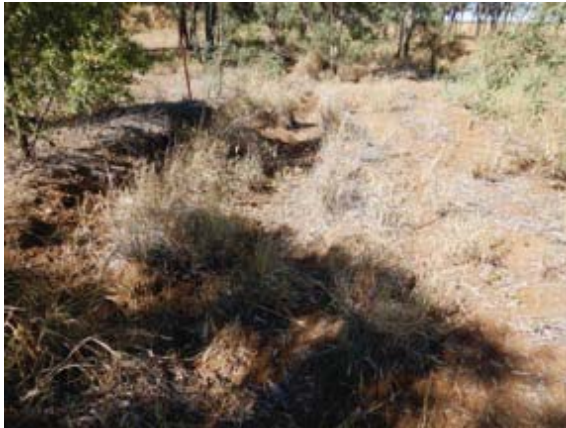
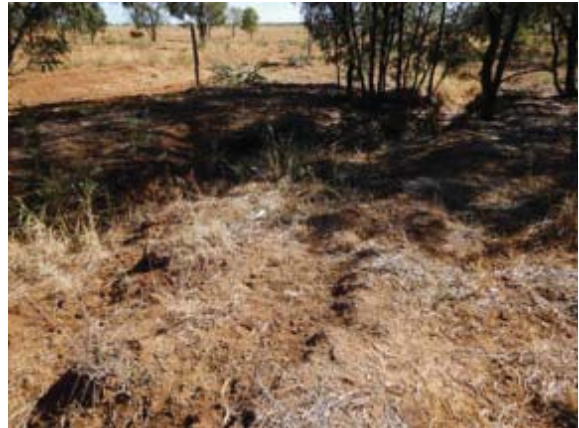
Figure 6.128 Site 122 showing a) upstream of dam with flow entrance and overflow, b) looking downstream across dam, c) overflow channel from dam looking upstream, d) overflow channel looking downstream e) overflow channel further downstream, and f) channel spreading out into paddock as drainage line

Site 112 (FD4 in previous assessments; see Appendix A) is a constructed dam (Figure 6.128). The dam walls are approximately 7 m in height and restrict connectivity to downstream reaches. There is a drainage channel on the western extent of the dam that funnels flow into the dam from upstream areas. Aquatic plants within the dam include bull rush, rushes, and sedges.

Outside of the dam, a narrow drainage gully runs along the northern edge of the dam wall, and likely directs dam overflow downstream, to the east. This drainage gully consists of broken sections of a drainage channel and does not have continuous defined bed and banks, or any other waterway features. The drainage channel is not a waterway providing for fish passage.

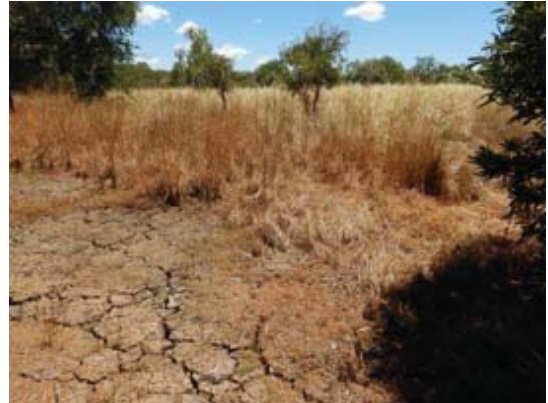
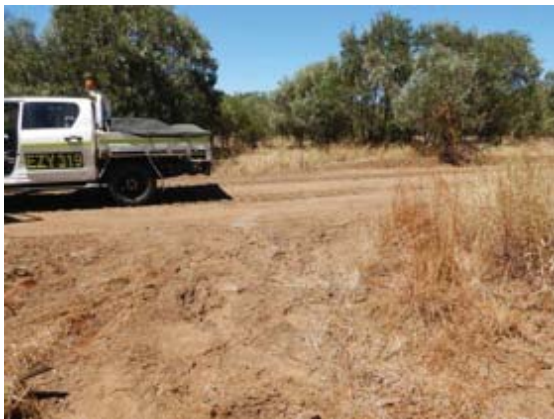
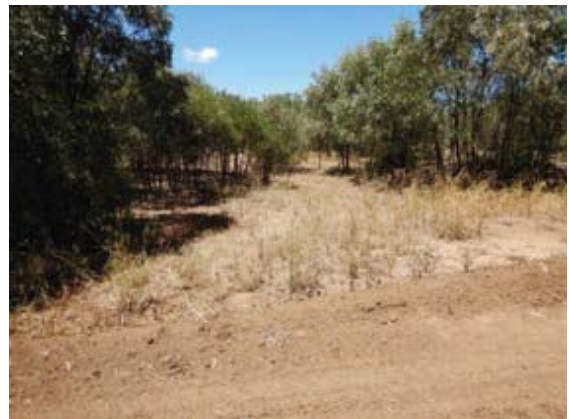
Figure 6.134 Site 151 showing a) upstream, b) left bank, c) downstream, with road crossing, d) downstream from road crossing, e) unconsolidated/cracked soils, and f) showing lack of defined drainage channel further downstream within brigalow

Site 151 (close to C10 from previous assessments; see Appendix A) is located at a road crossing a drainage depression (Figure 6.134). The road is approximately 0.4 m above the drainage depression. Immediately upstream of Site 151, there are dry, cracked beds, indicating water is likely pooling up against the road. The depression consists of broken sections of a drainage channel and does not have continuously defined bed and banks.

However, as sites downstream of this location were not surveyed, and as there was an indication of water pooling on the upstream site of the road crossing, Site 151 has conservatively been considered the upstream extent of the waterway providing for fish passage for the southern unnamed feature.

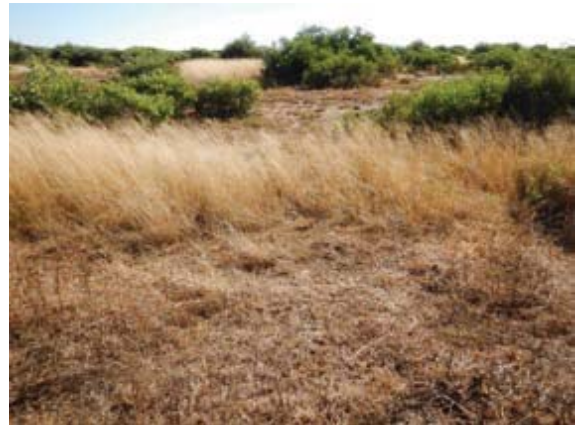
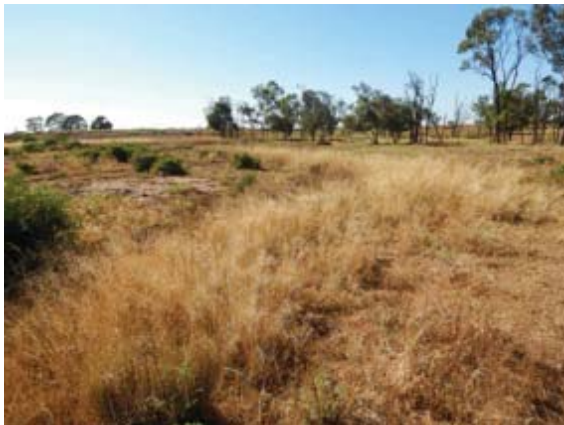
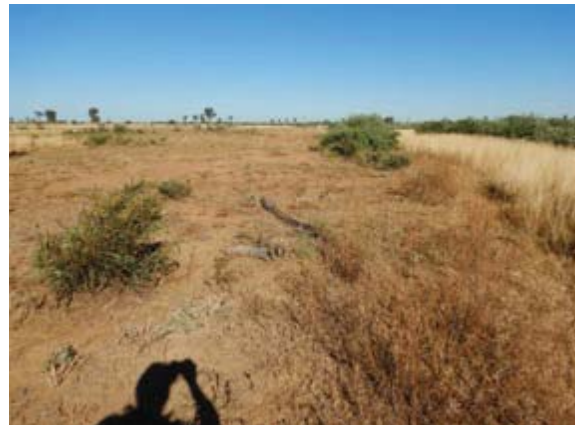
Figure 6.137 Site 108 showing a) upstream, b) left bank, c) downstream, and d) right bank

Site 108 is a drainage depression, or gully, directing flows toward a large, constructed 'turkey's nest' dam (Figure 6.137).

The lack of defined bed and banks, in combination with insufficient water availability to sustain basic aquatic ecological processes and habitats, suggests this reach of the unmapped feature is not a waterway providing for fish passage.
