# WINCHESTER SOUTH PROJECT

Environmental Impact Statement  
**Additional Information**

# **Winchester South Project EIS**

## **Aquatic Ecology and Stygofauna, Additional Information**

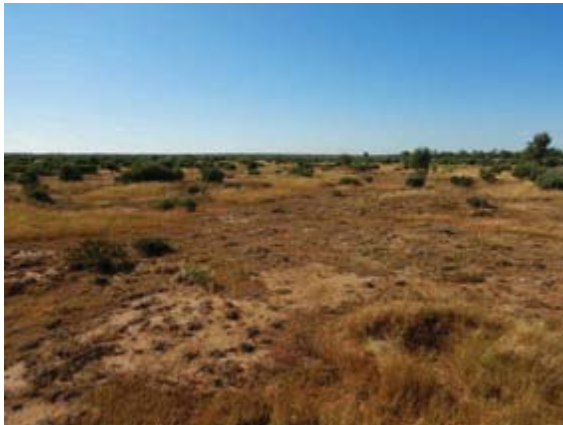
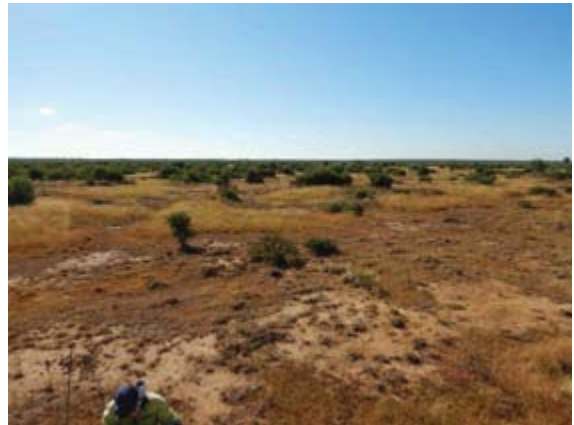
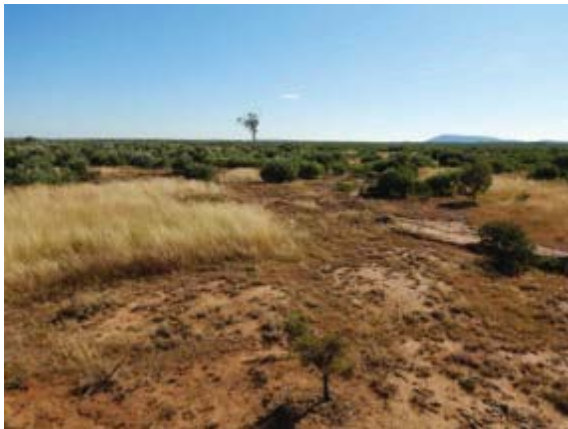
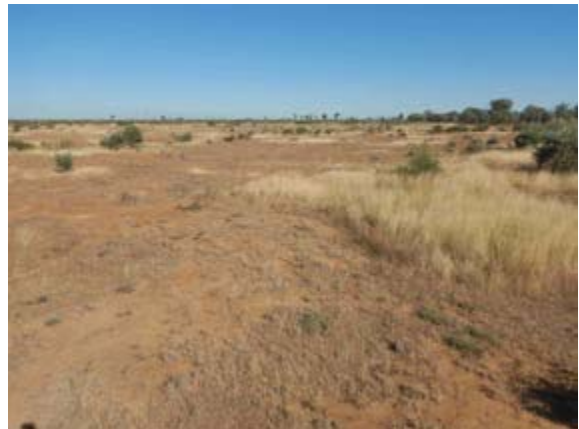
Figure 6.139 Site 109 showing a) upstream, b) left bank, c) downstream, and d) right bank

Site 109 is south of the large, constructed dam at Site 107. Here, the ground is undulating with no clear drainage channel (Figure 6.139). Instead, the site consists of several drainage depressions leading in a southerly direction. The area is reminiscent of undulating Gilgai country.

Due to the lack of a channel with continuously defined bed and banks, no riparian vegetation, and a lack of fish habitat and connectivity for fish passage, Site 109 is not a waterway providing for fish passage.

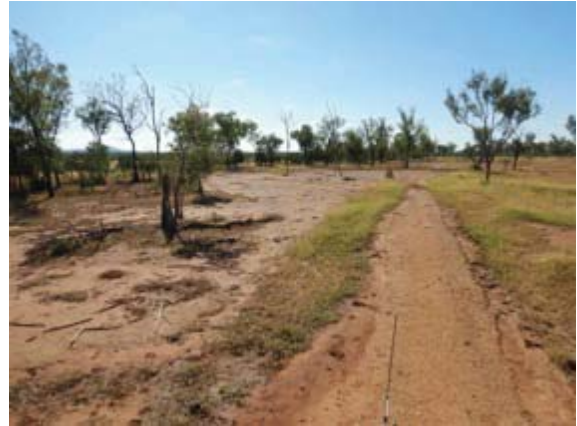
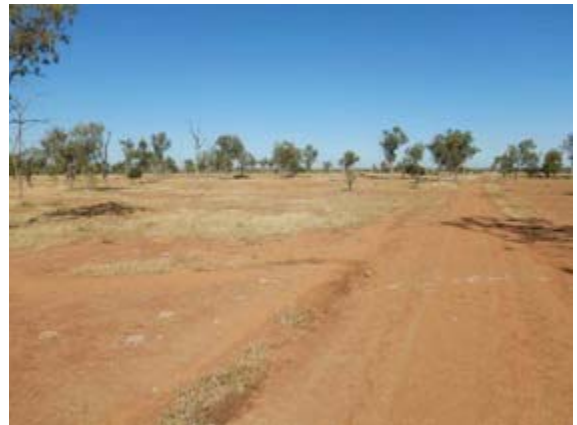
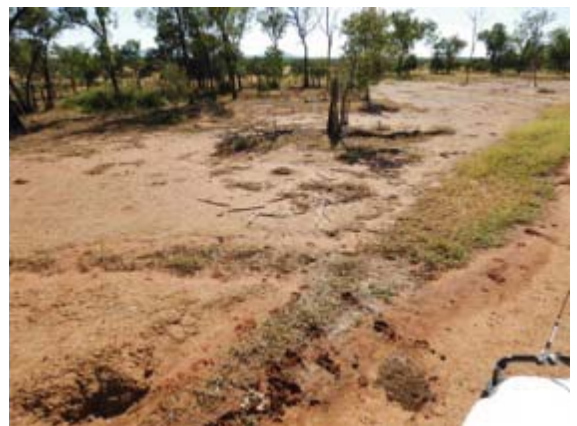
Figure 6.140 Site 110 showing large depression, looking a) south, b) west, c) north, and d) east, with road

There were no aquatic plants at the time of the assessment, and the large depression does not have defined bed or banks (Figure 6.140). During periods of high rainfall, it is possible that this site provides ponded water and aquatic habitat. However, it is unlikely to provide fish passage opportunities as there does not appear to be any connectivity to waterways upstream or downstream of the site.
