Nathan Dam on the Dawson River

Aquatic Flora and Fauna Dry Season Field Survey (November 2007)

SunWater

frc environmental

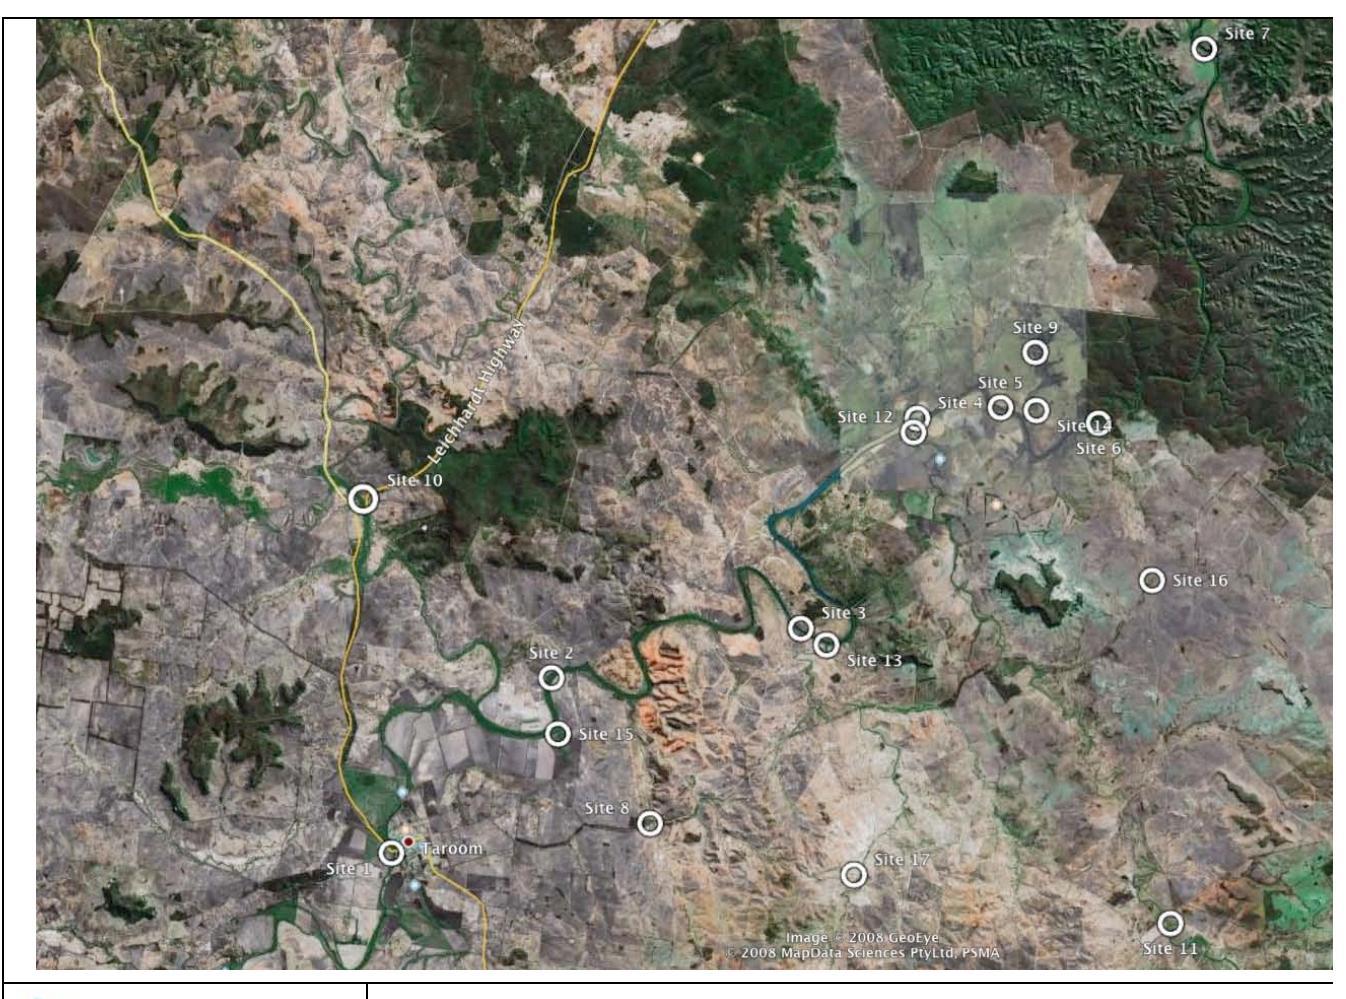
886	Nathan Dam, Aquatic Flora an	d Fauna Dry Season Field
frc environmental deep thinking. science.	Figure 2.1	Survey sites.
\cup	Source: Google Earth

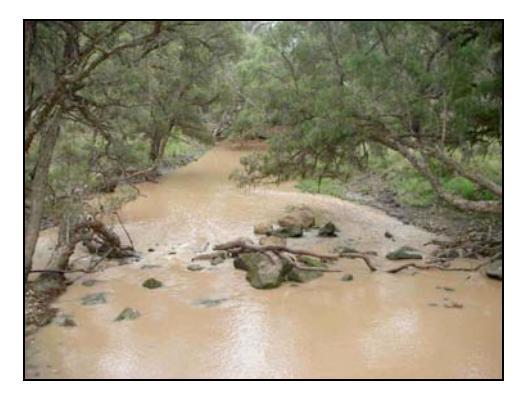
Dawson River within the inundation area, at the Bundulla Rd crossing. This site contained a variety of habitats at the time of survey, including: pool, run, glide, riffle and rapid habitats. Discharge was estimated at 0.06 m³/s in the glide habitat. The river was braided; however only the main channel was surveyed. The banks were generally steep, but well vegetated with little sign of erosion. Common species in the riparian zone included eucalypts, casuarinas, callistemons. melaleucas and Submerged tree roots, boulders and fallen logs and branches provided instream habitat. There were a variety of substrate types including boulders and cobbles, as well as finer sediments such as silt and sand.

View downstream through the channel before the flood (27-11-2007).

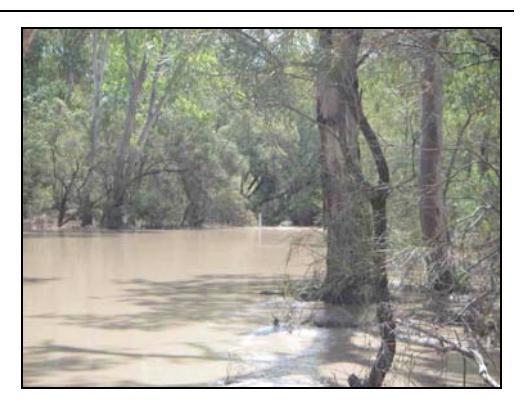
View downstream from the right bank during the flood (3-12-2007).

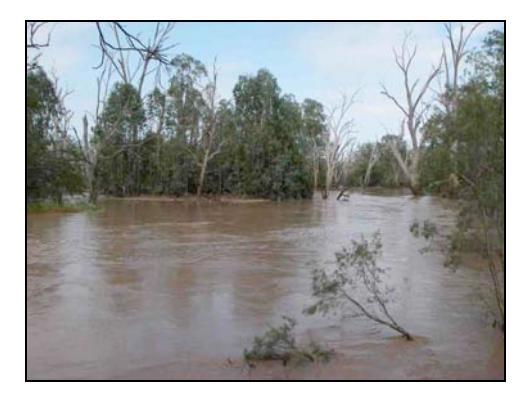
View upstream through the channel during the flood (30-11-2007).

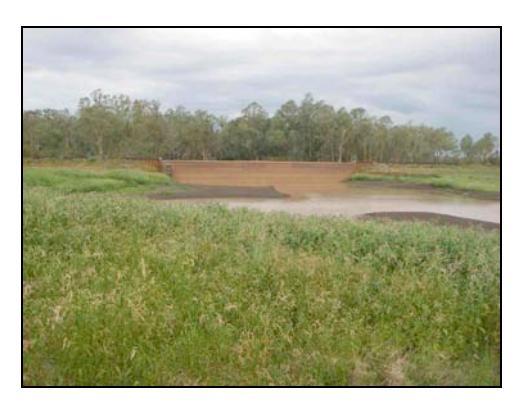
Site 4

Dawson River within the inundation area, immediately upstream of Glebe Weir. This site was within the Glebe Weir inundation area, and there was no flow at the time of survey (i.e. there was only pool habitat). The banks were relatively stable and riparian vegetation was dominated by eucalypts and casuarinas. Bars of accumulated sediment along the edges of, and within, the inundation area supported dense beds of smart weed. Little instream physical habitat was observed, although the water was opaque so it was difficult to see. Fine sediments such as silt and clay dominated the substrate.

View downstream from the left bank before the flood (29-11-2007).

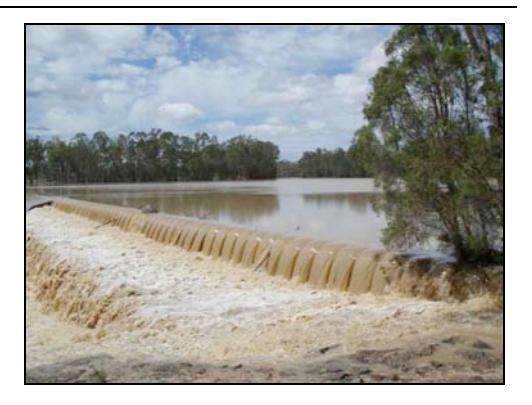
View upstream from the Glebe Weir (left bank) during the flood (2-12-2007).

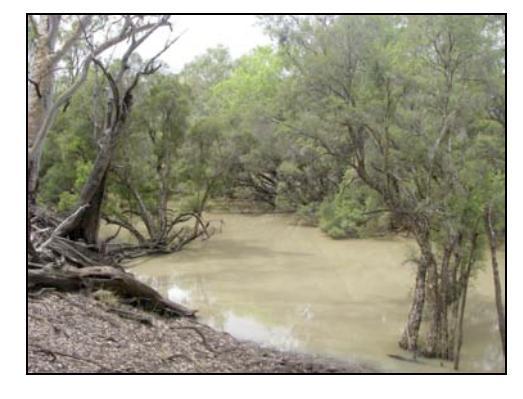
Dawson River within the inundation area, downstream of Glebe Weir, on the Becker property. Not surveyed due to flooding and access issues in the wet. This site was visited during a reconnaissance of the study area. At this time it was a pool on an anabranch of the Dawson River.

View downstream from the left bank before the flood (7-11-2007).

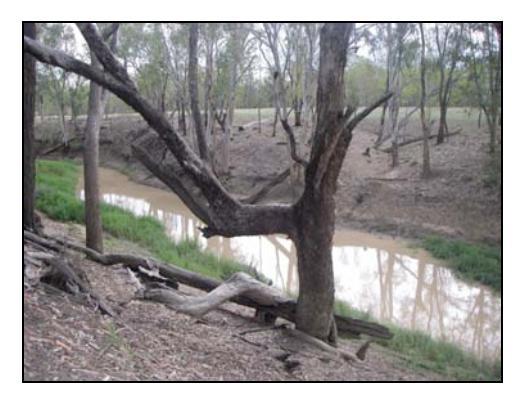
Bentley Creek within the inundation area, on ' The Bentley' property. Not surveyed due to flooding. This section of the creek is within the Glebe Weir inundation area and was visited during a reconnaissance of the study area. Smart weed was abundant on exposed silty bars and banks.

Bentley Creek looking upstream from the right bank, before the flood (6-11-2007).

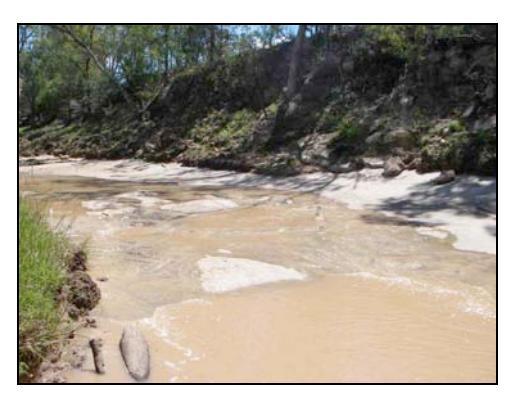
Bentley Creek upstream of the inundation area, at the Cockatoo Rd crossing. This site was surveyed for water quality during the flood only. Sediments were generally silty, with some bedrock. The left bank was steep and eroded. Water was flowing rapidly and covered the ford crossing of the creek. Bony bream were noted swimming upstream.

View upstream from the right bank (2-12-2007).

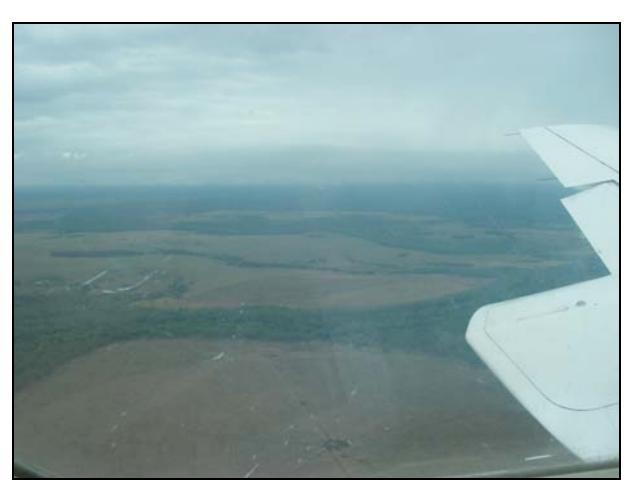
Cropping in the study area.

Photo taken during reconnaissance fly-over, 06-11-2007.

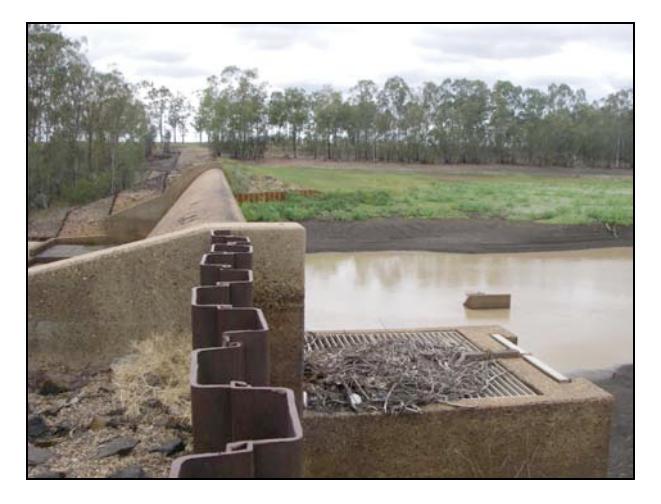
The Glebe Weir is relatively high with no fishway installed.

Photo taken from the left bank during the reconnaissance on the 07-11-2007.

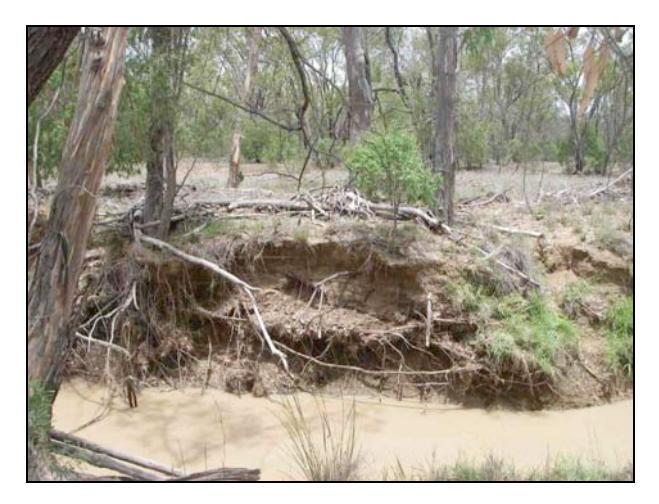
Exposed tree roots and undercut banks at site 8 (Blackboy Creek).

Photo taken 30-11-2007

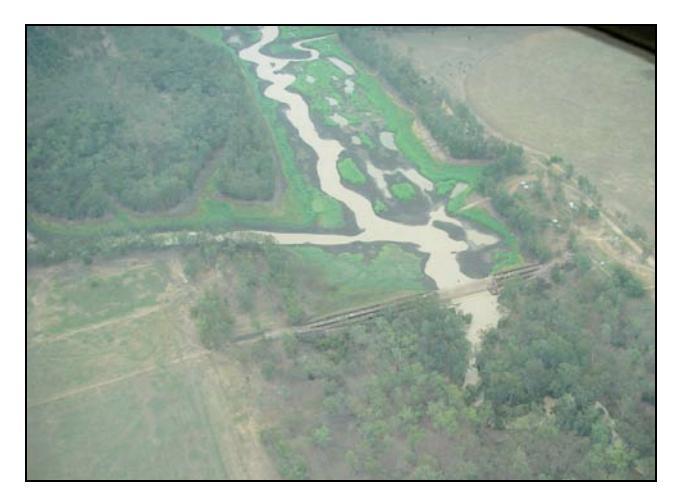
Glebe Weir, showing the channel bar plain at site 4 upstream of the weir (Cockatoo Creek to the left).

Photo taken during reconnaissance fly-over, 06-11-2007.

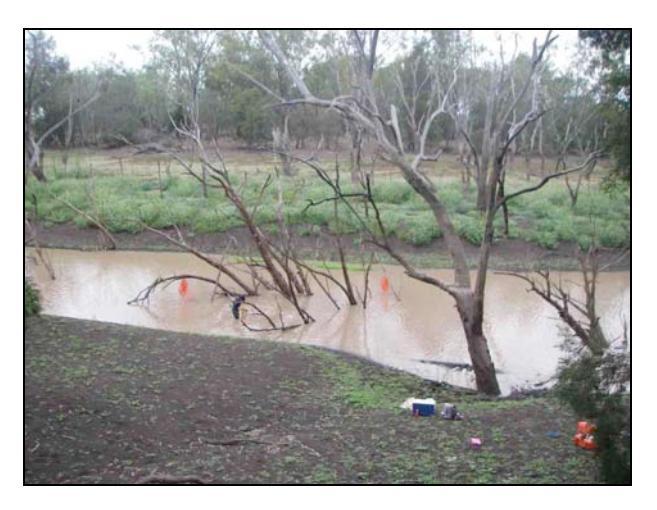
Dead trees and fallen branches at site 12 (Cockatoo Creek) provided some physical in-stream habitat.

Photo taken 29-11-2007

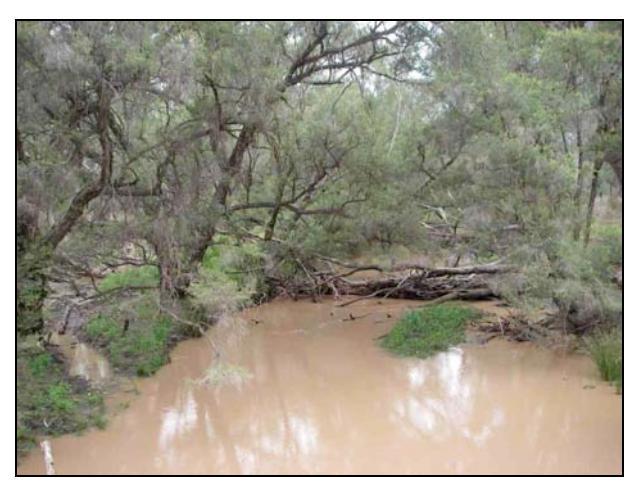
Physical habitat at site 2 included log-jams, macrophytes and overhanging vegetation.

Photo taken 27-11-2007

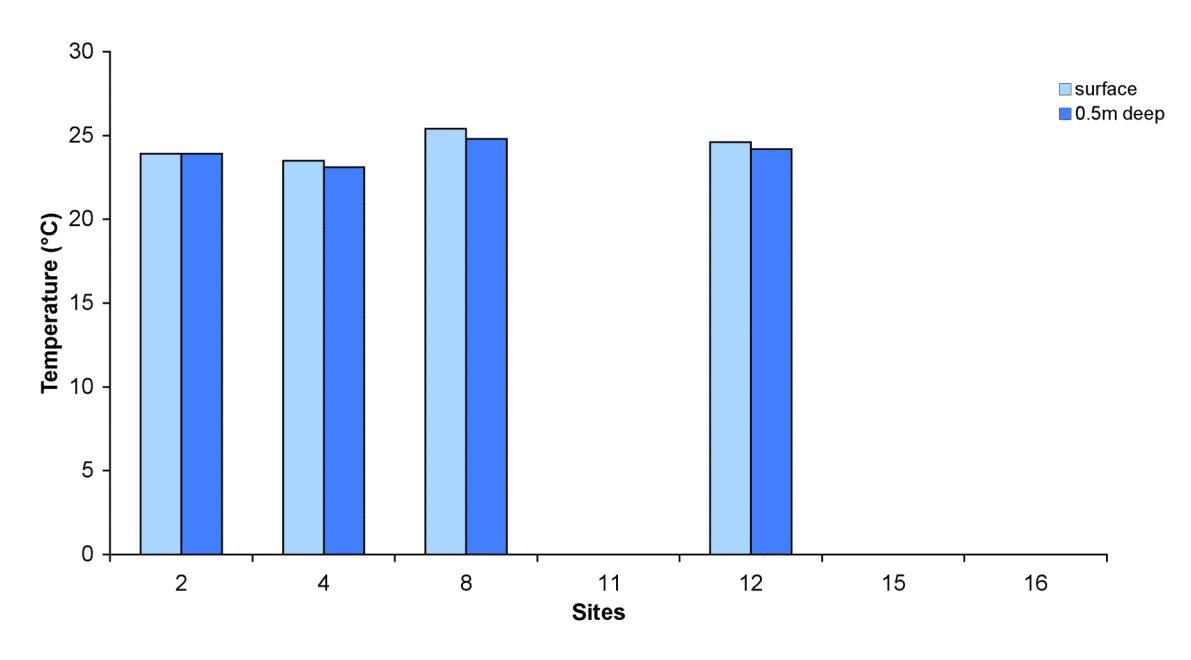
Water temperature was similar across each of the sites surveyed that held water (around 25 °C), and did not vary greatly between surface waters and water 0.5 m deep (Figure 4.7).

Figure 4.7 Water temperature (°C) at each site before flooding, recorded at 0.5 m depth increments.

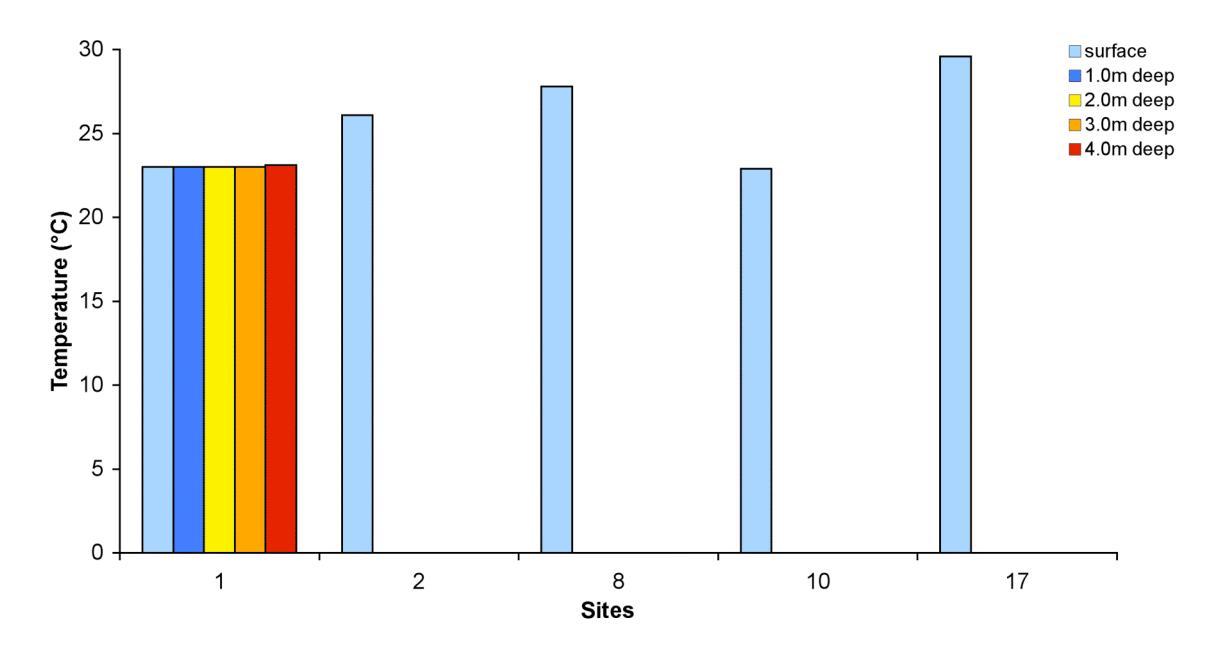
The water temperature of flooded sites was similar to pre-flood temperatures, but was higher at sites 2, 10 and 17 compared with sites 1 and 10 (Figure 4.8). This is likely to be because measurements at these sites were taken in the afternoon, and measurements at site 1 and 10 were taken in the morning. Water temperature did not vary with depth in the floodwaters at site 1 (Figure 4.8).

Figure 4.8 Water temperature (°C) at each site during flooding, recorded at 0.5 m depth increments.

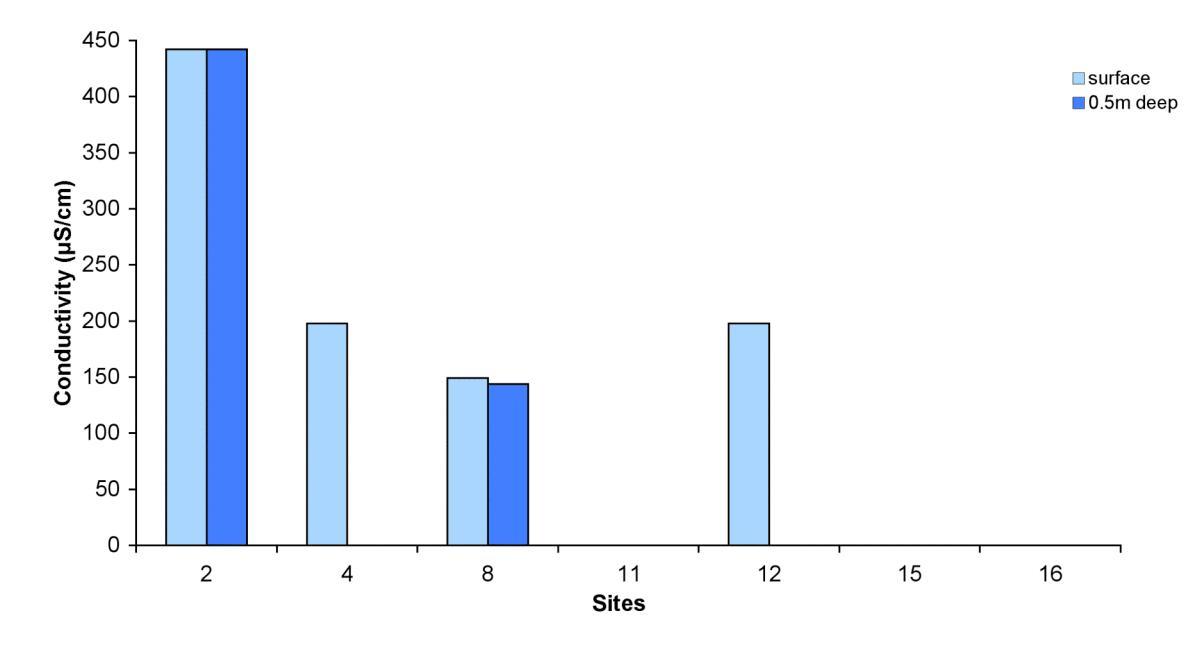
Conductivity during flood conditions was lower at each of the sites surveyed compared with pre-flood conditions (Figure 4.9 & Figure 4.10). Conductivity was generally similar across the sites surveyed, although conductivity at site 10 (Palm Tree Creek) was much lower than at any other site (Figure 4.10). There were no substantial variations in conductivity with depth.

Figure 4.9 Conductivity (μ S/cm) at each site before flooding, recorded at 0.5 m depth increments.

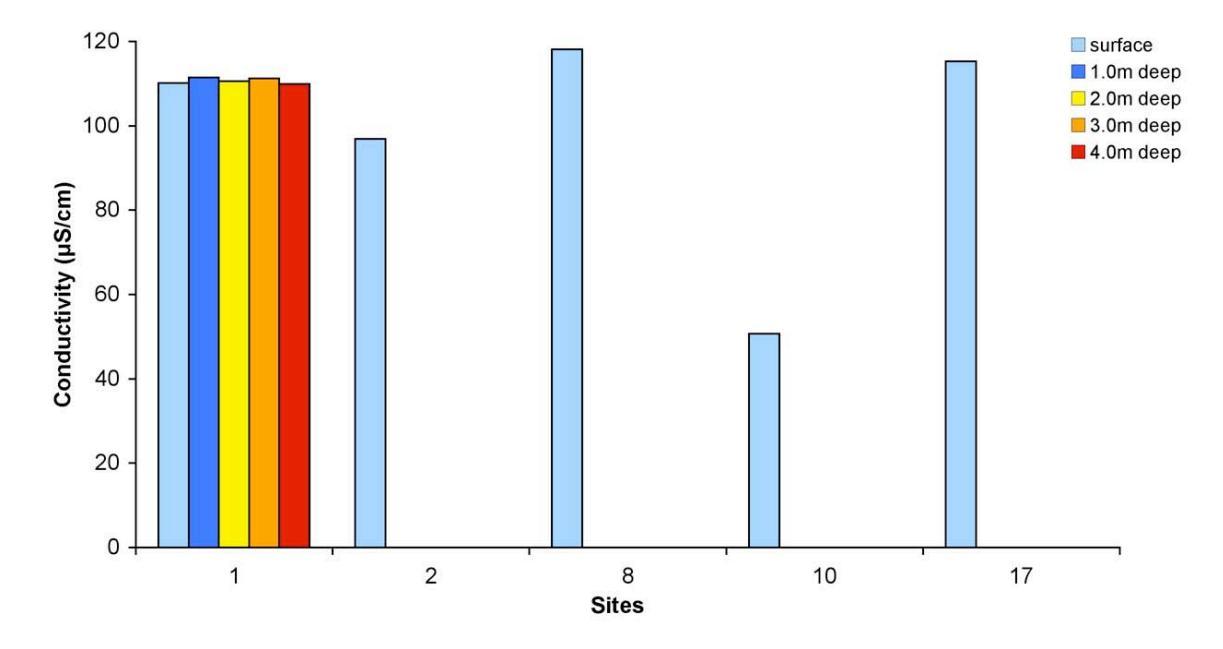
Figure 4.10 Conductivity (μ S/cm) at each site during flooding, recorded at 0.5 m depth increments.

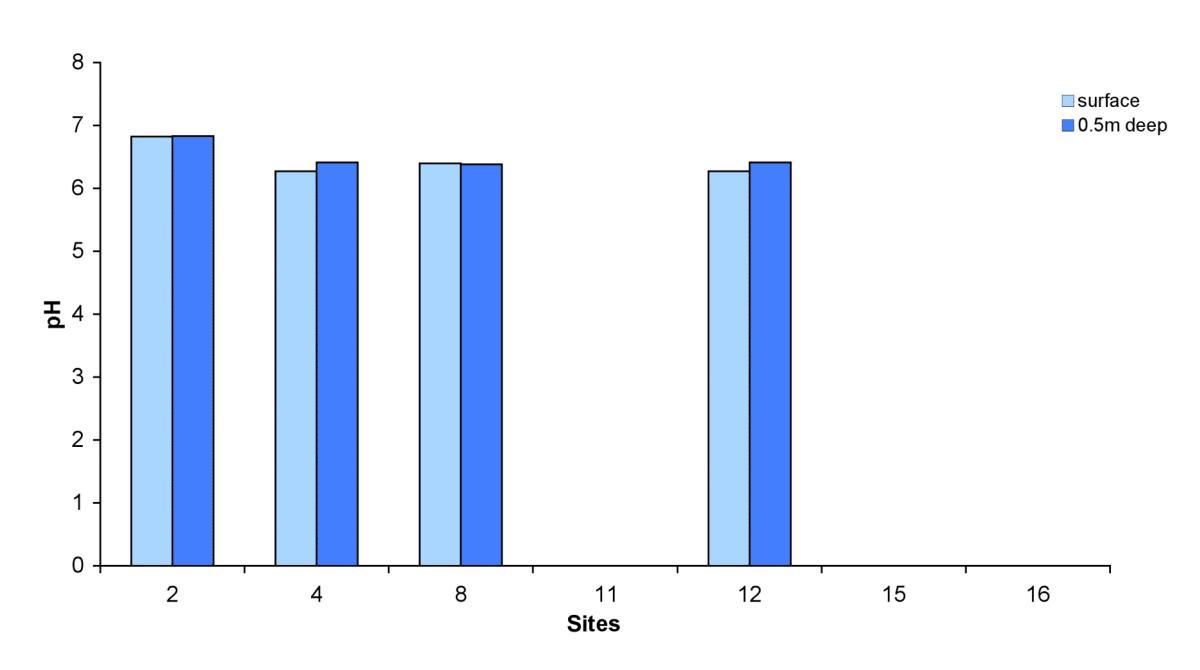
pH ranged between 6.2 and 6.9 at each of the sites surveyed (Figure 4.11). pH did not vary substantially between surface waters and water 0.5 m deep.

Figure 4.11 pH at each site before flooding, recorded at 0.5 m depth increments.

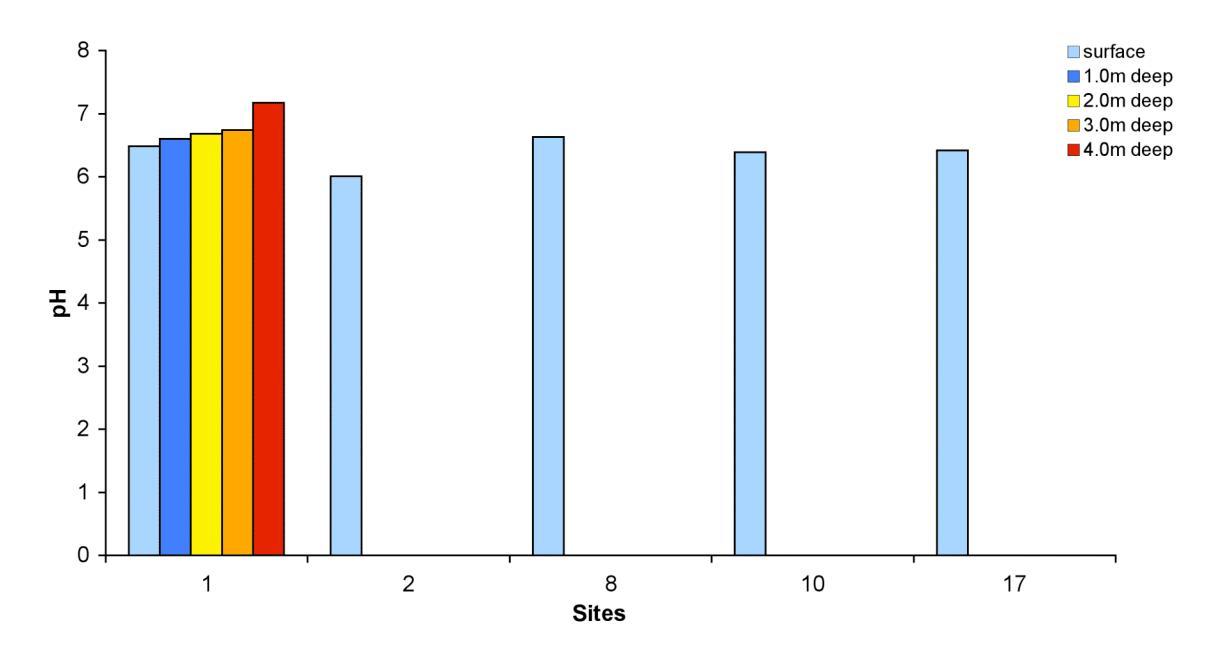
pH ranged between 6.0 and 7.2 at each of the sites surveyed during flooding (Figure 4.12). pH slightly increased with depth at site 1 (Dawson River at Taroom) (Figure 4.12).

Figure 4.12 pH at each site during flooding, recorded at 0.5 m depth increments.

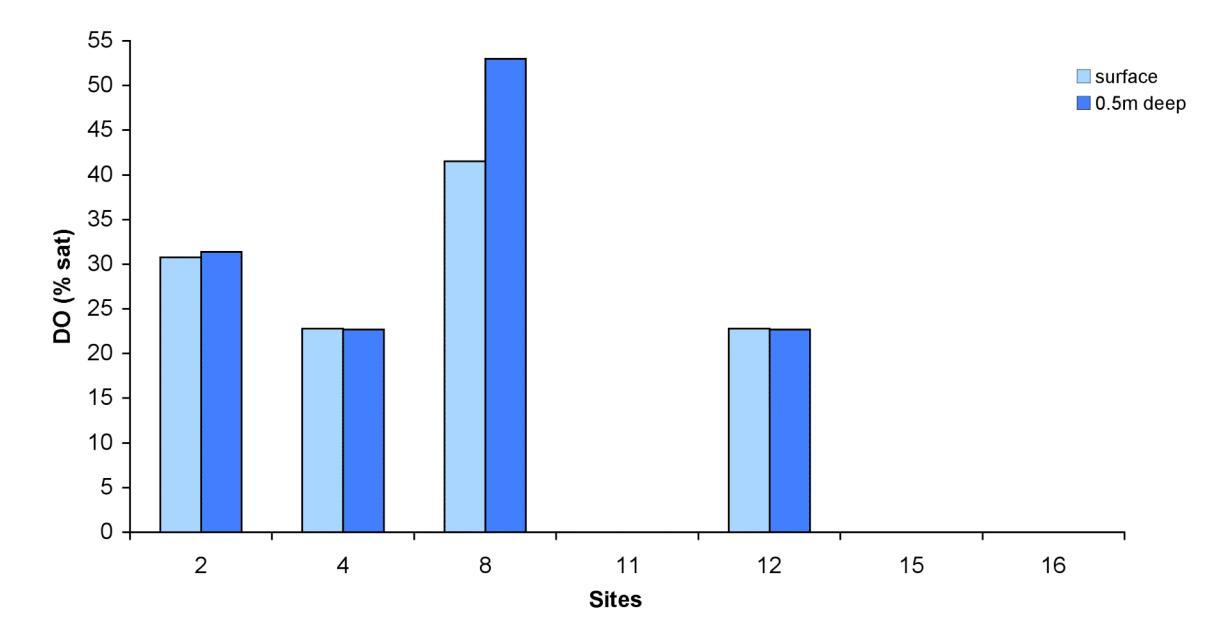
Figure 4.13 Dissolved oxygen (% saturation) at each site before flooding, recorded at 0.5 m depth increments.

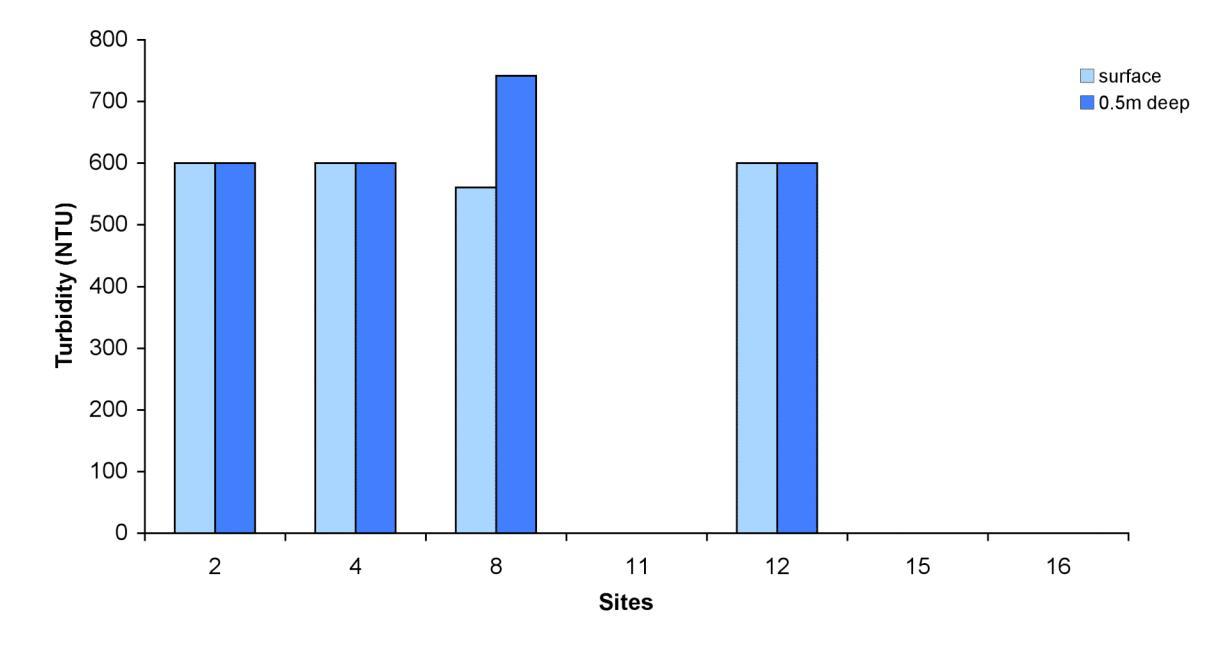
Turbidity was higher at each of the sites surveyed during flooding compared with pre-flood measurements (Figure 4.14 & Figure 4.15). Turbidity was >1 000 NTU at each of the sites surveyed during the flood, and was highest at site 10 (Palm Tree Creek). Turbidity slightly increased with depth at site 1 (Dawson River at Taroom) (Figure 4.15).

Figure 4.14 Turbidity (NTU) at each site before flooding, recorded at 0.5 m depth increments.

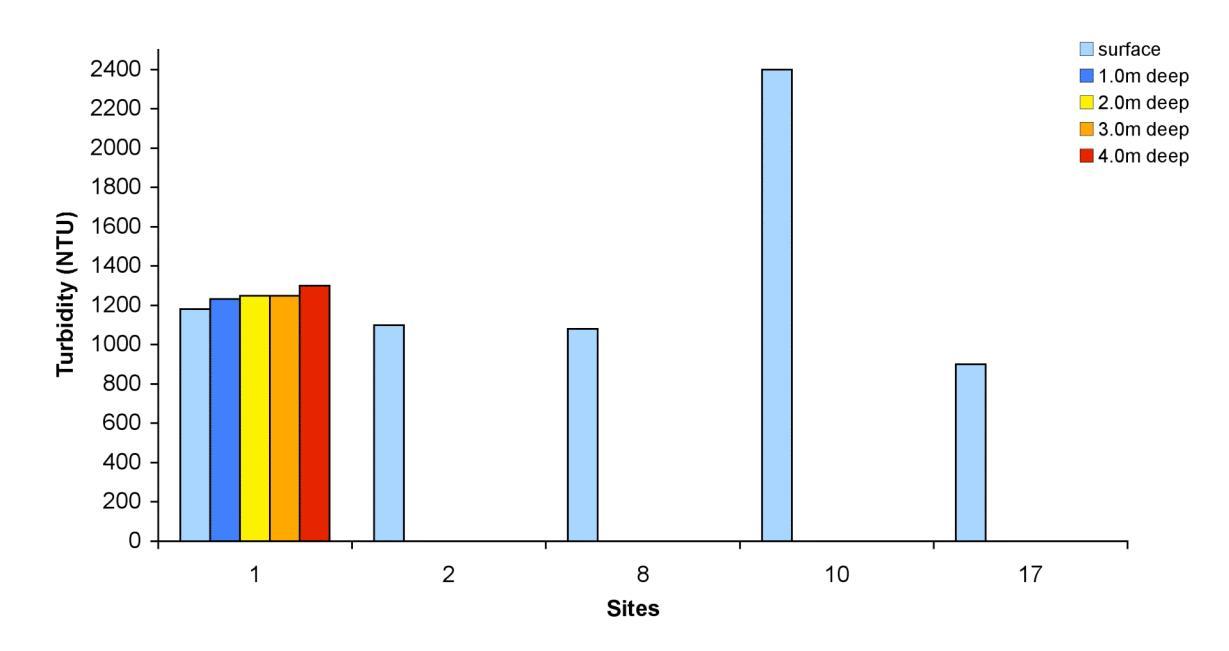
Figure 4.15 Turbidity (NTU) at each site during flooding, recorded at 0.5 m depth increments.

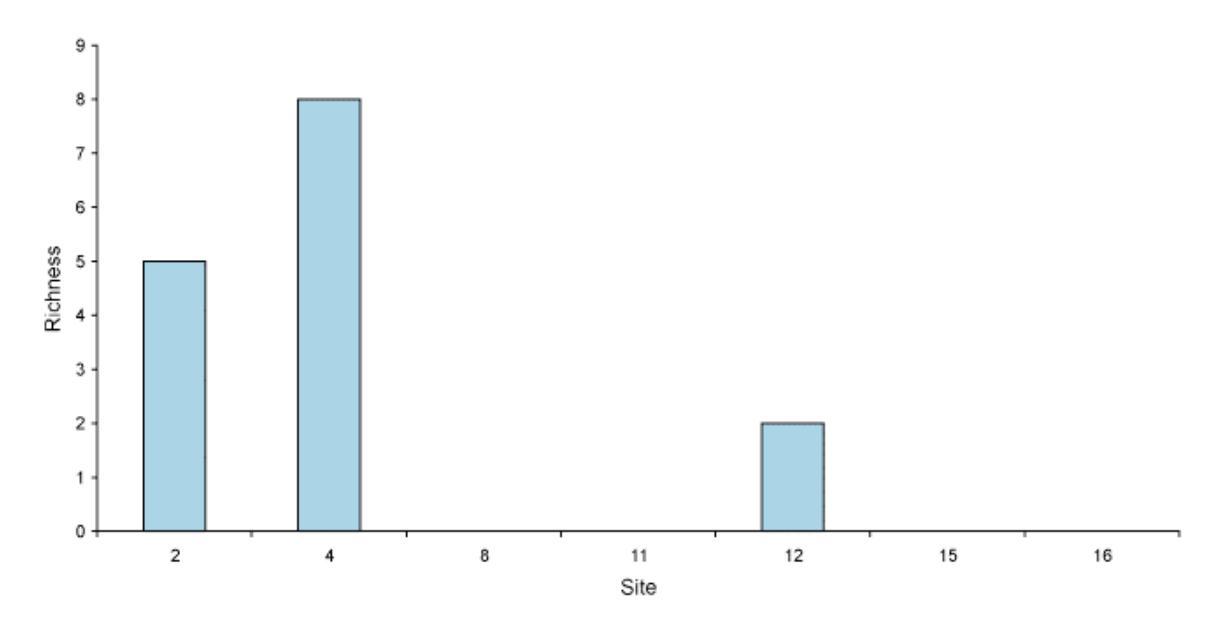
Aquatic macrophyte richness (the number of species present) ranged from no species at site 8 on Blackboy Creek and at the dry sites (sites 11, 15 & 16), to 8 species at site 4 (Figure 4.16).

Figure 4.16 Number of aquatic macrophyte species (richness) at each site.

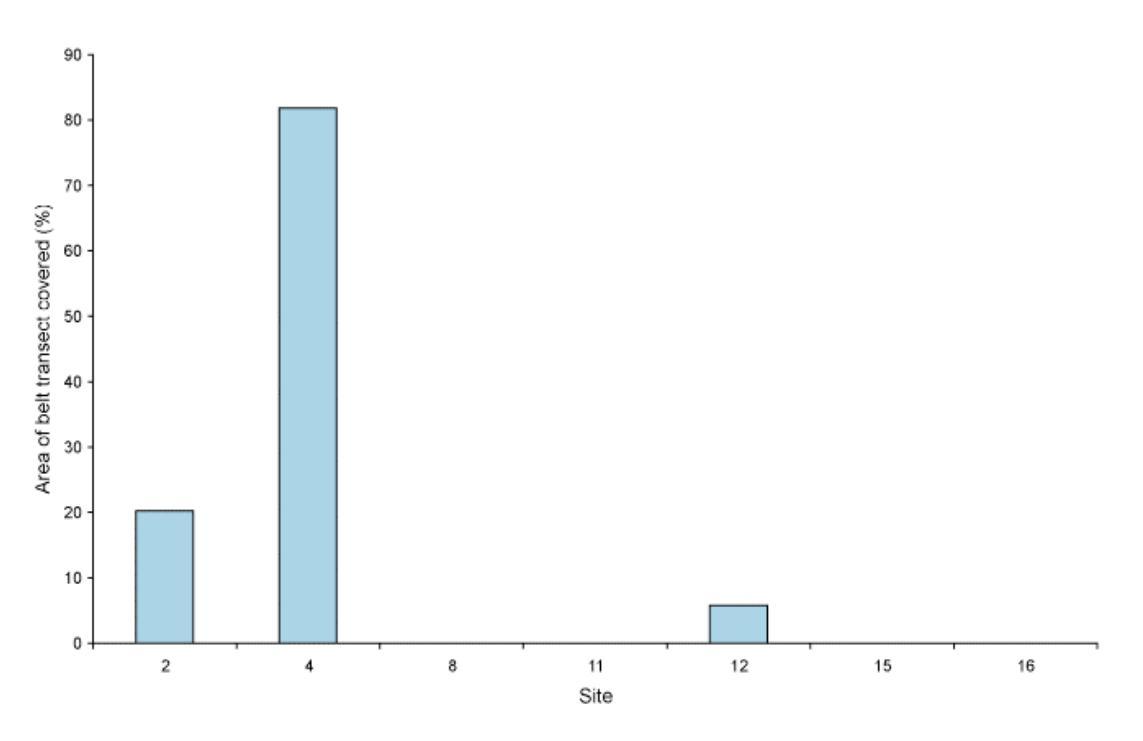
Aquatic macrophyte cover in the belt transects ranged from 5.3% at site 12 (Cockatoo Creek within the Glebe Weir inundation area) to 81.8% at site 4 (Dawson River at Glebe Weir) (Figure 4.17; Figure 4.18). Belt transects included a large proportion of the lower bank at each site, as no submerged or floating macrophytes were found in the study area. The only species with > 10% cover at any one site was *Persicaria orientalis* (Prince's feather) at site 4 (Figure 4.18).

Figure 4.17 Percent cover of all aquatic macrophytes in the belt transect at each site.

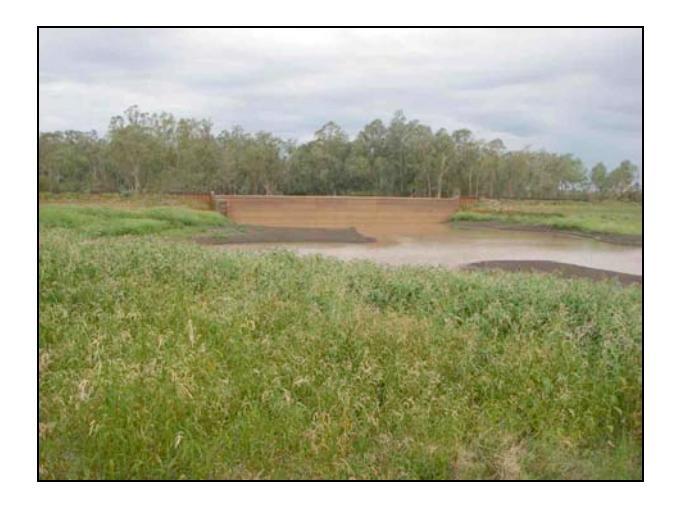
The belt transect at site 4, situated along the left bank, had the highest aquatic macrophyte cover.

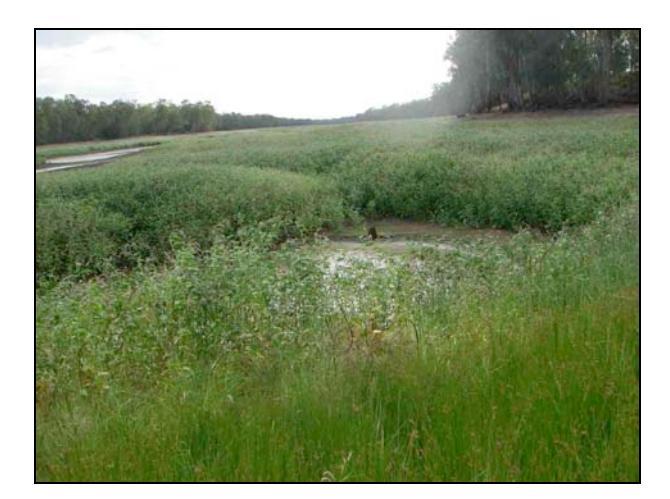
The sedges growing at site 4 were located in a small moist patch of the lower bank; water may be discharged here from the adjacent recreational and camping facilities.

Persicaria spp. and sedges (family Cyperaceae and Juncaceae) growing at site 4.
