Aquatic Ecology Responses

WINCHESTER SOUTH PROJECT

Response to Submissions

RE: Winchester South Project – Aquatic Ecology Responses

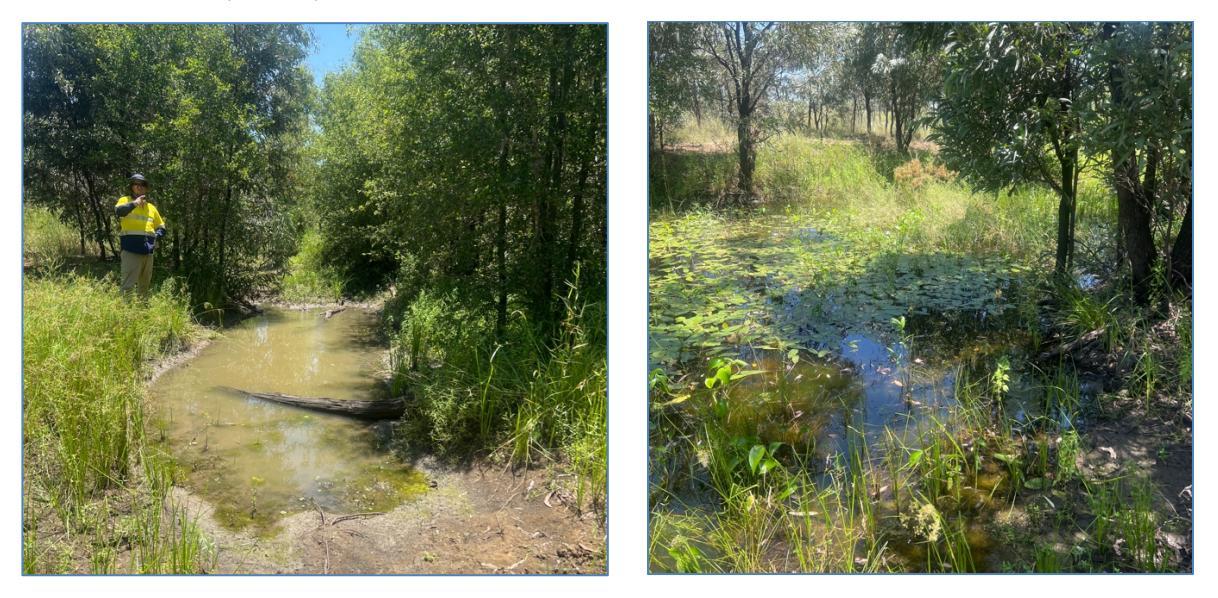
Plate 1 Stop 6 near the upstream extent of the northern waterway, showing waterway features

This section of the northern waterway contained several attributes of a waterway providing for fish passage (DAF 2022), including defined bed and banks, the presence of distinct bed sediments in the channel that differed from the surrounding landscape, riparian vegetation, and fish habitat (such as isolated pools, woody debris, and aquatic plants; Plate 1). Fish were observed in the pool at Stop 6 during the February 2023 site inspection, and were caught at sites further downstream during baseline and supplementary surveys undertaken by ESP (2021 and 2022a).

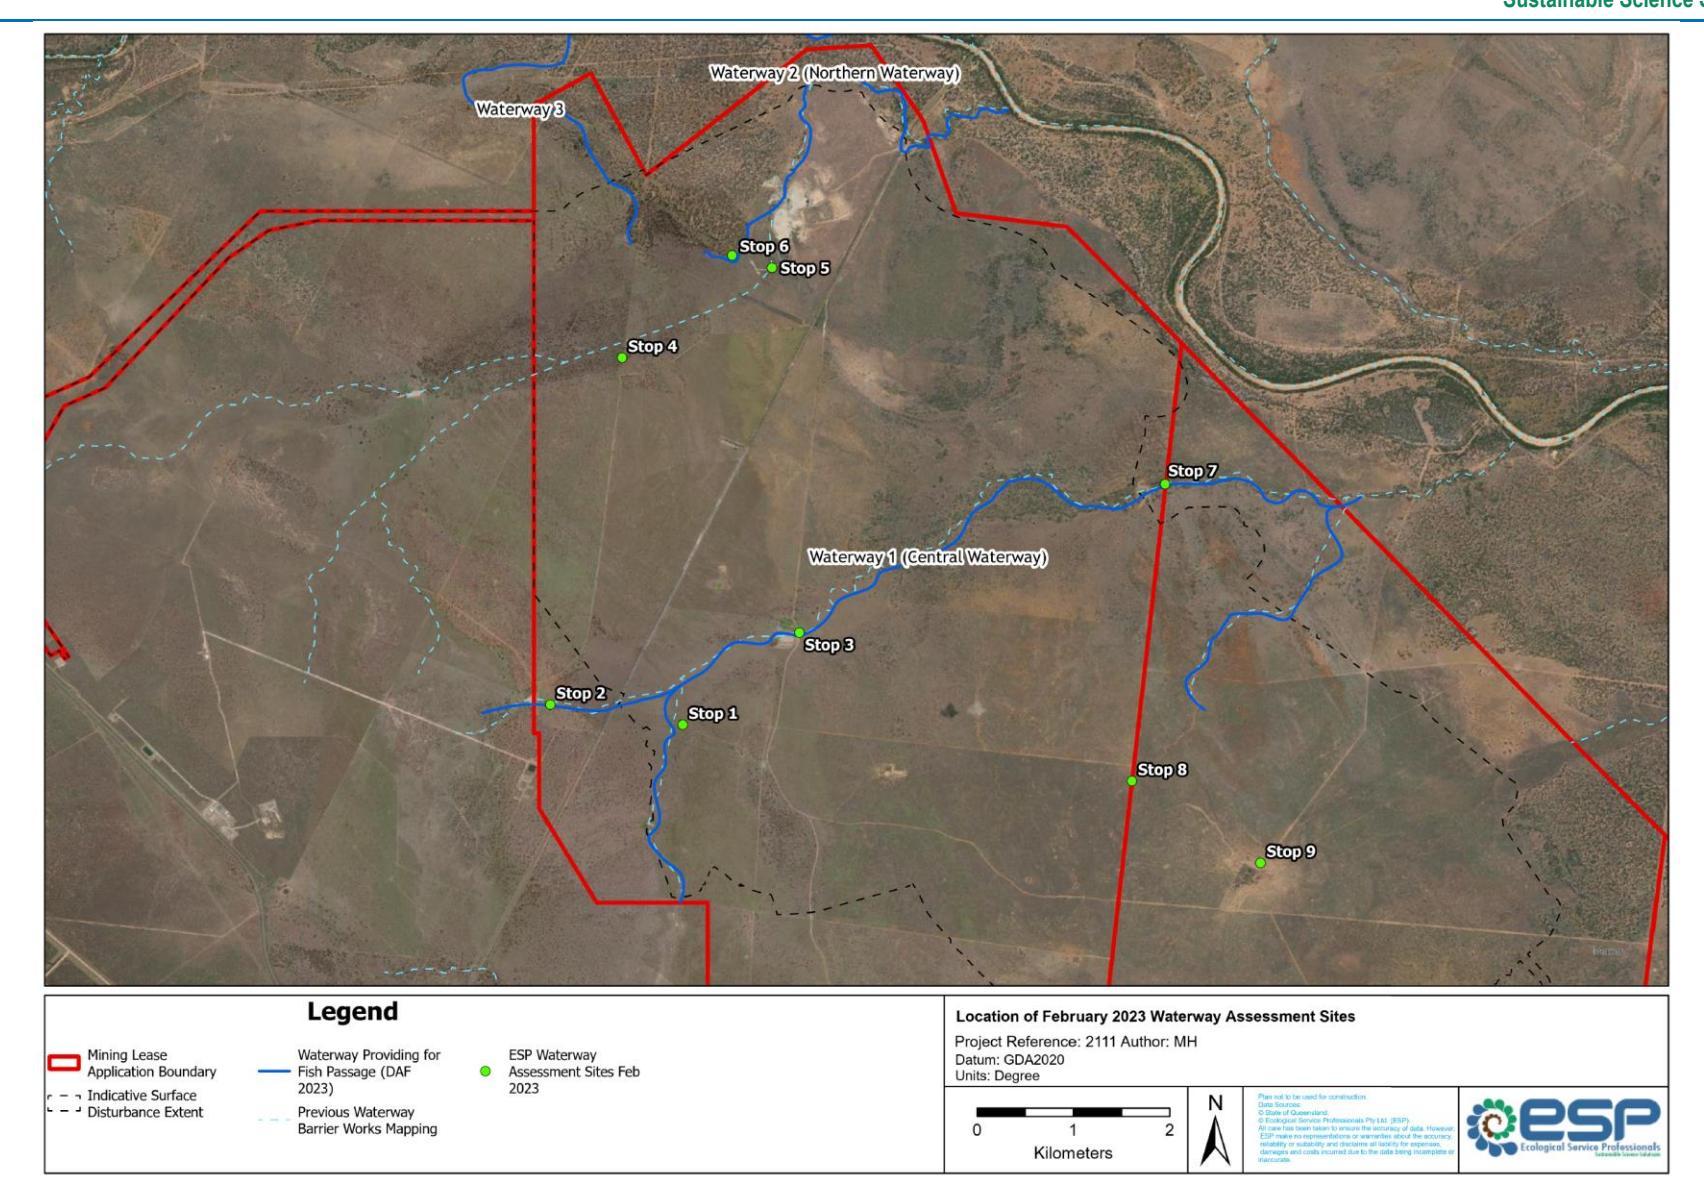
Figure 1 Extent of waterways on the site as determined by DAF (2023), showing location of the stops visited during the 14 February 2023 site inspection

The northern waterway (referred to as Waterway 2 in DAF 2023) extends from approximately 1 km upstream of the quarry (i.e. just beyond Stop 6¹) downstream to the Isaac River (Figure 1). Based on the outcomes of the February 2023 site inspection, ESP's assessment is consistent with the waterway determination for the northern waterway, as mapped by DAF (2023).

During the site inspection on 14 February 2023, five stops were made along the central waterway and its tributaries during the site visit: DAF Stops 1, 2, 3, 7 and 8 (Figure 1³), all of which were reported by DAF to display the features of waterways providing for fish passage (DAF 2023). Results of ESP's assessment during the site inspection are provided below.

These sites were located towards the upstream extents of the three mapped first order features that flow into the central waterway (Figure 1).

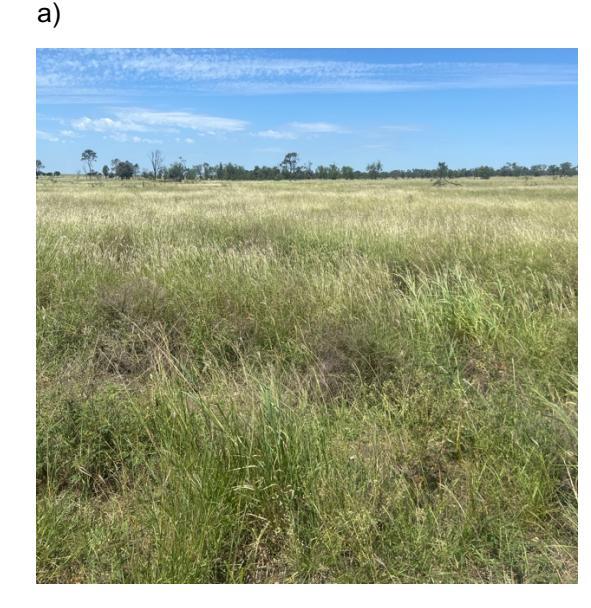
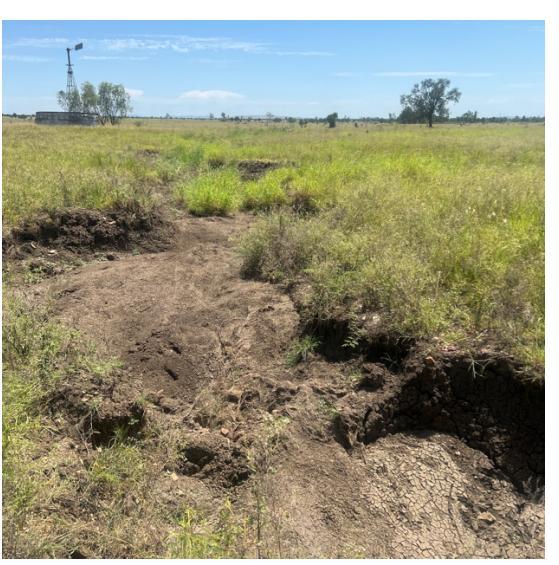
DAF (2023) concluded that bed and banks were clearly visible as flow paths at Stops 1 and 2. Regarding Stop 8, DAF concluded that although the feature is not a waterway providing for fish passage where the farm road and fence cross the feature, it is apparent that overland flow and multiple smaller features join the feature. As such, it was considered likely (based

ESP's assessment found that these upstream reaches as mapped by DAF (2023) do not provide for fish passage due to a lack of sufficient flow to sustain basic (aquatic) ecological processes and habitats, and that the upstream reaches of the feature are characteristic of 'channels that funnel immediate localised rainfall' (DAF 2022) (Plate 2). A previous comprehensive waterway determination by ESP at sites along these tributaries in close proximity to Stop 1 (Figure 1) (i.e. Sites 139, 140 and 143 in ESP 2022a (Figure 2)); Stop 2 (Figure 1) (i.e. Sites 135, 137, 154 and 155 in ESP 2022a (Figure 2)); and Stop 8 (Figure 1) (i.e. Sites 56, 119 and 120 in ESP 2022a (Figure 2)) further supports this conclusion (see ESP 2022a).

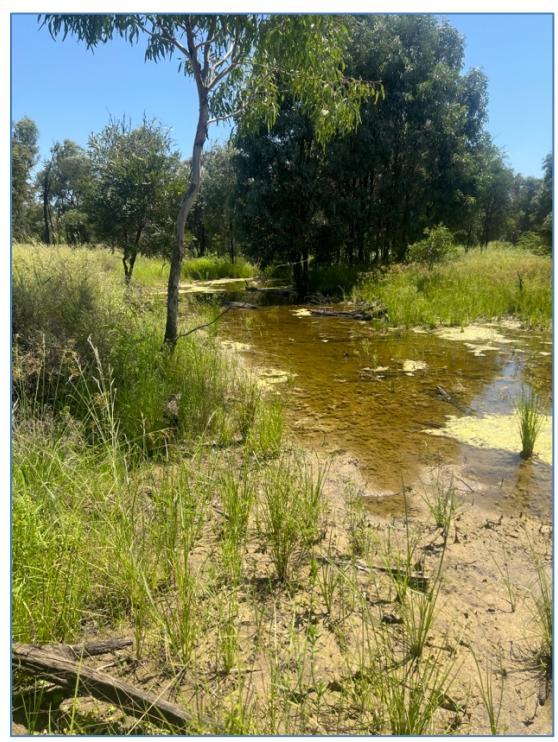
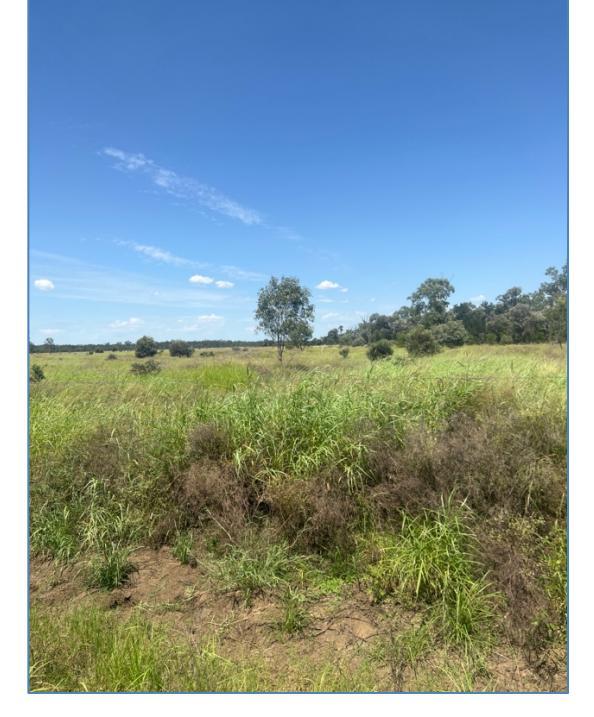
Plate 3 View of the waterway at Stop 7, with views:a) upstream of the track and fenceline; andb) downstream of the track and fenceline.

Stop 7 was located downstream of a farm dam (Figure 1). Standing water containing fish was present at this site, and DAF stated that there was a visible flow path through a paddock with defined bed and banks further downstream. Fish have also been recorded previously at the farm dam upstream of this site (ESP 2021). As previously acknowledged by DAF, the farm dams within the disturbance area are not waterways providing for fish passage⁴.

ESP accepts that waterway features were present upstream of the track and fence, such as riparian vegetation, defined bed and banks, ponded water and the presence of small-bodied fish. However, ESP did not observe a defined channel downstream, i.e. there was a lack of continuous defined bed and banks, and the connectivity with the pool is impaired (Plate 3). A previous comprehensive waterway determination by ESP at sites in close proximity to Stop 7 (Figure 1) (i.e. Sites 62 to 66 in ESP 2022a (Figure 2) and Plate 4) further supports this conclusion (see ESP 2022a).

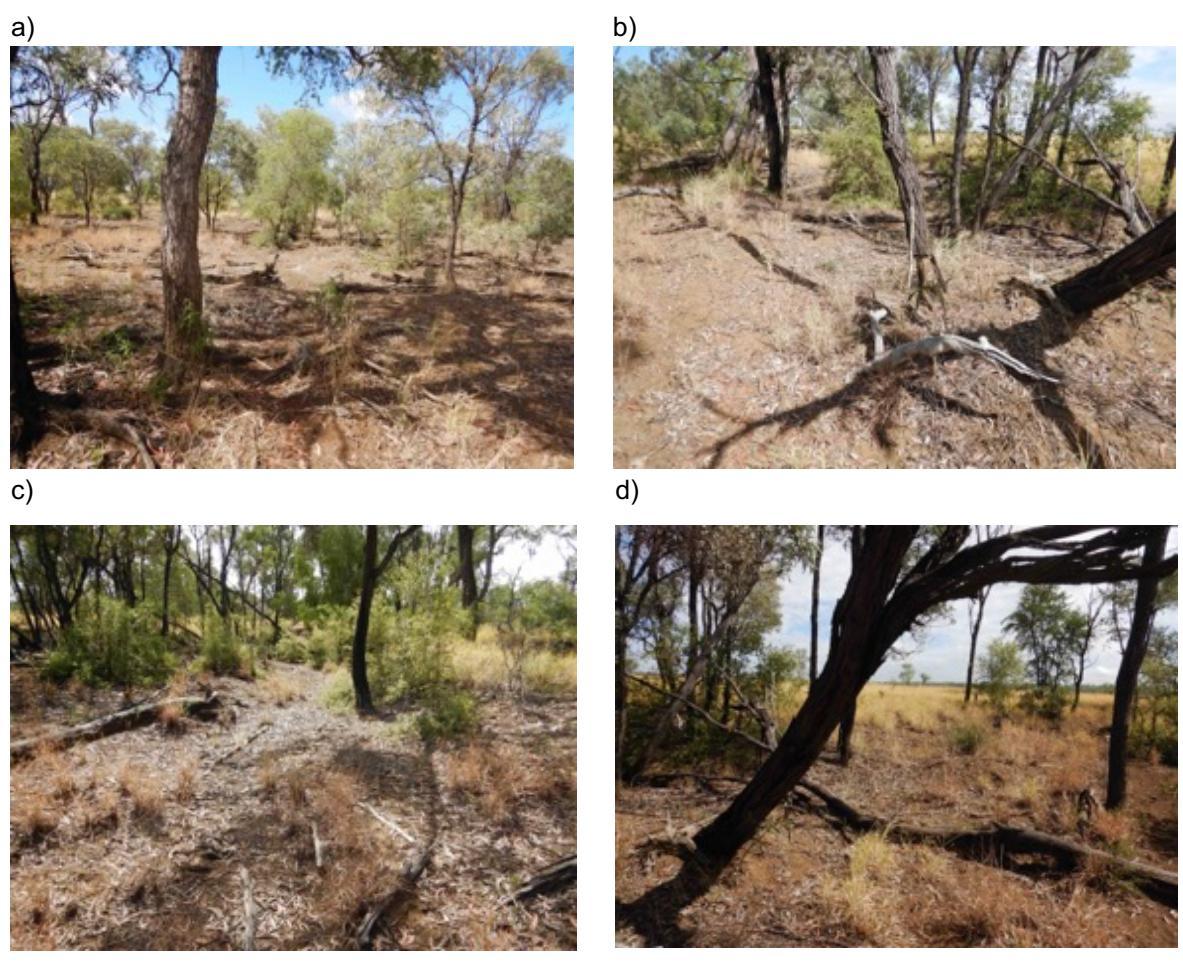
Plate 4

- Site 62 showing a lack of waterway features, with views: a) upstream; b) towards the north; c) downstream; and
 - d) towards the south

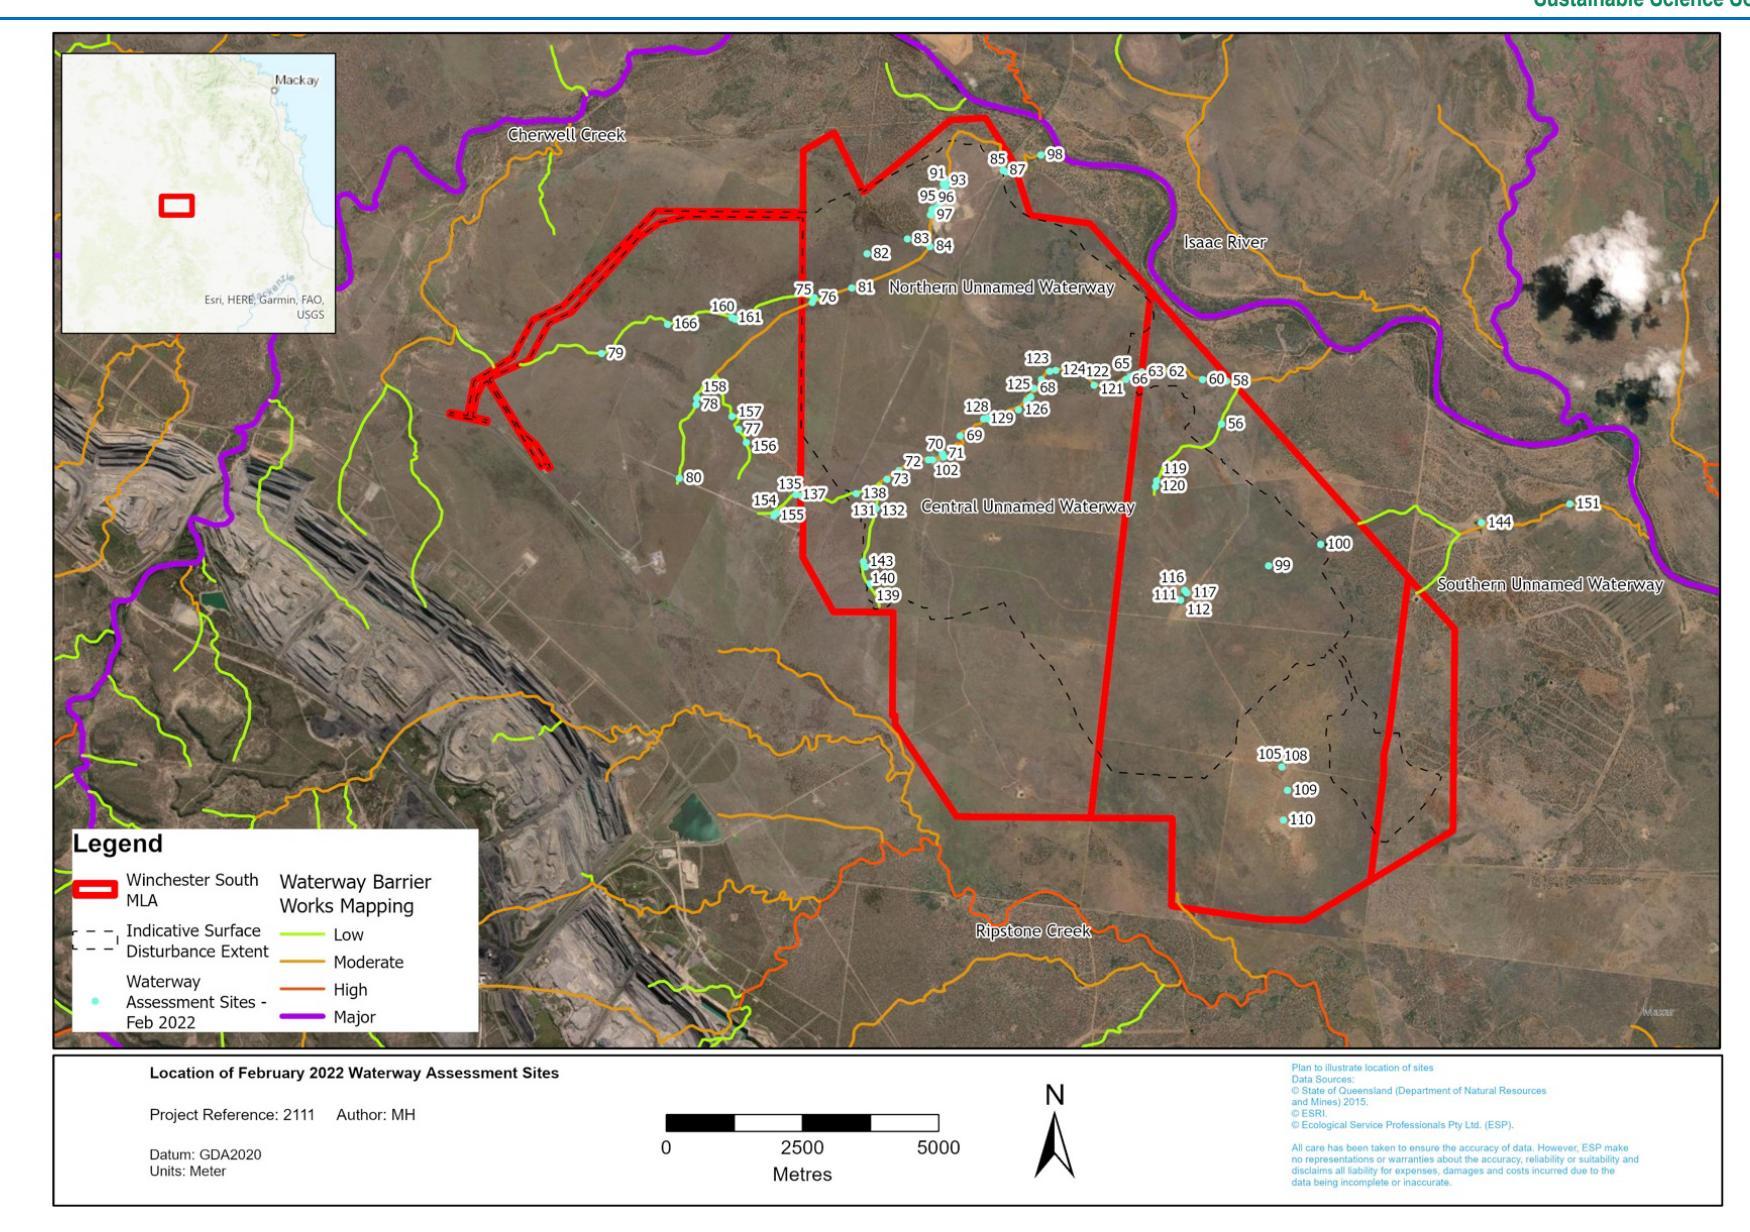
Figure 2 Waterway assessment sites surveyed by ESP in February 2022 (ESP 2022a)

ESP's conclusion is that this site consisted of an eroded drainage channel. Water-deposited gravel and green terrestrial vegetation are not necessarily indicative of an extended period of flow that continues beyond a rain event, or adequate flow to sustain basic ecological processes and habitats. Furthermore, no fish habitat was identified at this site. A previous comprehensive waterway determination by ESP at sites in close proximity to Stop 3 (Figure 1) (i.e. Sites 70 and 71 in ESP 2022a (Figure 2)) further supports this conclusion (see ESP 2022a).

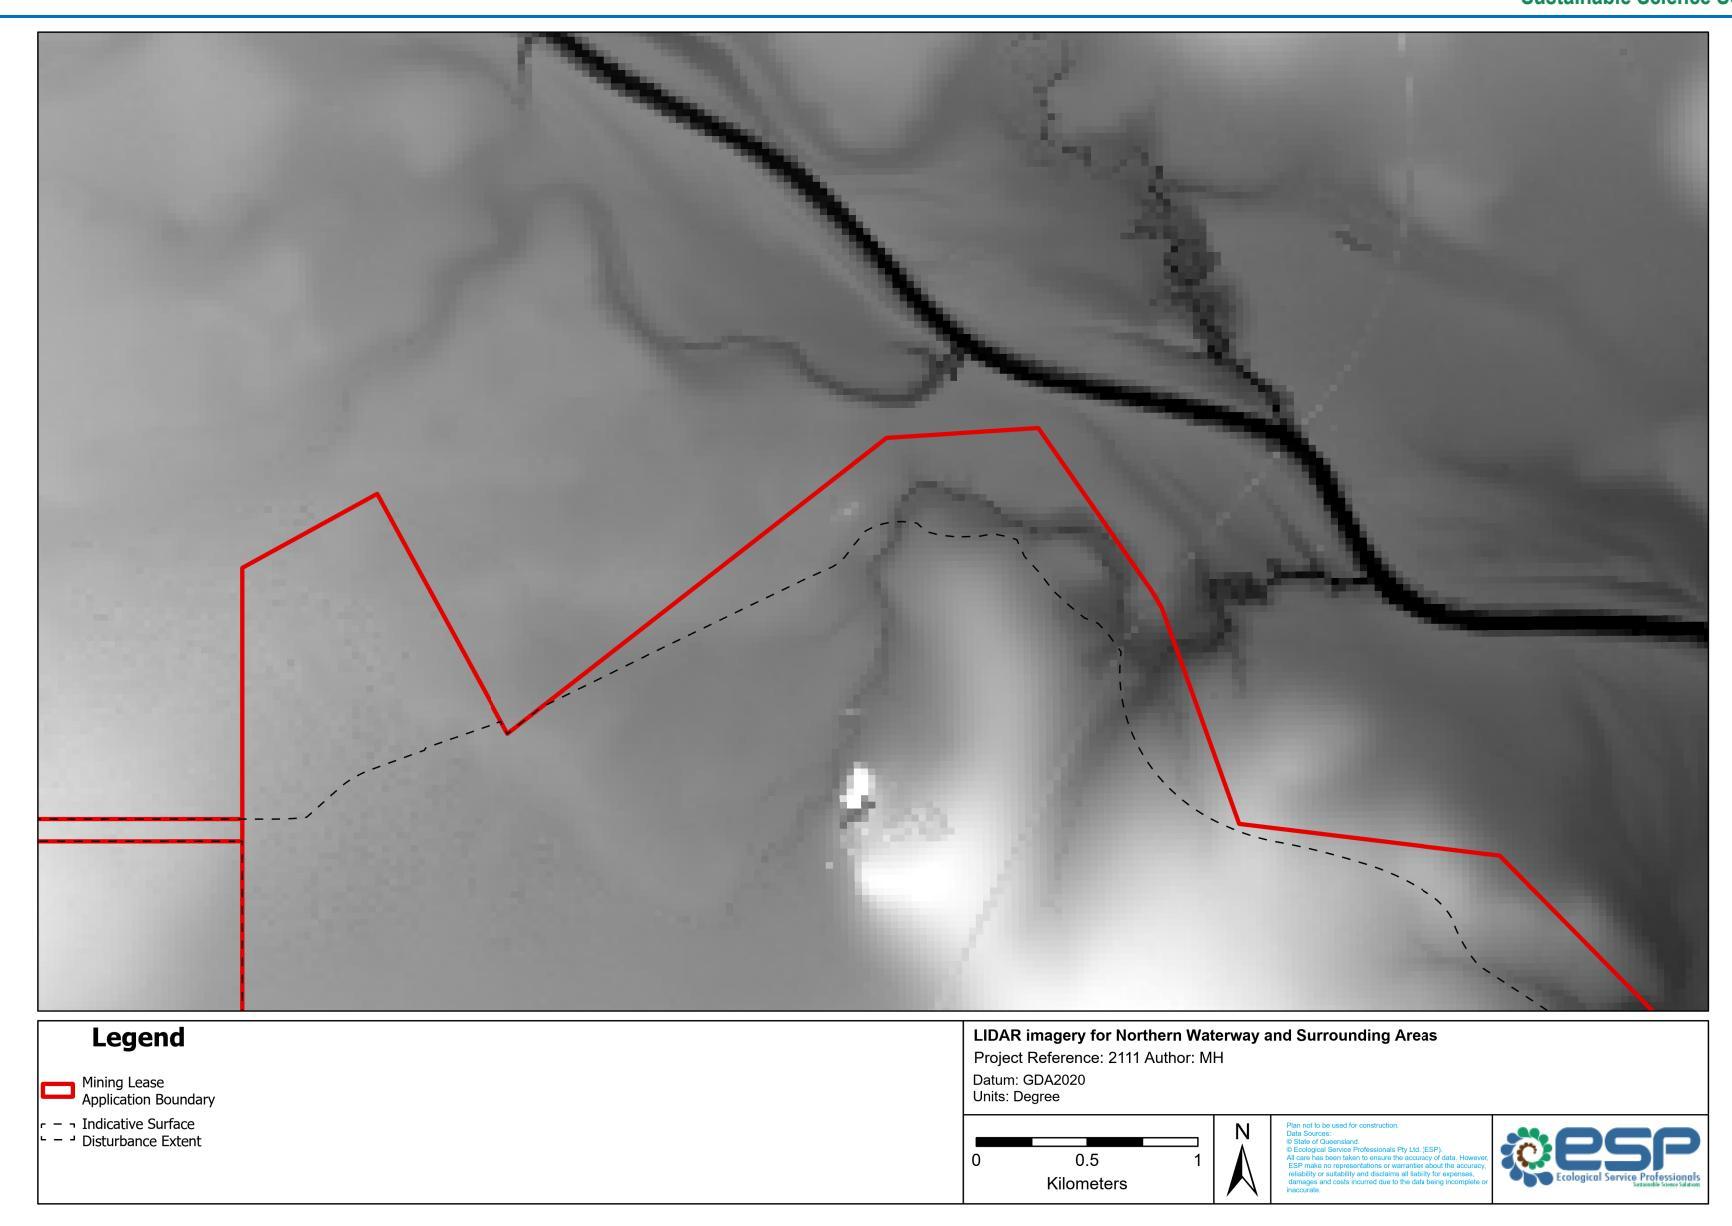
Figure 3 LiDAR imagery for the areas surrounding DAF's Waterway 2 and Waterway 3

This unnamed waterway, as mapped by DAF (2023), appears to flow through gilgai country, and to ESP's knowledge has not been subject to any onsite waterway determination. Based on desktop review of available aerial and LiDAR imagery (Figure 3), ESP does not consider this unmapped feature to be a waterway providing for fish passage within the disturbance area as it does not have any identifiable channel. Rather, the upstream extent of the waterway channel appears to be north of the mining lease application boundary (Figure 3). Within the disturbance area, the feature (as mapped by DAF) appears to consist of numerous gilgais that are fed through localised overland flow. During the terrestrial ecology assessment for the Draft EIS (E2M 2021), this region was characterised by pastureland with gilgai, bordered by Eucalypt woodland and Brigalow with Eucalypt (including areas of mature and immature regrowth; E2M 2021).

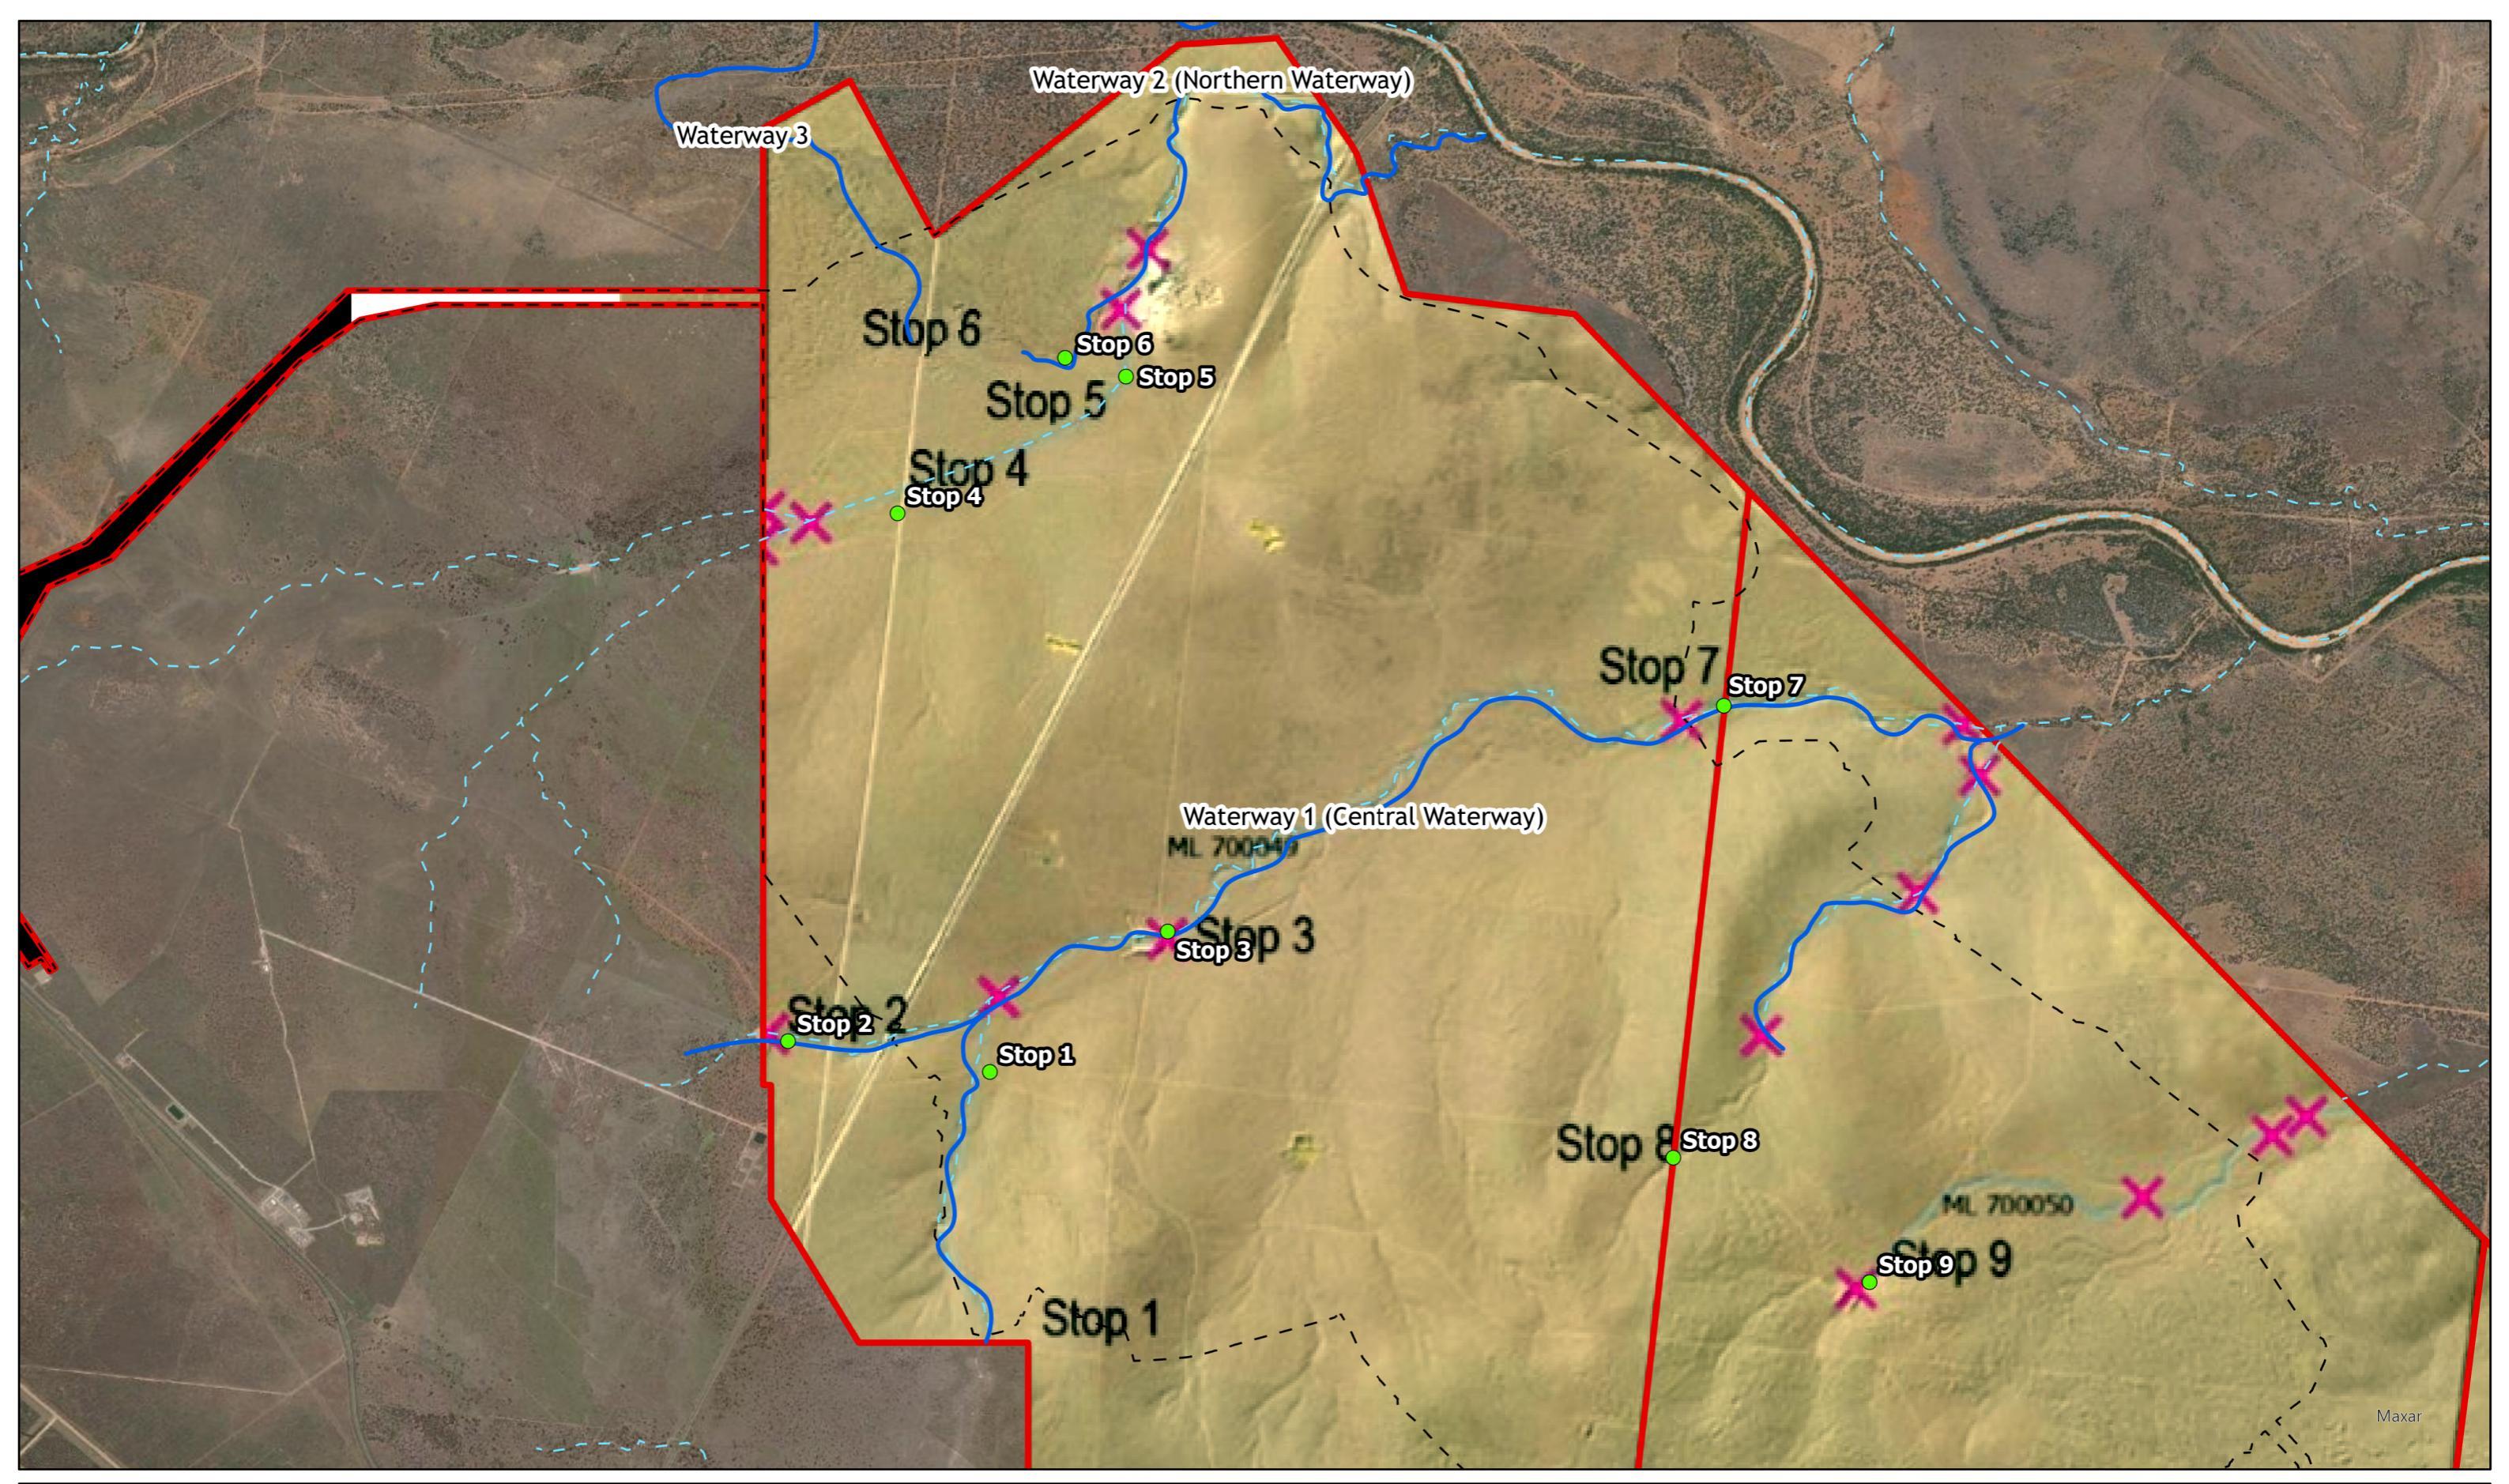
Attachment A Figure Showing DAF's Indicated Stop Locations (per DAF 2023) for February 2023 Site Visit

The Winchester South Site Inspection 14 February 2023 report (DAF 2023) incorrectly states that Waterway 3 was visited during the site inspection on 14 February 2023 (i.e. Stop 6; shown on Figures 12, 13 and 14 in DAF 2023, and in Attachment A). However, Stop 6 was the pool at the headwaters of the northern waterway (Waterway 2); the coordinates for Stop 6 based on ESP's assessment are 22.136044°, 148.252871° (Figure 1).
