CAIRNS SHIPPING DEVELOPMENT PROJECT

Revised Draft Environmental Impact Statement

APPENDIX O: Marine Water Quality Baseline Report (2016)

Cairns Shipping Development EIS – Additional Field Studies - Marine Water Quality

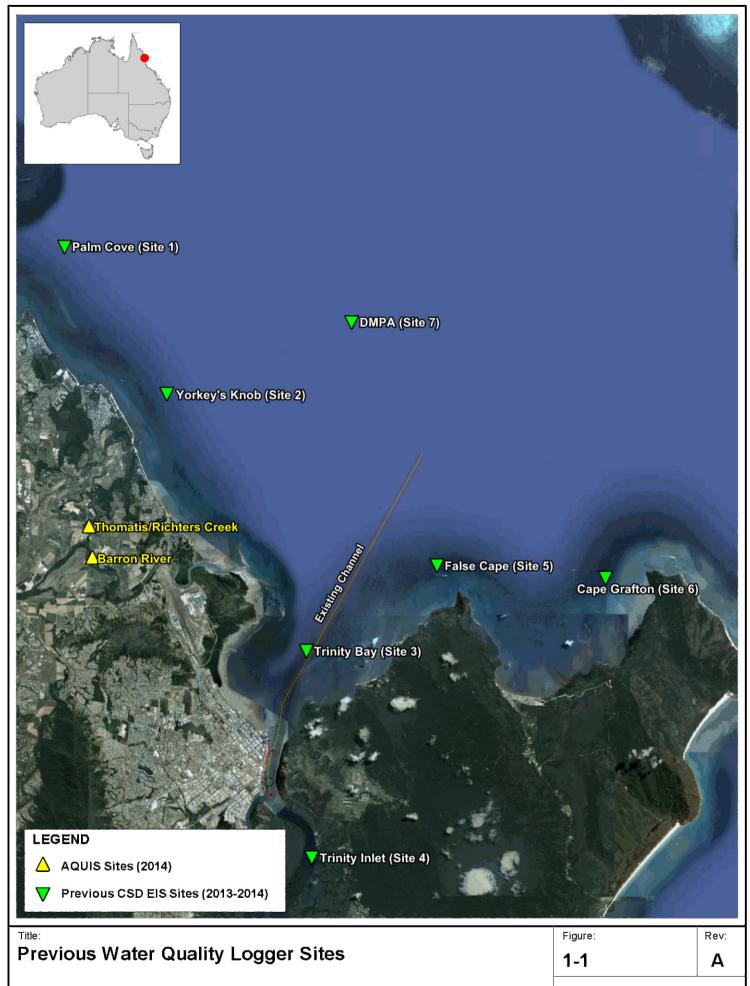
12 months of continuous water quality data (July 2013 to July 2014) has previously been collected for the CSD EIS at six locations as indicated in Figure 1-1 (red triangles). An additional six months (approximately) of water quality data (Jan 2014 to July 2014) has also been collected by BMT WBM (and made available to the Project) for the AQUIS project at two relevant locations indicated in Figure 1-1 (yellow triangles). The Barron River location (from the AQUIS data set) collected two months of data during the dry season (July 2014 to September 2014), while the Thomatis/Richters Creek location collected 14 months of data (Dec 2013 to Feb 2015).

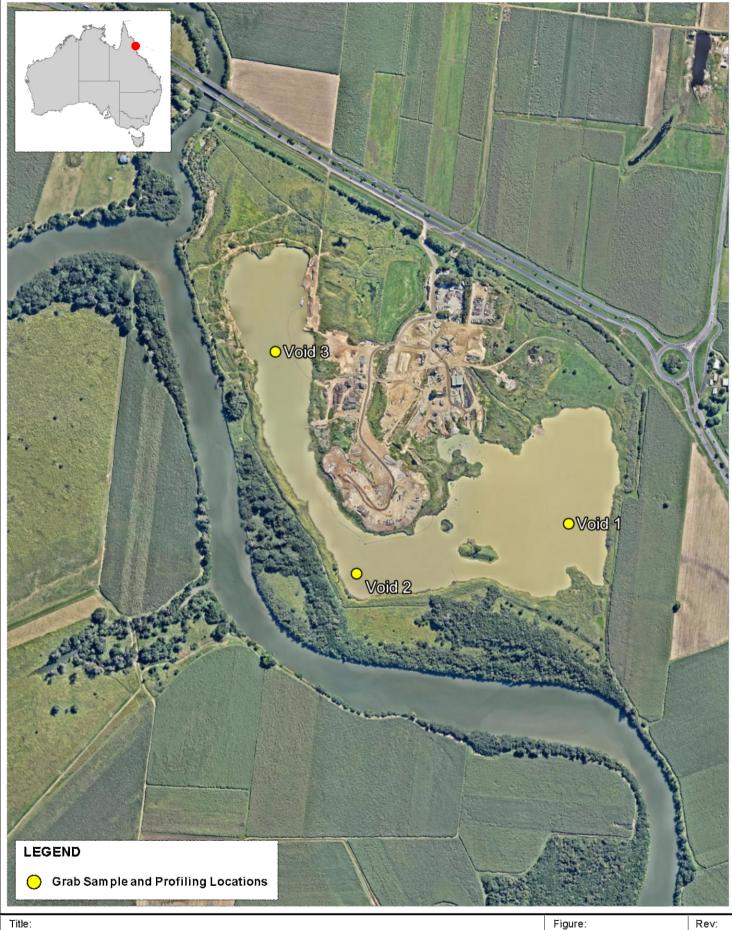
Northern Sands Void Sample Locations

A range of water quality data (*in situ* readings and laboratory analysis) were collected at the existing Northern Sands void, with samples collected at surface, mid-way and near the bottom at three within the void.

Refer to Figure 2-1 for grab sample locations.

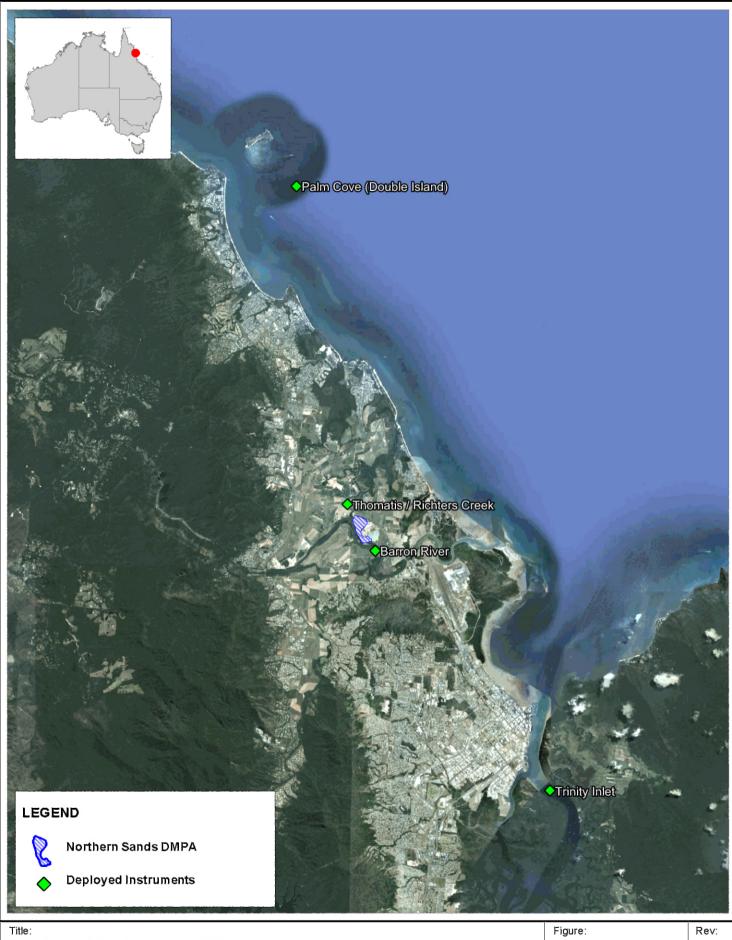
Deployed Instrument Sites

- (1) Barron River in the general vicinity of the potential tailwater discharge point. Measuring temperature, depth, turbidity and EC/salinity.
- (2) Trinity Inlet near the proposed inner harbour dredging areas. Measuring temperature, depth, turbidity and EC/salinity.
- (3) Palm Cove (Double Island) near to the previously monitored site (2013-2014). Measuring turbidity only.
- (4) Thomatis / Richters Creek in the upper reaches near the confluence with the Barron River. Measuring temperature, depth, turbidity and EC/salinity.

Refer to Figure 2-2 for locations.

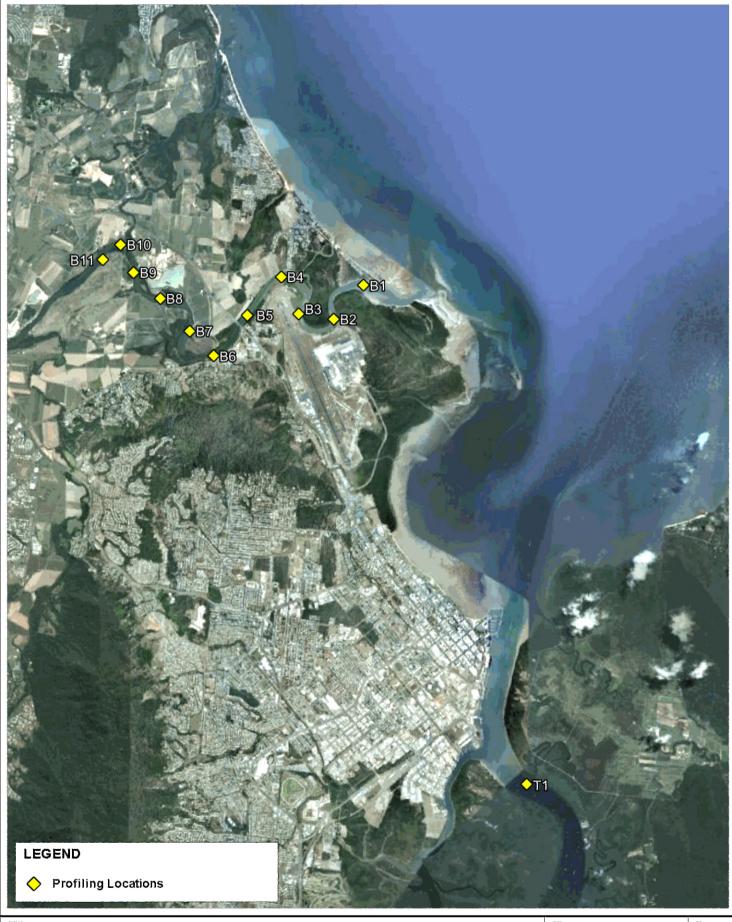
Water Quality Profiling Sites

Water quality depth profiling was undertaken at three sites in the Northern Sands void, ten sites in the Barron River and one site in Trinity Inlet. The Northern Sands void profiling sites are the same as the grab sample locations sites shown in Figure 2-1, while the profiling sites in the Barron River and Trinity Inlet are shown in Figure 2-3.

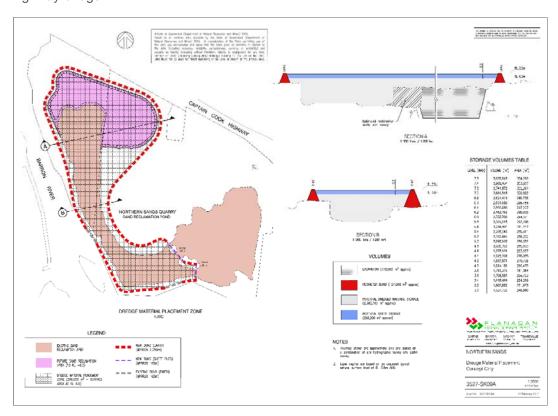
Figure 3-1 Northern Sands DMPA Concept Design

The proposed layout of the site is shown in Figure 3-1. Tailwater is proposed to be discharged adjacent to site in the Barron River or pumped to a location further downstream at the Barron River highway bridge.

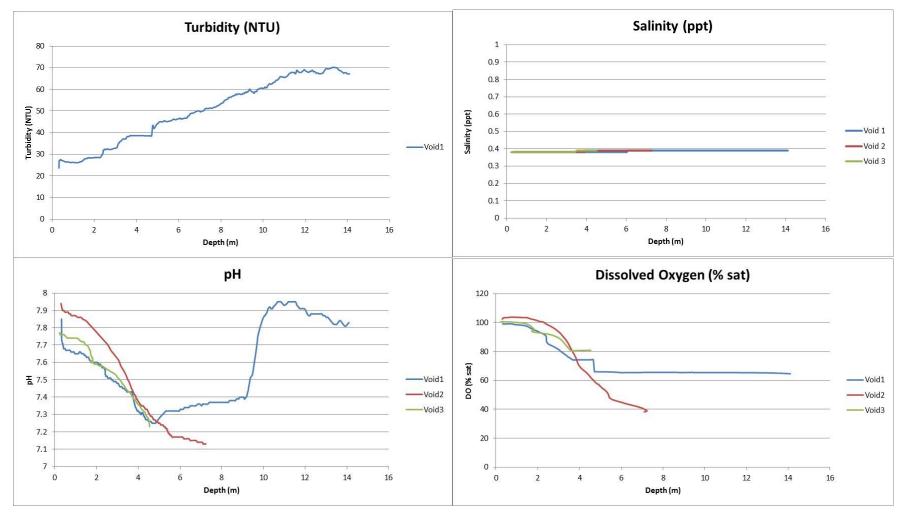
Figure 3-2 Northern Sands Void Profiling Data (26 July 2016)

- The void water has historically been relatively fresh (electrical conductivity between 200 and 1,000 μs/cm Figure 3-3) and on 26/7/16 the salinity was consistent around 0.4 ppt through the water column (Figure 3-2).
- On 26/7/16, turbidity was 25 NTU at the surface and increased to approximately 70 NTU near the bottom (Figure 3-2).
- Dissolved oxygen (DO) levels have historically fluctuated significantly, with levels between 0 mg/L and 9 mg/L (Figure 3-3). On 26/7/16, DO was approximately 100 % saturation at the surface and decreased to approximately 40-60 % saturation near the bottom (Figure 3-2).
- Historically pH has been relatively neutral, with levels maintained between 6.5 and 8.0 (Figure 3-3). On 26/7/16, pH generally decreased with depth, and was between 7 and 8 (Figure 3-2).

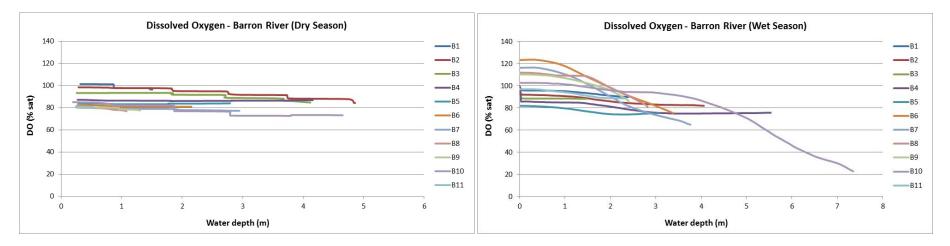
Figure 3-6 Barron River Profiling Data – Dissolved Oxygen – Dry Season and Wet Season

- Dissolved oxygen was consistently between about 80% and 120% during both surveys. There
 was a slight decrease in dissolved oxygen with increasing water depth, especially during the wet
 season survey.

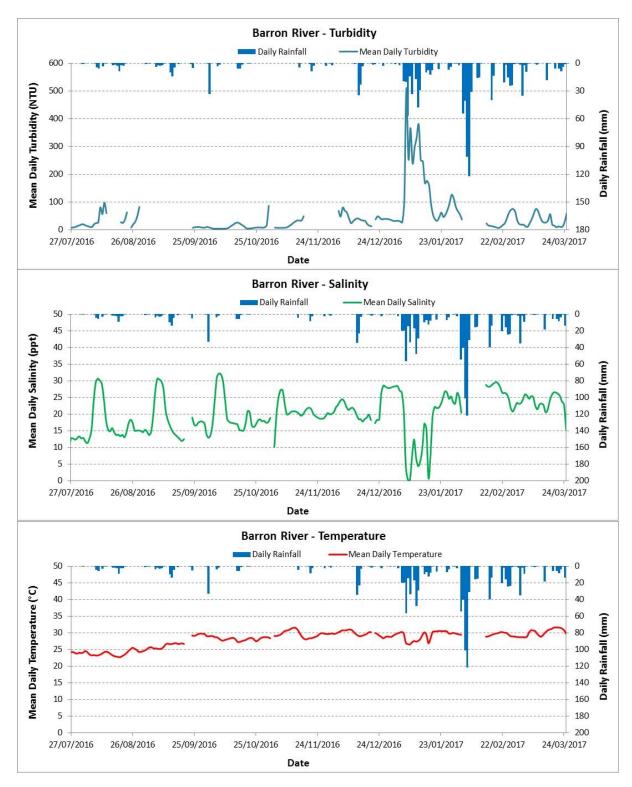
Figure 3-7 Barron River Deployed Instrument Data – July 2016 to March 2017

- Temperature was relatively consistent during both deployment periods, with temperature between 25°C and 30°C during the 2016/2017 deployment, and 20°C to 25°C during the 2014 winter deployment.

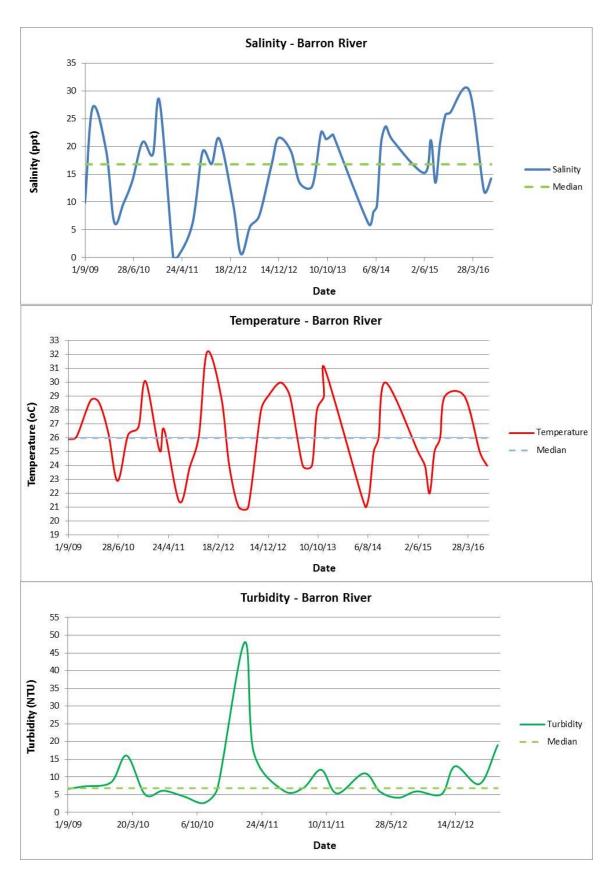
Figure 3-10 Cairns Regional Council - Barron River Data (Barron River Site 2)

The salinity data collected by CRC over a number of years has a similar range of salinity as collected by the deployed instruments (Section 3.2.3), with salinity ranging between 5 ppt and 30 ppt, with a median of approximately 17 ppt. Turbidity was mostly below 20 NTU, with a larger spike up to 50 NTU in March 2011. Median turbidity is approximately 7 NTU. Over the years, temperature has fluctuated between 21°C and 32°C.

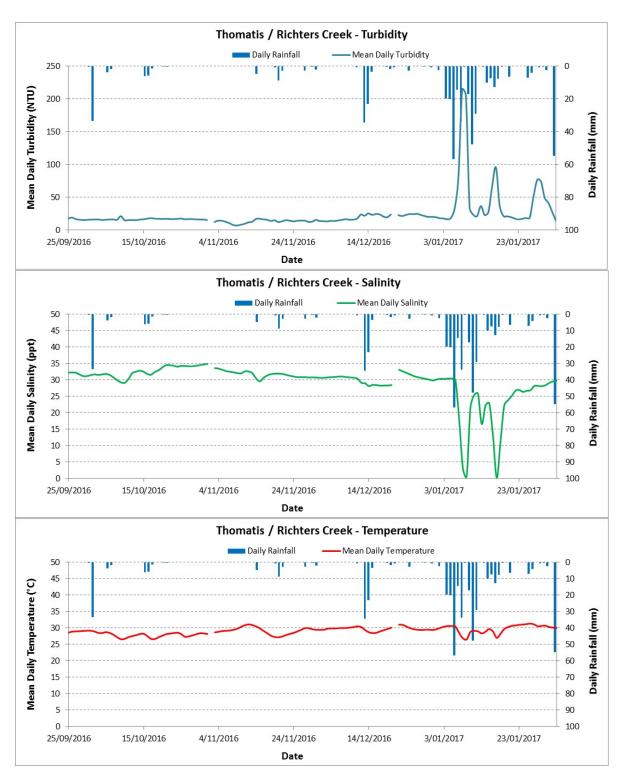
Figure 3-12 Thomatis / Richters Creek Deployed Instrument Data - Sept 2016 to Feb 2017

- Turbidity during both deployments was mostly below 50 NTU, with some larger spikes of approximately 200 350 NTU coincident with rainfall events (Figure 3-12 and Figure 3-13).
- Salinity in Thomatis/Richters Creek was mostly around 30 ppt during both deployments. Salinity
 only decreased during large rainfall events when freshwater flows in the Barron River were large
 enough to push into Thomatis/Richters Creek. During these periods, salinity would decrease to
 about 0.1 ppt for short periods of time.
- Temperature was relatively consistent during both deployment periods, with temperature between 25°C and 30°C during the 2016/2017 deployment, and 20°C to 30°C during the 2013 to 2015 deployment.

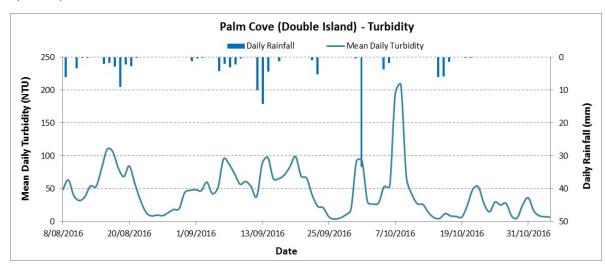
Figure 3-15 Palm Cove (Double Island) Deployed Instrument Data – Aug 2016 to Nov 2016

This data indicates that turbidity during the most recent deployment was around 50 NTU for most of the time, with some larger spikes in turbidity around 100 - 200 NTU. Turbidity during the 2013/2014 deployment period was slightly lower in general, however there were some larger turbid spikes up to around 400 - 700 NTU.

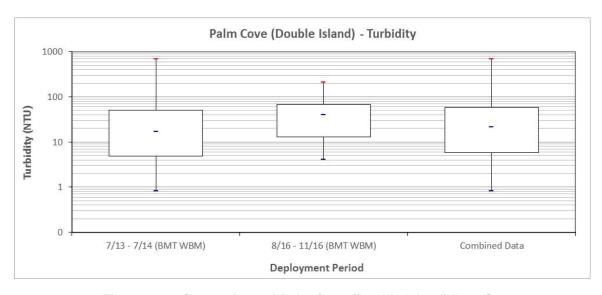
Figure 3-17 Comparison of Palm Cove (Double Island) Data Sets

To provide a comparison of the different data sets, a box and whisker plot of the turbidity data is presented in Figure 3-17. This indicates that turbidity was generally higher during the latest deployment (2016), with median turbidity of 40 NTU, compared to a median turbidity of 17 NTU during the 2013/2014 deployment period. However, it should be noted that the latest deployment was for a three-month period while the earlier deployment (2013/2014) was a 12-month deployment.

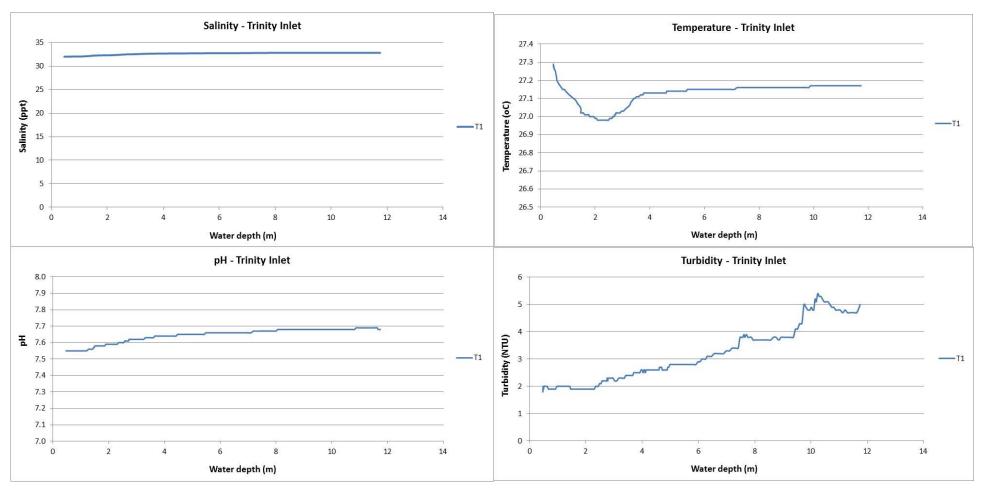
Figure 3-18 Trinity Inlet Profiling Data

- Salinity in Trinity Inlet was consistent through the water column at around 32 ppt, which is close to the typical salinity of sea water (~35 ppt).
- Temperature decreased slightly (~0.3°C) from surface down to about 2 m water depth, then
 increased slightly and remained consentient around 27.2°C through the rest of the water
 column.
- pH was consistent through the water column at around 7.5 to 7.7.
- Turbidity was lower at the surface (~2 NTU) and increased with water depth up to about 5 NTU near the bottom (10-12 m depth).

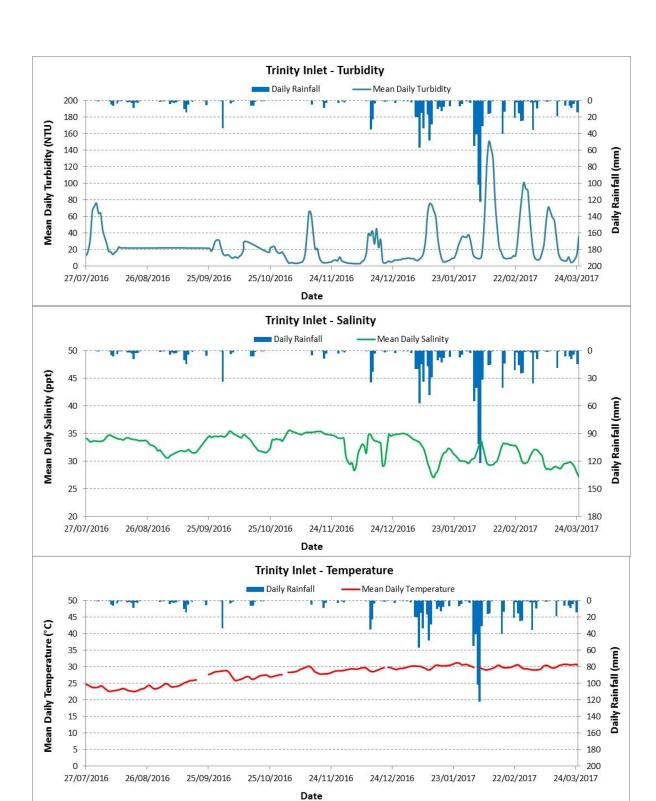
Figure 3-19 Trinity Inlet Deployed Instrument Data - Jul 2016 to Mar 2017

The data in Figure 3-19 indicates that turbidity fluctuated with tidal cycles and rainfall events, but was mostly below 20 NTU. There were some larger spikes in turbidity up to about 100 NTU coincident with spring tides and/or significant rainfall. Salinity and temperature were relatively consistent throughout the deployment period, with salinity between 30 and 35 ppt and temperature between 20°C and 30°C.

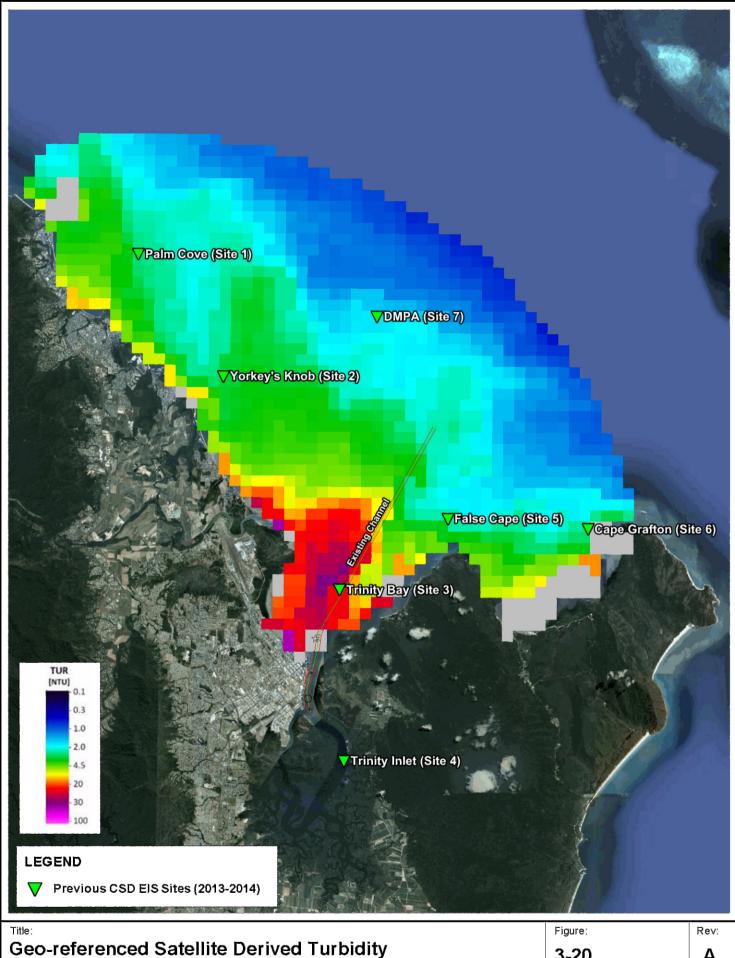
Geo-referenced Satellite Derived Turbidity (One of 100 Images Processed)

The satellite image data was processed by EOMAP using a physics-based Modular Inversion and Processing System (MIP). Satellite-derived turbidity is determined by the backward scattering of light between 450 to 800 nm, which is physically retrieved using satellite data. The processed satellite derived turbidity data was provided as geo-referenced images (100 images spanning a 10-year period). An example is provided in Figure 3-20, which illustrates the general trend of higher turbidity in nearshore waters (especially in Cairns Harbour) and less turbidity in offshore waters.

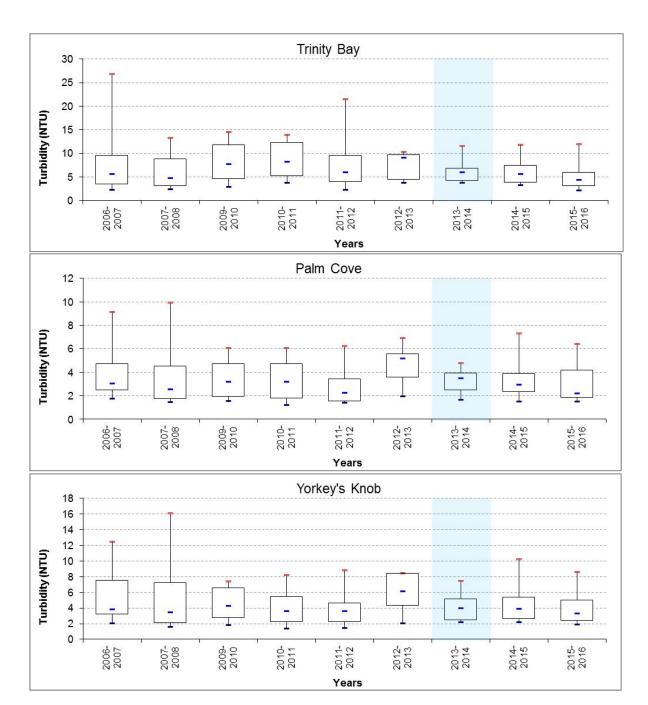
Figure 3-21 Box and Whisker Plots of Satellite Derived Turbidity- Trinity Bay (top), Palm Cove (middle) and Yorkey's Knob (bottom)

As shown in Figure 3-21 and Figure 3-22, the monitoring period of July 2013 – July 2014 was fairly typical of conditions over the 10-year period between 2006 and 2016. If anything, the range of turbidity values is narrower compared to other years, meaning that the turbidity values used to represent background conditions in the impact assessment are conservative.
