Closure and rehabilitation strategy

Carmichael coal mine

Prepared for Adani Mining Pty Ltd | 19 March 2014

Report B13054RP1 | Prepared for Adani Mining Pty Ltd | 3 March 2014

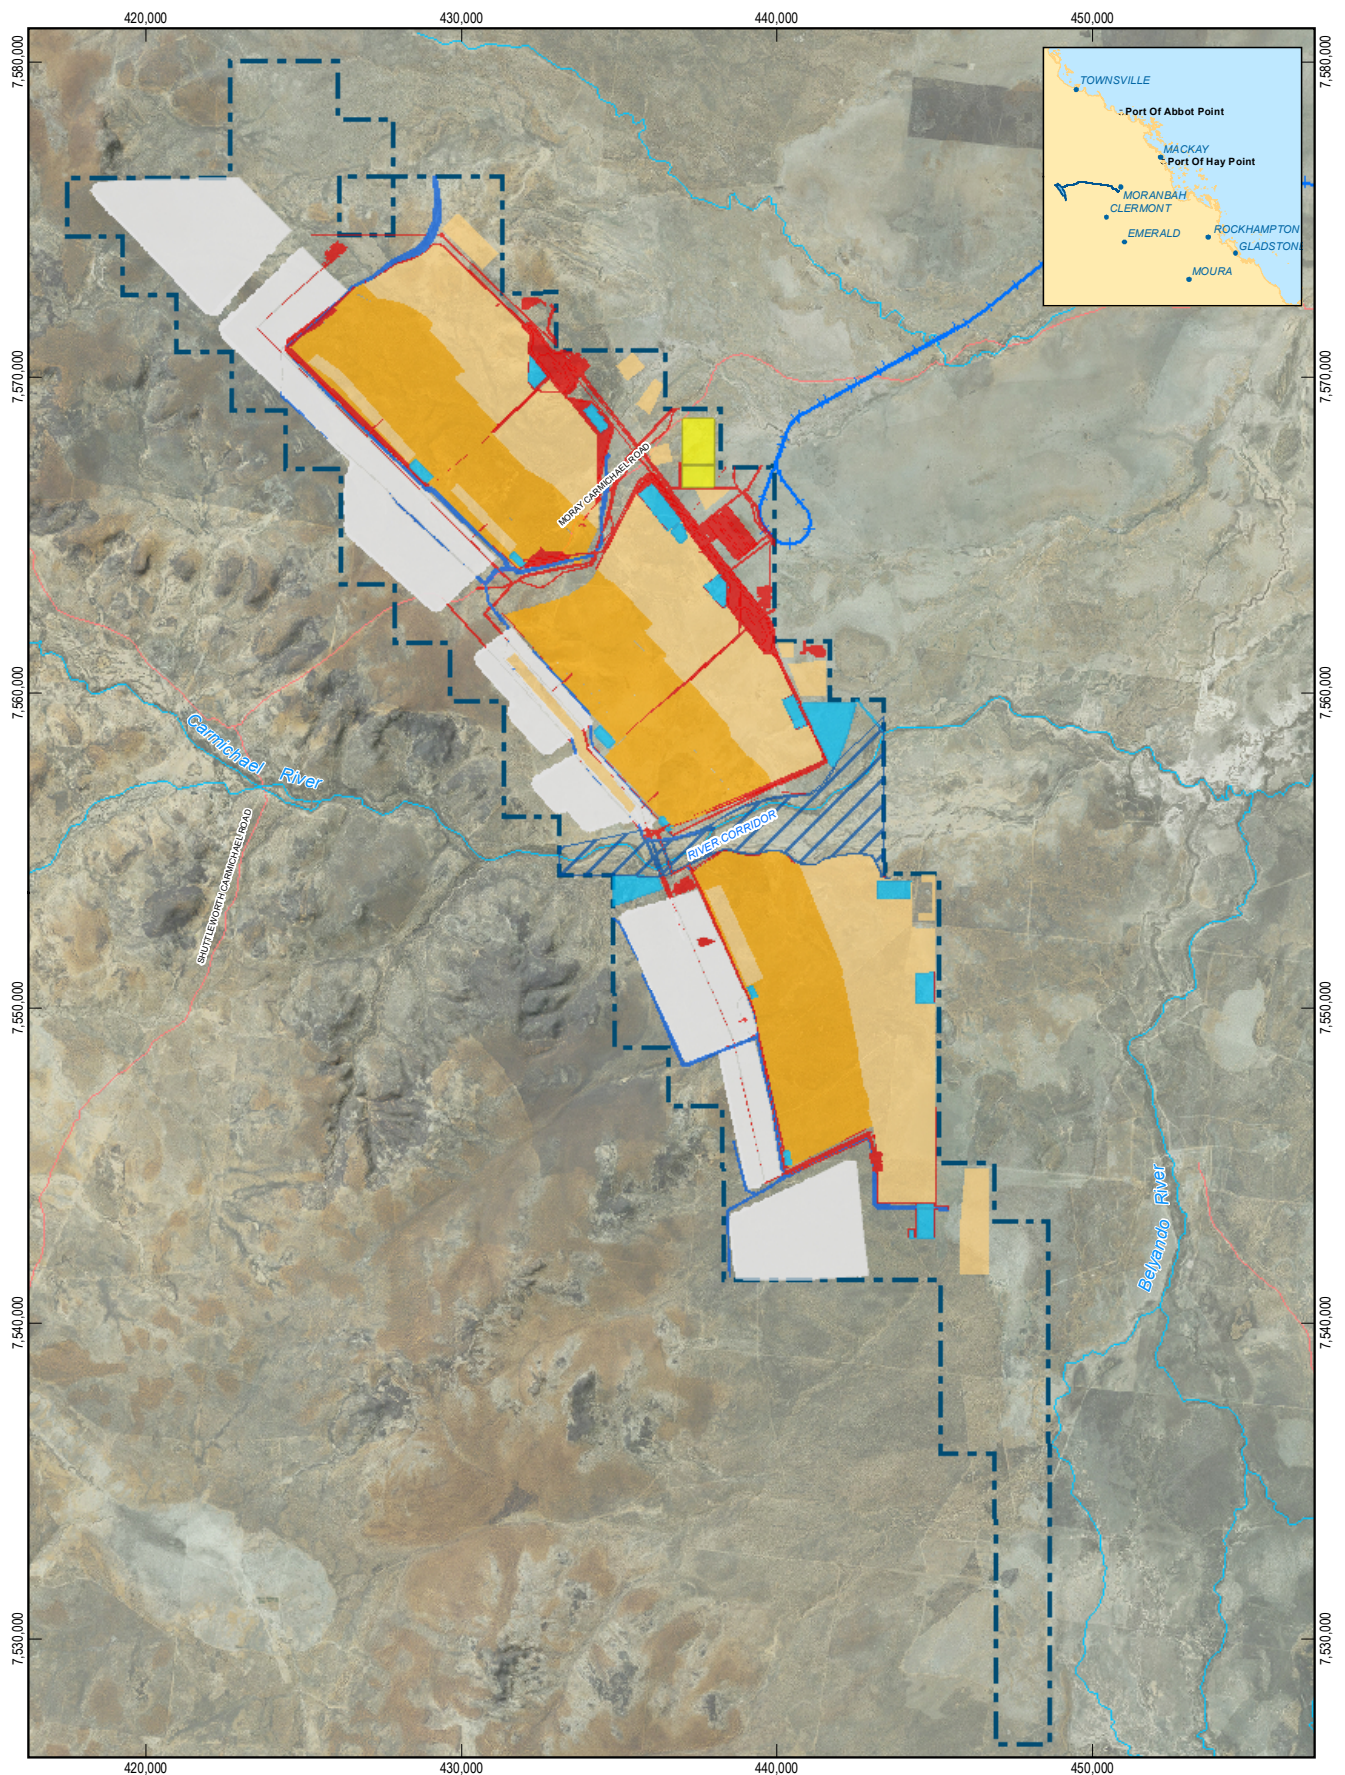
This closure and rehabilitation strategy incorporates rehabilitation objectives, an overall management strategy and general rehabilitation methods for the project structured around eight domains within the mine area (Figure 1.2). The individual domain maps can be found in Appendix A. The closure and rehabilitation strategy is structured as follows:

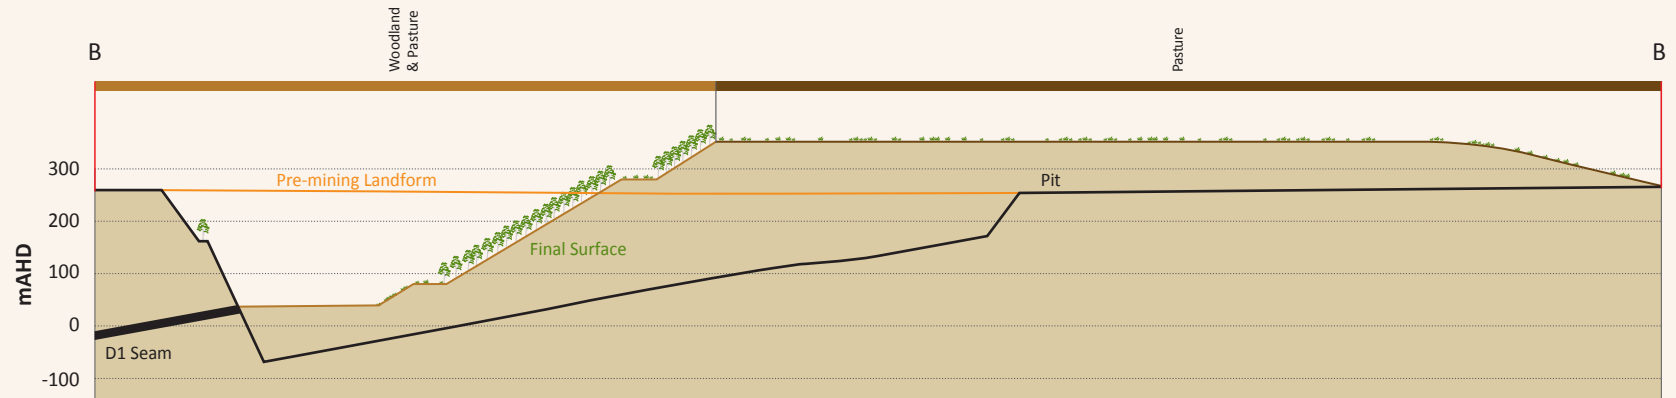
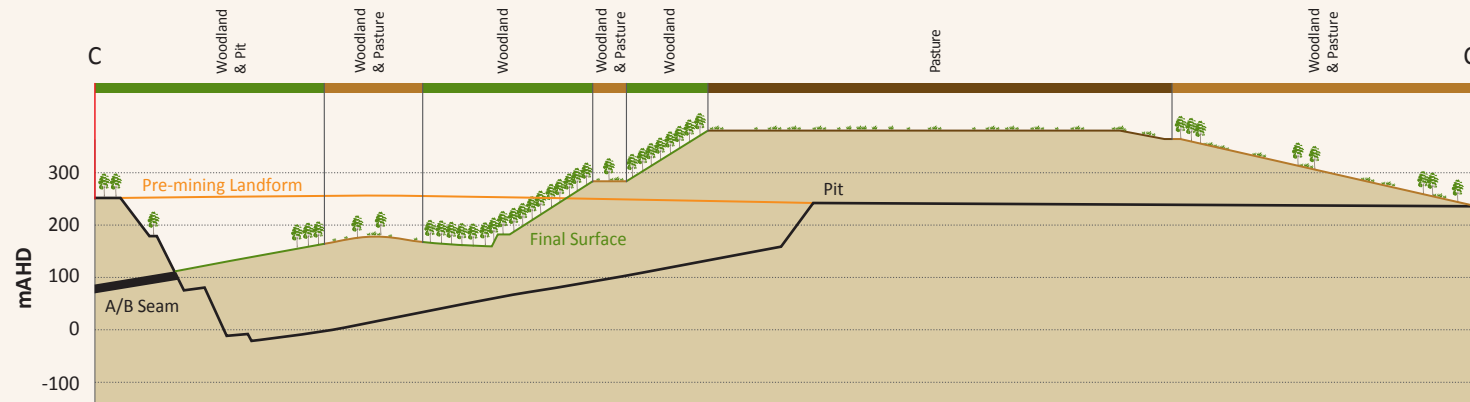
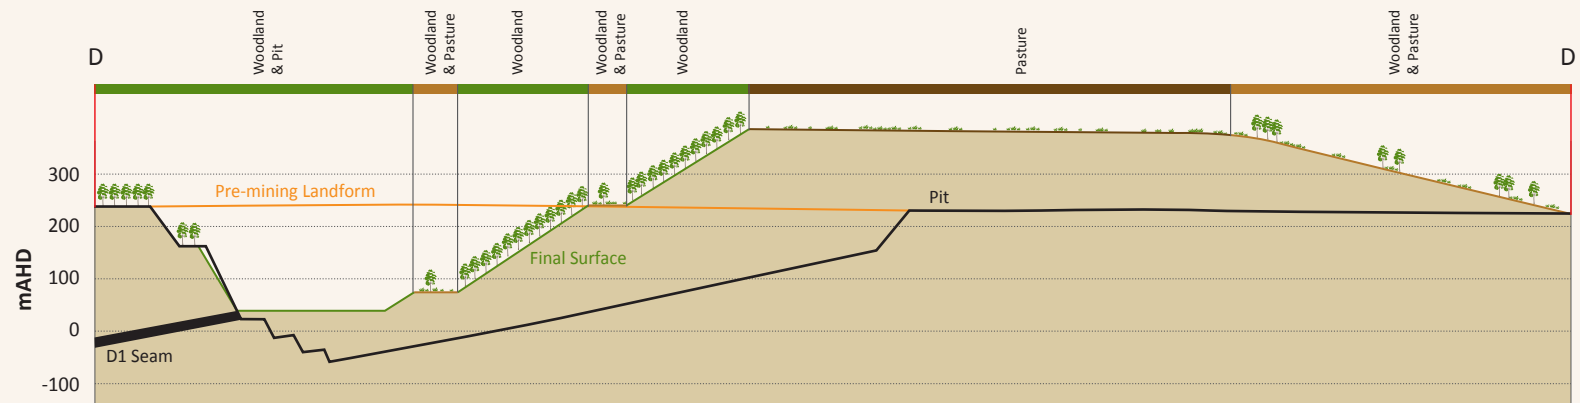
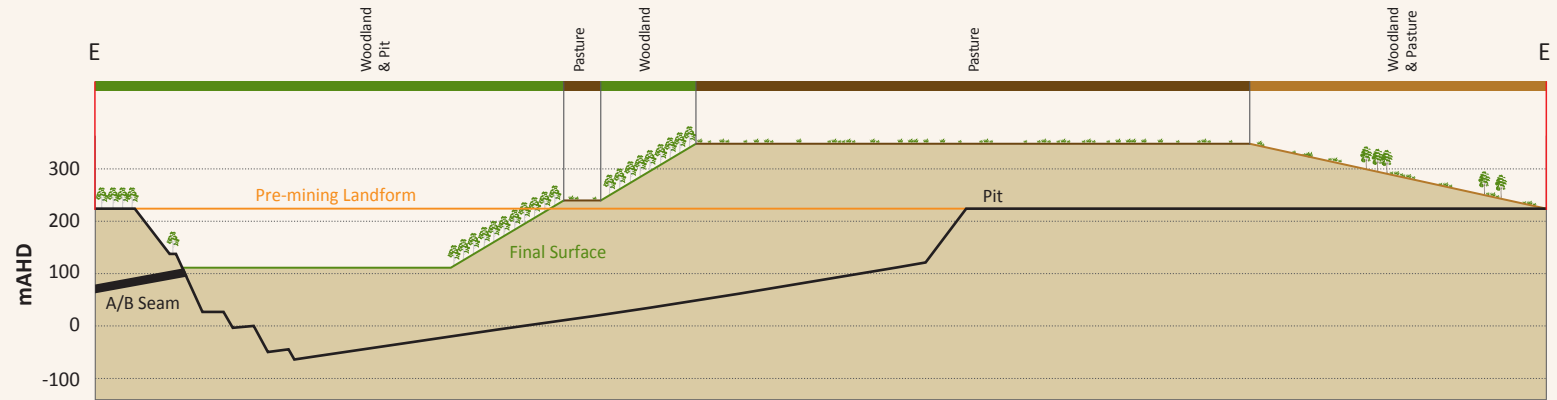
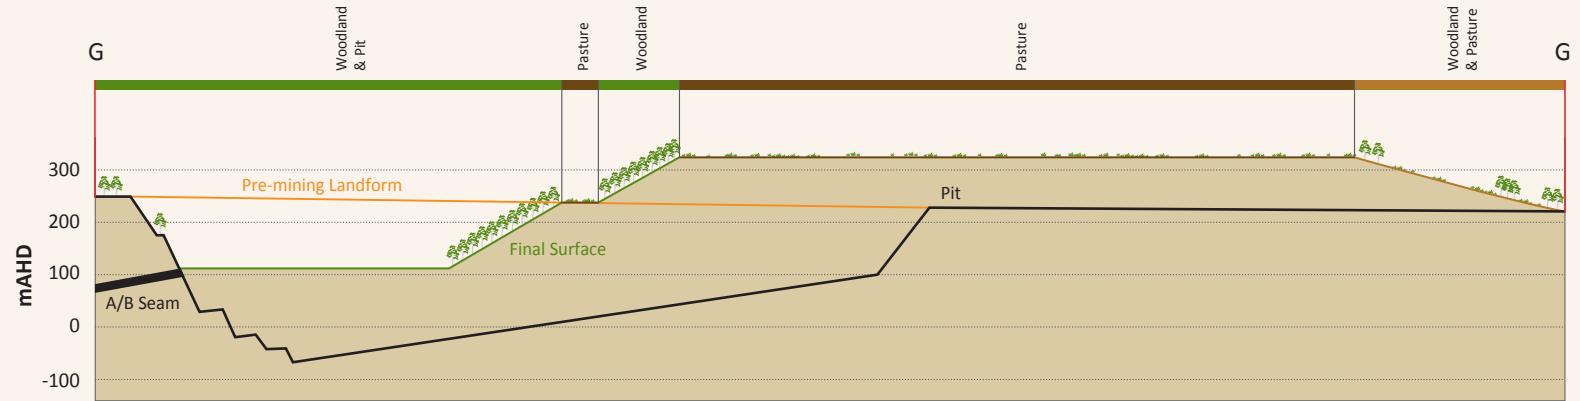
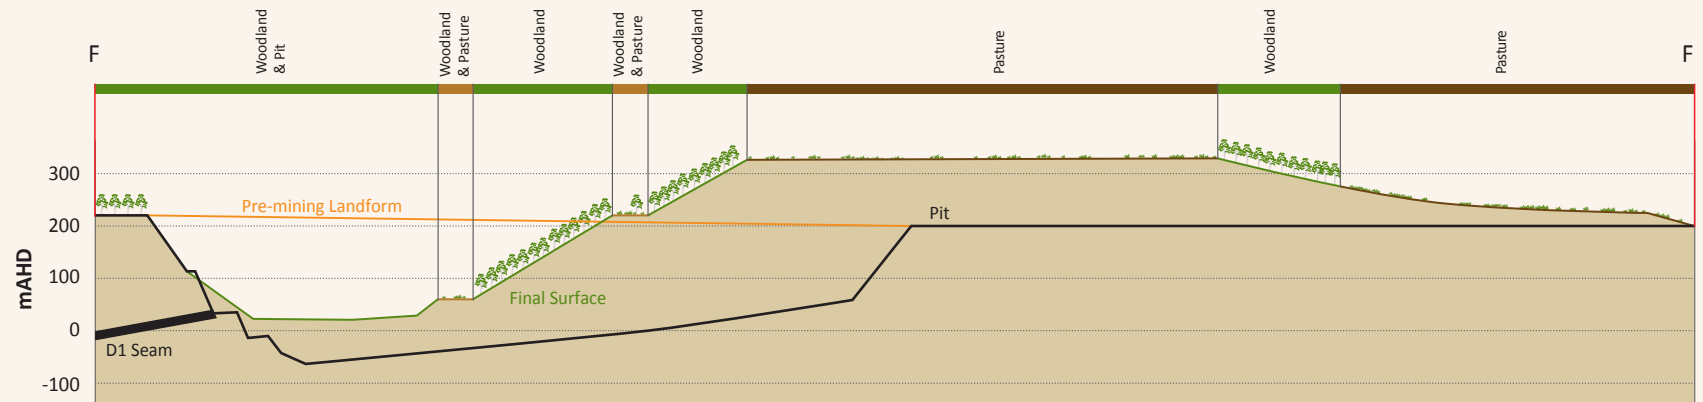
Figure 4.2 (sheet 1)

KEY	
■	Woodland
■	Native Pasture
■	Woodland and Pasture

Conceptual final landuse plan

The final landform requires backfilling of the void to a height above the coal seam as demonstrated in Figure 4.2. This will limit oxygen infiltration and heating of exposed faces of the coal seam; in order to reduce the risk of spontaneous combustion of the neighbouring coal reserves. The backfilling process will also limit the exposure and evaporation of exposed groundwater aquifers. The schedule of overburden and coal removal has been optimised so that some of the backfilling is maximised during final stages of operation. The optimisation has resulted in backfilling up to AB seam in three pits and backfilling up to D1 seam in three pits. The limited quantity of fill available post-mining will result in final void in each pit. This shortfall will prevent all groundwater aquifers from being covered by backfilling operations. The Mine Hydrology report (Carmichael Coal SEIS, Appendix K1, Section 5.7.1, p108) identifies that the voids will remain mostly dry except during periods of high rainfall. This is the result of the modelled groundwater intrusion, into the final constructed landform in the voids, being less than the daily evaporation rate.

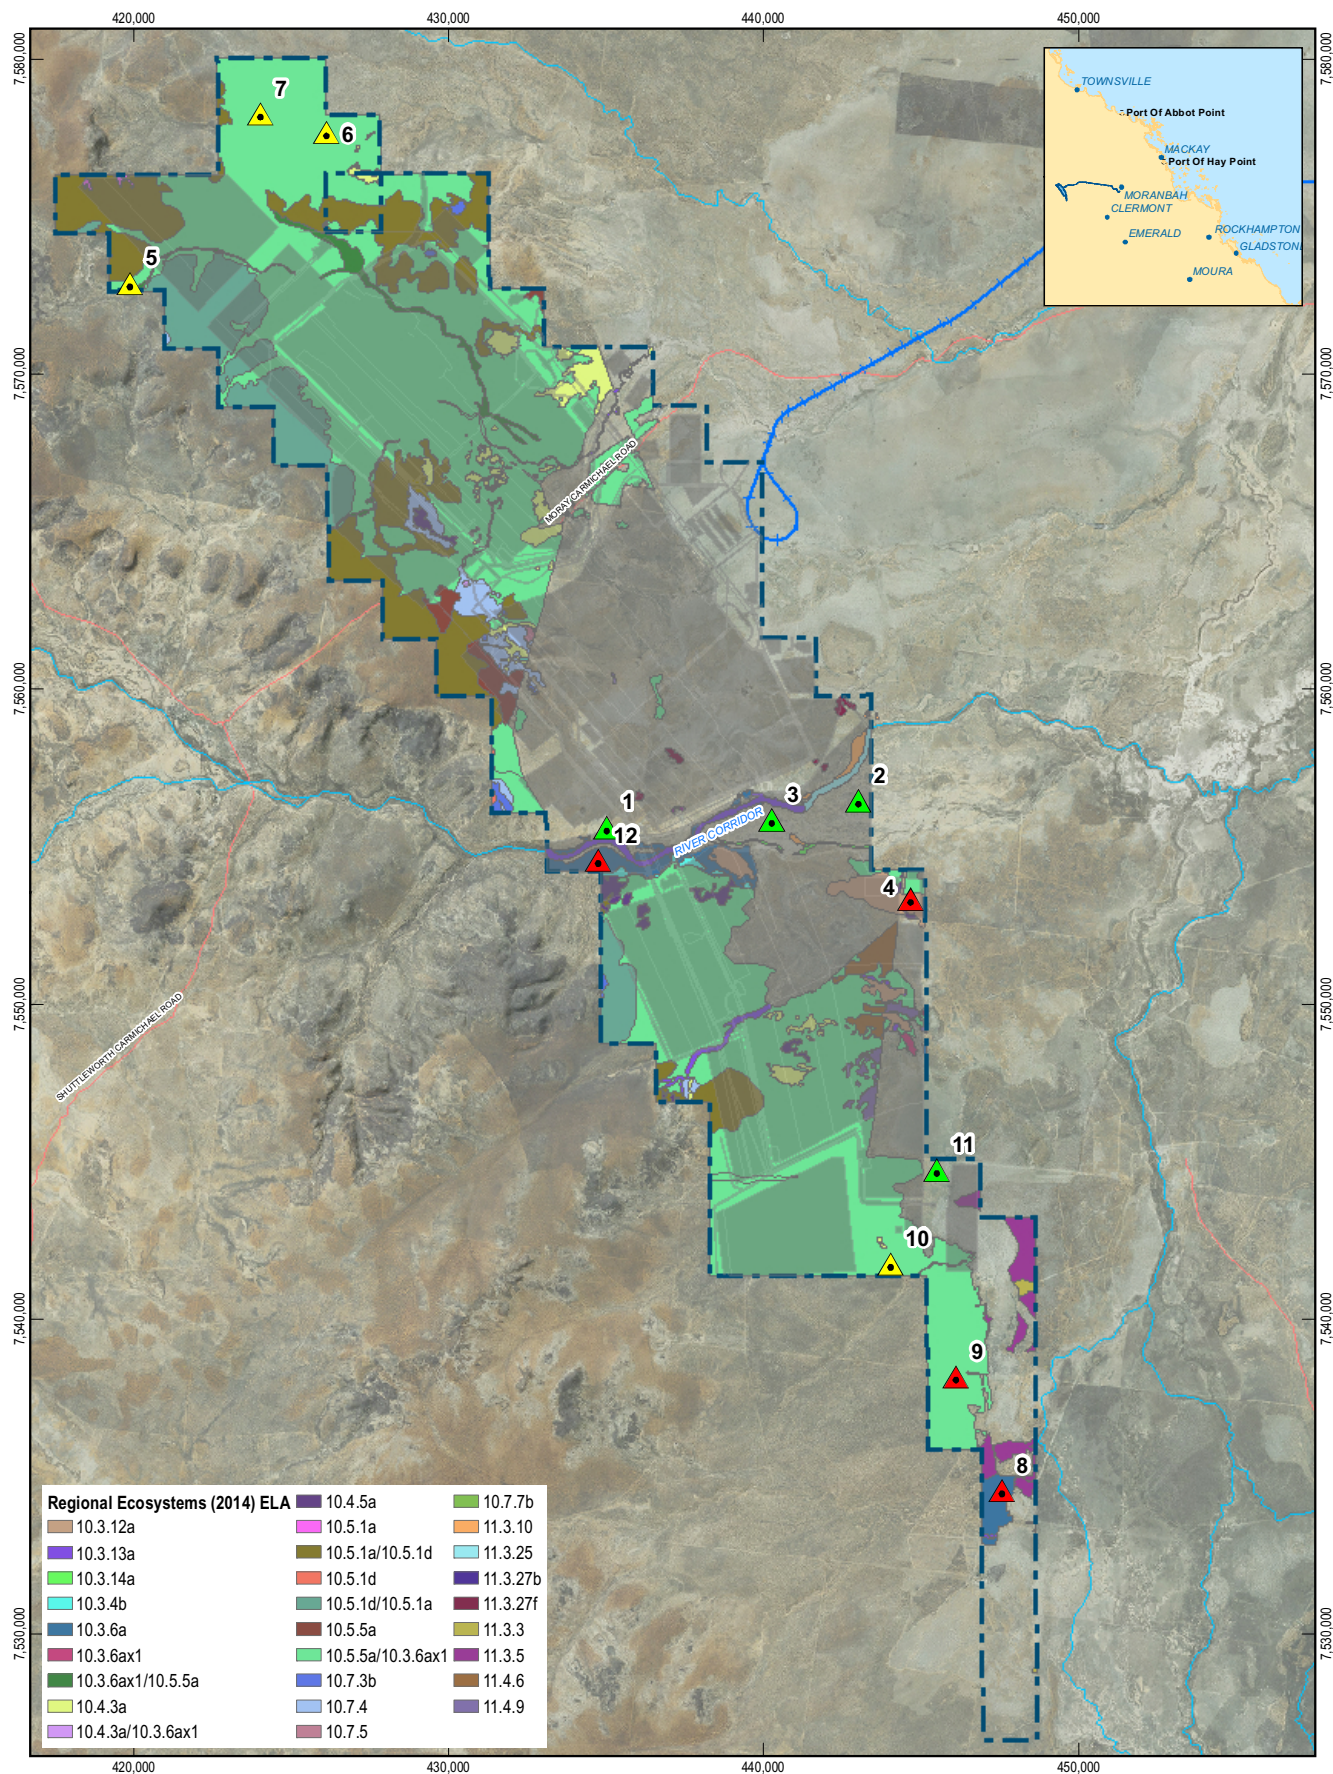
Table 4.3 Reference sites for final land uses

Final land use	Corresponding RE's	Reference sites
Woodland	10.5.5a/10.3.6ax1	5, 6, 7 & 10
	10.5.5a	5, 10
Woodland and pasture	10.3.12a	4
	10.3.6a	8 & 12
	10.5.5a/10.3.6ax1	9
Pasture	Non-remnant	1, 2, 3 & 11

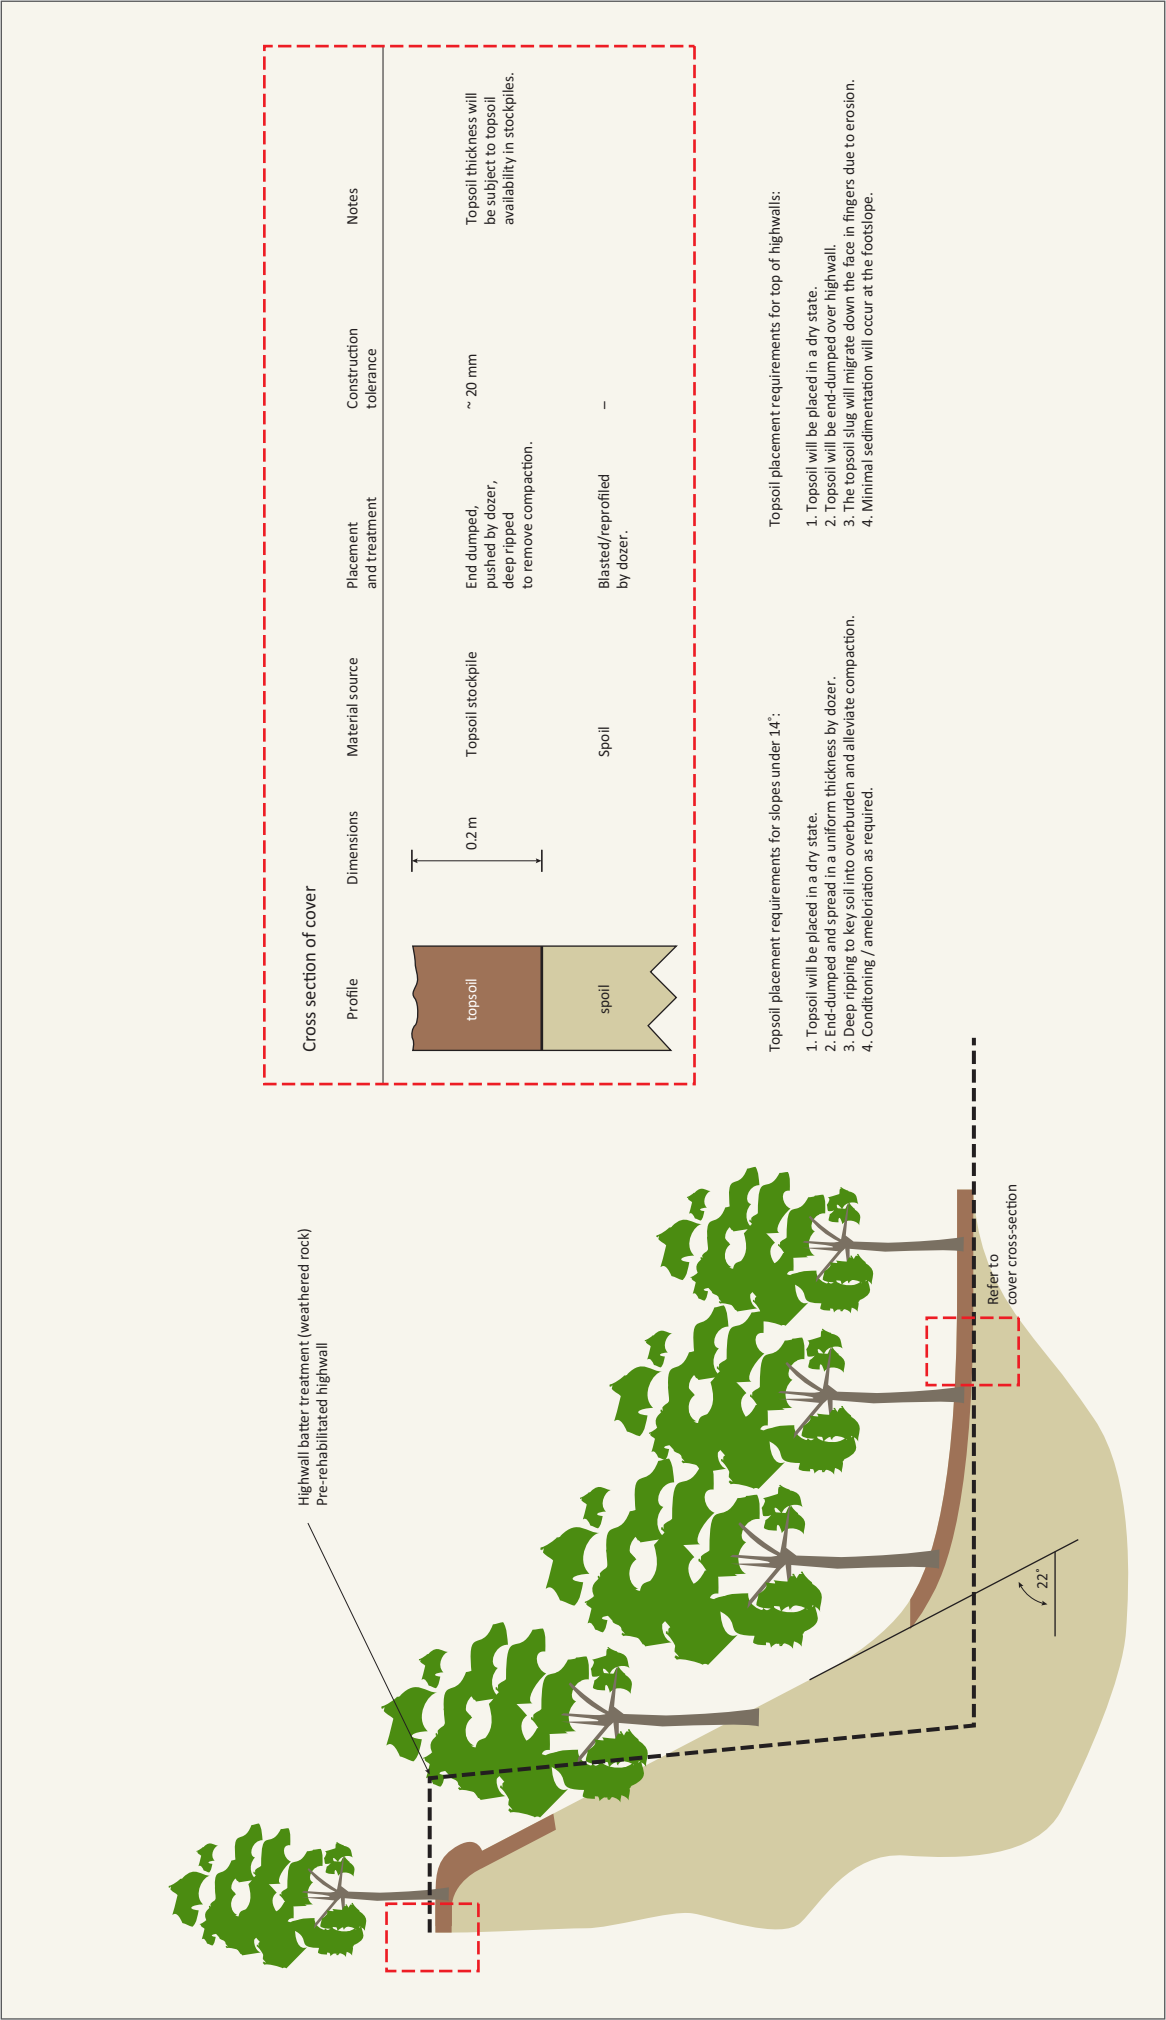
Conceptual landform design features for open-cut voids (not to scale)

Slopes will be designed to be stable and angled at a maximum slope angle of 22° (high walls) and 14° (low walls) based on geotechnical study recommendations. Prior to closure, investigations will be undertaken to specify the design criteria and appropriate action will be taken to ensure long-term stability, safety and management of the domain. Slopes below 14° will be topsoiled in accordance with section 5.2.1.

Conceptual landform design features for open-cut voids is shown in Figure 6.1.

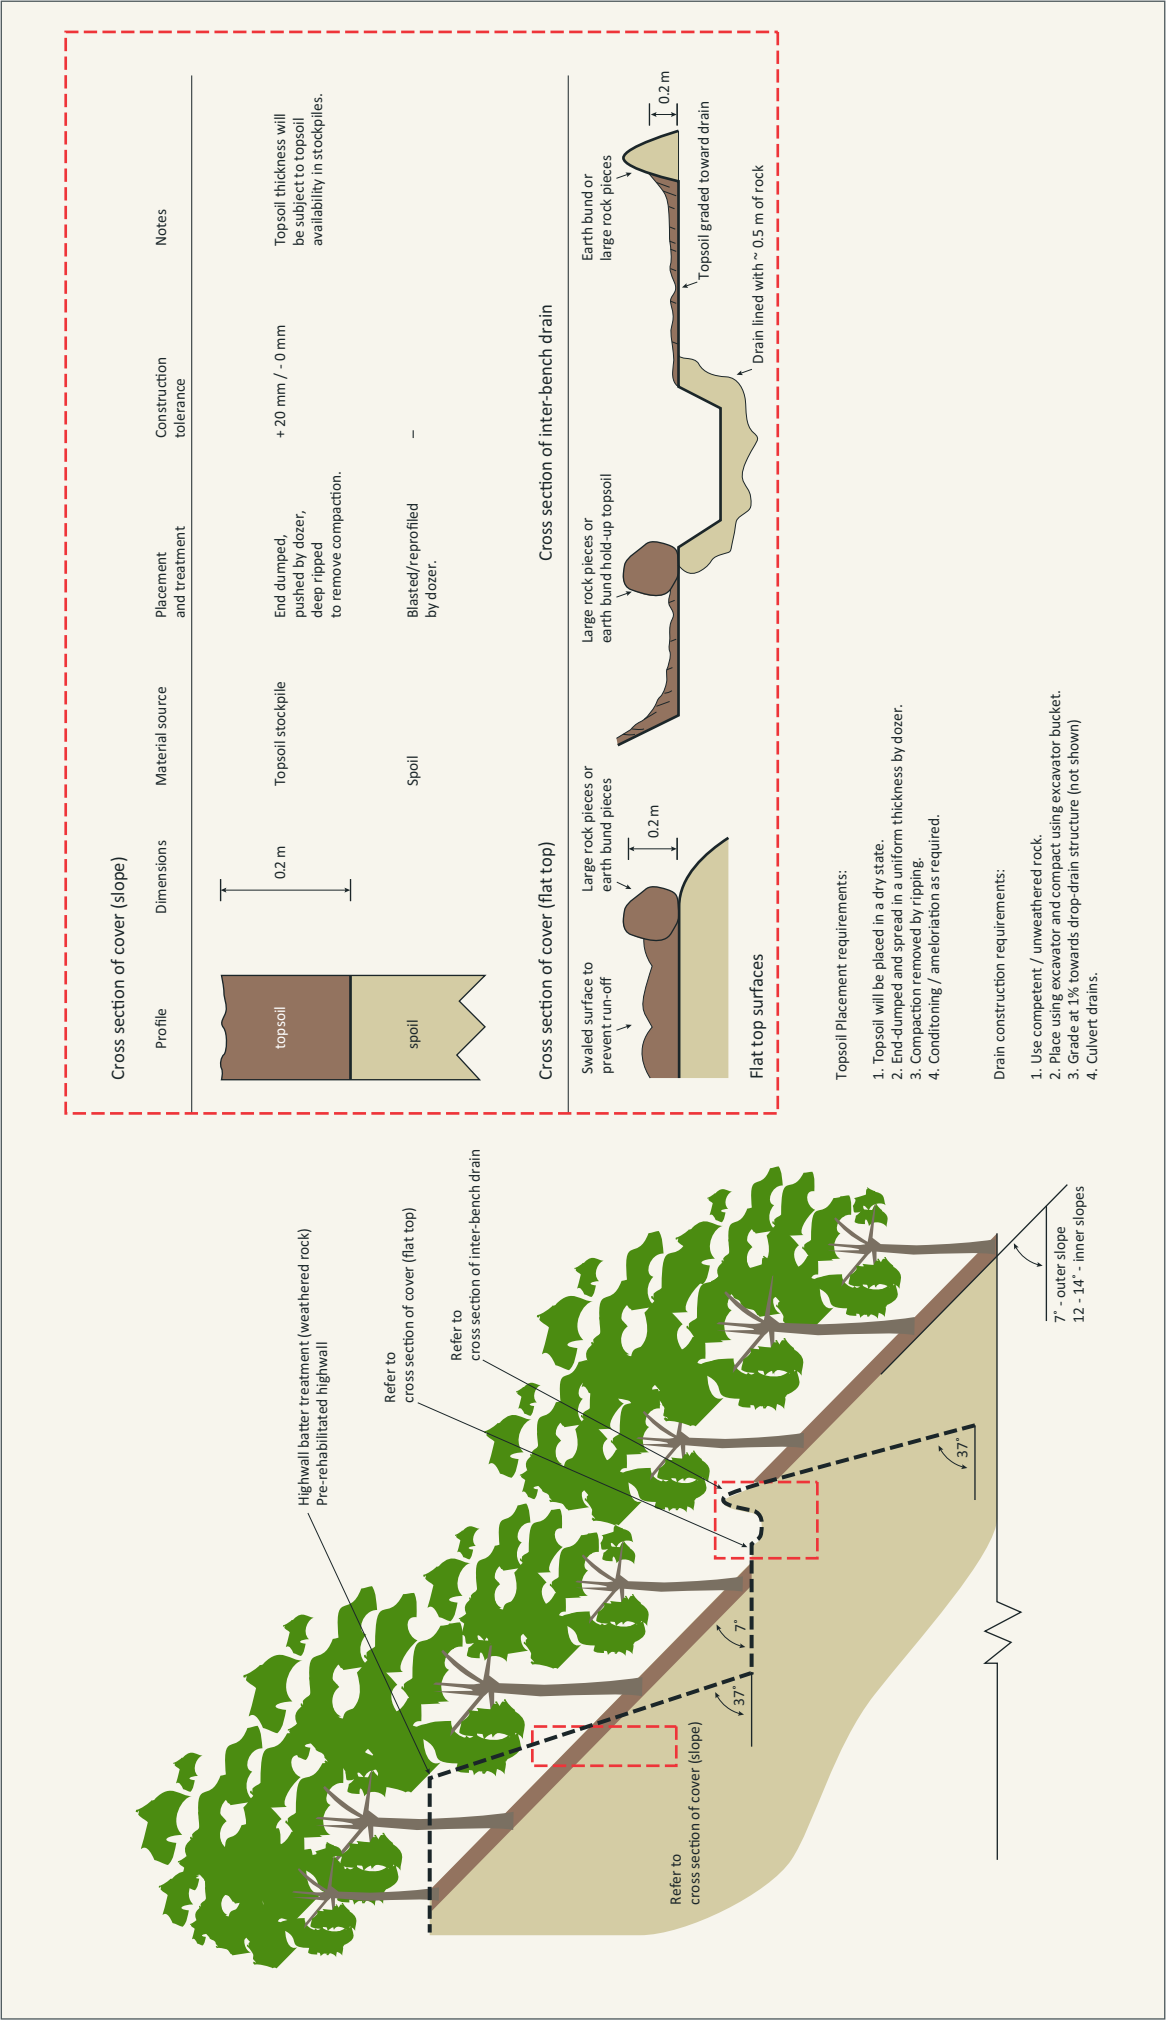
Conceptual landform design features for out-of-pit dumps (not to scale)

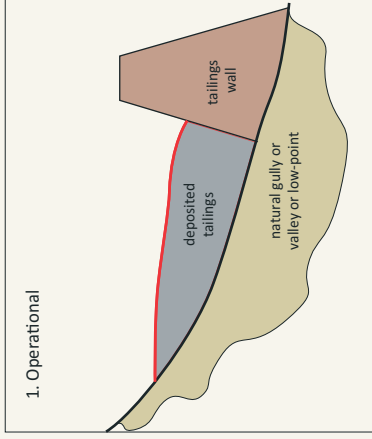
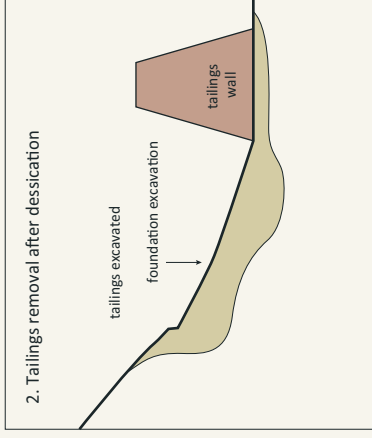
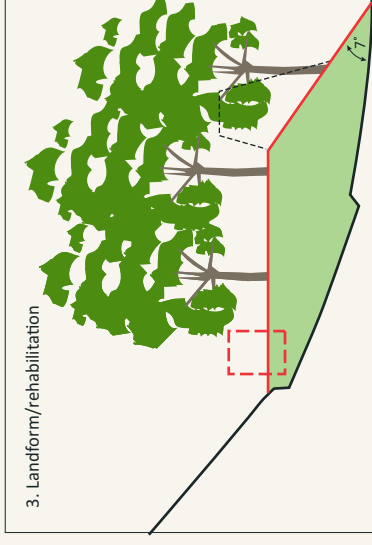
Tailings excavation requirements:

1. Foundation excavated if required.

Profile	Dimensions	Material source	Placement and treatment	Construction tolerance	Notes
topsoil	~1 m	Topsoil stockpile	End dumped to create a swaled final surface.	+ 200 mm / - 200 mm	Topsoil maybe substituted with weathered oxide spoil, subject to topsoil availability.
compact clay	~0.5 m				
foundation		Tailings wall core	Pushed in uniform thickness by dozer and compacted to 0.5% of maximum standard compaction.	+ 100 mm / - 0 mm

Conceptual landform design features for the tailings drying cell (not to scale)

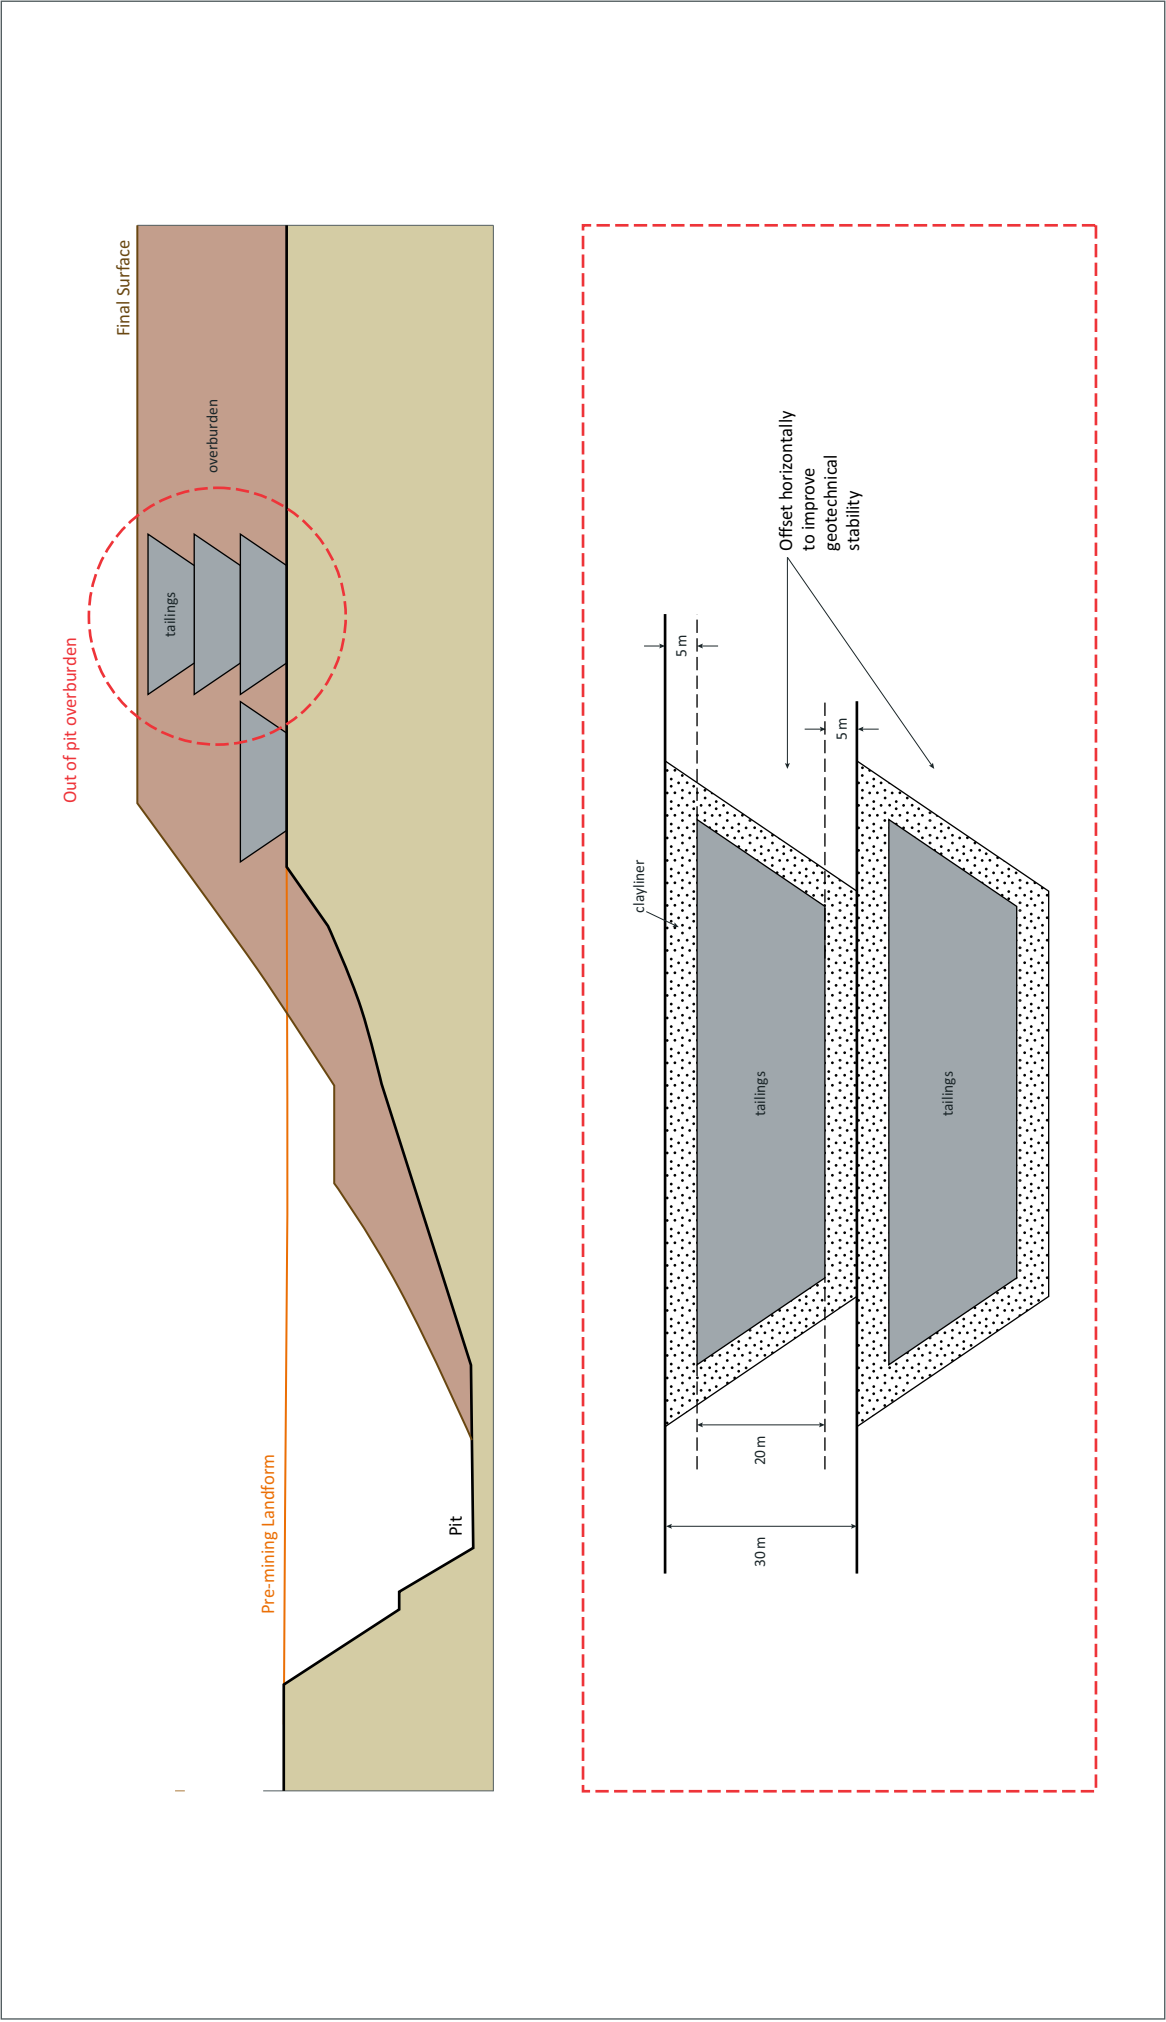
Conceptual landform design features for tailings placement in the out-of-pit spoil dumps (not to scale)
