Northern Pipeline Infrastructure Stage 2 EIS

Six Mile Creek Study
January 2008

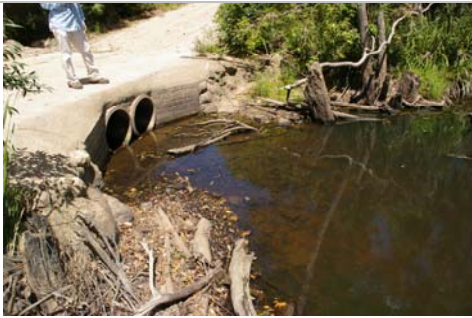
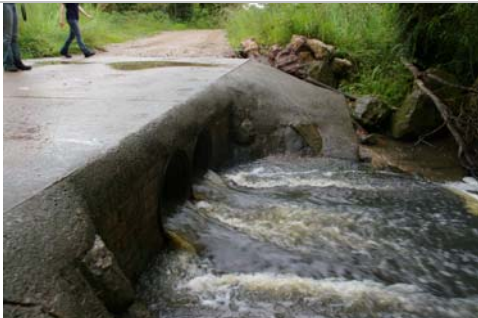
Plate 3-1 Key features of the Left Branch of Six Mile Creek identified during the site visit

<i>a) steep incised channel banks</i>	<i>b) dense riparian cover and large woody debris</i>

<i>c) the causeway at the brick works posing a barrier to fish movement</i>	<i>d) water flowing through the same causeway during the December site visit</i>

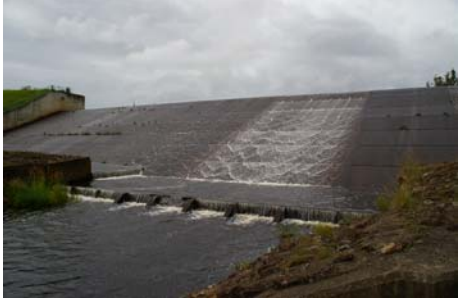
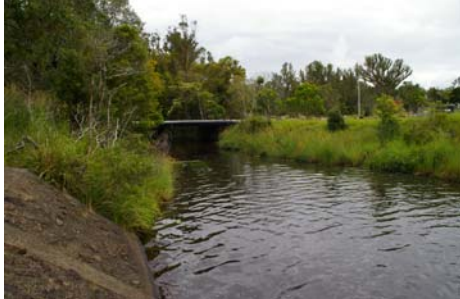
<i>e) eroded banks downstream of the existing pipeline crossing</i>	<i>f) a flood runner adjacent the main creek</i>

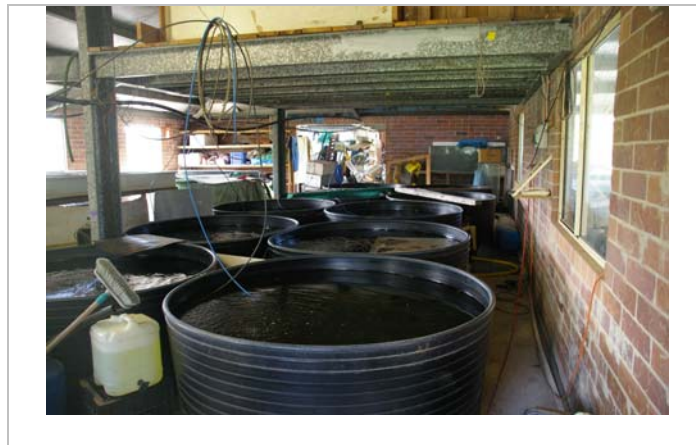
Plate 3-3 Mary River cod broodstock tanks at the privately owned hatchery

owned Mary River cod hatchery on his property (see Plate 3-3). Mr Manning's hatchery is one of only two licensed commercial breeding facilities in the State, with the other facility located near Noosa. These hatcheries supply brood stock for recreational fishing and the aquarium trade. At the time of writing, Mr Manning's cod hatchery featured several grow out ponds and a series of egg harvesting, juvenile rearing and broodstock managing ponds maintained within a shed. Mr Manning had submitted an application for the expansion of his cod hatchery to include a large water storage and a number of new ponds. Advice from Dr Peter Kind (head of freshwater fisheries research), QDPI&F, suggested that, although Mr Manning's facility does not currently provide cod fingerlings for cod recovery, it may be required to do so at some point in the future, particularly if the proposed Traveston Crossing Dam proceeds and insufficient broodstock are available for restocking from the Gerry Cook Hatchery or the proposed new research facility outlined in SKM (2007). Consequently, Mr Manning's operation (present and proposed) is regarded as a key insurance policy for the Mary River cod conservation strategy by QDPI&F.
